F-1-176
Henry Zimmerman Farmstead
Buckeystown
Frederick County

Maryland Historical Trust State Historic Sites Inventory Form

historic Henry Zimmerman Farmstead

street & number 4810 Ballenger Creek Pike not for publication

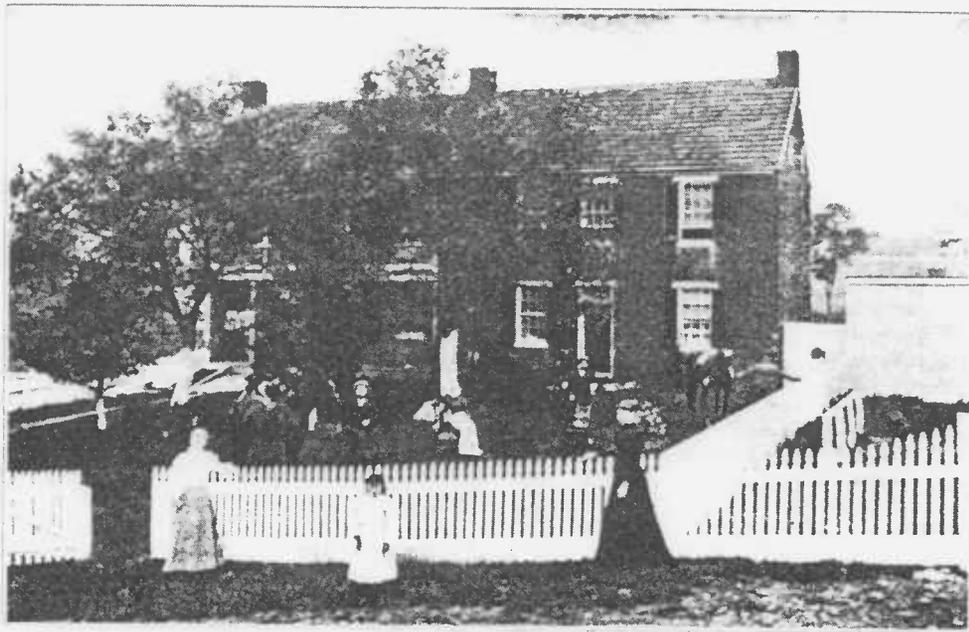
Old Zimmerman Homestead, on Carroll's Manor.

F-1-176
Henry Zimmerman Farmstead
Frederick County
Ca. 1900 view from Williams and
McKinsey, History of Frederick
County, 1910.

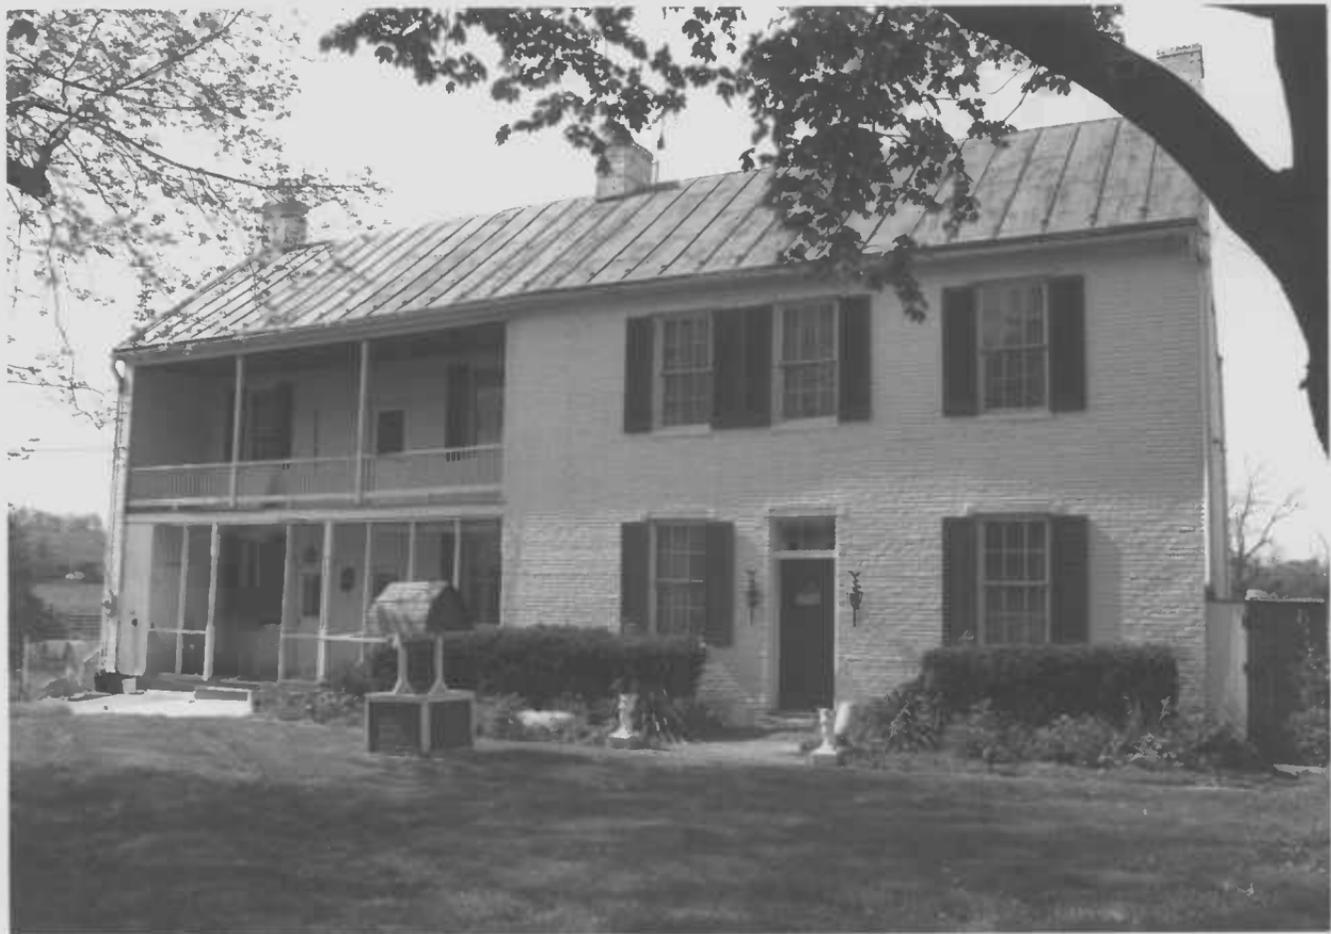
1/8

Southeast elevation

The dwelling has two sections, a three-bay main section on the north and a four-bay side service wing on the south. The 5:1 American bond walls are painted white and the roof is covered with standing seam metal. Interior end chimneys are located at the north and south gable ends of the main section, the southern chimney, with the 1840 date on its north face, being enclosed by the adjoining service wing. A third chimney is located at the south end of the wing. The principal elevation faces east. The three bays of the main section are slightly irregular in spacing with the north bay set at a greater distance from the center entrance. The window lintels have bulls'-eye corner blocks. The sash is 6/6 with louvred shutters. The three-light transom above the door has muntins embellished with floral scrollwork. The door has 10 panels and modern carriage lamps flank the entrance. The boxed cornice has a simple applied molding. The side service wing has an integral two-story open porch with a plain balustrade and chamfered posts on the second level and turned columns on the first level, with added plain supports. The wing has two doors in the inner bays, one of which has been boarded on the second story. The windows are 2/2 on the first story and 6/6 on the second. A circa 1900-1910 photo of the house in Williams & McKinsey, History of Frederick County (1910) shows that the house was unpainted at that date and had a wood shingle roof, which may still be in place under the present metal roof covering. The west elevation of the house has a two-story addition off the service wing, possibly built about 1890, according to Mrs. Curtis Zimmerman, one of the present owners. The addition is covered with vinyl siding, possibly over German siding, and has a composition roof. An enclosed shed porch is on the north side of the addition. The west side of the brick part of the house has three widely placed bays with 6/6 sash and a door opening from the north section of the house onto a concrete porch with a plain modern iron railing.

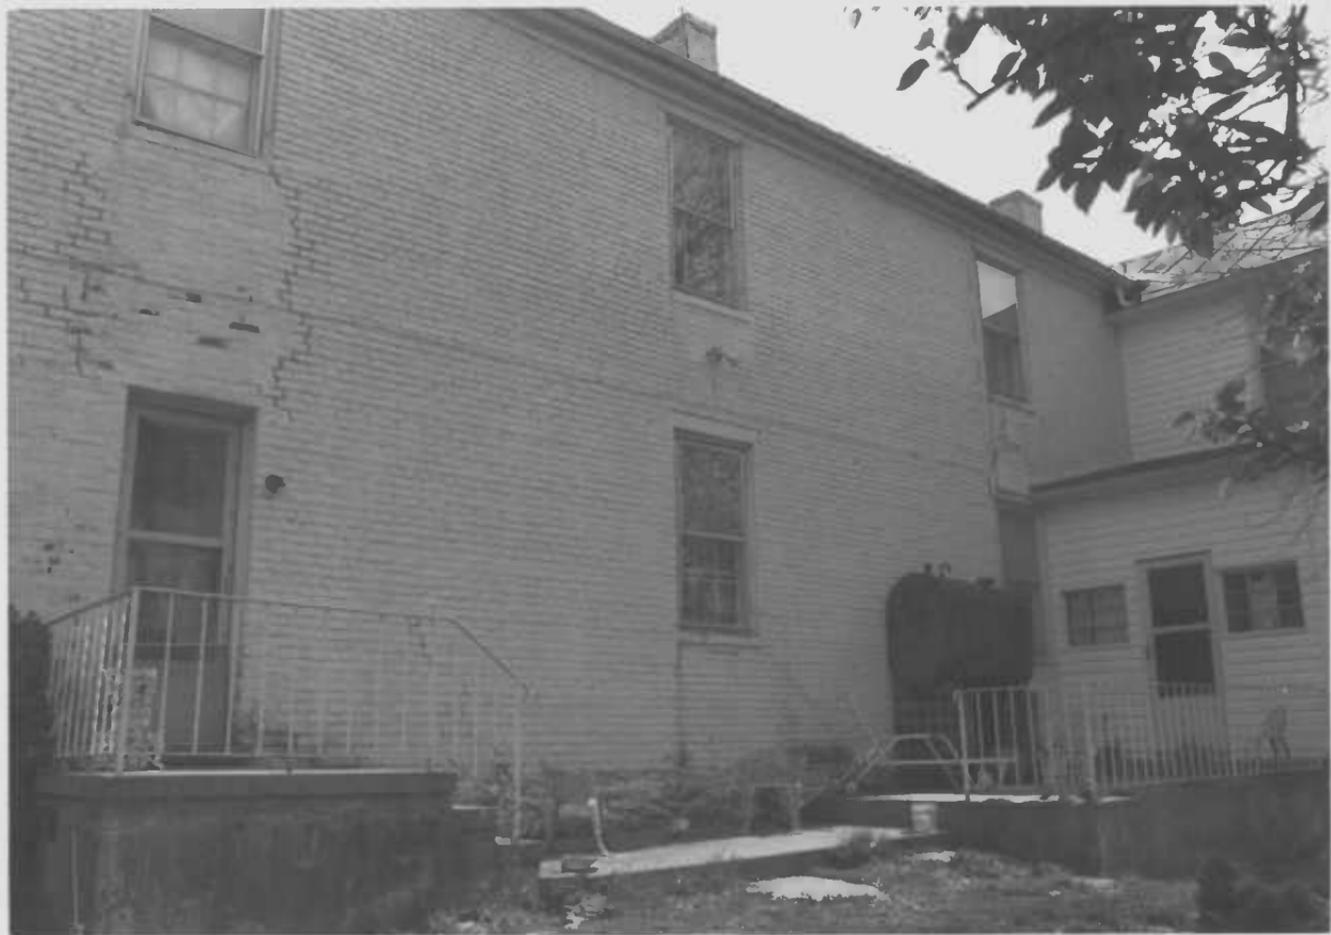
3/8

West elevation, partial view

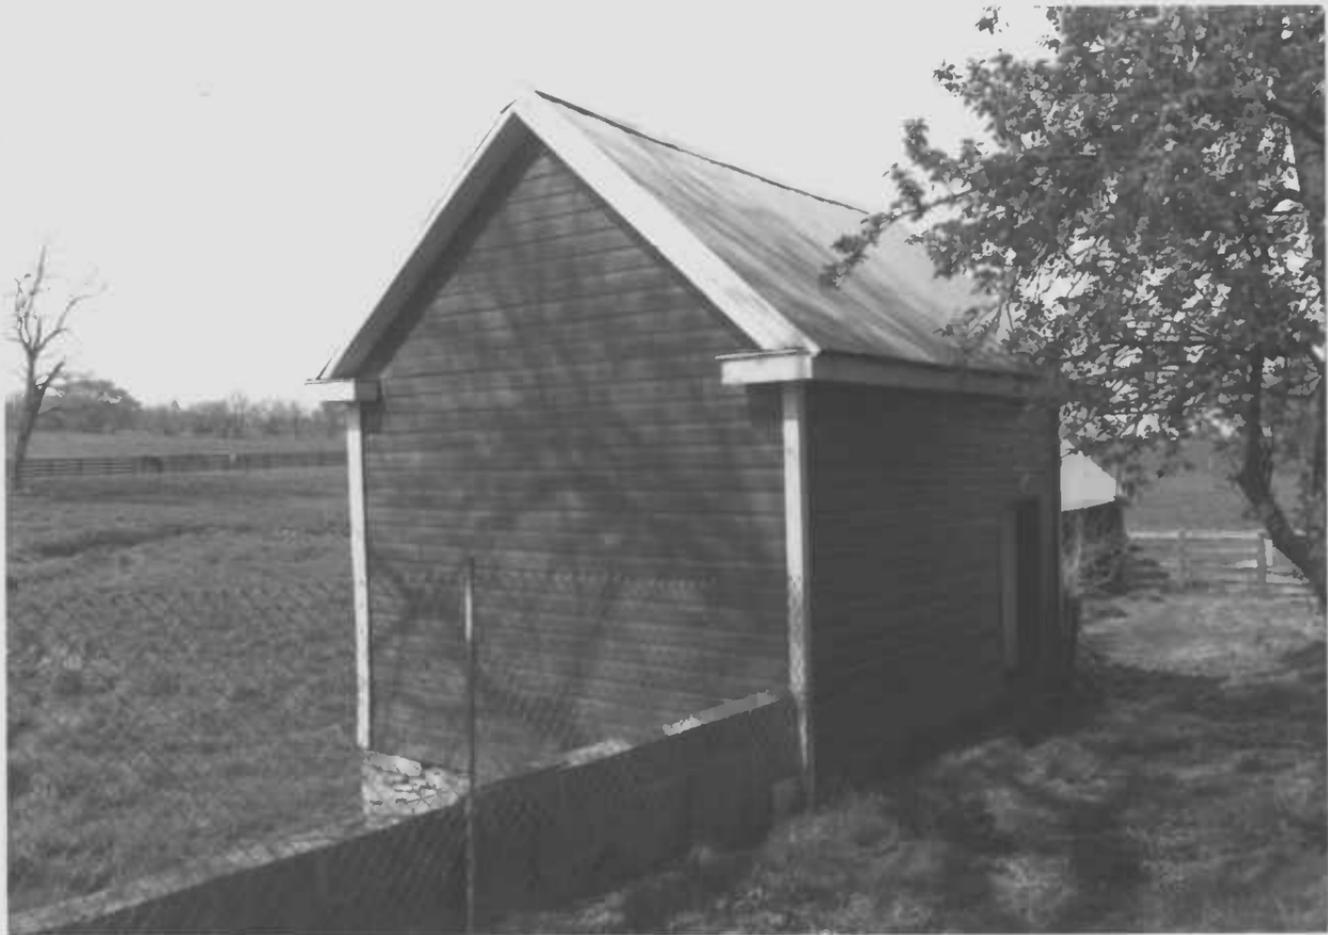
4/8

Smokehouse, southeast corner view

Smokehouse: The log smokehouse is located directly west of the dwelling and has an exposed stone foundation on the west side. The exterior of the small rectangular building is covered with both vertical and german siding. A single door of vertical boards is located near the northeast corner. The gable roof is covered with standing seam metal. The smokehouse probably was built about 1840 based on its location in relation to the house and its log structure.

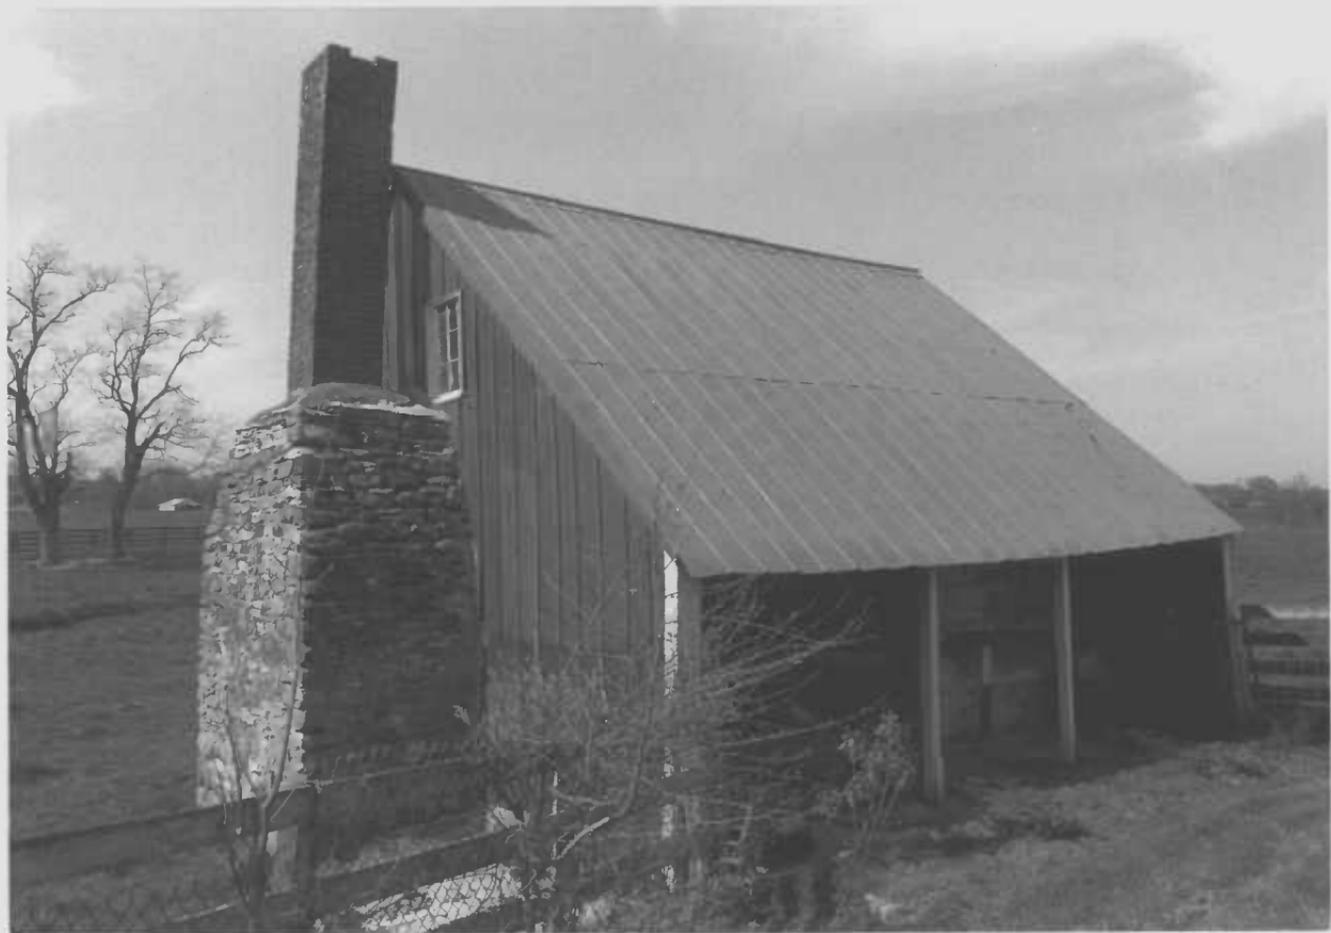
5/8

Summer kitchen, southeast corner view

Summer kitchen: The log summer kitchen is a 1-1/2 story building just north of the smokehouse. It has an exterior stone and brick chimney on the south gable end, where the exterior is covered with board and batten siding. The standing seam metal roof extends low over the east elevation, forming a shed porch over the exposed logs of the facade. A center entrance leads into the two-room first story. A winding enclosed stair rises up to the attic or loft to the left of the door. The partition wall is beaded vertical boards and forms a smaller room on the north end of the building. The large fireplace opening had a crane and tools which were used well into the 20th century and are retained by the present owners. The windows in the first story are 6/6 and a small vertical 6-light window is located in the south elevation next to the chimney stack. Mrs. Zimmerman relayed the family tradition that this structure was the original, late 18th century dwelling on the farm, which was replaced by the brick structure in 1840. Williams & McKinsey's biographical sketch of Isaac Zimmerman (p. 979-980) tends to support this tradition, stating that Henry Zimmerman (1791-1875) "improved the homeplace by the erection of a two-story brick house near where the former dwelling stood." The summer kitchen's size

and finish suggest that it could well have been used as a residence and that it was probably built about 1790.

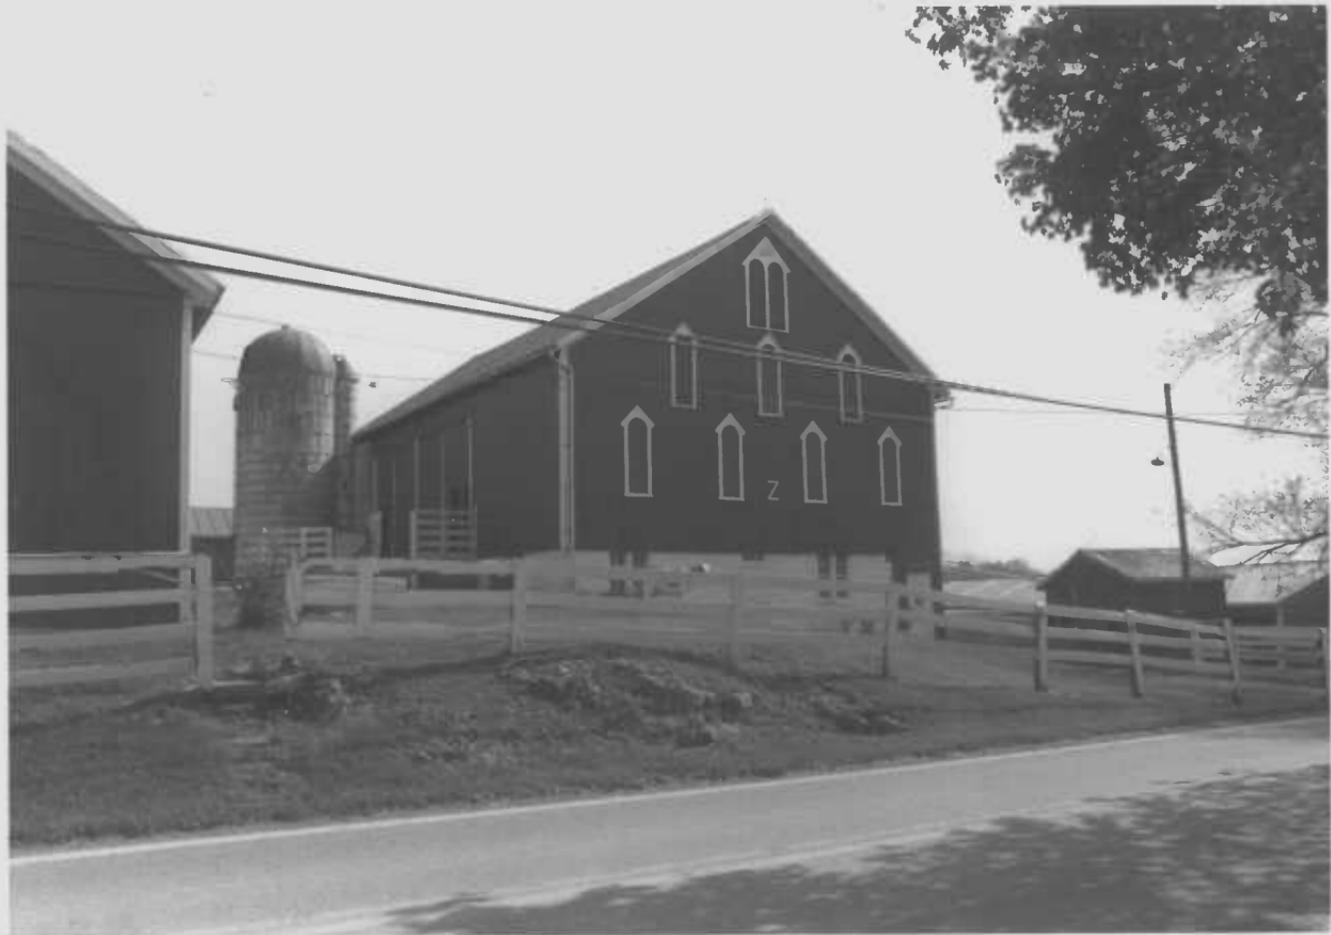
7/8

Born, view from west

Bank barn and milk house: The frame bank barn bears the date 1884 in the west gable end and is sited perpendicularly to Ballenger Creek Pike directly east of the road and the domestic group on the west side. The barn was built by Peter T. Zimmerman (1819-ca. 1903), the son of Henry Zimmerman. The red-painted barn has vertical tongue-and-groove siding with tall narrow louvred vents painted green with white flat surrounds culminating in a gable peak above each vent. On the west elevation the vents are in three ranks with a pair of vents in the gable topped by the inscribed date. An applied initial "Z" is located between the center vents on the lowest rank. The stall level on the south elevation has a partial frame enclosure near the southeast corner for use as a milking parlor. The north elevation has a concrete silo near the ramp to the double swing doors. Two sliding doors are located on the barn level on the south side. The roof is covered with corrugated metal. The milk house is a rusticated concrete block building located near the northeast corner of the barn. Built about 1920-1930, the building has a standing seam metal gable roof and 6/6 windows.

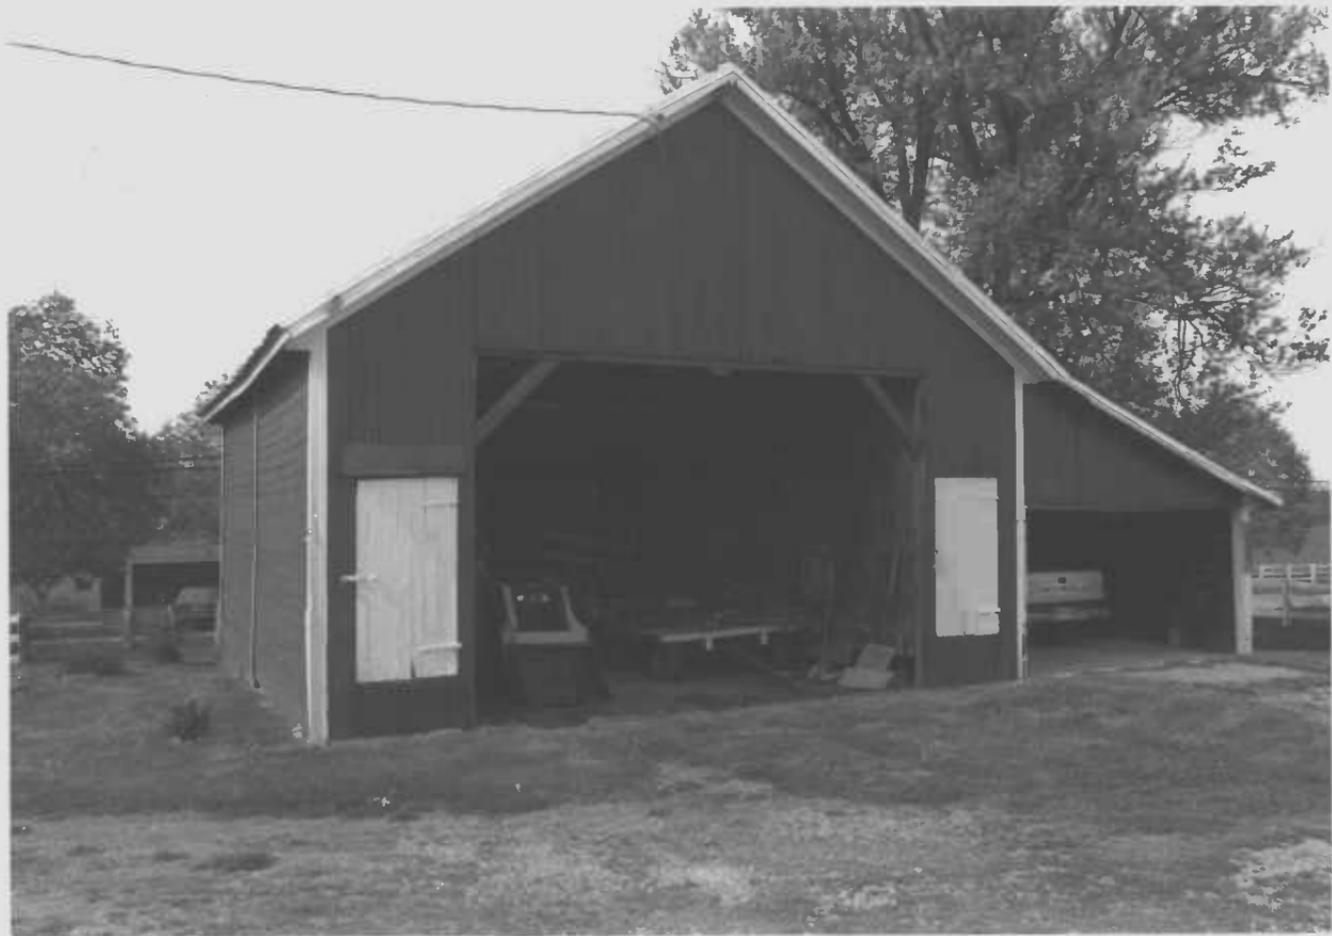
Neg. loc.: Mid. SHPO, Crownsville, Md.
Wagon shed/corn crib, east elevation
8/8

Wagon shed/corn crib: The wagon shed/corn crib is located just northwest of the barn with its drive-through perpendicular to the road. The exterior is covered with tongue-and-groove siding on the gable ends and horizontal siding on the north and south elevations. The roof is covered with corrugated metal. A later extended shed roof on the north elevation forms an extra truck garage. The materials and design of the wagon shed suggest its date as about 1884, probably built about the same time as the barn.
