F-1-196

F-1-196  
Hargett-McBride Farmstead  
Feagaville  
Frederick County

Maryland Historical Trust  
State Historic Sites Inventory Form

historic Hargett-McBride Farmstead

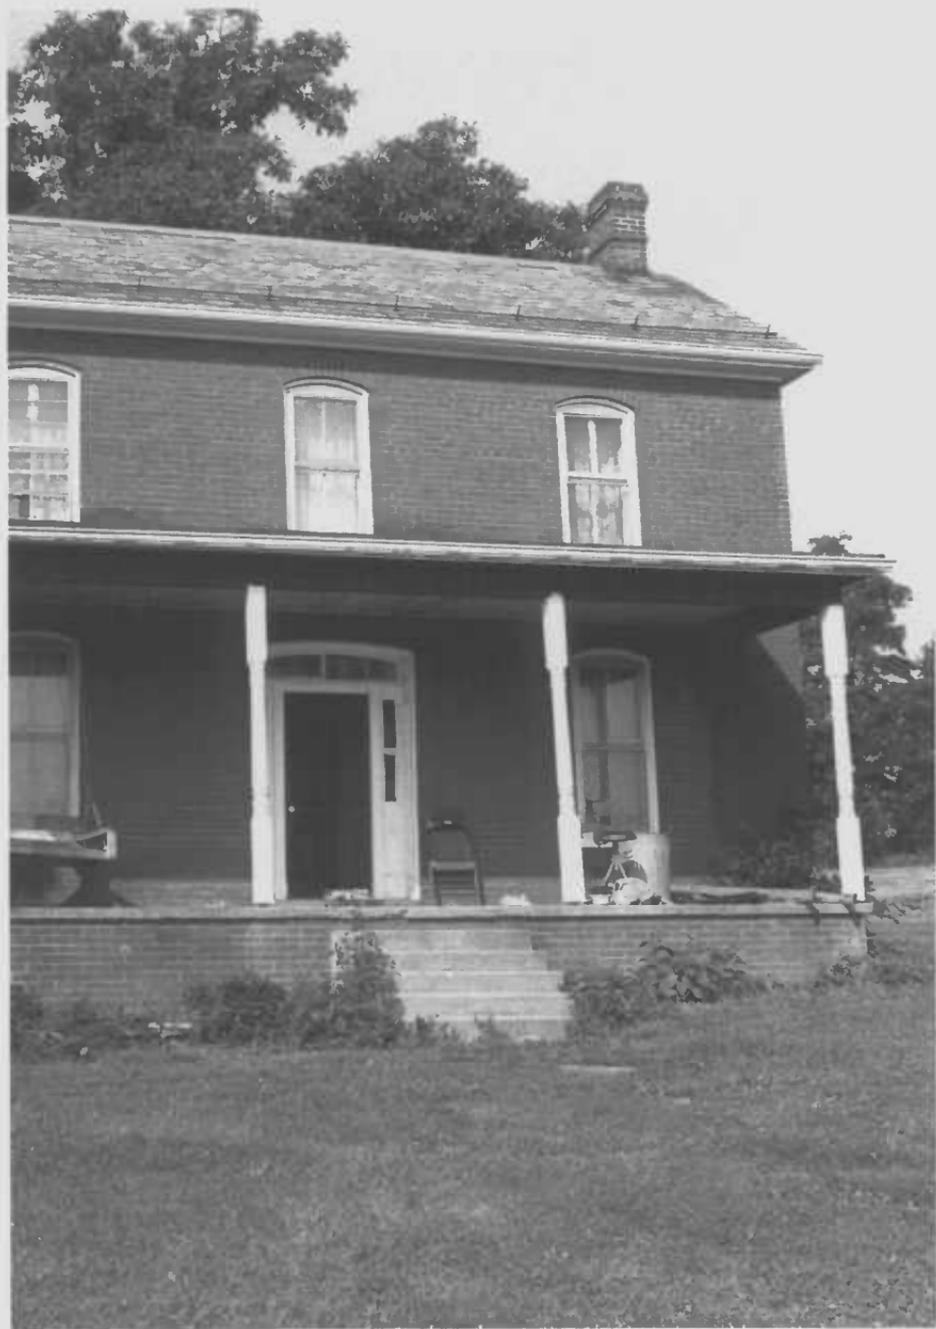
1/6

Northeast elevation

The dwelling is a two-story house with 7:1 American bond walls and three bays on the northeast elevation. A one-story porch with turned columns shelters the main elevation. A two-story rear wing extends from the southwest corner of the main section, with a two-story open porch on the southeast side. The entrance is in the center bay on the principal elevation with a 4-panel door featuring arched moldings. The transom has two lights. The door and window openings have segmental arches and the window sash is 2/2. The gable roof is covered with patterned slate and interior end chimneys are at the north and south ends, which have 2/2 attic windows and a single bay on the northwest gable end. The rear wing's porch has enclosed brick sections at the southwest end on both the first and second stories. The interior was inaccessible for this survey.

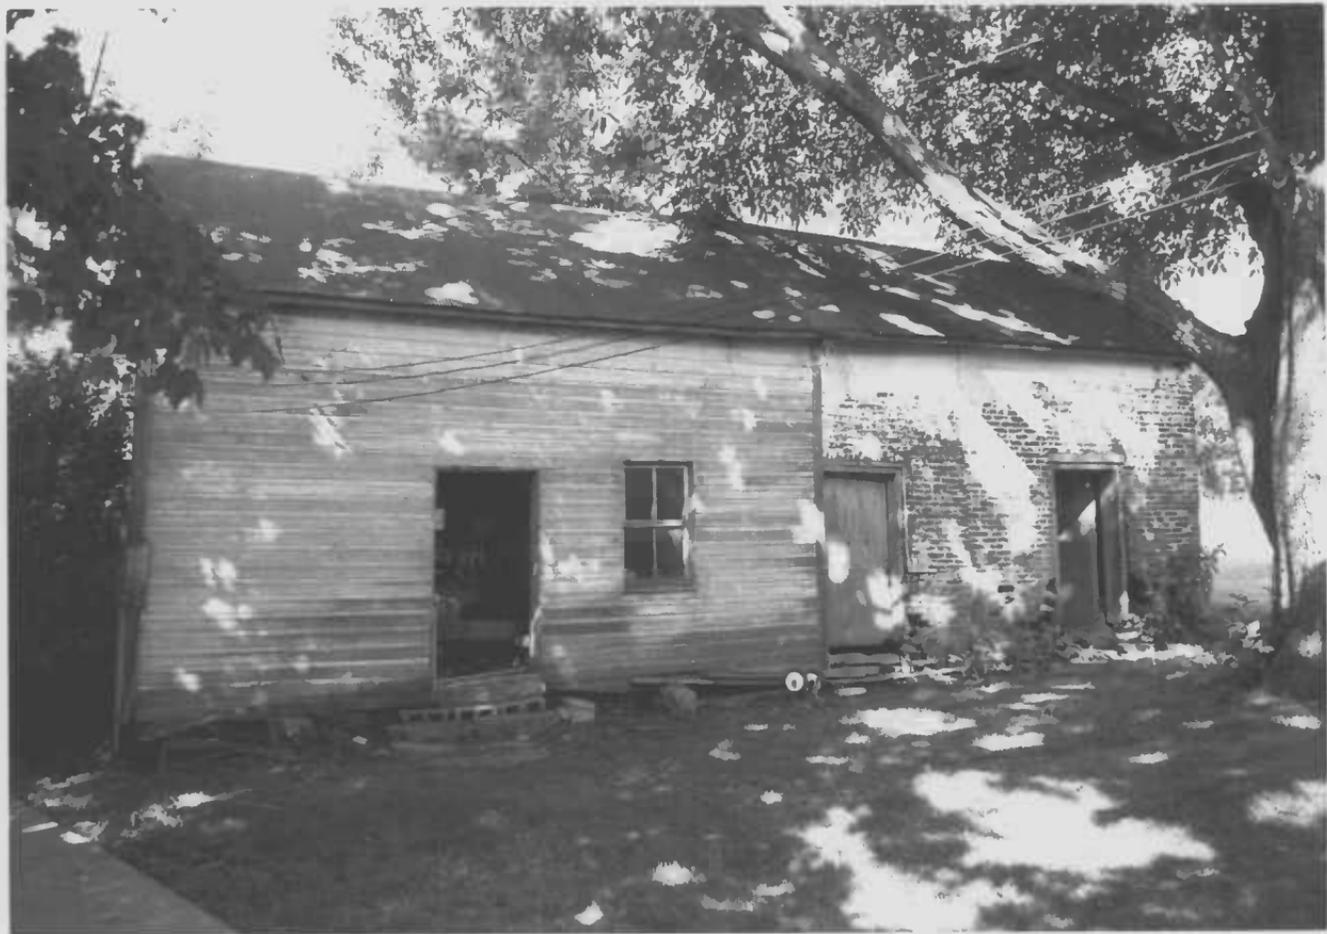
3/6

Smokehouse / summer kitchen, northeast  
elevation

Summer kitchen: The two-section summer kitchen is a one-story building located directly west of the rear wing. Rectangular in form, the north end is brick and the south end, slightly larger, is log with German siding. The roof is corrugated metal and the single window is 2/2 in the log section. Each section has a door opening on the northeast side and a brick section between the two doorways has a third door opening. This plan appears to suggest that the brick section was the smokehouse, perhaps with a bake oven in the middle section adjoining the log summer kitchen, which has a fireplace in the west end. The two sections may have originally been freestanding and were later linked by the middle brick section. The date of the building is at least 1856, but may date in the log part from the second quarter of the 19th century. The brick section is probably of the 1850's or the same date as the house.

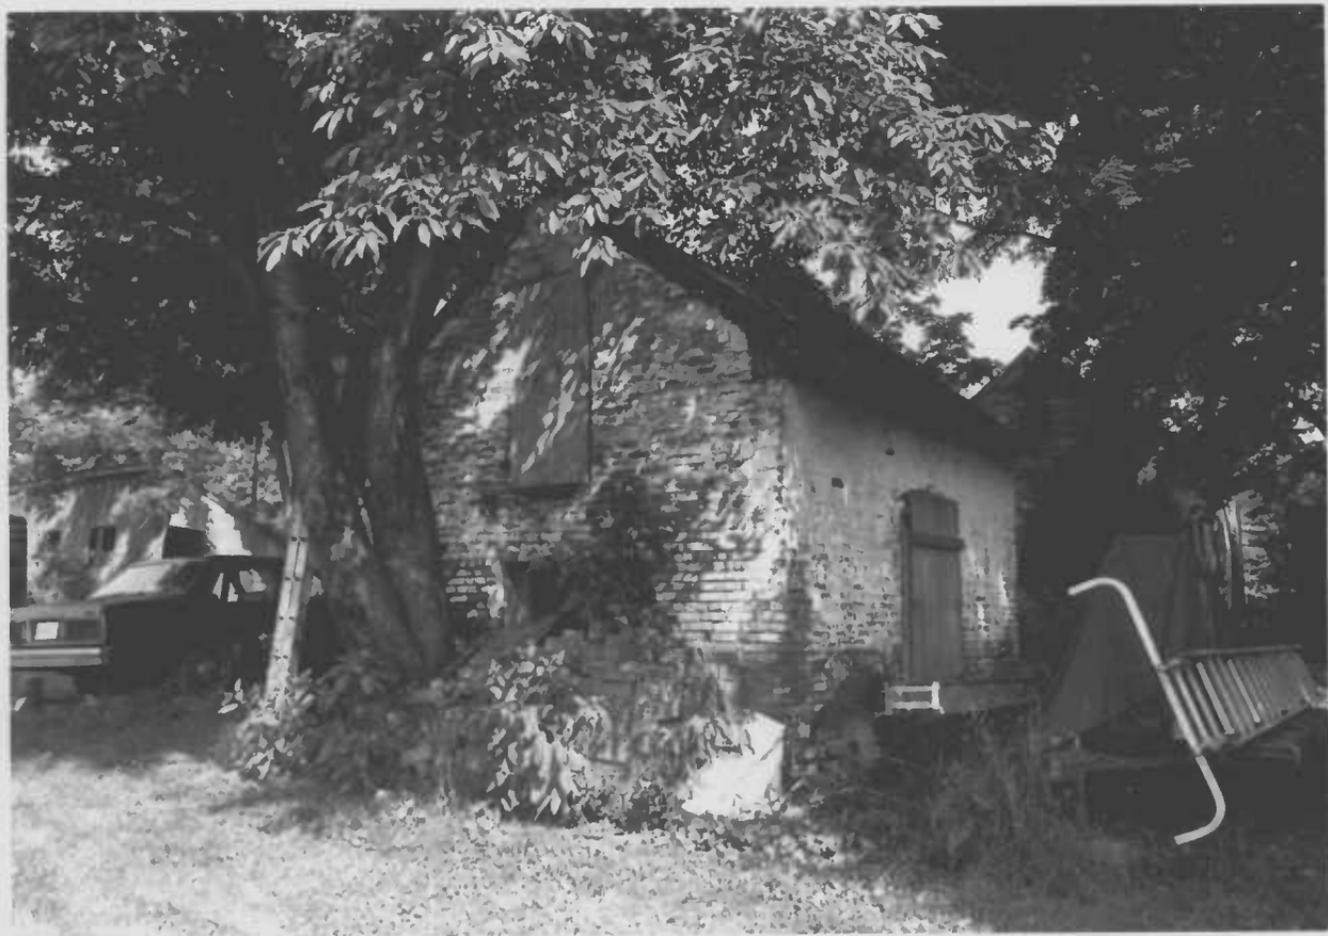
4/6

Smokehouse, southeast corner view.

**Meathouse:** The square plan brick meathouse is located south of the summer kitchen/smokehouse. It has no openings except a door on the north elevation and two doors on different levels on the south elevation. Logs project just below the eaves on the north and south elevations, probably to support hooks for the meats. The gable roof is covered with corrugated metal. The meathouse is in deteriorated condition. The date of this building may be about 1856-1860, possibly built as a separate meathouse when the summer kitchen and smokehouse were linked.

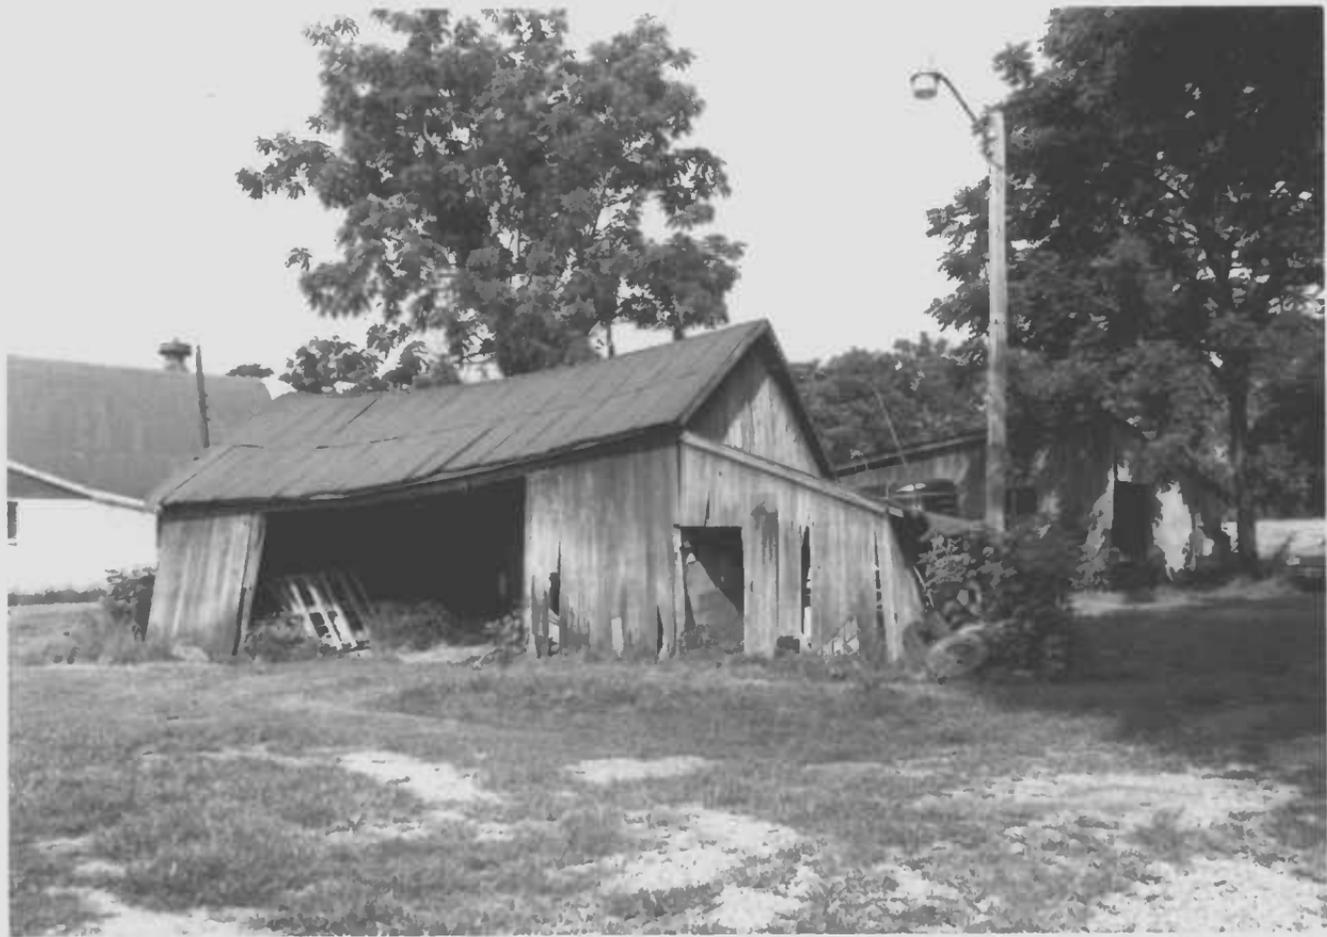
5/6

Chicken houses and sheds, southeast eleva-  
tion

**Chicken houses:** Several frame chicken houses and sheds are located west of the domestic buildings. They are in very deteriorated condition, but most have vertical siding and corrugated metal roofs. According to Millard F. McBride's biography in Williams & McKinsey, these chicken houses probably date at the earliest from about 1907, when he began to raise poultry for commercial sales. Owners of the property subsequent to McBride, after 1917, probably carried on this use and may have added other chicken houses up to the 1940's. A non-contributing dairy barn and milk house nearby suggest the transition to dairying as the principal farm product during the second quarter of the 20th century.

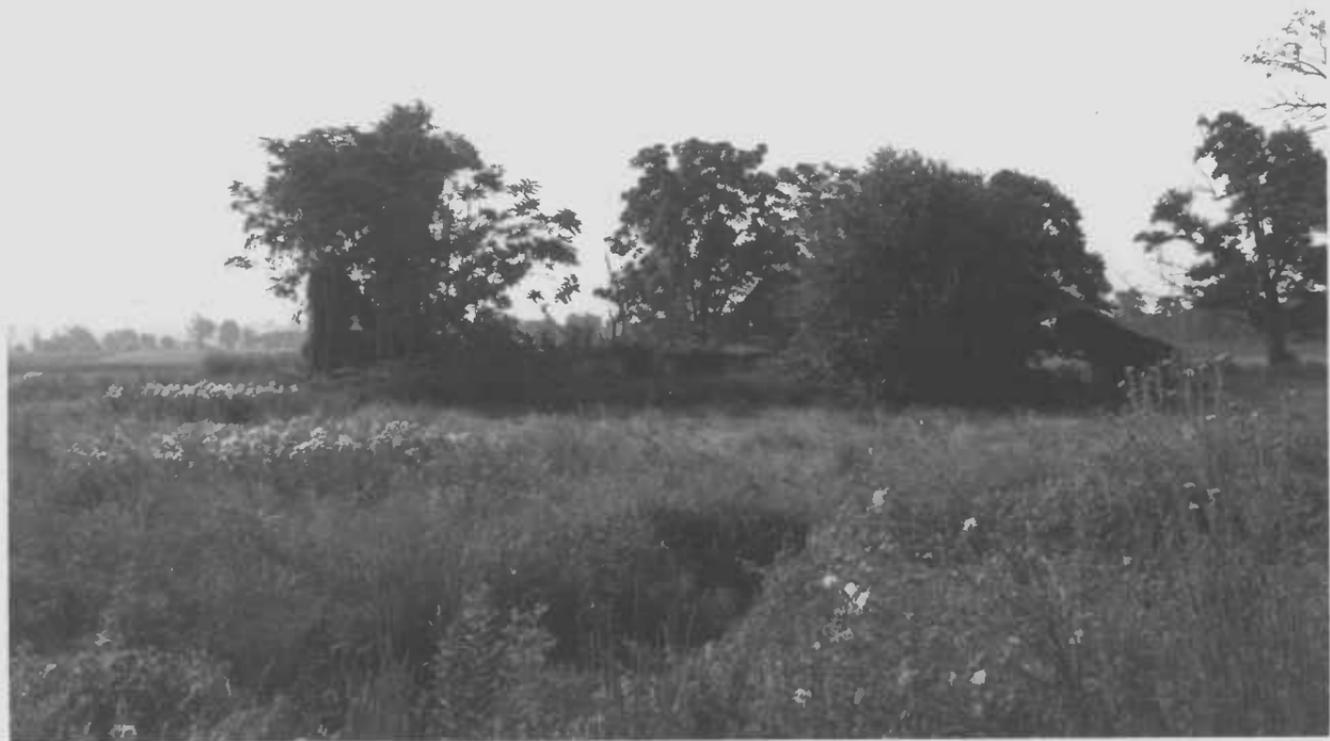
6/6

Ruins of brick barn and wagon shed/corn crib  
View from north

**Ruins of brick barn and wagon shed/corn crib:** The ruins of these two buildings are visible to the south of the main section of the farmstead, with overgrowth concealing much of their appearance. The barn's stone foundation is visible and the remaining sections of the end walls show that it had pierced vents in the wheat sheaf pattern observed on brick barns more commonly found in the northern section of Frederick County. The barn ruins could not be dated from the distant field observation; however, Williams & McKinsey's biographical sketch of McBride states that it was "one of the oldest in the county". The wagon shed/corn crib ruin is at the southwest end of the barn. It appears to have been the typical frame type of the period about 1900 with a single drive-through, vertical siding, and a corrugated metal roof.
