Samuel C. Thomas Farm Outbuildings  
Adamstown vicinity  
Private

# Maryland Historical Trust State Historic Sites Inventory Form

historic Samuel C. Thomas Farm Outbuildings

Survey No. F-1-197

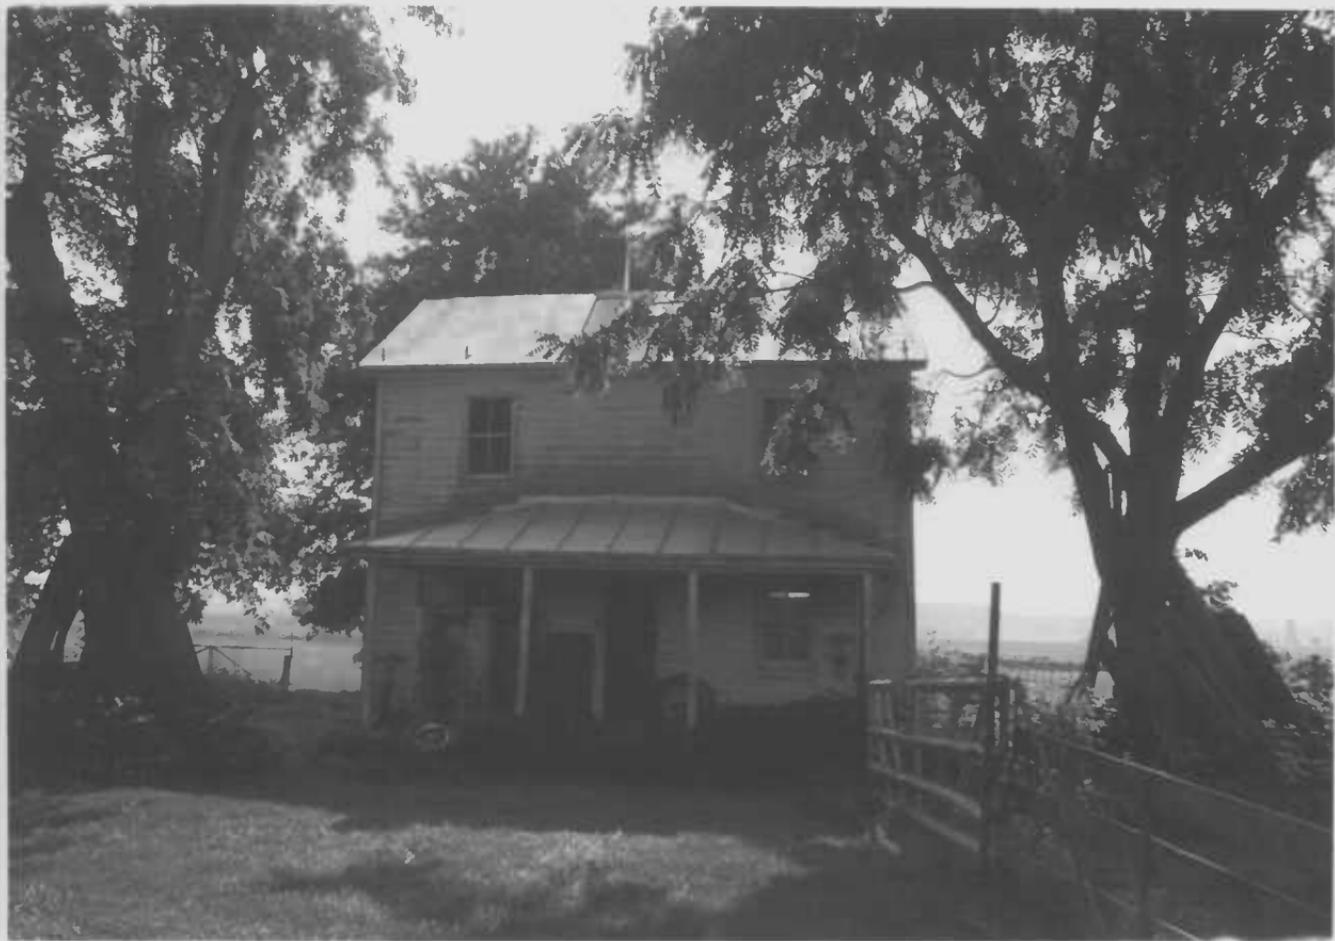
1/5

The tenant house was also built about 1900, based on its materials. According to information supplied by Ms. Sarah Hoffman, whose aunt lived in the house in the 1950's, the house was originally a chicken house that was later converted to a tenant dwelling. The two-story german sided building has all the features of a simple vernacular house of the period about 1890-1910, pointing to the possibility that the chicken house may have been a temporary use in the early 20th century. The west elevation had three bays on the first story and two on the second. A one-story shed porch covers the lower part of the elevation. The sash is 2/2 and the roof is covered with standing seam metal. The chimney is off-center at the ridge. The east elevation has two bays, one with a glazed panel door. The interior has plaster walls over lath and a two-room plan. No fireplace or mantelpiece is present, and it appears that a wood stove provided heat as well as the cooking fire. The house is

in generally deteriorated condition and is also a storage building in the farmstead.

Tenant house, west elevation

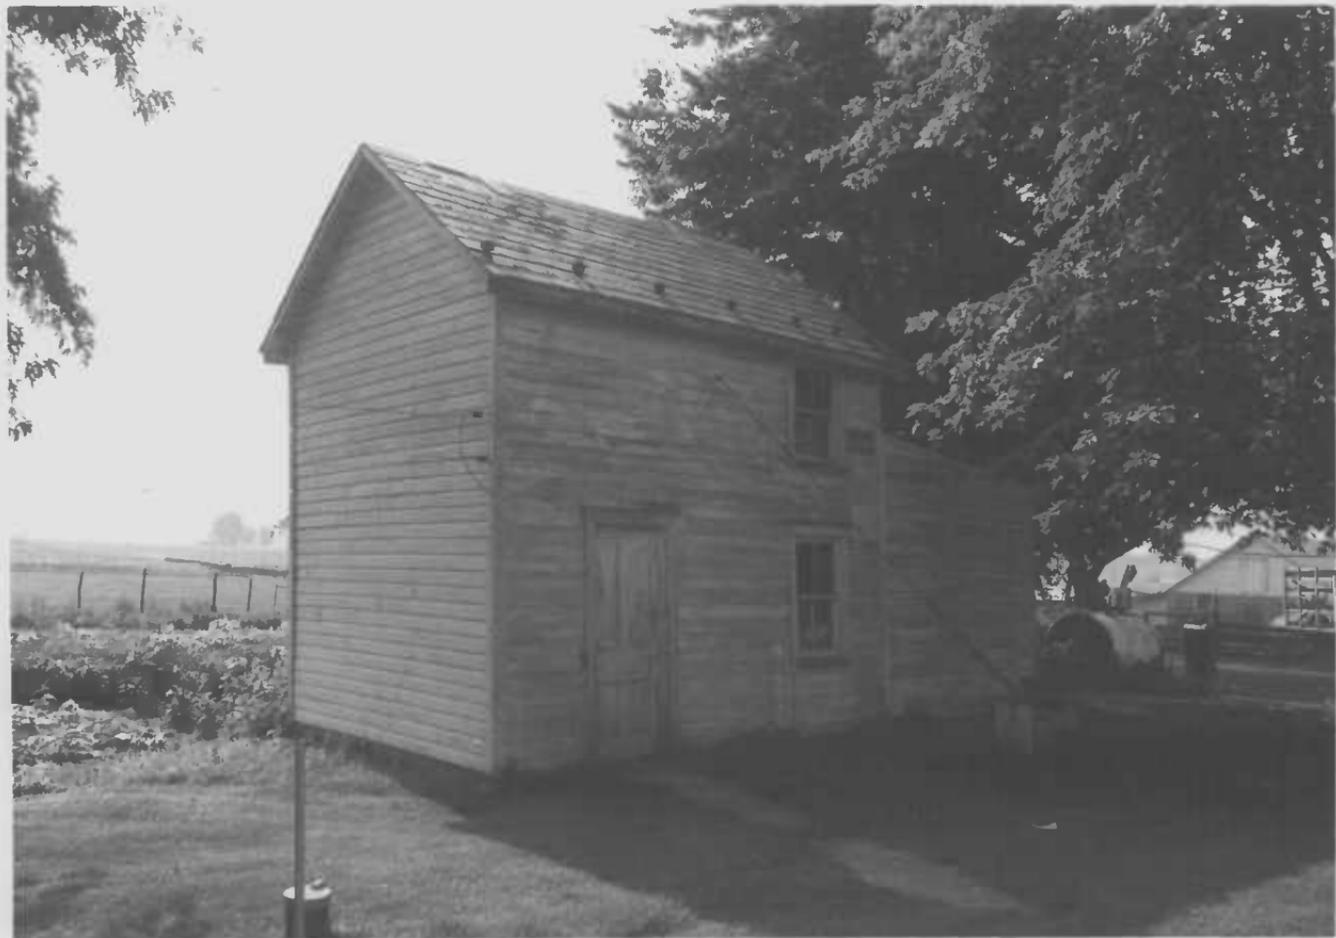
2/5

The summer kitchen is a frame building with two stories and a gable roof with its principal elevation facing west. The exterior is covered with german siding and the roof is slate. The west elevation has an irregular bay arrangement, with a single doorway in the north bay and a two-story bay on the south with 2/2 windows on each level. The door itself is a 4-panel type. The north elevation has no openings and the east elevation has a single off-center bay with 2/2 windows. The south elevation originally had an exterior chimney which has been removed. The outline of the chimney is visible on the south gable end and the slate roof has a break in the eave where the stack rose above the roof. The chimney was apparently removed at an unknown date prior to the 1950's and a one-story windowless shed addition added to the structure. On the interior, the south wall was completely removed inside this shed. The outline of the original hearth is still evident in the floor. The building was probably built about 1875-1878 in its original form and is now in fair condition and used for storage.

Summer kitchen, northwest corner view

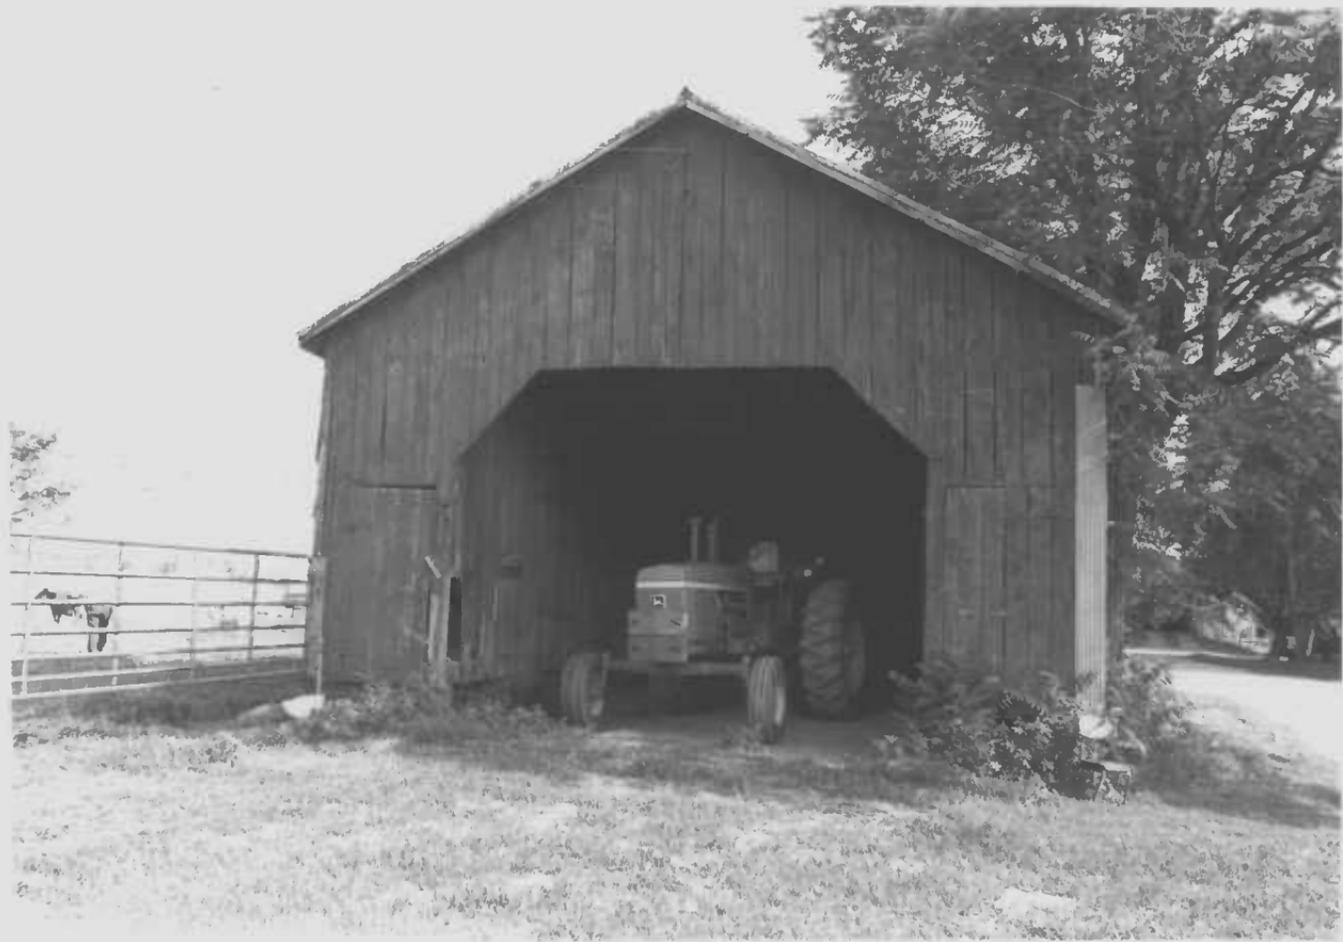
3/5

The wagon shed/corn crib has vertical siding on the south elevation, while the east and west elevations are covered with various types of metal siding. The roof is corrugated metal. On the north end of the shed is a non-contributing, open-sided equipment shed added after 1964. The wagon shed was probably built about 1900.

Wagon shed/corn crib, south elevation

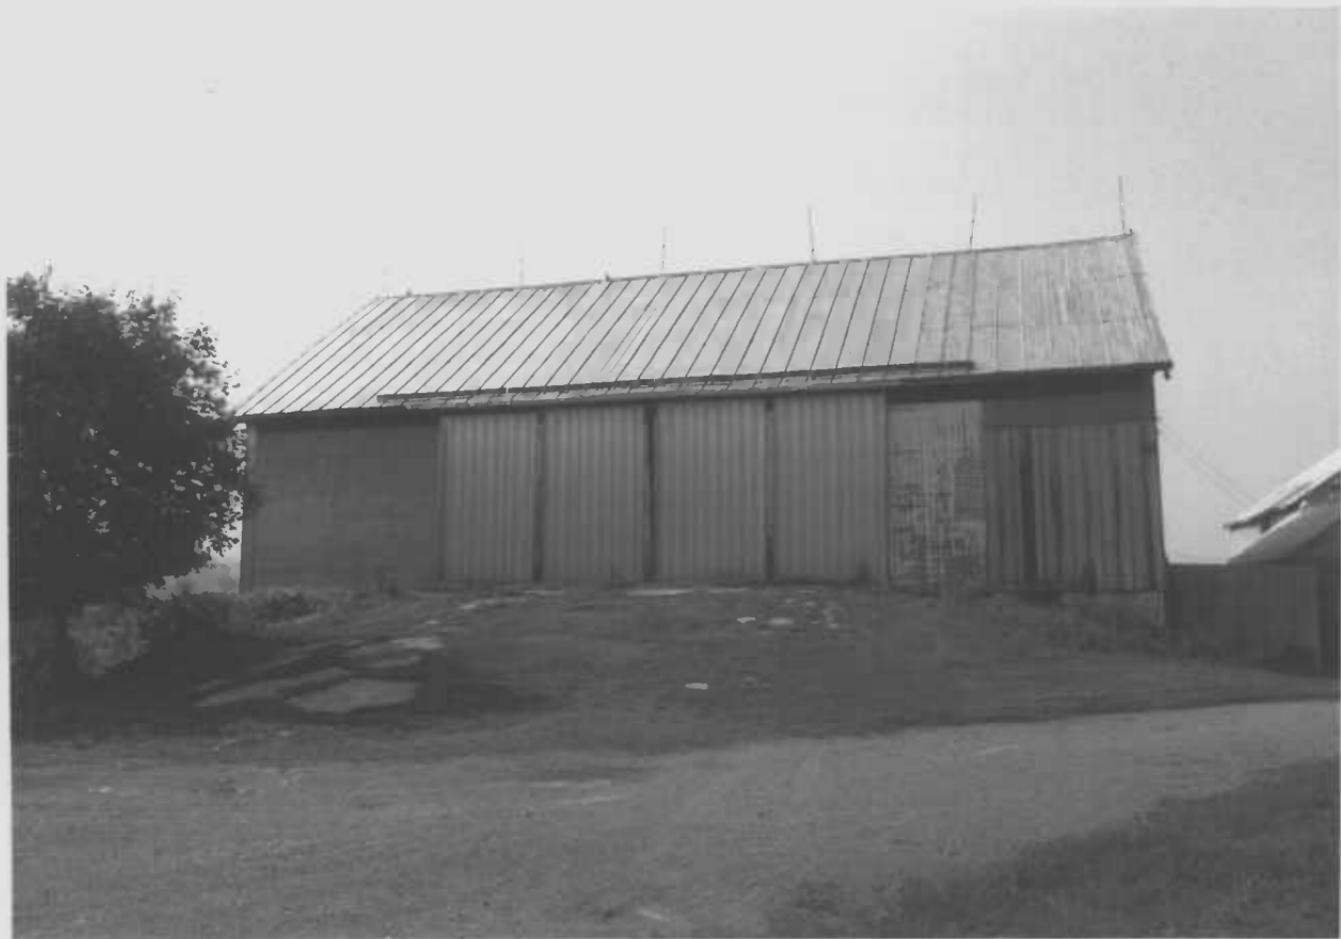
4/5

The bank barn is located south of the domestic buildings and the wagon shed. It has been almost completely covered with various types of metal siding on the north, west, and east elevations. Large sliding metal doors are on the north elevation. A small section of the vertical siding is exposed to the right of the doors, showing a louvred arched vent as well. The roof is also standing seam metal. The barn was probably built about 1875-1890, based on its general form and details. The rusticated concrete block milk house with corrugated metal roof and german sided gables is located east of the barn. It appears to have been built about 1920.

Bank barn, north elevation

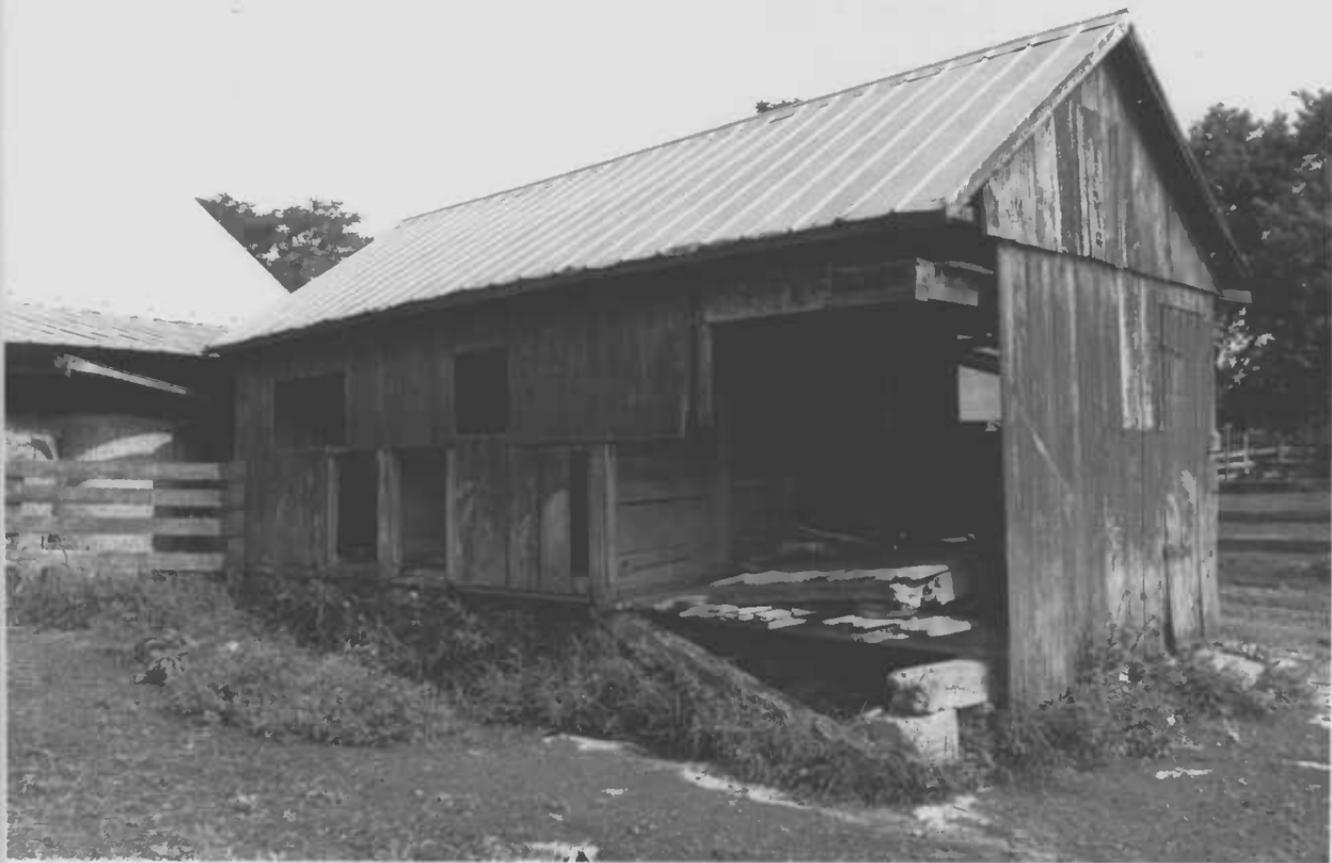
5/5

The hog barn is located east of the bank barn. It is in deteriorated condition and part of its south wall has been removed. The rest of the vertical siding and standing seam metal roof remain fairly intact, however. The barn was probably built about 1910-1920.

Hog barn, southeast corner view
