Hersperger-Harley Farmstead
Burkittsville vicinity
Private

Hersperger-Harley Farmstead
Frederick County

Survey No. F-2-87

**Maryland Historical Trust
State Historic Sites Inventory Form****1. Name** (indicate preferred name)

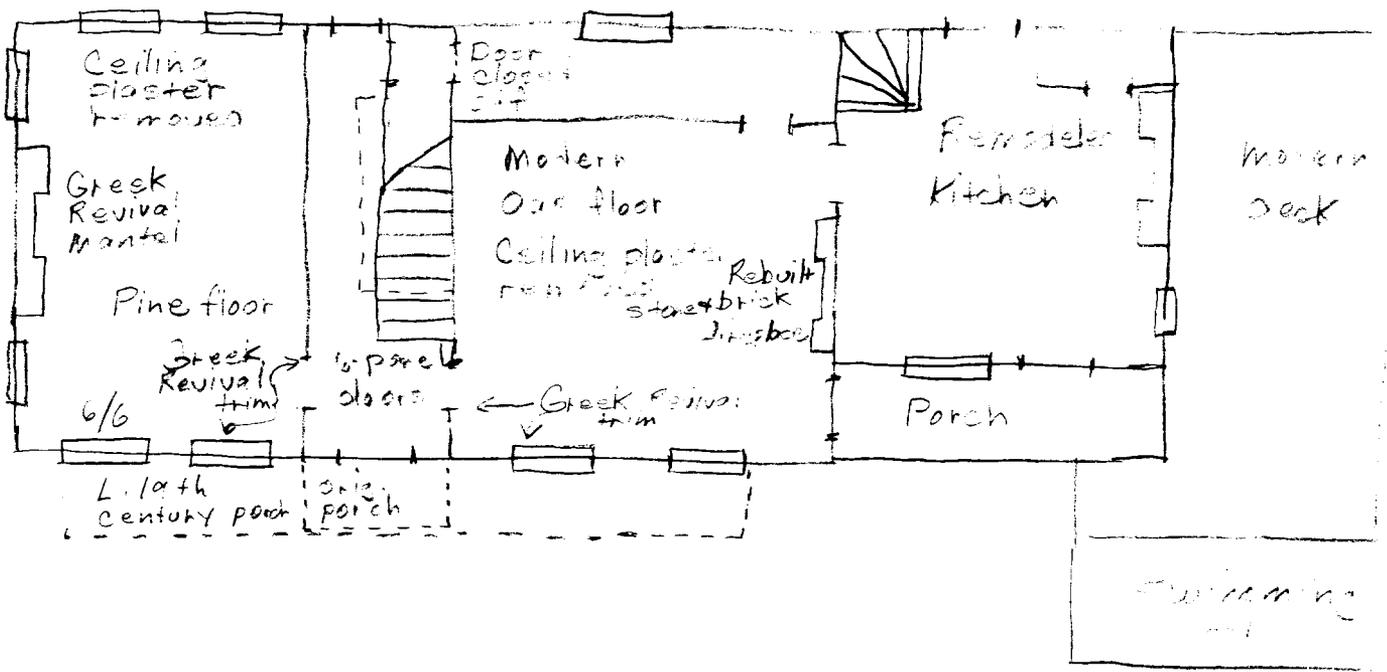
Hersperget-Harley House
Frederick County

The interior plan of the house has a center hall with flanking parlors, the east parlor having a small rear room separated by a partition wall. This plan is typical of the mid-19th century in Frederick County. The side wing is accessed on the first story through a doorway flanking the fireplace in the east room. The

interior has been considerably altered through deterioration, repair, and rehabilitation and remains a work in progress. At most of the doorways and windows is the original Greek Revival trim with shallow molded architraves and bull's eye corner blocks. The windows have simple recessed paneled soffits. The plaster walls have been largely resurfaced or covered with wallboard, although the baseboards are original. The doors are painted and grained, although some have been painted since the 1980's. The floor in the east parlor has been covered with new pine flooring and the stone and brick fireplace is a 1980's rebuilding with the original bricks. A hearth was added during this work. The current owners, Mr. and Mrs. Rice, said an inscribed and dated brick bearing the name of Cornelius Harley was in the deteriorated chimney before the work was done. This suggests that the 1849 chimney was probably altered by Harley when he acquired the house in 1879. The ceilings in the first story parlors have been removed, revealing the floor joists anchored into a large hewn summer beam running east and west through the structure. In the west parlor is an original Greek Revival mantelpiece with a simple paneled form surrounding an opening which has been altered at least twice, the most recent being in the 1980's. The first alteration probably closed off the fireplace for use with a wood stove, the typical heating system improvement of the late 19th century. The latest alteration re-opened the fireplace and added a glazed firebrick lining. The pine floor is original. Considerable water and dampness deterioration took place in the room and the walls have been covered with wallboard. According to Mrs. Rice, a stenciled border was on the original wall near the ceiling. In the center hall, two colors of paint on the original walls seem to indicate that a border or other feature was also present, but layers of paint over wallpaper, now in fragments, have obscured its original appearance. The main door has a four-light transom. The staircase has plain square balusters and a turned newel with an extended, drum-shaped cap.
