F-3-75
Pittinger-Hiteshew Farmstead
Lewistown vicinity
Private

F-3-75
Pittinger-HitesheW Farmstead
Lewistown
Frederick County

Maryland Historical Trust State Historic Sites Inventory Form

historic Pittinger-Hiteshew Farmstead

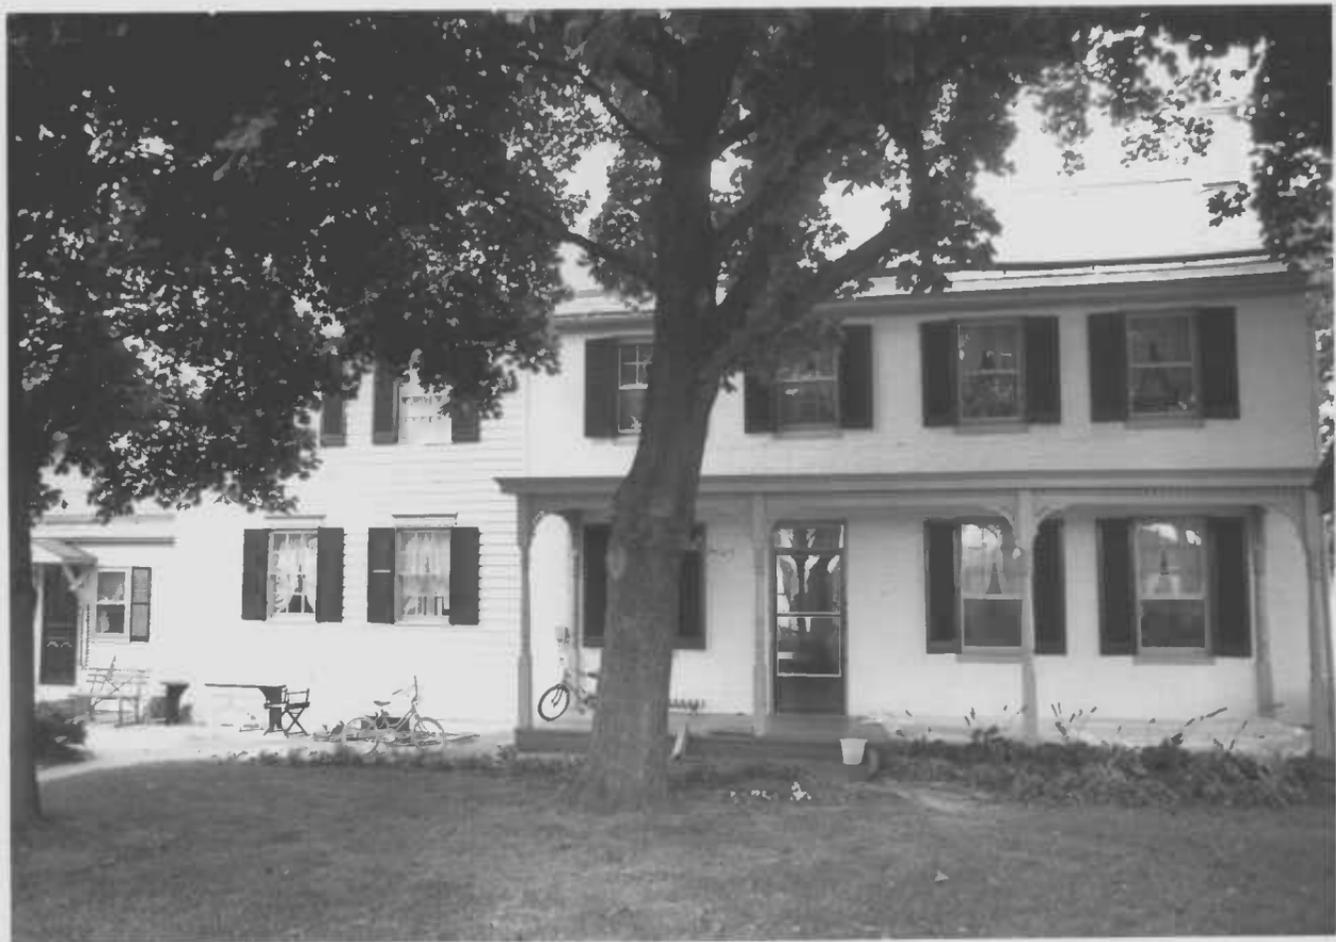
1/7

The dwelling has a four-bay west elevation on the main section with a late 19th century one-story porch with brackets, a dentil molding, and turned columns. The flemish bond brick is painted. The cornice is corbeled and the slate roof is patterned, indicating that it may be a late 19th century replacement of an original roof. The chimneys are located at the north and south gable ends. The north chimney is enclosed by the adjoining two-story wing. The main elevation originally had double entries, but the southernmost entrance was converted to a window, possibly in the early 20th century. The remaining doorway has a paneled door. The windows are 9/6 on the first story and 6/6 on the second story, with working louvred shutters and gauged arches. The south elevation has no openings except two 2/2 attic level windows. The east elevation and the south elevation are in 5:1 American bond. On the east elevation of the side wing is a modern addition which also extends to part of the main section. The west elevation of the wing originally was built as a recessed front wall with an exterior two-level open porch in the traditional vernacular style of German houses. In the early 20th century, the upper level was enclosed and in the mid-20th century, the lower level was also enclosed to be converted to a bathroom. The present exterior wall is flush with the elevation of the main section and faced with weatherboard siding. Attached to the wing on the north is the modern kitchen in what was probably a summer kitchen which may have been free-standing or linked to the side wing of the dwelling. This section is one story in height and has a plain slate roof. The original chimney may have been located on the north gable end and was moved to the east elevation in the early 20th century. With the modern sun porch addition on the rear of this section, all interior traces of the original or later location of the chimney have been removed.

West elevation

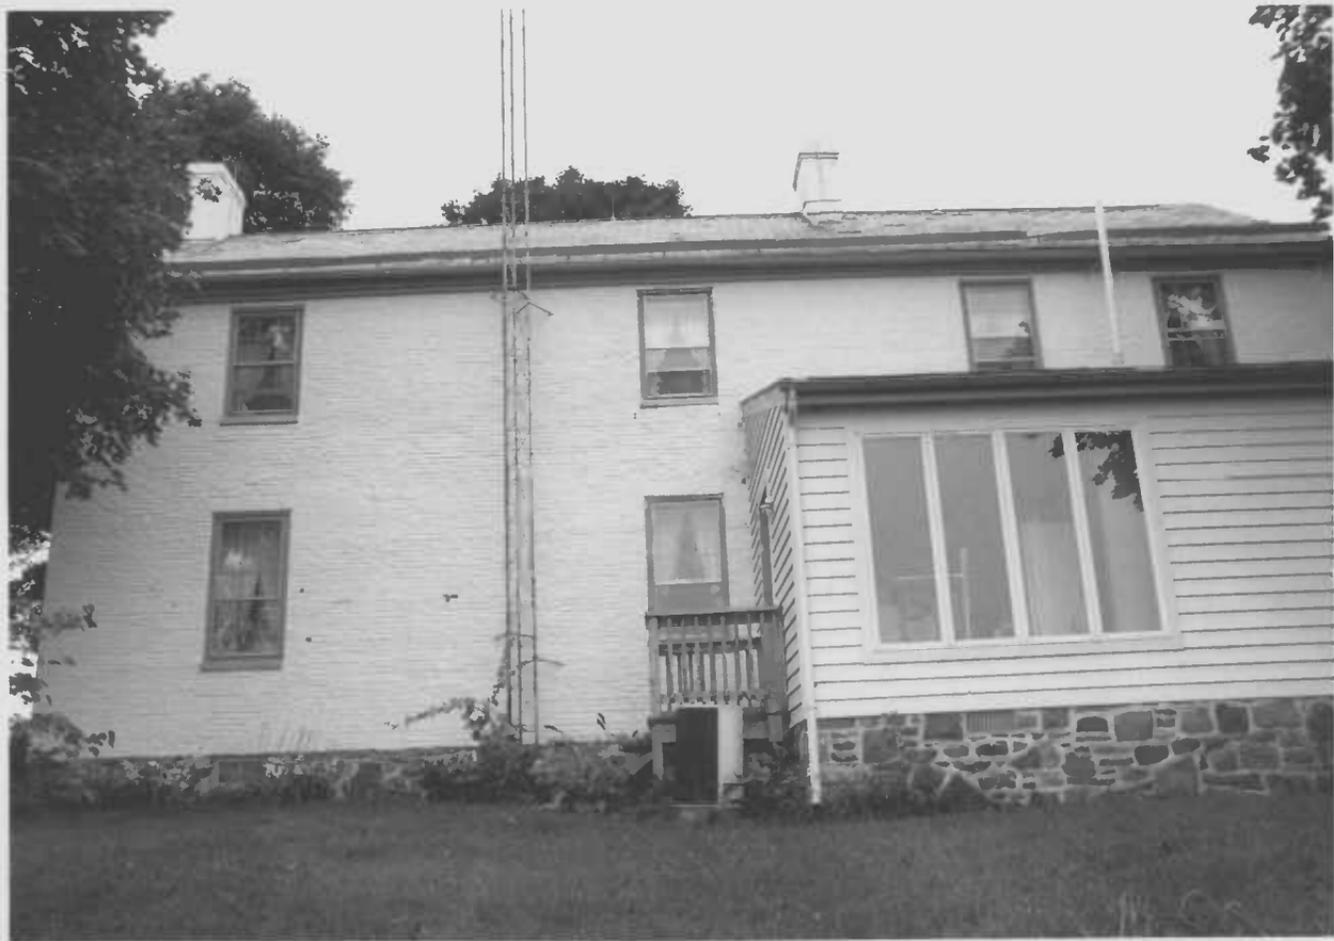
2/7

East elevation

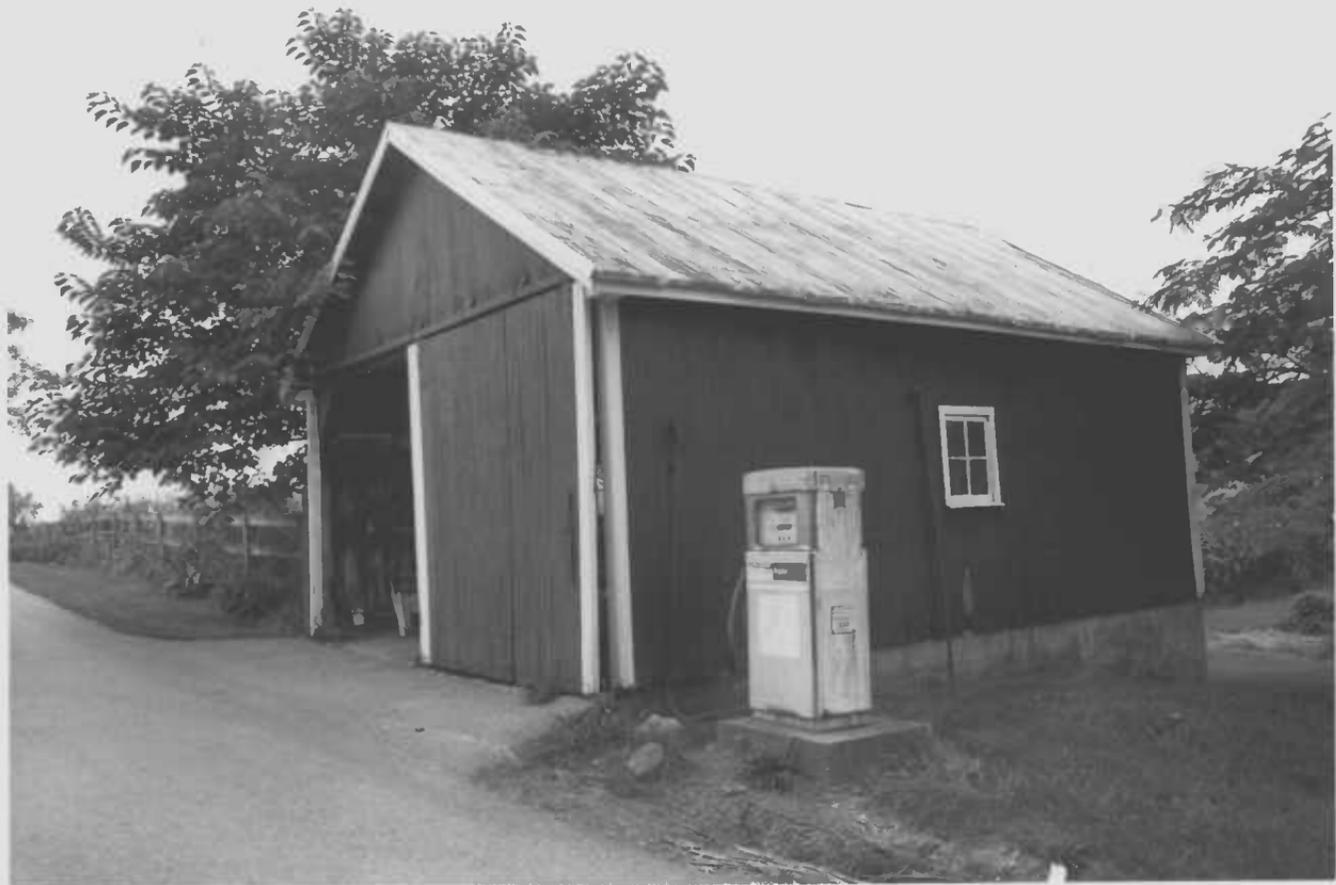
3/7

Garage: The frame garage appears to have been built about 1890-1900. It has tongue-and-groove siding and sliding doors on the south elevation. A 2/2 window is located in the east elevation and the roof is standing seam metal.

Garage, view from east

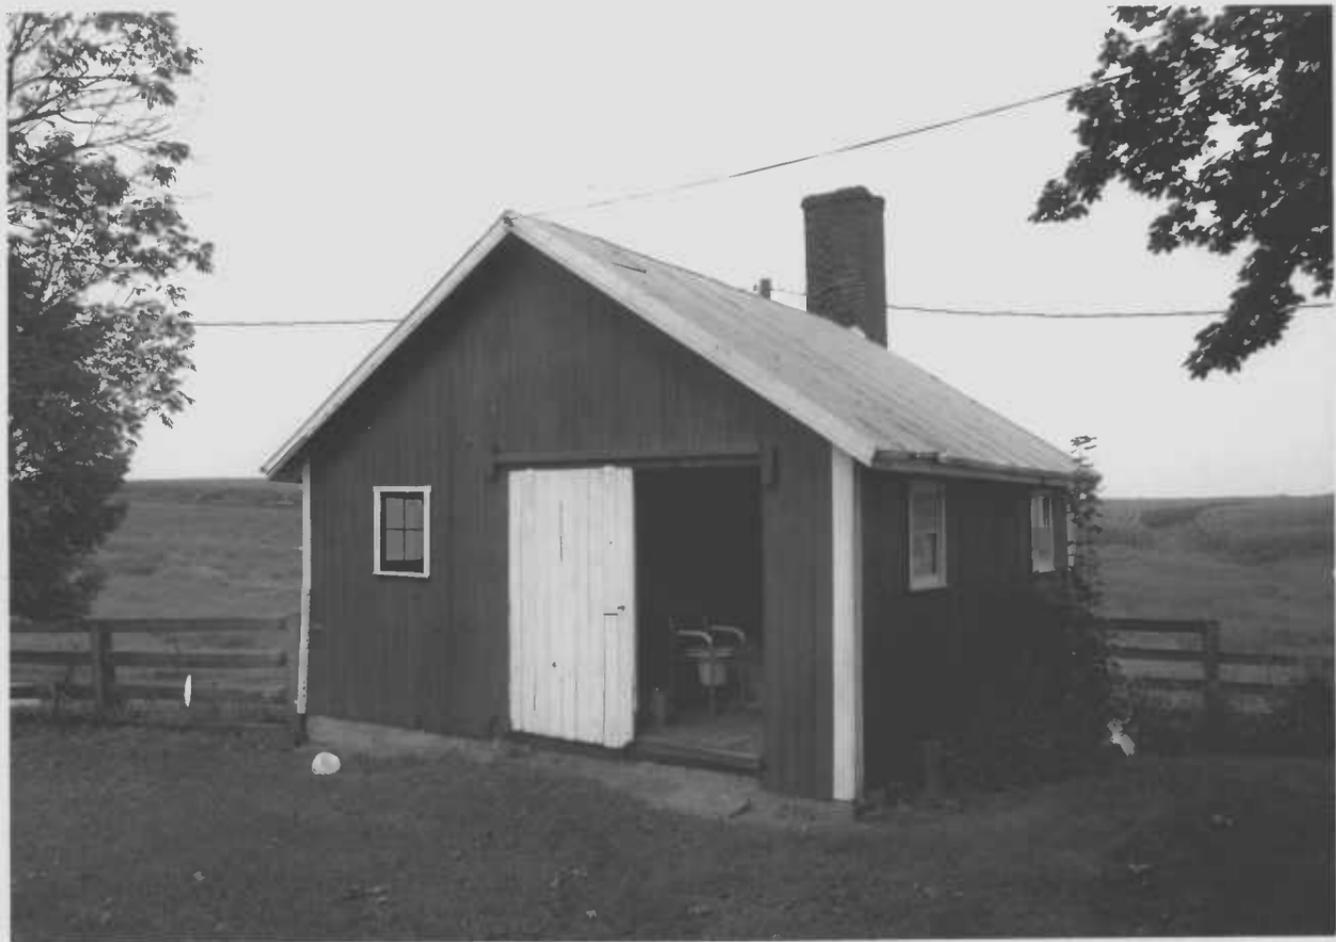
4/7

Butchering shed: The frame shed now used as a farm shop may have been built about 1890-1900 as a butchering shed. It is located just north of the house and a smokehouse, now demolished, stood between the house and the shed. The one-story frame building has tongue-and-groove siding and a standing seam roof with a stone and brick chimney located on the east gable end. A vertical board door is in the west elevation and 2/2 windows are in the north and south elevations. A trap door in the interior floor leads into a stone cellar under the building.

Butchering shed, west elevation

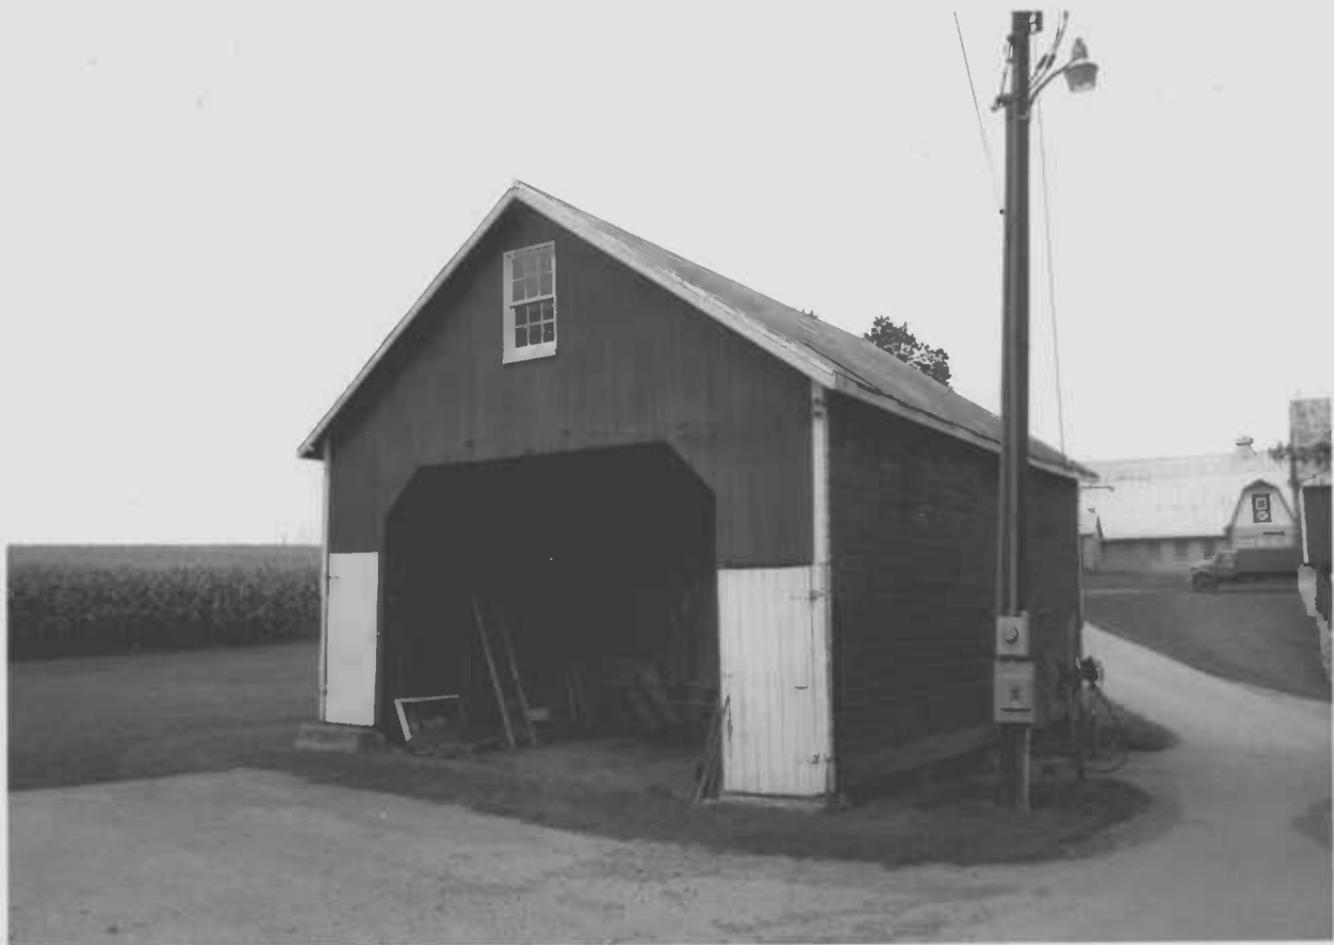
5/7

Wagon shed/corn crib: The frame wagon shed/corn crib was built in 1916, according to an inscribed concrete support pier, which has the date May 22, 1916 and the name Everett Stull. Since John H. Whitmore was the owner of the farm at that date, Stull was probably the farm tenant at the time. In the 1940's, the Stull family acquired the farm in its own name. The wagon shed has vertical tongue-and-groove siding on the south elevation and horizontal flush boards on the east and west elevations. The roof is covered with corrugated metal. In the south gable is a 6/6 window.

Wagon shed / corn crib, south elevation

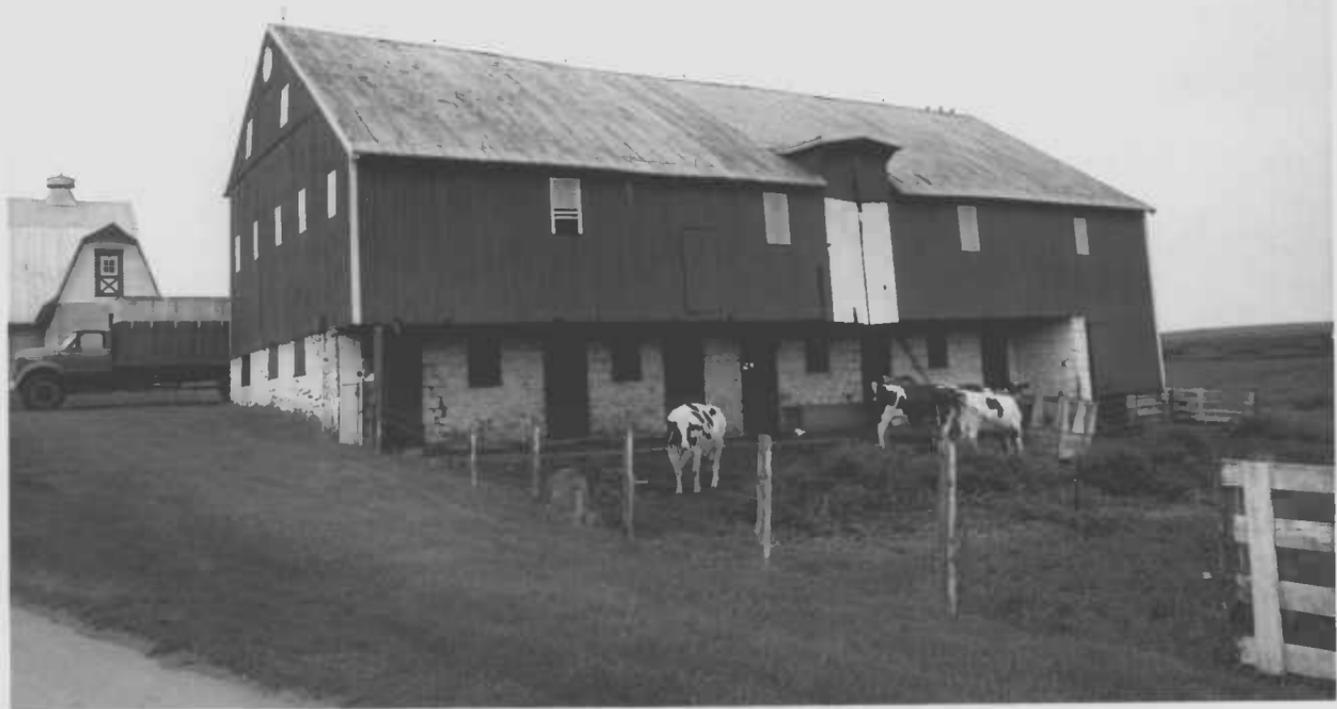
6/7

Bank barn: The stone and frame bank barn was probably built about 1850 or approximately contemporary with the main dwelling. It has a stone-enclosed stall level on the south elevation with vertical board dutch doors to the stalls and feeding aisles. The upper structure has vertical siding and a projecting loading door from the loft is in the south elevation, a late 19th century addition to the structure. The east and west elevations have louvred vents. The roof of the barn is standing seam metal.

Bank barn, south elevation

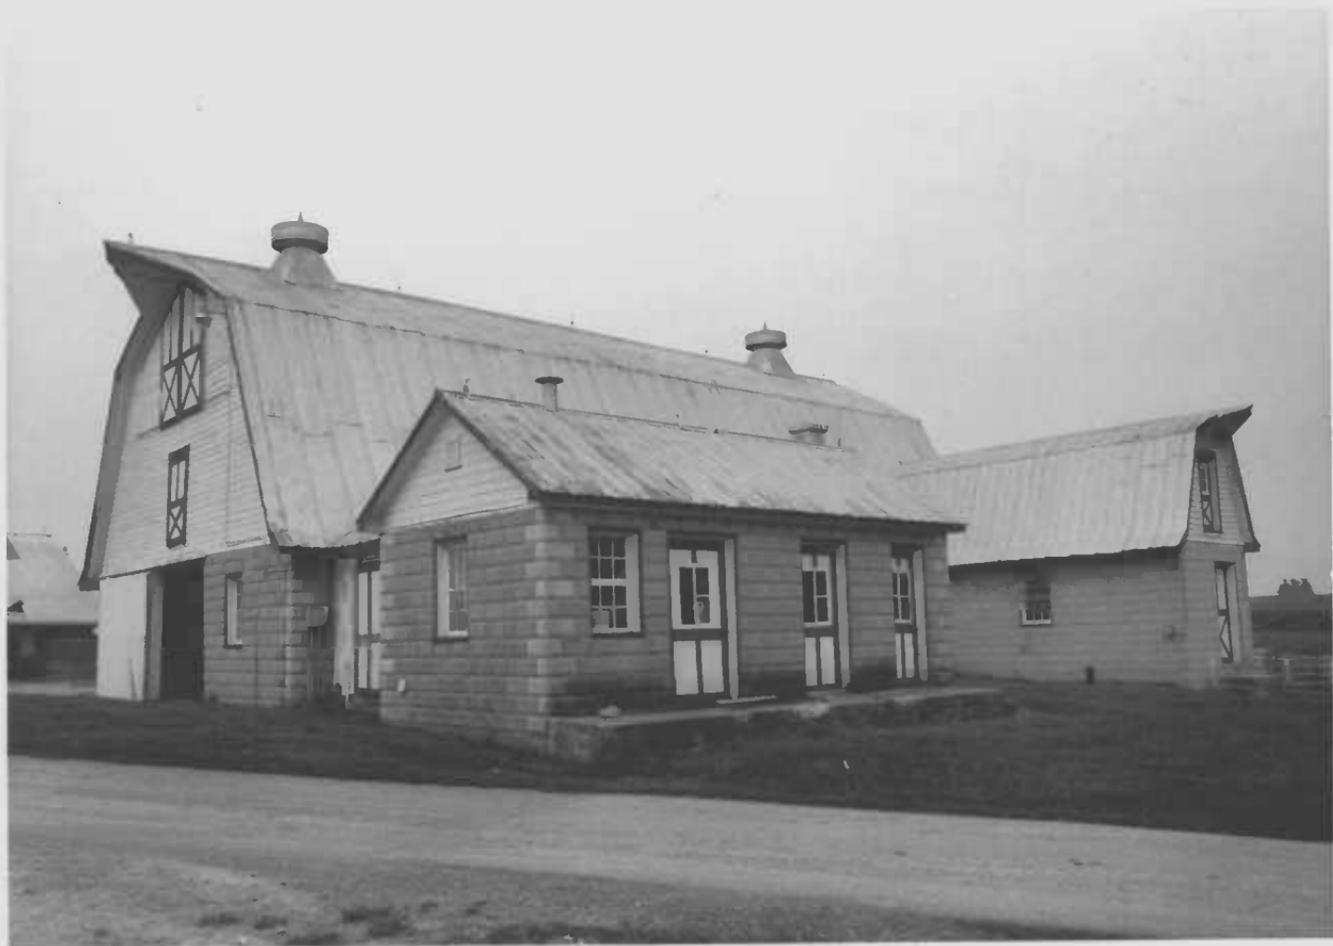
7/7

Dairy barn and milk house: The rusticated concrete block dairy barn and its matching milk house were built about 1940 and are the northernmost contributing structures in the farmstead. Non-contributing concrete block and metal farm buildings are located north and west of the dairy barn. Built in two sections, the rear or eastern end of the dairy barn is in plain concrete block and has a second entrance on the south elevation. This addition probably took place after 1945. The gambrel roof over both sections is standing seam metal with ventilators along the ridgeline. The rusticated concrete block section has quoins. The sash is 6/6. The small milk house located south of the dairy barn was built at the same time and has similar materials and features, except for a gable roof.

Dairy barn and milk house, southwest corner view
