F-3-82
Schley-Ramsburg Farmstead
Lewistown vicinity
Private

Ca. 1840-1899

F-3-82
Schley-Ramsburg Farmstead
Lewistown
Frederick County

Maryland Historical Trust State Historic Sites Inventory Form

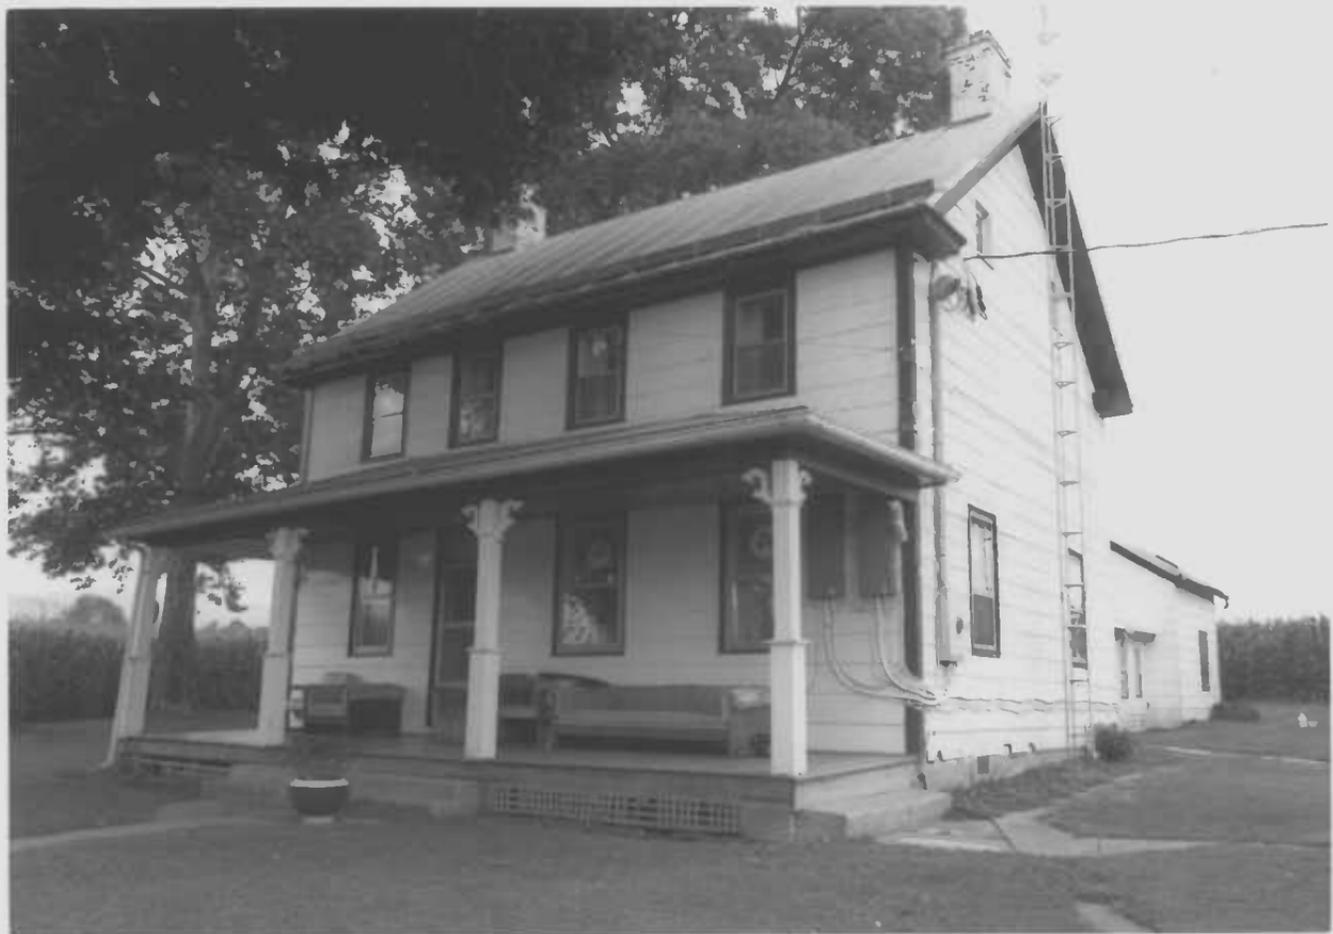
1/5

southeast corner view

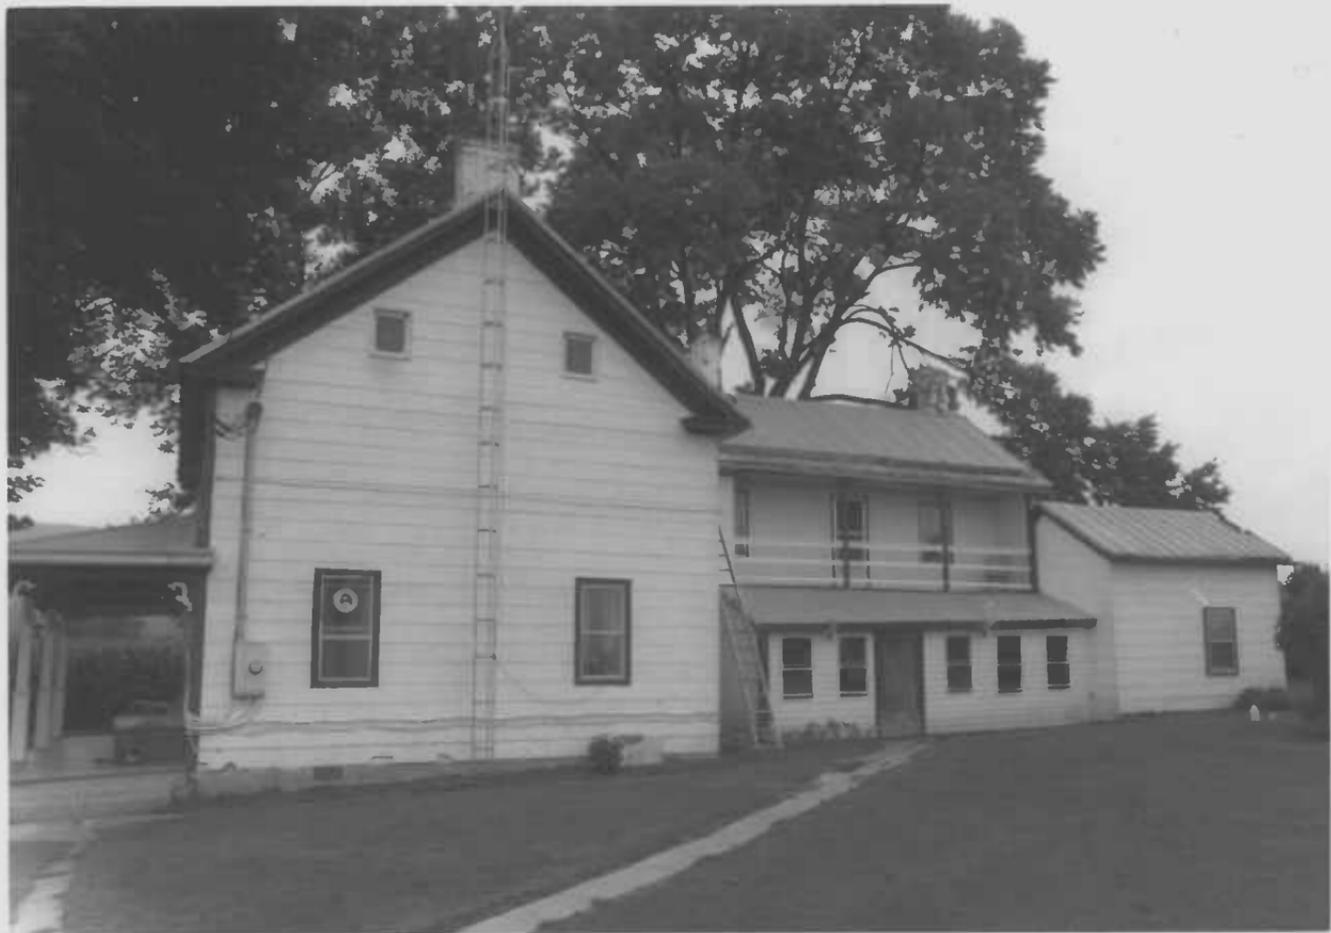
2/5

East elevation and rear wing

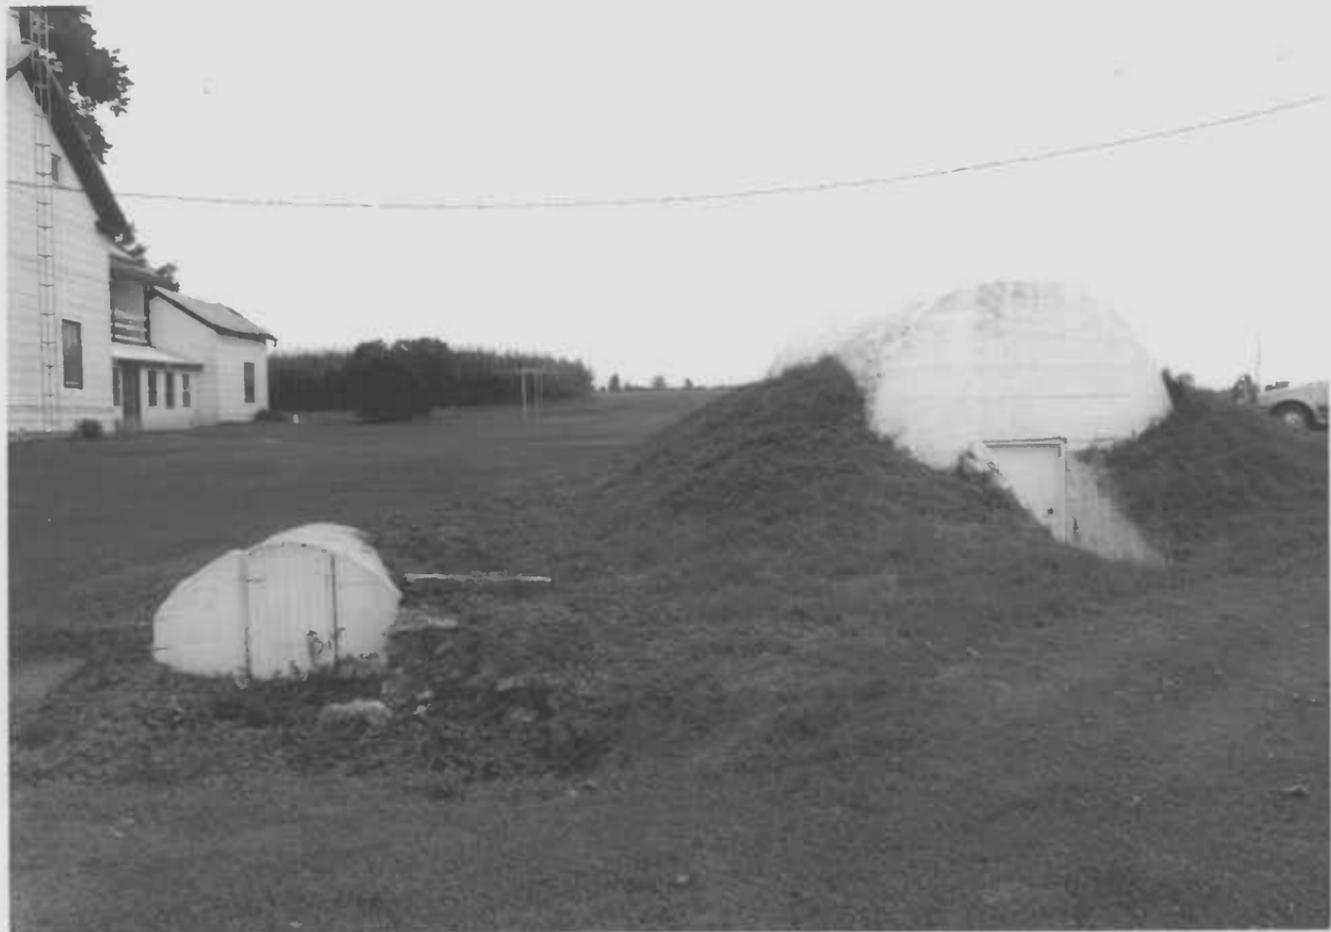
3/5

Root cellar and spring enclosure: The root cellar and the spring enclosure are located southeast of the house near the site of the springhouse noted in the James Survey inventory form (F-20-7) of about 1968, which has since been demolished. The root cellar is a partially earth-covered mound with a whitewashed stone and concrete roof and south elevation, where a vertical board door leads into the below-ground cave. The spring enclosure is a lower mound with a similar enclosure on the south side and the remains of the stone-lined trough which ran through the lower level of the springhouse. Both structures are difficult to date, although the spring would be the most likely to be contemporary with the house. The root cellar site may have been in use since the same period, but its present appearance with the concrete block enclosure probably dates from the early 20th century.

Spring and root cellar, view from south

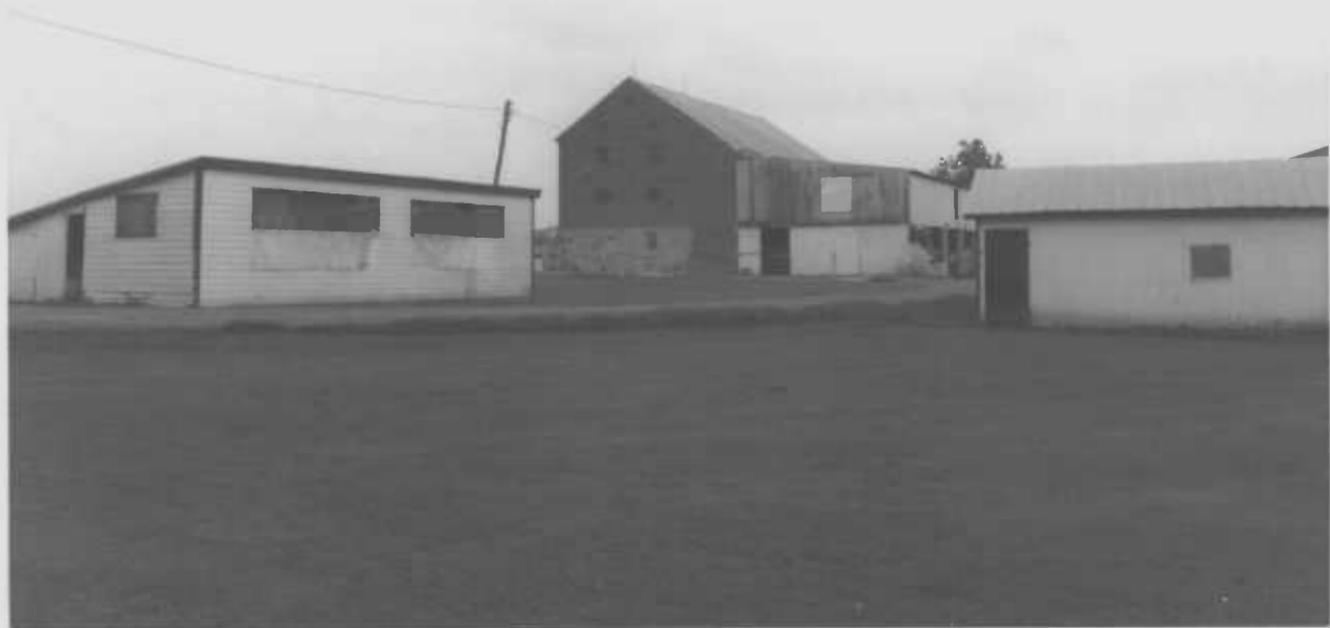
4/5

Chicken house: The frame chicken house is located east of the house on the farm drive from Hessong Bridge Road. Built about 1900-1920, it has a shed roof with corrugated metal covering and german siding. The south elevation has ribbon windows across the entire elevation.

Garage: The frame garage is also apparently a circa 1920 structure. Located southeast of the chicken house, it has tongue-and-groove vertical siding and a vertical board door on the west elevation. The gable roof is covered with standing seam metal.

Agricultural outbuildings, view from southwest

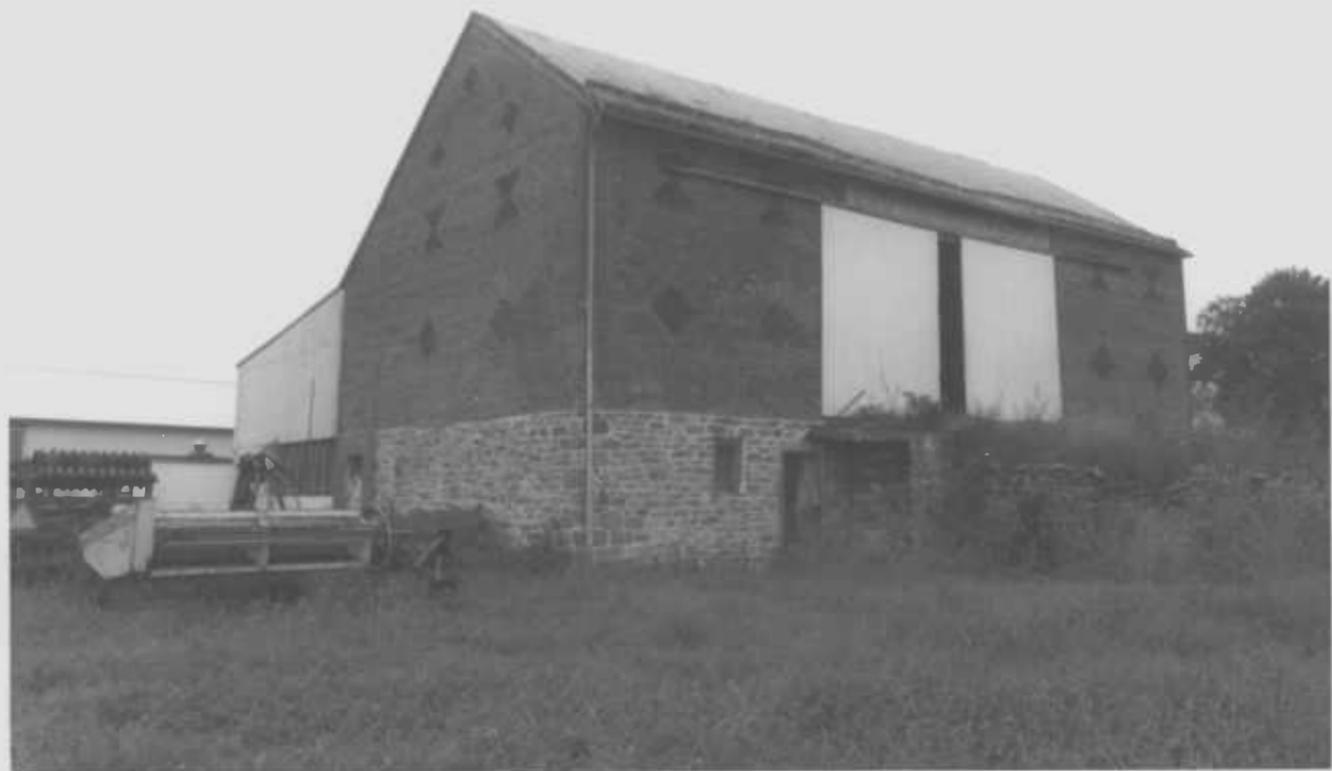
5/5

Brick barn: The bank barn is the most visible structure in the farmstead from the road. The foundation is field stone which has been repointed and the upper structure is 5:1 American bond with wheat sheaf and diamond pattern vent openings on the gable ends and the north elevation. The north side has large vertical board sliding doors and the roof is standing seam metal over wood shingles. The south elevation is dominated by a two-level extension of the hay loft supported above an open first level by concrete block columns. The extension has modern siding. The original forebay over the stalls is still visible from the open first level, with the vertical board ends just below the extension's second level floor. The original stall enclosure is also in brick, painted white, but the openings have been altered to some extent to allow access to the modern pens under the extension. The stone end walls show that the forebay side walls were built out with brick, interweaving with the stone quoins of the barn base. This alteration may have taken place in the period 1875-1900, judging by the apparent weathering of the brick in the original end wall and the forebay extension.

Bank barn, northeast corner view
