F-4-19

Vincent Sanner Farmstead
Middletown vicinity
Private

Vincent Sanner Farmstead
Middletown
Frederick County

Maryland Historical Trust State Historic Sites Inventory Form

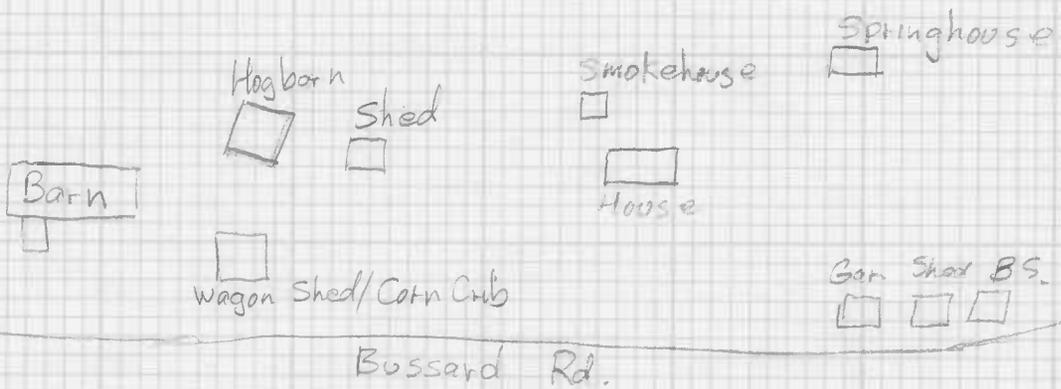
F-4-19
Vincent Sannet Farmstead
Frederick County

The Vincent Sanner Farmstead is an agricultural group centered on a circa 1784 brick dwelling of two stories with an associated stone springhouse and a concrete block meathouse and an agricultural outbuilding group consisting of a frame bank barn, a frame wagon shed/corn crib, a frame hog barn, a frame hay barn, a frame blacksmith shop, a frame tool shed, all dated about 1875-1890, and a non-contributing concrete block garage. The farmstead is located on the south side of Bussard Road about 2/10 mile east of Old Middletown Road near Middletown, Frederick County, Maryland. The principal elevation of the house faces north and the agricultural outbuildings are located east of the dwelling. The blacksmith shop, garage, and tool shed are located northwest of the house at the edge of Bussard Road.
