F-4-57  
Harshman-Frushour Farmstead  
Wolfsville  
Frederick County

# Maryland Historical Trust State Historic Sites Inventory Form

Survey No. F-4-57

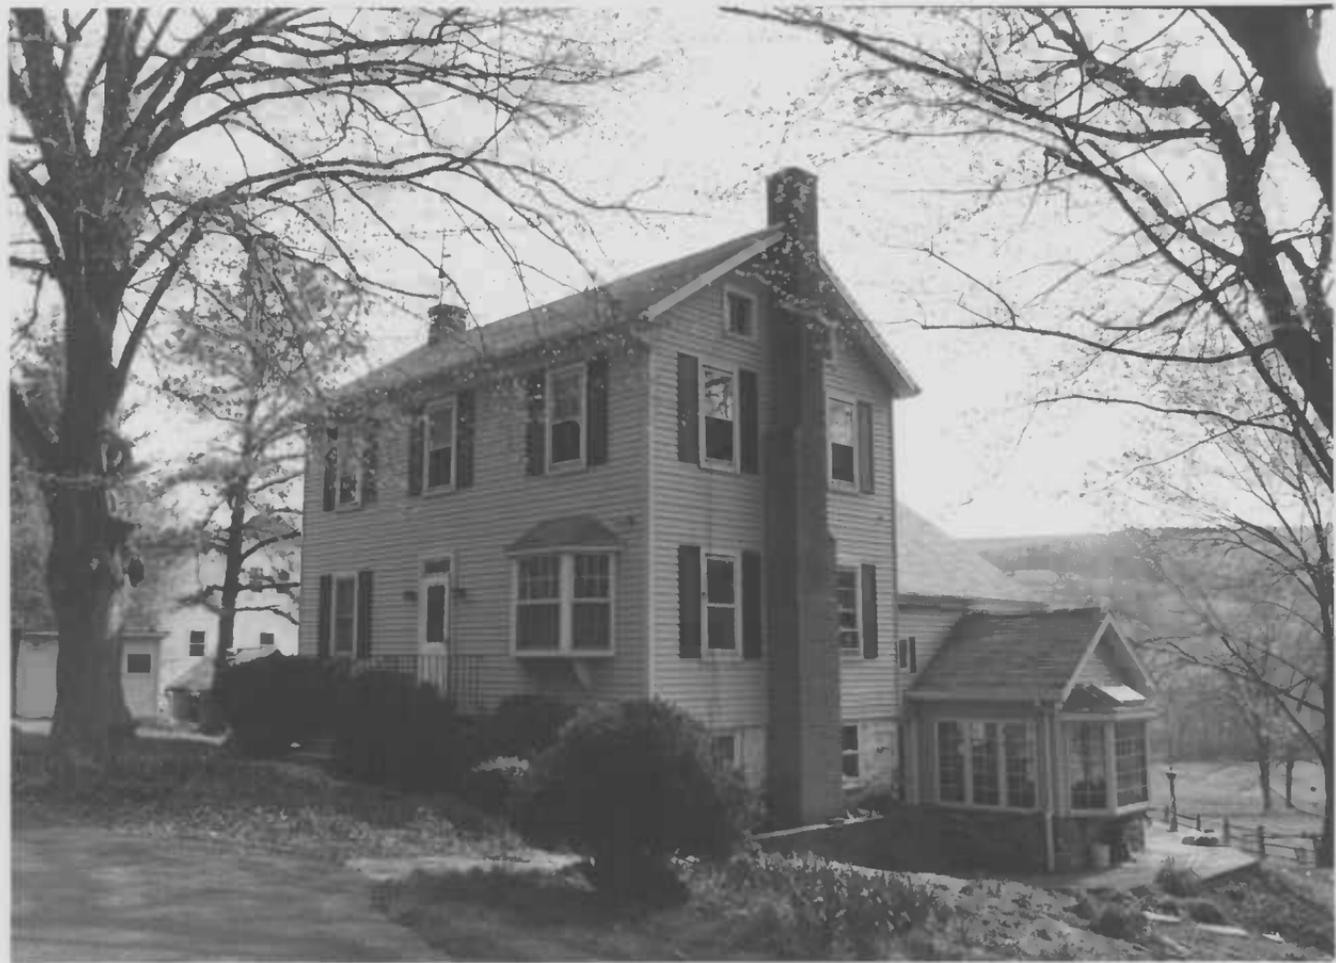
1/2

South of Crown View

The circa 1880 dwelling is located on a slope with the principal elevation facing west and the rear part of the house following the slope downward to the east. The west elevation has three bays with a center entrance. A two-light transom tops the doorway and the door has four panels. The siding was probably originally german, but is now covered with vinyl. In the south bay is a modern bay window. The rest of the sash is 2/2 with replacement shutters. The roof is composition and the original chimneys were on the interior walls of the gable ends. One has been rebuilt on the exterior of the south gable end. The modern additic. extends from the original rear two-story wing and virtually engulfs the wing. The interior was inaccessible for this survey.

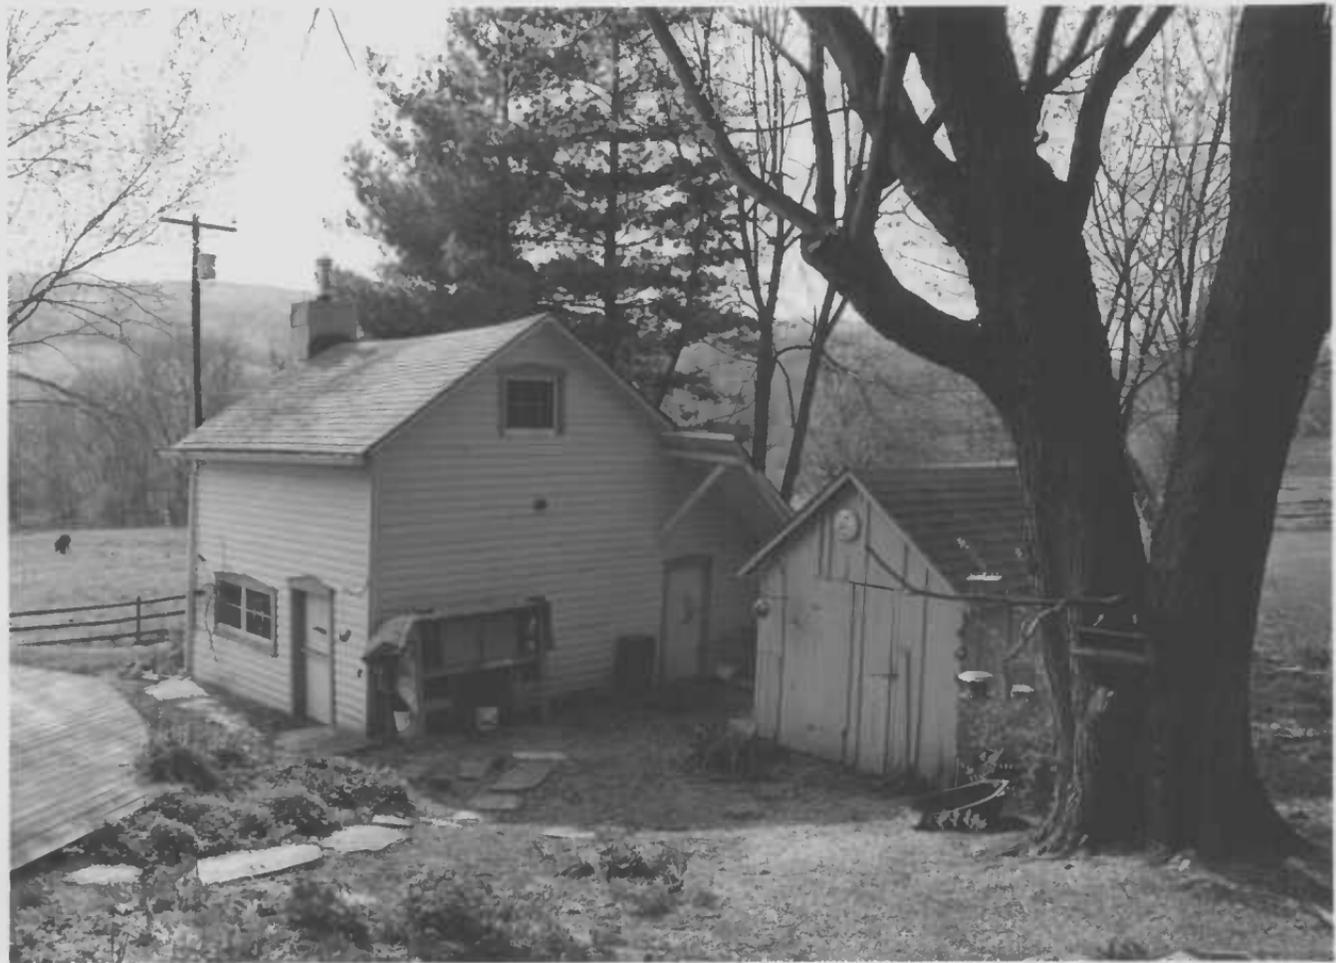
2/6

Summer kitchen & smokehouse

Summer kitchen: The summer kitchen is a 1-1/2 story frame structure with german siding and a vertical board dutch door in the north elevation. Also on the north elevation are 3/3 windows with peaked window frames which may have been rebuilt from the originals. The composition roof extends over a small shed addition on the south elevation. The exterior brick chimney is located on the east gable end. The building probably dates from about the same period as the dwelling, the 1880's.

Smokehouse: The frame smokehouse is now used as a garden shed. It has a rectangular plan with board and batten siding and a vertical board door in the north elevation. The gable roof is composition. Like the summer kitchen, the smokehouse is probably contemporary with the dwelling.

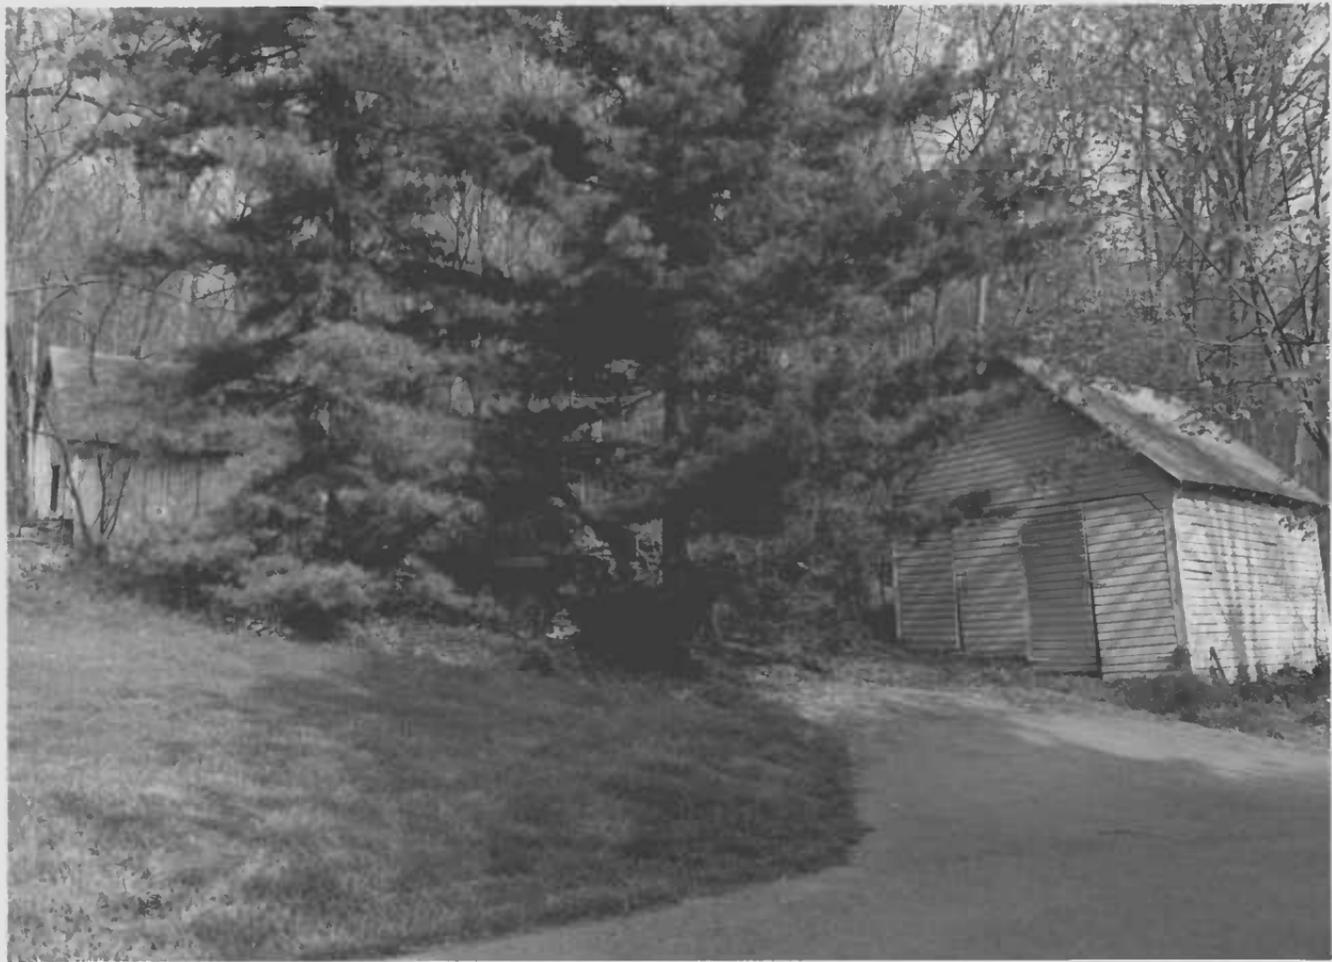
3/6

Ice house and sheds, view from east

Root cellar/ice house: The stone root cellar may have been used as an ice house. It is built into the slope of the hill northwest of the house in a grove of pine

trees. A vertical board gable supports a corrugated metal roof. The single door in the east elevation is board and batten and a second boarded opening is located directly above it.

**Wagon sheds:** There are three frame wagon sheds west of the barn, clustered near the stone root cellar/ice house. The westernmost has board and batten siding, a corrugated metal roof, and double swing doors in the east elevation. The other two sheds are located north of the root cellar. One has double bays on the south elevation, german siding, and a corrugated metal roof. Each bay has double vertical board swing doors. The third shed has a single bay with an open doorway on the south. It has vertical siding and a standing seam metal roof. All three sheds appear to date from about 1900.

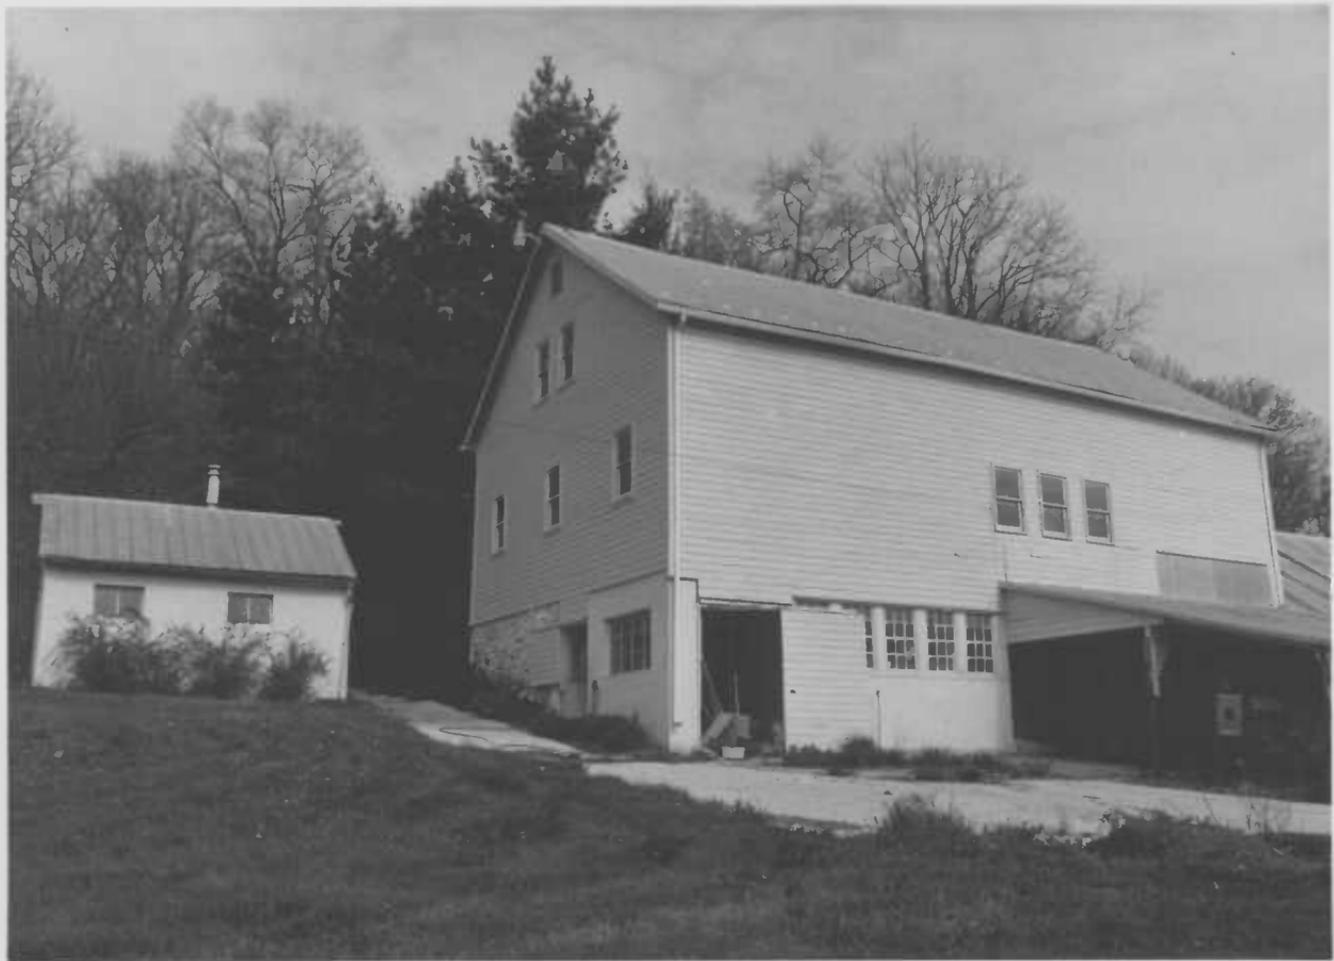
4/6

Box 114 with large view from east

**Barn:** The frame bank barn appears to date from about 1900. It has a stone foundation and recently replaced vertical siding on the upper level. The stall level was partially enclosed with concrete block in the 1930's for use as a milking room. The rest of the stall level has been altered in the 1980's for use as a horse barn, with extensions on the east and the north. The ramp on the west elevation has been rebuilt. The interior main beams show almost straight saw marks, indicating that the structure may incorporate members of an earlier barn. The sliding doors are german siding.

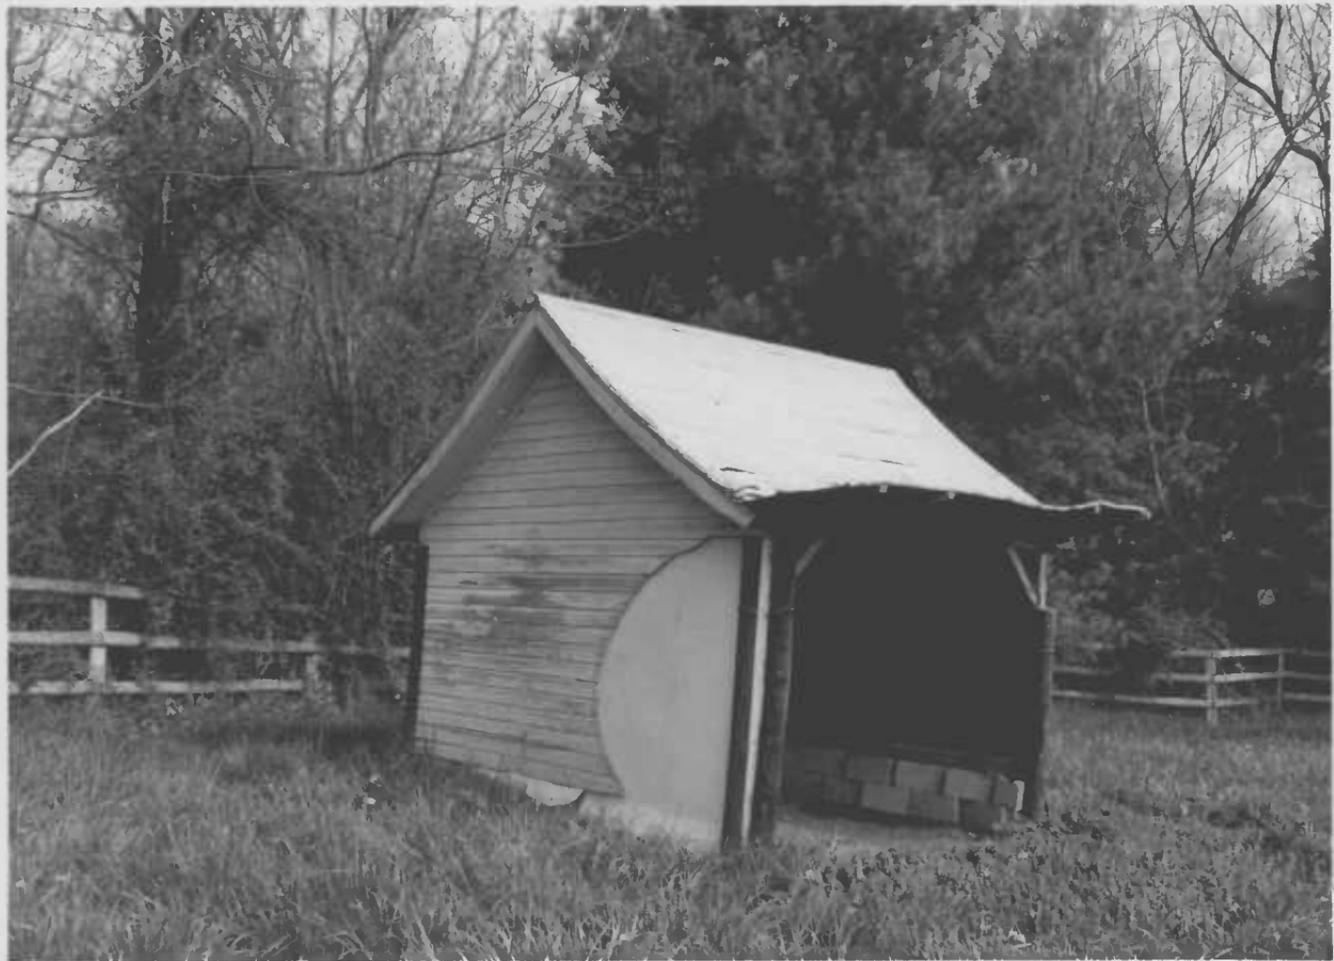
5/6

Trolley shelter, view from north

**Trolley shelter/hay shed:** The trolley shelter is located in a pasture southwest of the main complex and is visible from Meeting House Road. It is a small rectangular frame structure with german siding and a bellcast gable roof covered in original pressed metal. The west or back of the structure has been altered with a sliding door, giving access to the hay rack installed on the rear wall. A small metal extension of the roof projects from the east or open side of the shed. On the north and south sides of the structure were originally cut out in a C-curve; these have been filled with sheet metal. The shelter was built about 1900-1910 and probably moved from the electric railway line between Myersville and Middletown about 1945 when the line was discontinued. About 6 of these structures were scattered throughout the Hagerstown & Frederick system, but this is the only known remaining one. A photo of one of the shelters in use is in Harwood's Blue Ridge Trolley, p. 69.

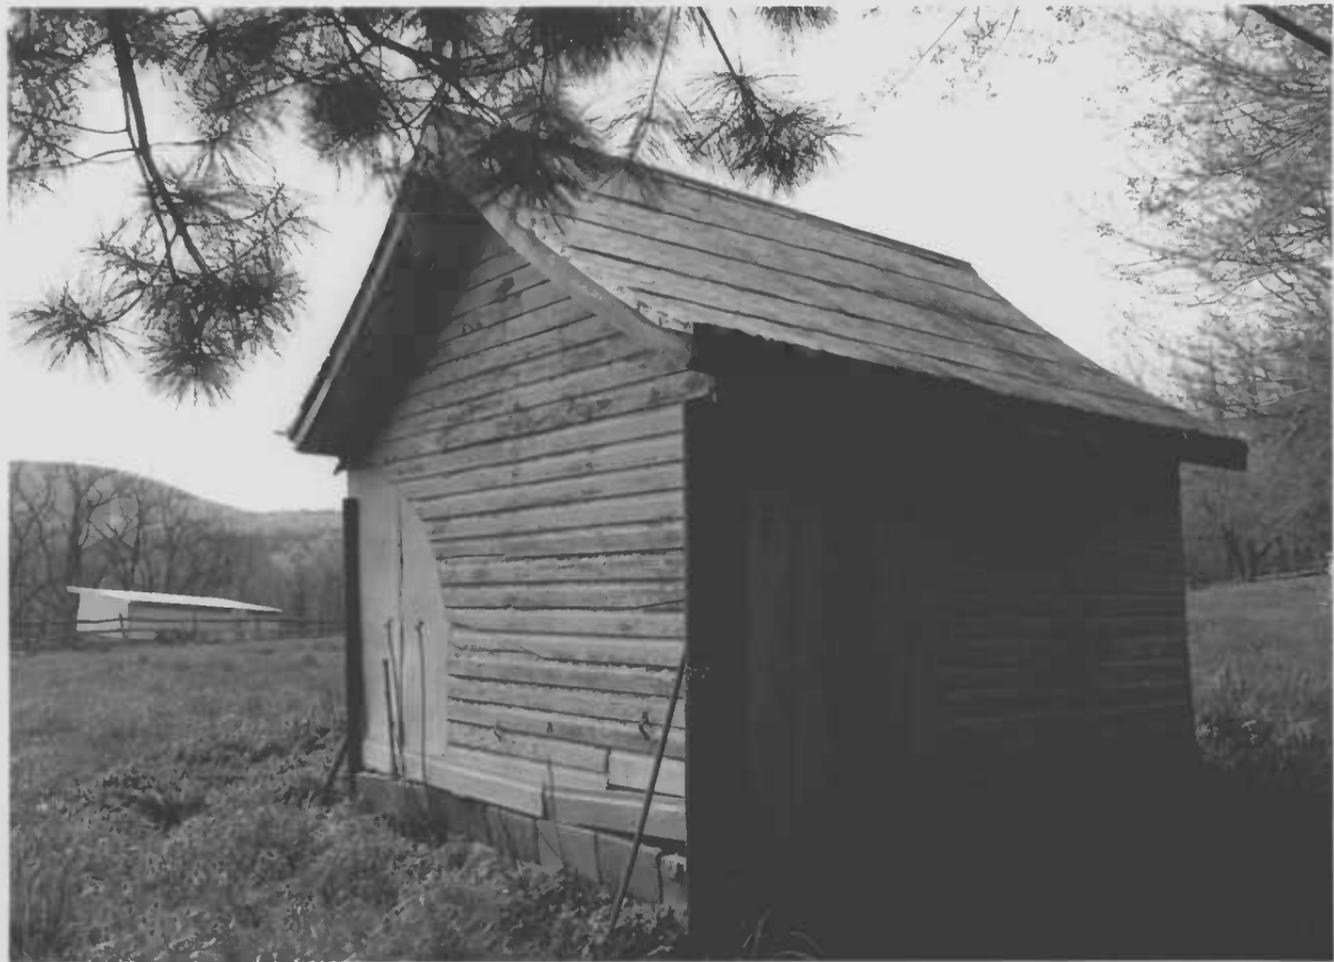
6/6

Trolley, S. 1100, 1/2 mi. from north
