F-4-70

Schlosser-Waters Farmstead
Myersville vicinity
Private

F-4-70
Schlosser-Waters Farmstead
Myersville
Frederick County

Maryland Historical Trust
State Historic Sites Inventory Form

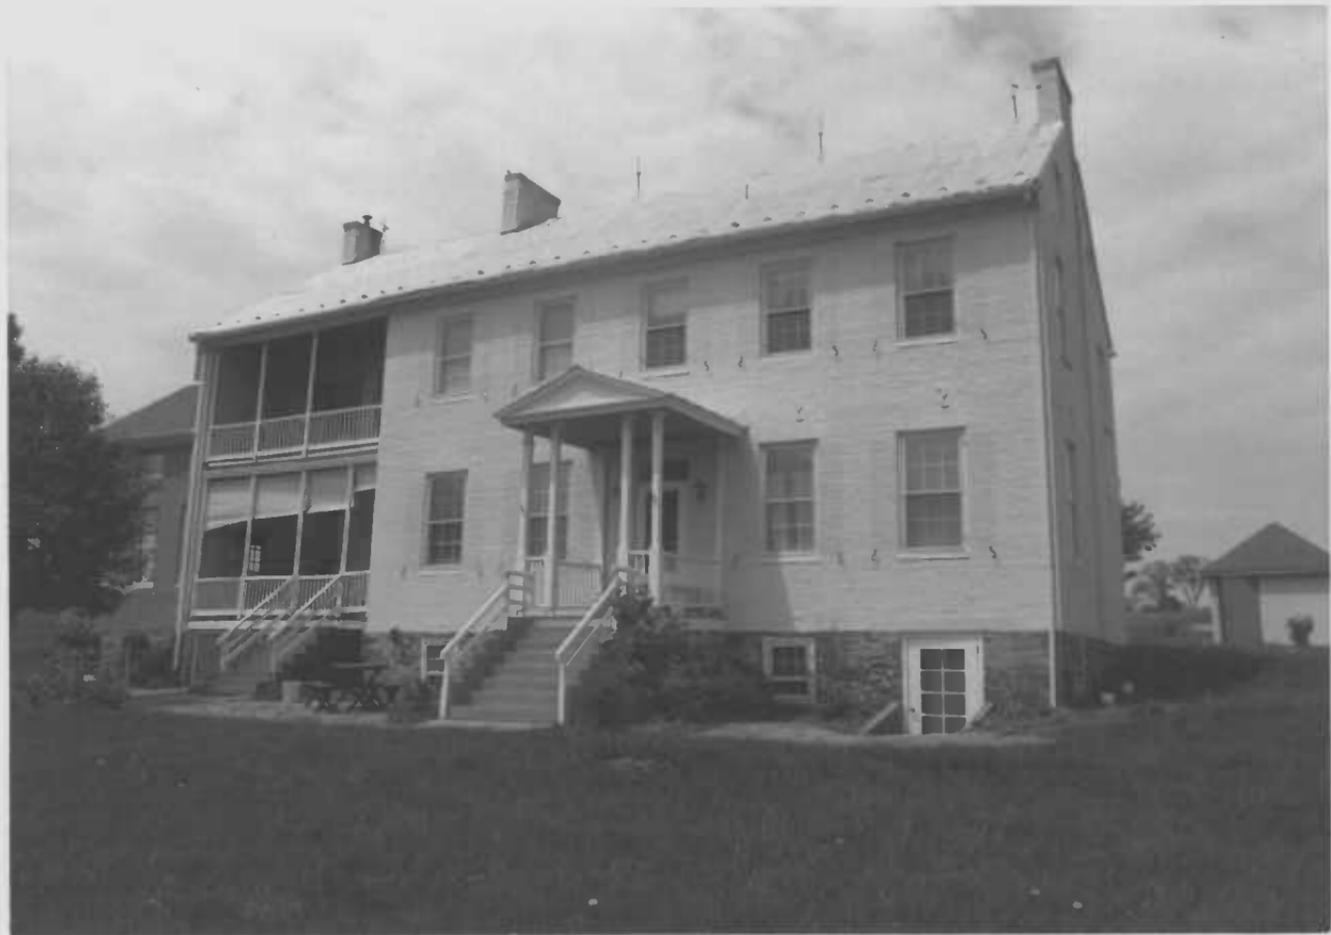
116

East elevation

The dwelling faces east toward a small pond on the edge of which are the summer kitchen and the springhouse. The house has a flemish bond exterior in the earlier section which is painted white. The north side and west elevations have 4:1 American bond. The east elevation has five bays with a center entrance. The entrance porch has been rebuilt on a stone foundation with new brick steps. The modern pedimented roof has paired square columns which appear to be about 1850 in date. The main entrance door has 10 panels, with raised profiles, under a three-light transom. The window openings have gauged arches and wood sills. The sash is 6/6 with original shutter hardware still in place, although the shutters have been removed. The cornice is corbeled and the gable roof is covered with corrugated metal. The interior chimneys are located at the gable ends. On the south side of the five-bay section is a two-story side wing with a two-level open porch. The porch posts are chamfered and the balustrade is plain. The wing has two bays with 6/6 sash and a three-light transom above the 10-panel door. A third chimney is located at the south end of the wing, enclosed by the two-story modern addition on the south. The addition is faced with natural brick. The west elevation has the same number of bays in each section of the original dwelling as in the east elevation. The facade is flush, with no porches or other projections. The 6/6 sash are replacements. The north elevation has two bays with replacement 6/6 windows in the west bay on the second floor. The first floor window has been filled in. The interior was inaccessible for this survey.

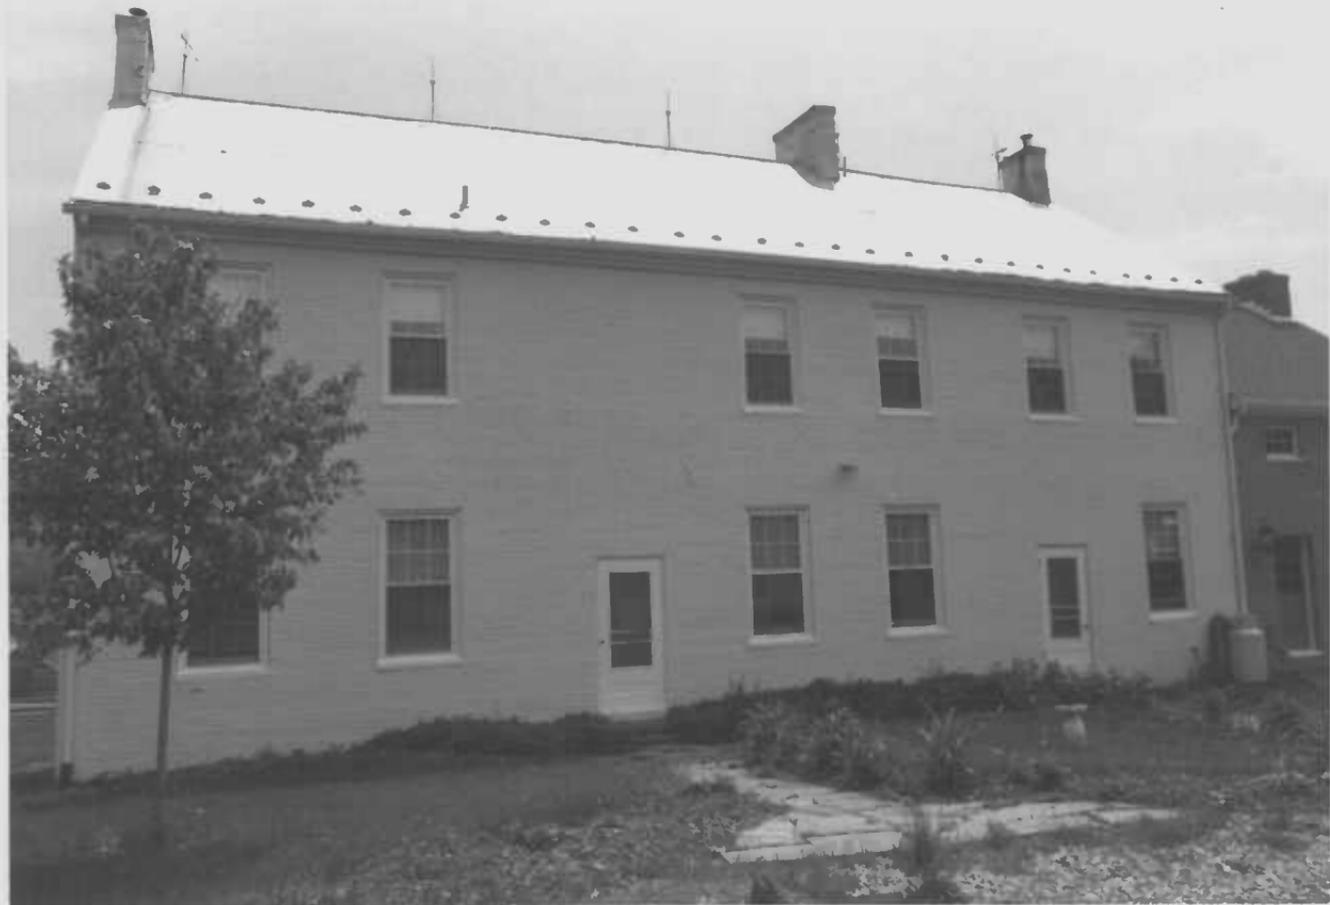
2/6

West elevation

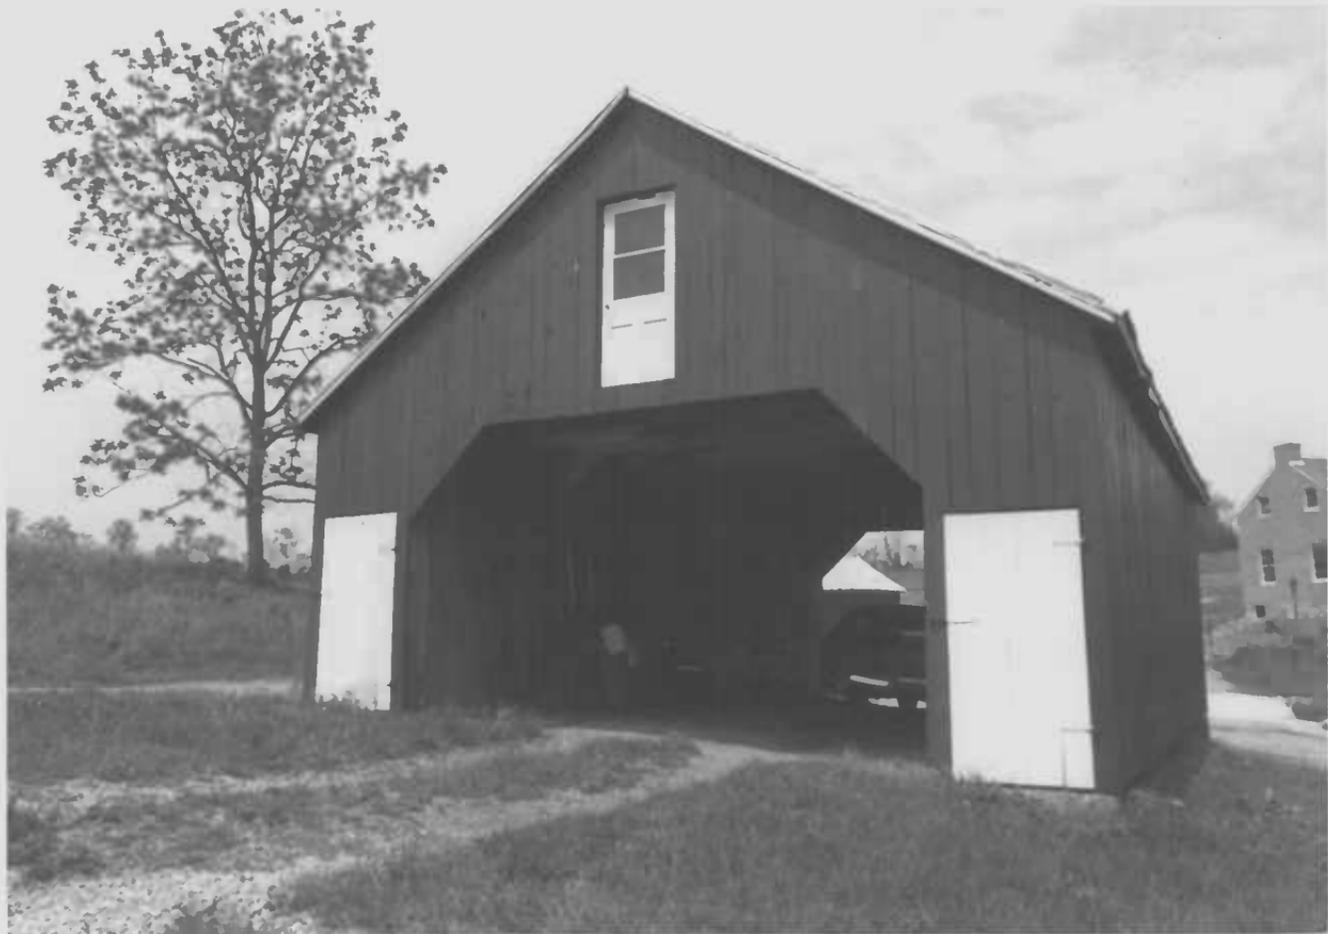
4/6

Wagon shed/corn crib, east elevation

Wagon shed/corn crib: Southwest of the bank barn is the frame wagon shed/corn crib, which dates from about 1875-1900. The double corn cribs are located on the north and south sides of the drive-through. The structure has a glazed and paneled door in the east elevation above the drive-through. The exterior is covered with vertical boards.

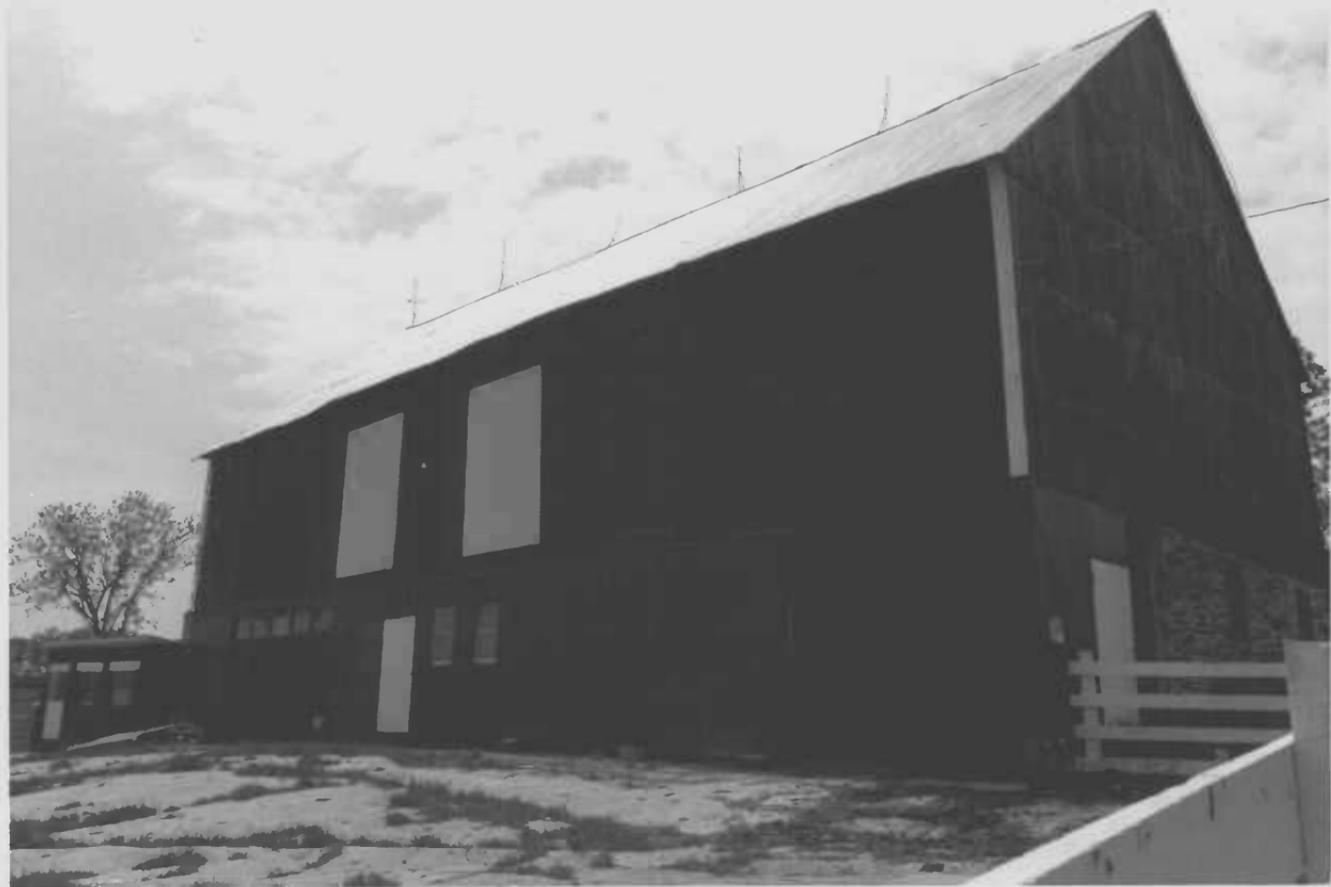
5/6

Bank barn, north elevation

Bank barn: The frame bank barn may have been built about 1875-1900. It has some replaced boards among the vertical siding of the upper level. The stall level on the north elevation has been partially enclosed with concrete block for dairy use, probably during the 1920's. A small section near the northeast end is faced with vertical boards. The doors on the upper level of the north elevation are sliding types, with vertical boards. The south elevation has two double doored entrances with sliding covers. Near the east side of the ramp is the debris of a demolished brick silo. The roof of the barn is corrugated metal. Attached to the east elevation is a small concrete block milk house with metal sash, probably added in the 1920's, which is now used as a chicken house.

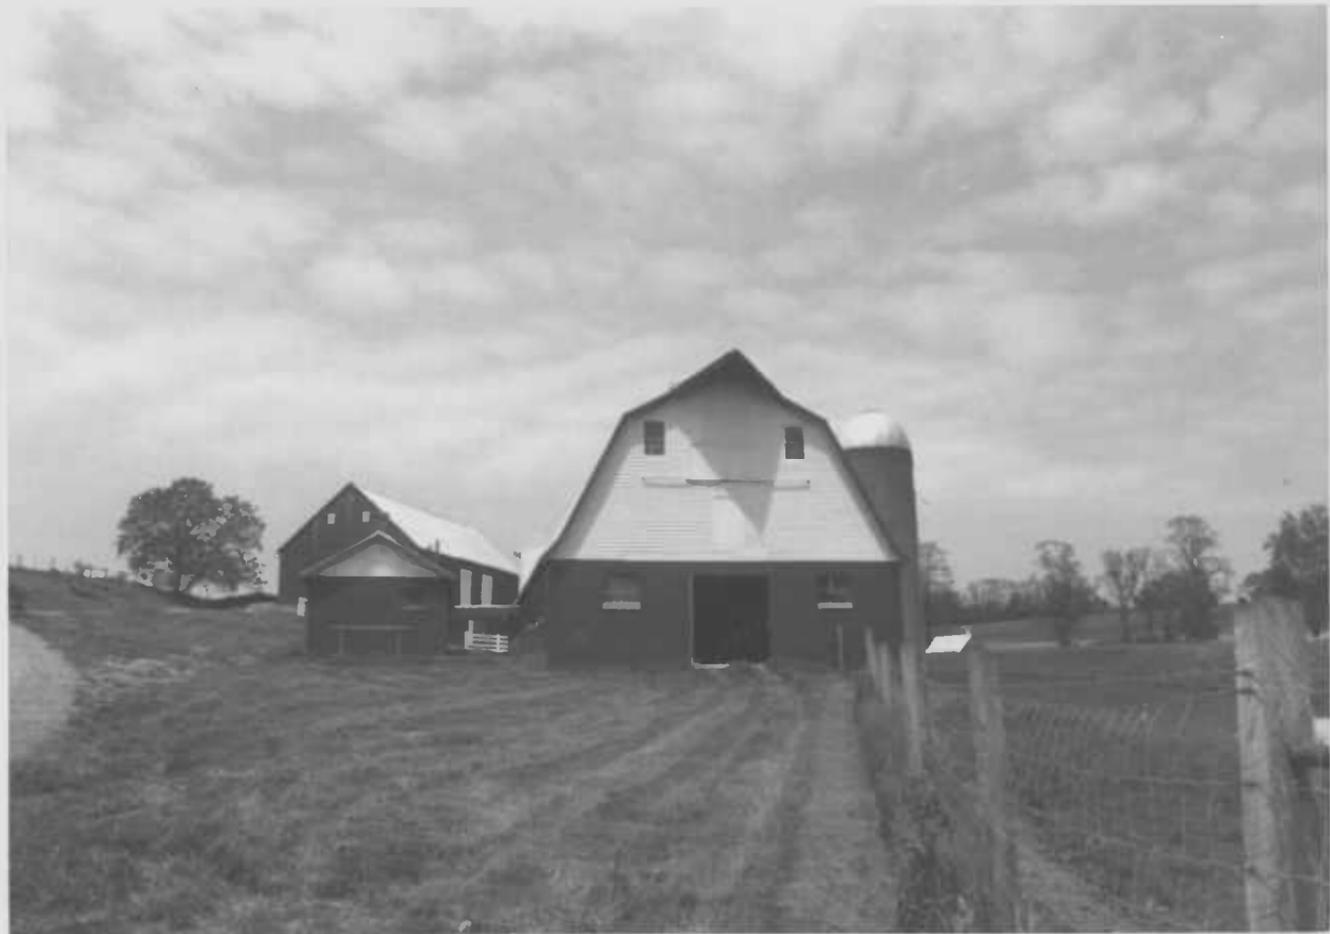
6/6

Dairy barn, milk house, and brick silo.
View from east
