F-4-80
Rout-Smith Farmstead
Myersville vicinity
Private

F-4-80
Rout-Smith Farmstead
Myersville
Frederick County

Maryland Historical Trust State Historic Sites Inventory Form

7. Description

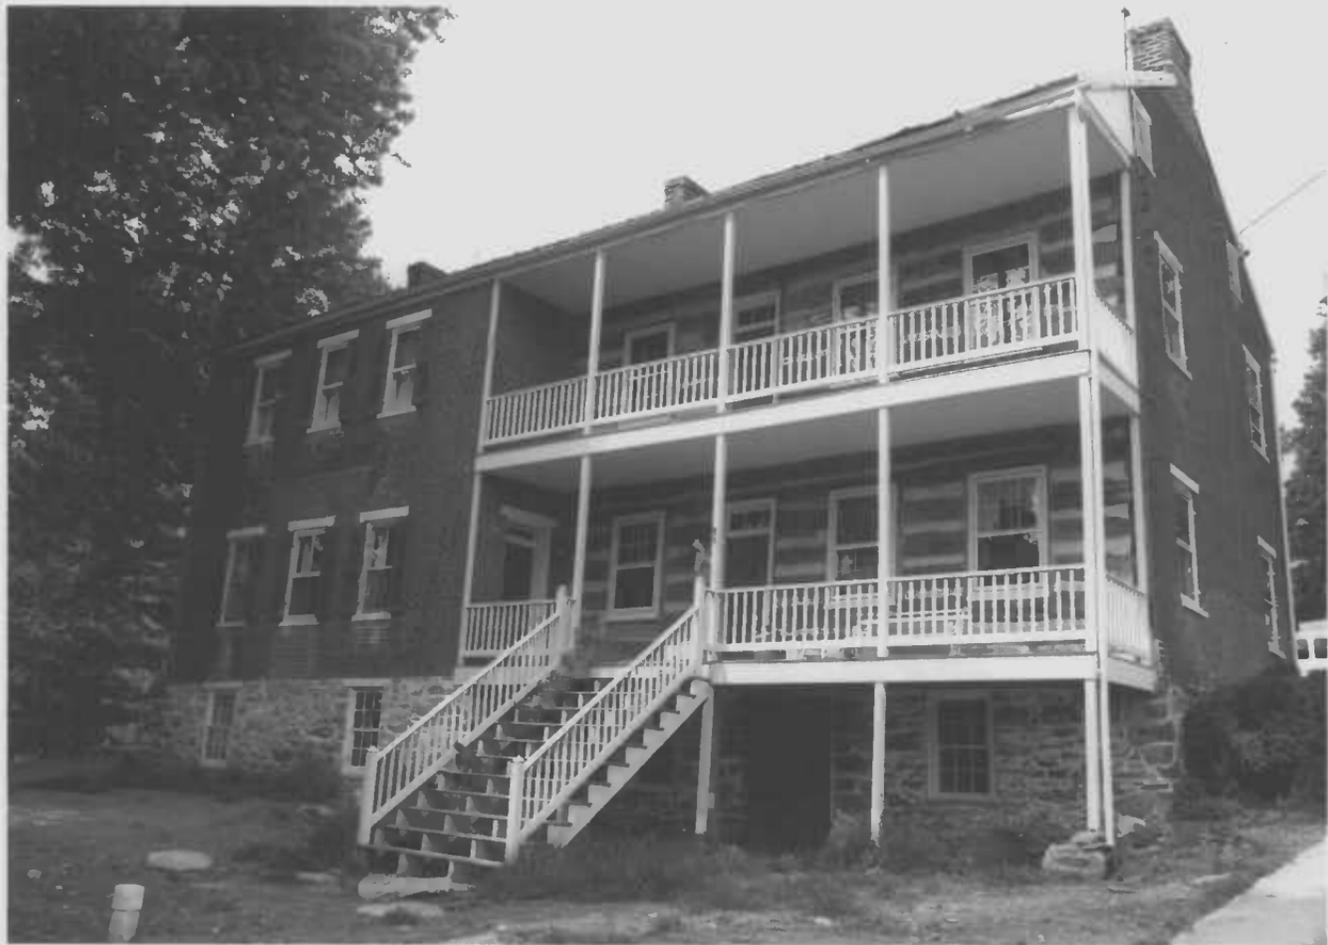
1/5

Southeast corner view

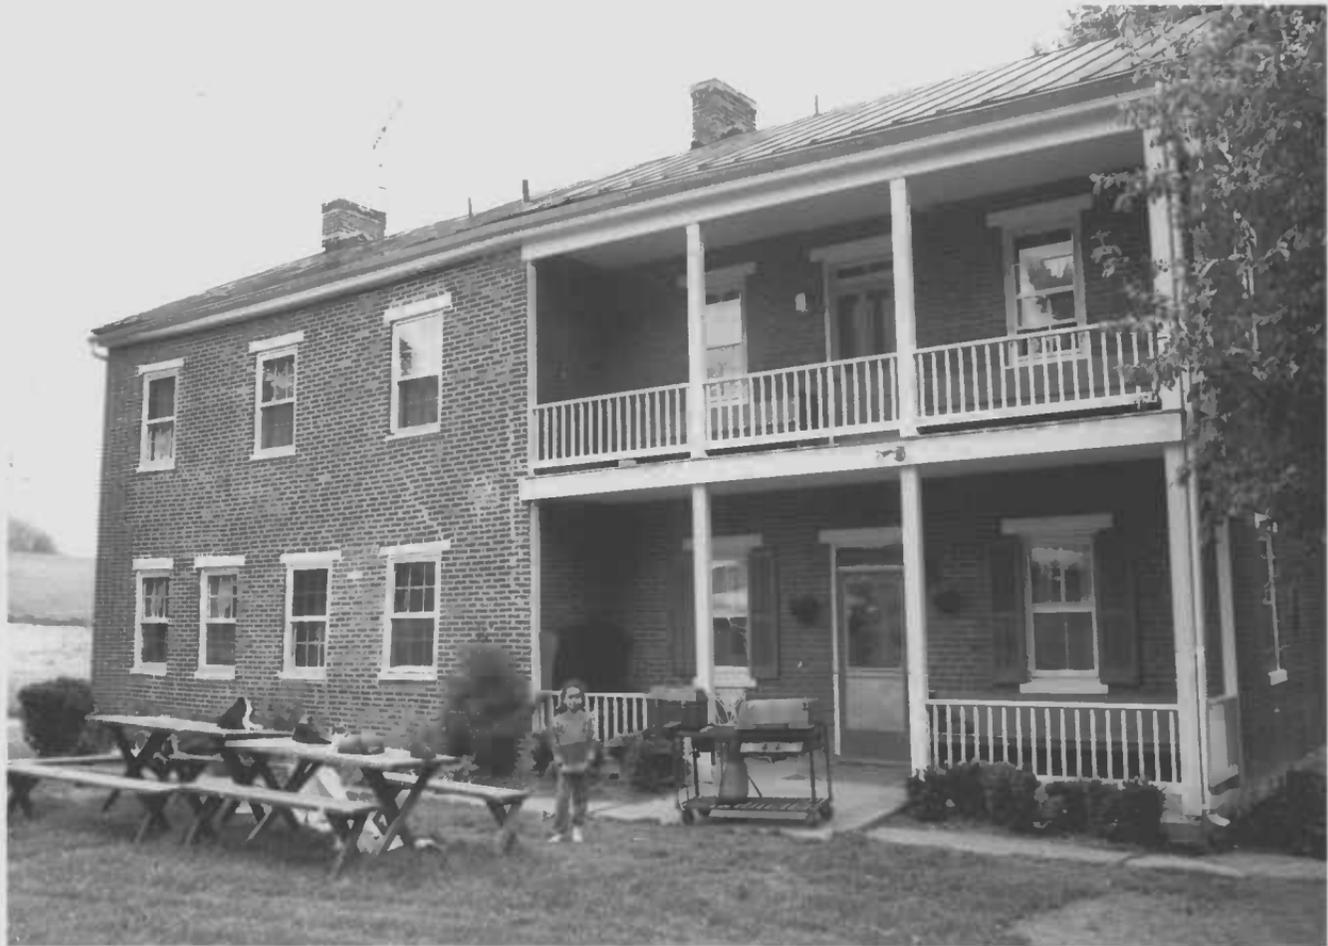
2/5

North elevation

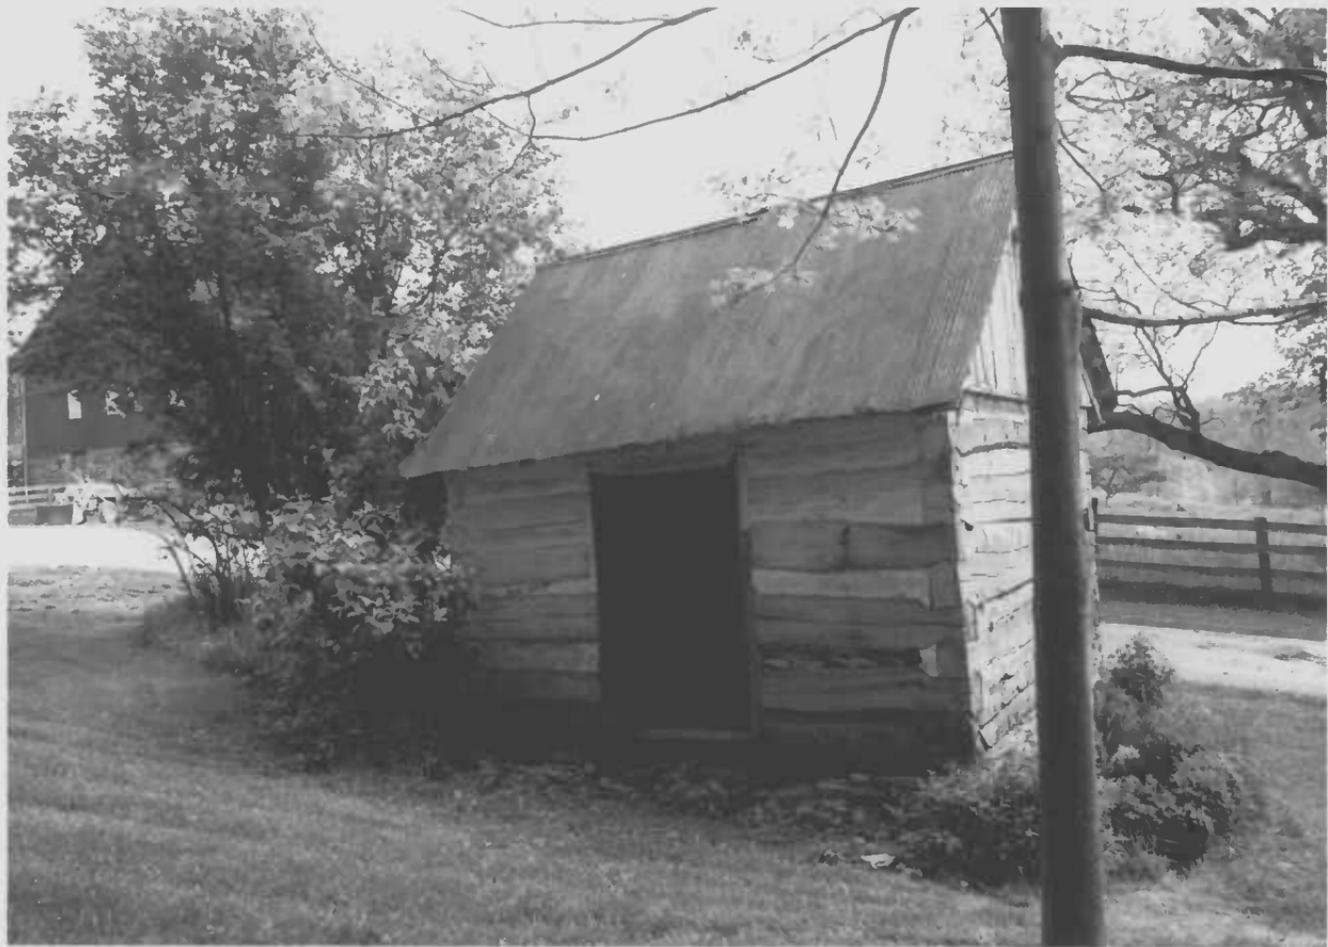
3/5

Smokehouse: The smokehouse is located east of the summer kitchen. It is also an exposed log structure with wood nogging and a corrugated metal gable roof. The gable end on the north is covered with board and batten siding. A vertical board door is also located on this elevation. The smokehouse may date from the same period as the main dwelling house.

Smokehouse, north elevation

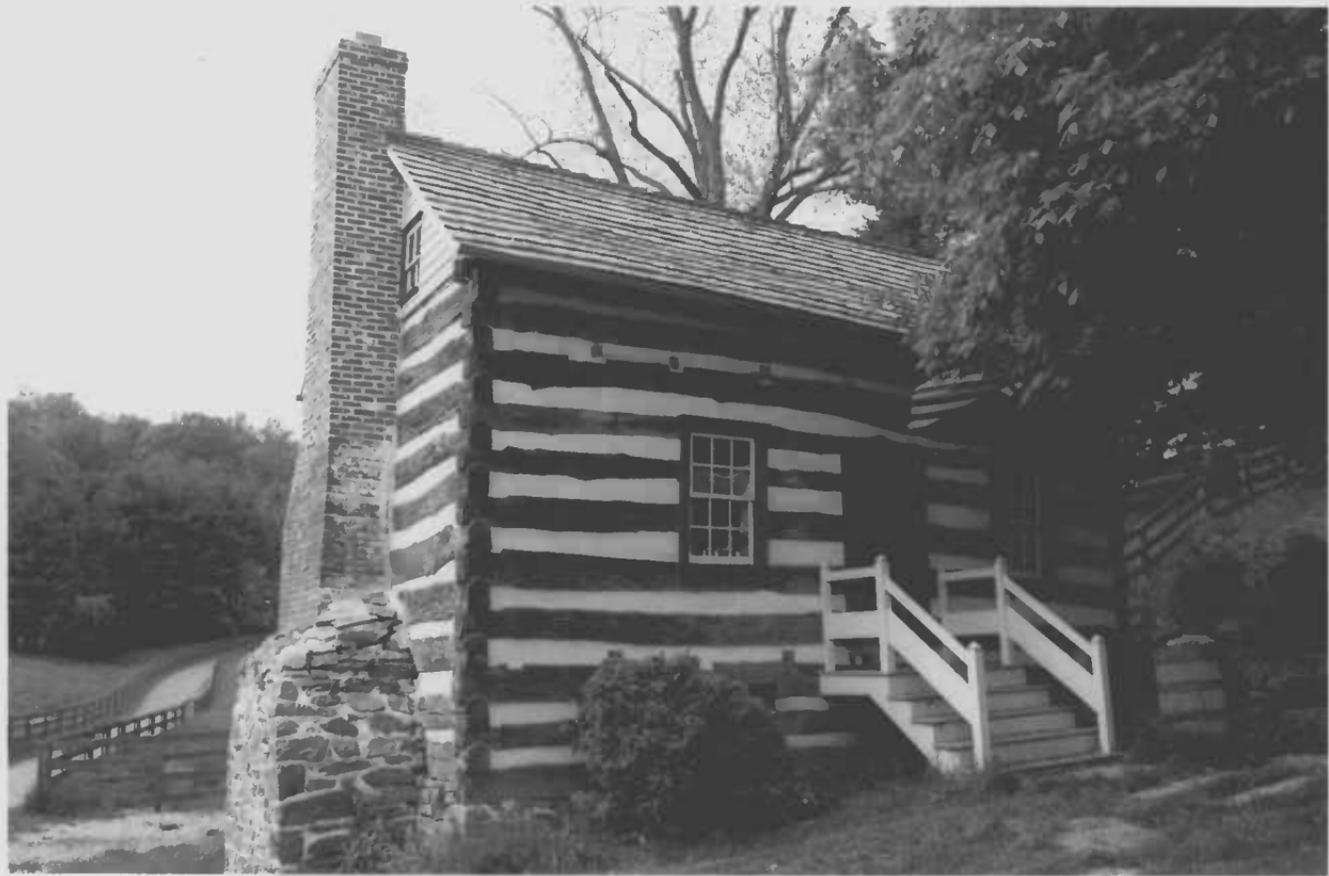
4/5

Summer kitchen: The log summer kitchen has a stone lower level which contains a springhouse. The stone is exposed on the south elevation. The east elevation has three bays with a vertical board door and replacement 6/6 windows. The repaired molded window frames appear to be of the first quarter of the 19th century. The wood shingle gable roof is also a modern replacement. The stone and brick exterior

chimney on the south elevation has been rebuilt. The west elevation has two bays with a vertical board door on the stone lower level. According to local residents in the area, the summer kitchen is thought to be the earliest dwelling in the farmstead, having been built prior to 1800 and used until the erection of the log section of the present dwelling. Although not observed in this survey, an interior inscription in the chinking between the logs gives a name and a possible date, according to Mrs. Christensen, the present owner. The summer kitchen is located south of the main building.

Summer kitchen, east elevation

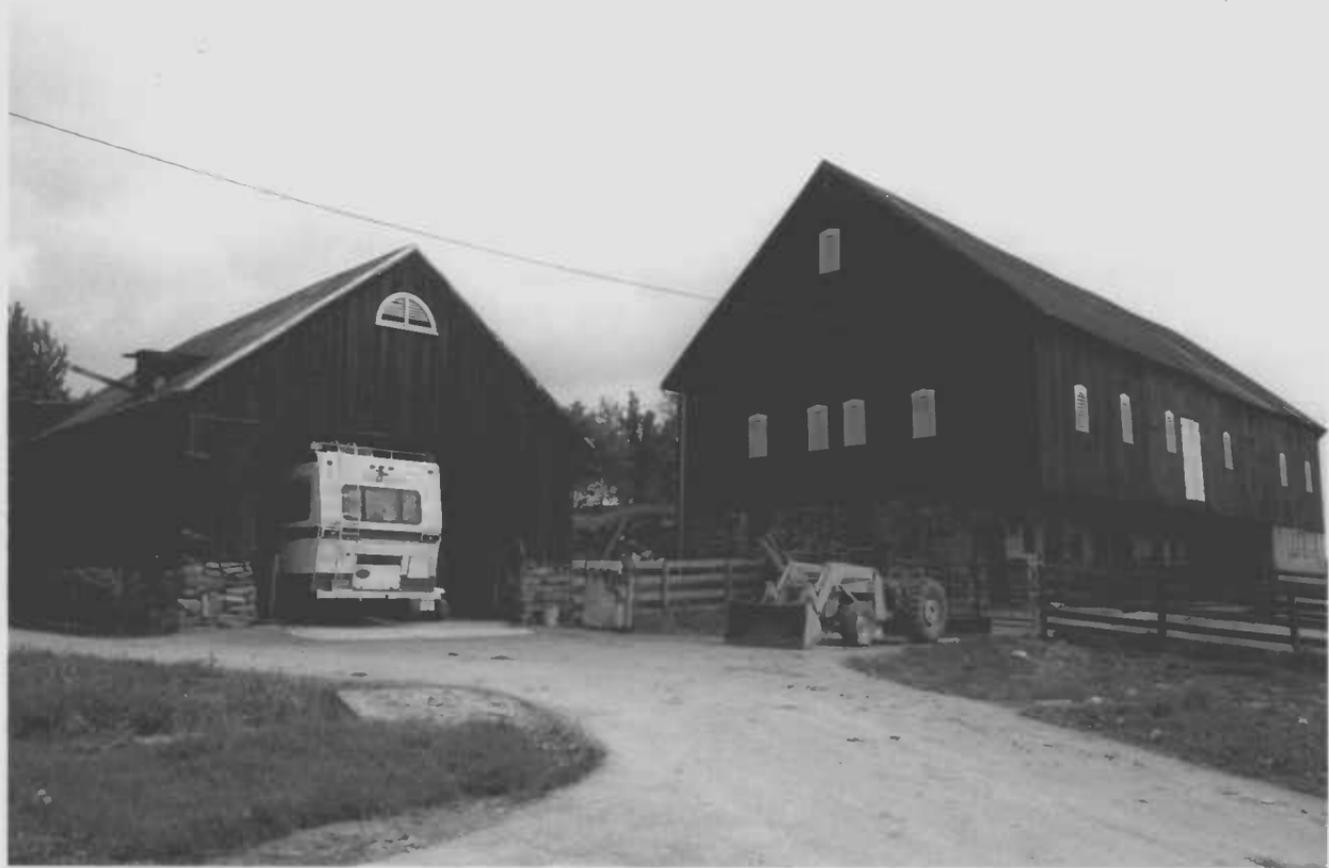
5/5

Barn: The frame and stone bank barn is located southeast of the domestic buildings. It was probably built about 1830-1840, but has been enlarged and altered through the late 19th and early 20th centuries. The stall level on the west elevation is stone, with a concrete block partial enclosure on the south end for a milking room. The vertical-sided upper section has louvred vents with repaired arched frames. The gable roof is covered with corrugated metal.

Wagon shed/corn crib: The frame wagon shed/corn crib is located north of the barn. Built in the period 1875-1900, it has vertical siding and a corrugated metal roof. Double cribs flank the drive-through opening and the building is supported on a stone foundation.

Wood shed/corn crib and barn, view from west
