F-4-86

Charles H. Coblenz Farmstead
Middletown vicinity
Private

Ca. 1820-1880

Maryland Historical Trust State Historic Sites Inventory Form

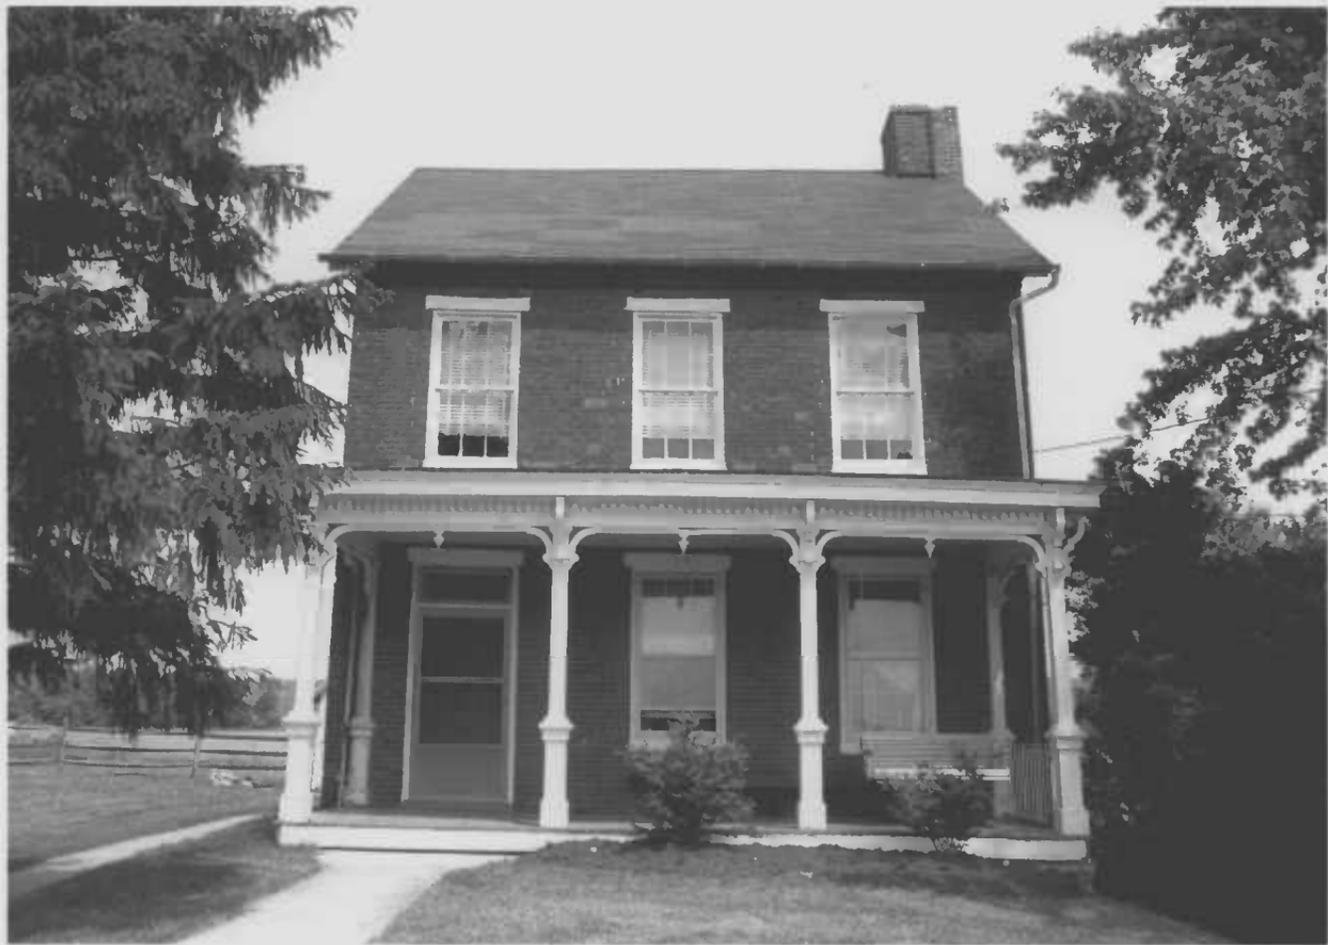
1/7

West elevation

The dwelling has a three-bay west elevation with the entrance in the north bay. The walls are 5:1 American bond and the cornice is corbeled. The doorway has a four-panel door and a four-light transom. The window openings have plain wood lintels and sills with 6/6 sash. A circa 1870-1880 frame porch extends across the west elevation with decorative brackets, pendants, dentil molding, and chamfered square columns. The roof is covered with composition material and a rebuilt exterior chimney on the south elevation. The north elevation has only a single attic level window with 6/3 sash. A two-story rear wing has been much altered, with an enclosed porch on the south elevation faced with brick veneer, and a frame addition adjoining the east end of the brick section which incorporates a frame wash house, according to the present owner. This frame section has german siding, 6/6 sash and a vertical board door. The base of an exterior stone chimney is located on the south elevation, with signs of recent rehabilitation in progress. The brick section of the wing has 6/6 sash and plain lintels and sills, matching the main section windows. The interior of the house has been considerably altered, with 20th century hardwood floors on the first story and a brick mantel of the mid-20th century in the south parlor. The parlor has been partitioned by an oak-columned arch in the style of 1920's Craftsman houses. The wing contains the dining room and the remodeled kitchen. The dining room has a simple Greek Revival style mantel and tongue-and-groove siding and the kitchen has been completely remodeled, with a rebuilt fireplace surround.

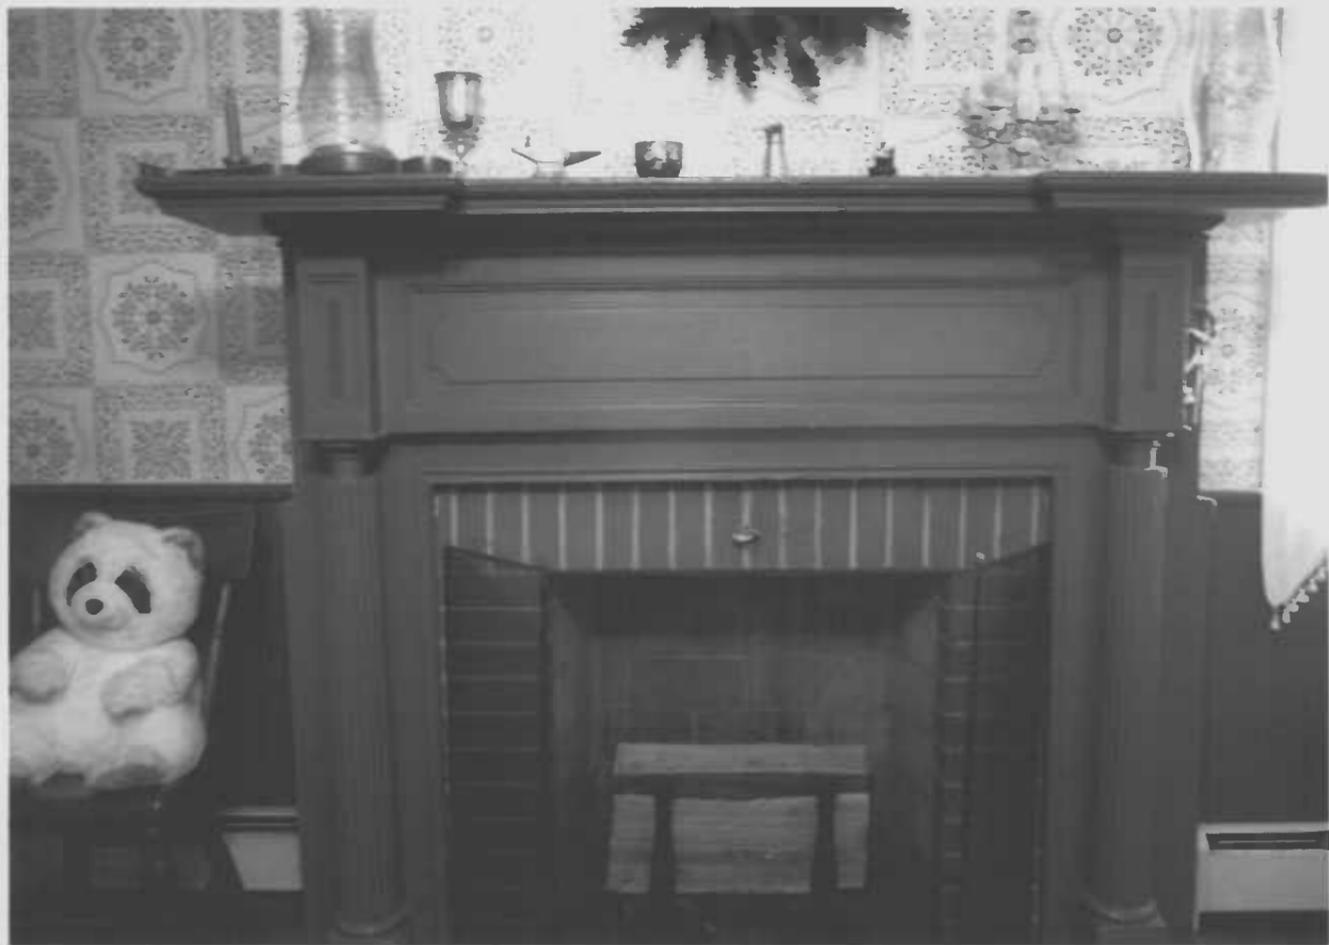
3/7

Dining room mantel

The Charles H. Coblentz Farmstead is a fair example of a domestic group of the second quarter of the 19th century, containing good examples, although altered, of stone domestic outbuildings and a brick dwelling which may date from about 1820, and an agricultural group of the late 19th century, with a large frame bank barn, a double-bay wagon shed/corn crib which is one of about six identified in the Middletown Valley, and a possible hog barn. This is a typical chronological categorization of Frederick County farms, the domestic group often predating the existing agricultural buildings. Advancements in agricultural science and the shift from grain-producing to dairy economy in the early 20th century caused an extended series of alterations in the farm buildings, while the domestic changes were often more subtle, involving interior changes such as indoor plumbing, electric power, and domestic appliance inventions which changed the arrangement and furnishing of the kitchen wing, rather than replacement of the entire structure. The Coblentz House shows some additional alteration in the living area in the replacement of the original mantel and the addition of the columned arch.

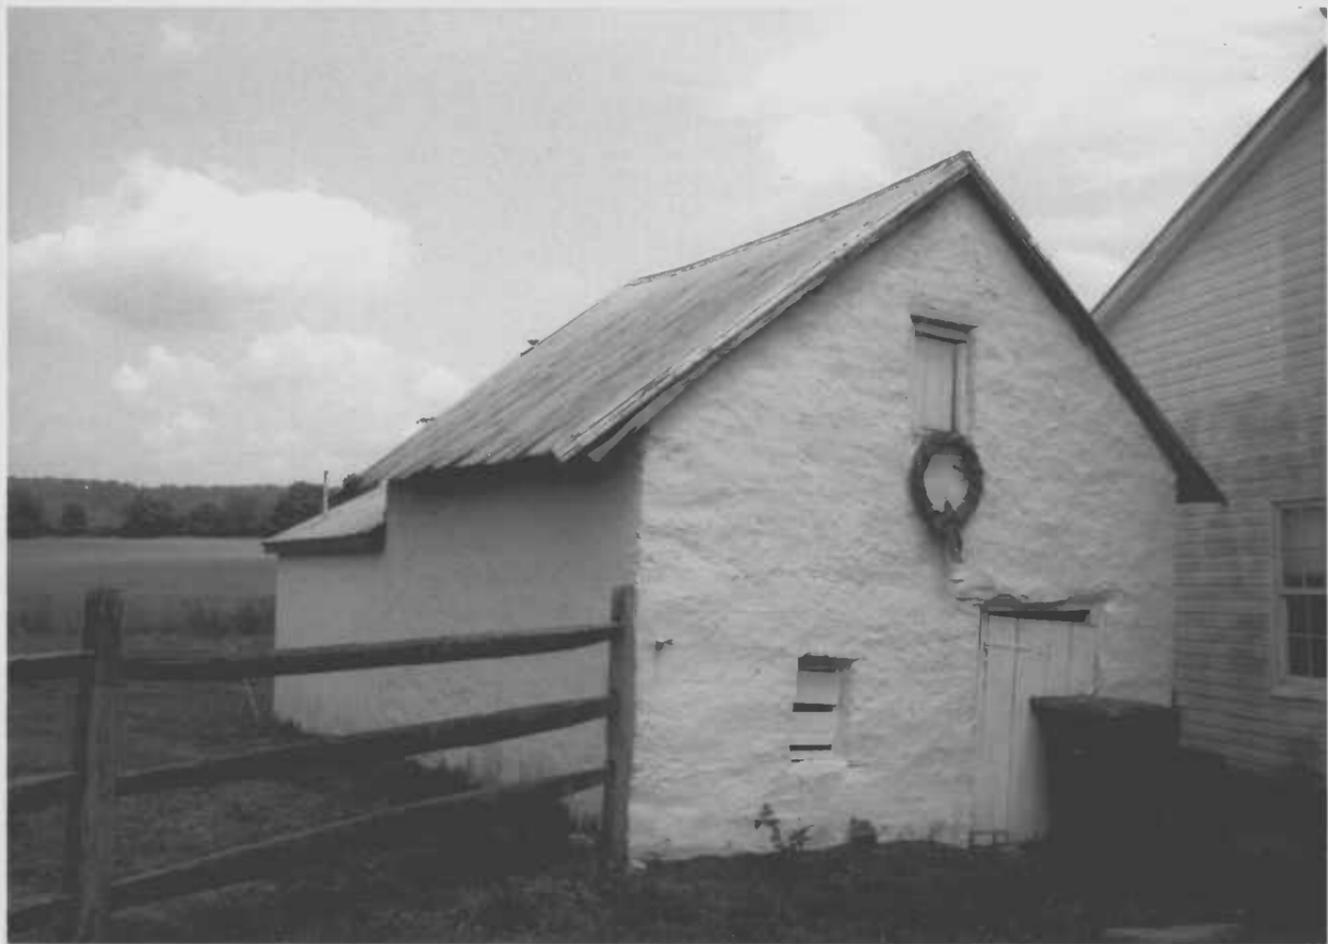
4/7

Meat house, west elevation

Smokehouse: The stone smokehouse or meathouse is located immediately northeast of the brick section of the rear wing of the house at an angle to the plane of the house. The stone walls are plastered and painted white. The vertical board door is located in the west elevation and the gable roof is covered with corrugated metal. A concrete block extension to the building, possibly dating from the 1940's, adjoins the east gable end. The stone part of the smokehouse was probably built about the same time as the house.

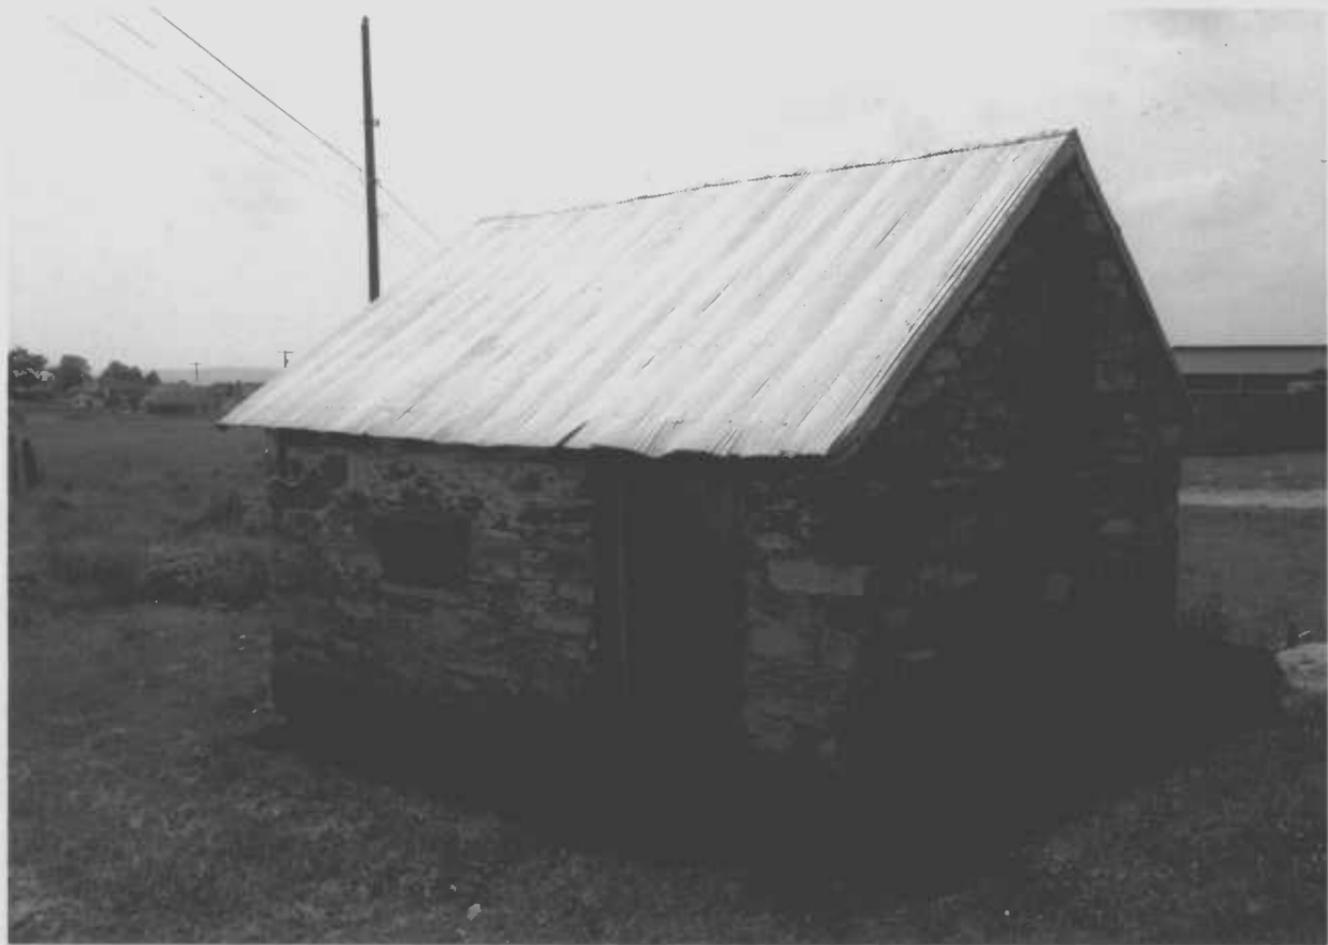
B/1

Neg. loc.: Md. SHPO, Crownsville, Md.
Springhouse, east elevation

Springhouse: The stone springhouse is located west of the house on the south side of the entrance drive from Coblentz Road. It has a corrugated metal roof and its exterior shows evidence of having been whitewashed in the past. A vertical board door is located in the south elevation and wood barred windows are in the south and east elevations. A small vertical board door in the gable of the north elevation gives access to an upper level storage loft. The springhouse also dates from the same period as the dwelling.

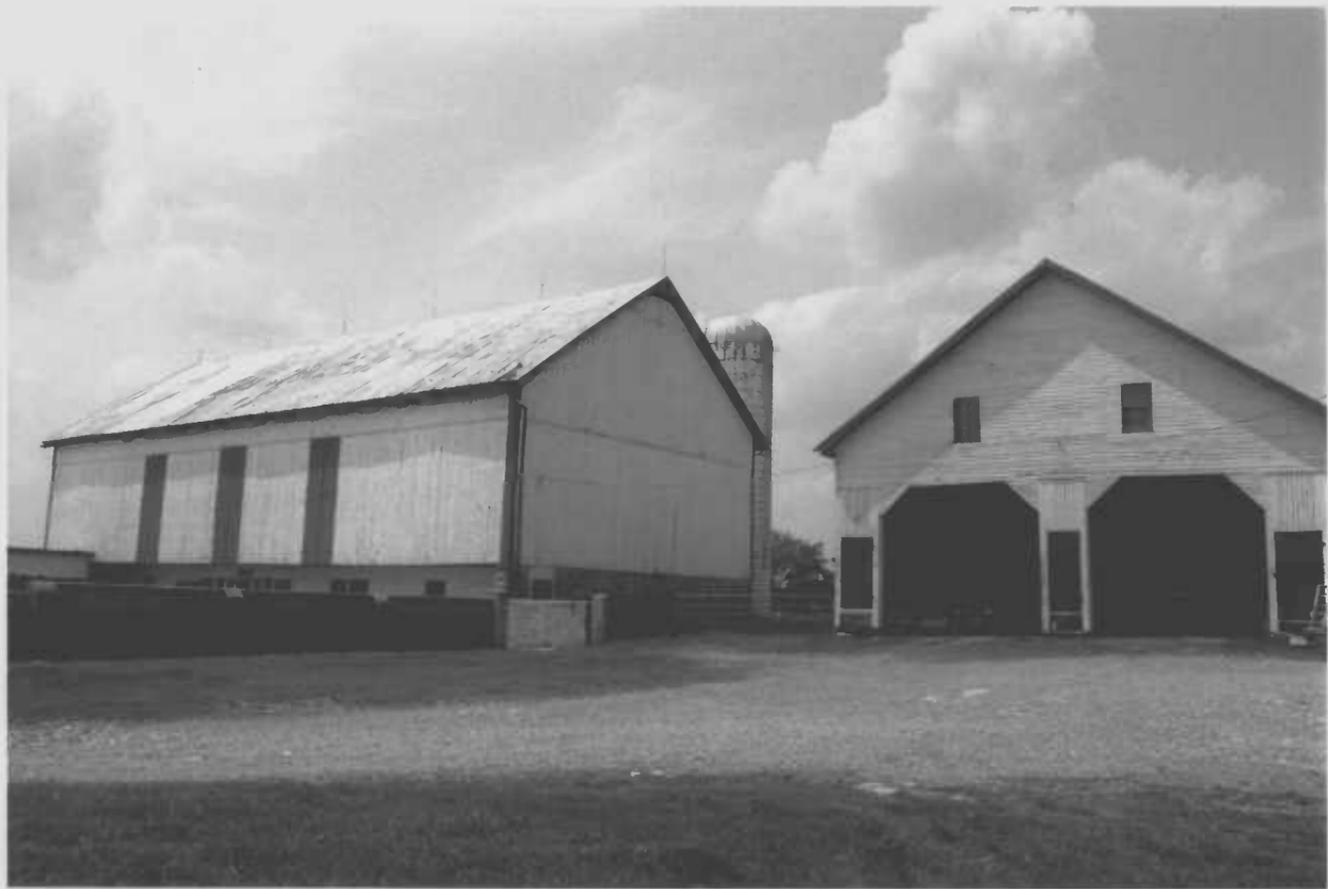
Barn and wagon shed / corn crib south elevation
6/7

Barn: The frame bank barn is the third barn on the site, two earlier barns having burned during the last quarter of the 19th century. It was last rebuilt about 1880. The stall level on the south elevation is faced with horizontal flush boards. The vertical board upper level has three sets of swing doors on the south elevation. A non-contributing concrete silo is located next to the ramp on the north elevation. A non-contributing concrete block loafing shed adjoins the west end of the barn. The roof is covered with standing seam metal.

Wagon shed/corn crib: The double bay wagon shed was built during the last quarter of the 19th century, possibly about 1880 at the same time the barn was rebuilt. It faces south, with the two drive-through passages flanked by corn cribs. The south elevation has german siding with two 6/6 windows in the loft level.

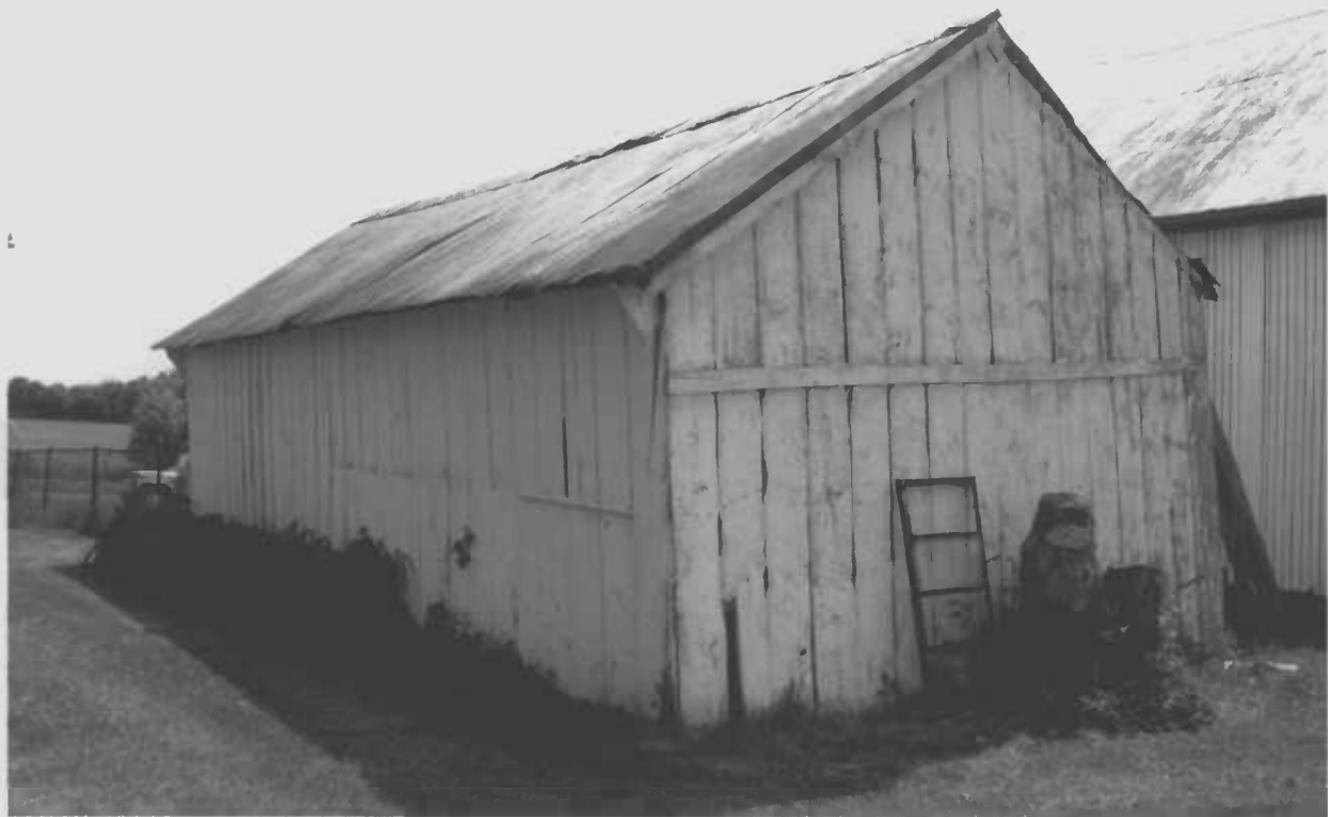
1/1

Hog barn/shed, northeast corner view

Shed: The frame shed is located east of the wagon shed and appears to date from the same period. Possibly built as a hog barn, it has vertical siding and a corrugated metal gable roof over wood shingles. Two sets of double swing doors are in the west elevation and sections of low doors on the east elevation suggest that the hog wallow or yard was on the east side.
