F-4-87  
William Green Farmstead  
Myersville vicinity  
Private

F-4-87  
William Green Farmstead  
Myersville  
Frederick County

Maryland Historical Trust State Historic Sites Inventory Form

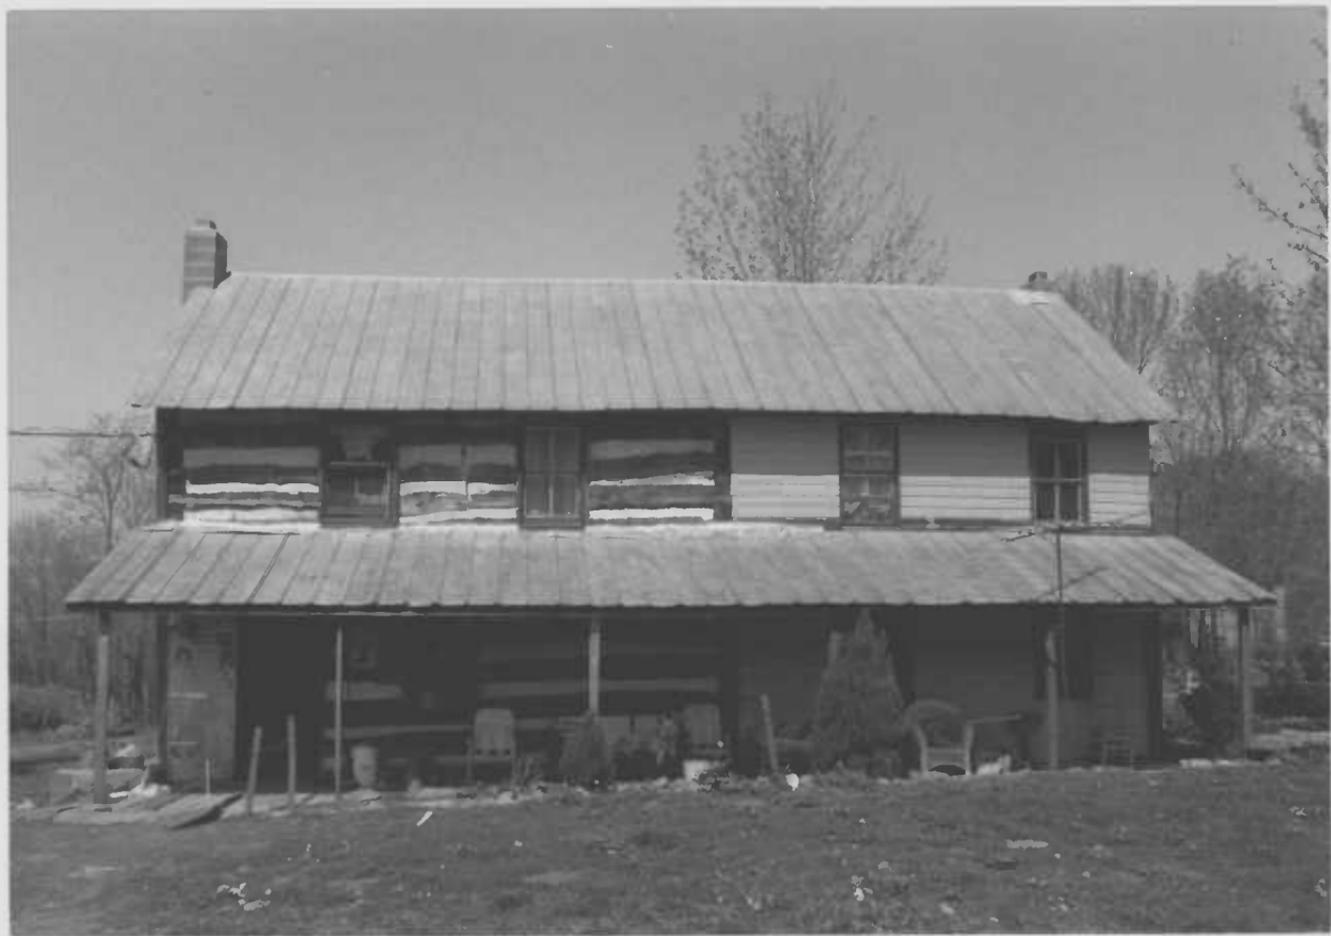
1/7

East elevation

The circa 1800 log section of the house is adjoined by the frame section on the north. The principal elevation of both parts faces east with two bays in each part and a one-story porch with plain square posts extending across both sections. The house is two stories in height and the gable roof over both parts is standing seam metal. Both sections have entrances with replacement doors. The windows are 6/6 in the log section and 2/2 in the frame part. On the north elevation is a 1/1 window. The west elevation has both 6/6 and 2/2 sash. The chimneys are exterior concrete block replacements of the original stacks and are located on each gable end of the building. The south elevation and a part of the west elevation is covered with pressed metal and corrugated metal, which has been partially removed, revealing german siding over the log section. The interior walls of the log section were once covered with lath and plaster, but this has been removed, leaving the logs exposed on the interior. Wide board floors are intact and the low ceilings are plastered. The log section has been partitioned to create a bathroom. The fireplaces are closed off and a winding stairway is located in the southwest corner next to the former fireplace.

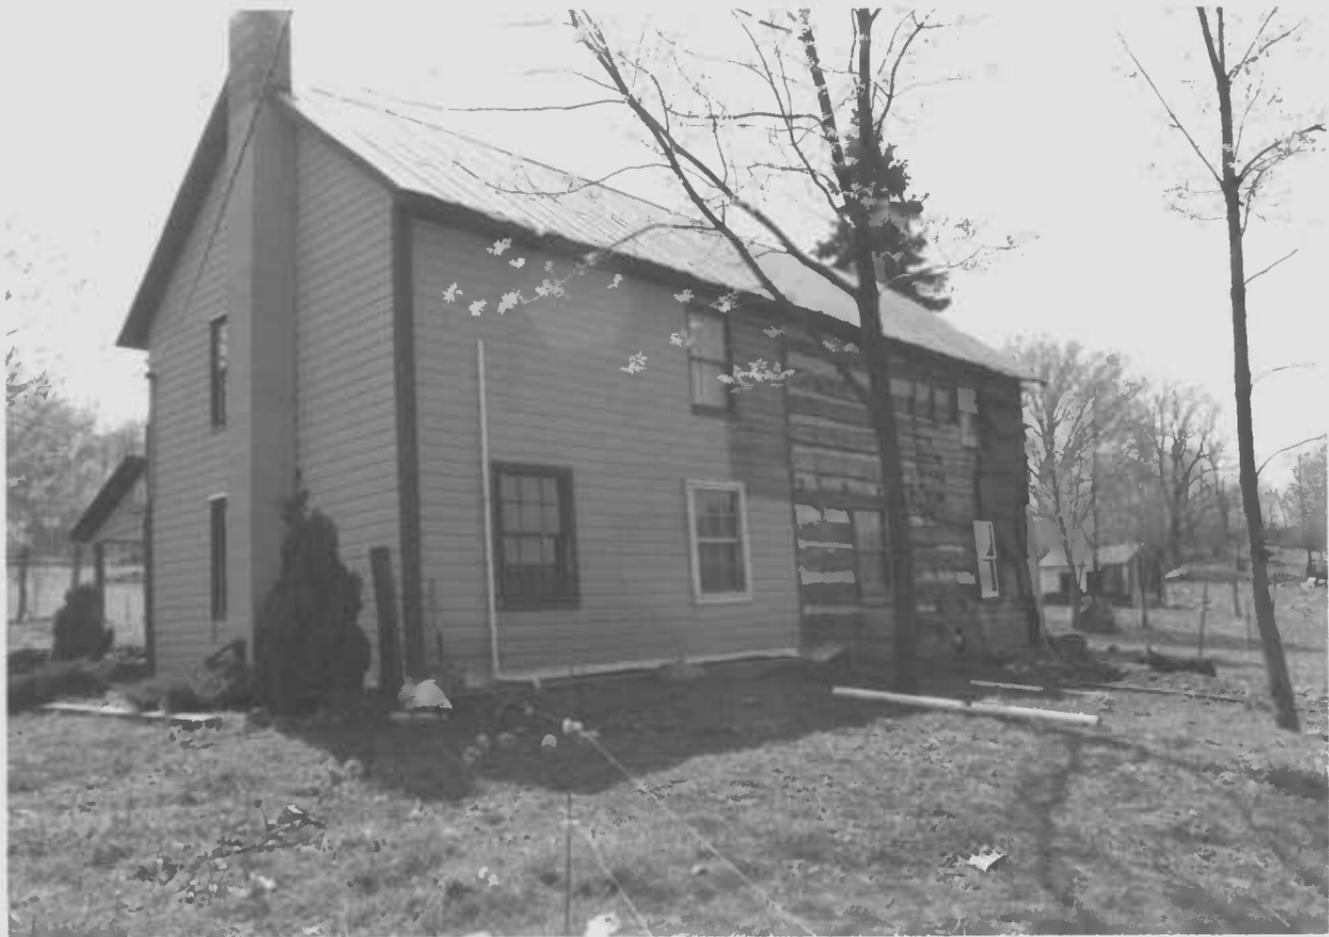
2/7

Northwest corner view

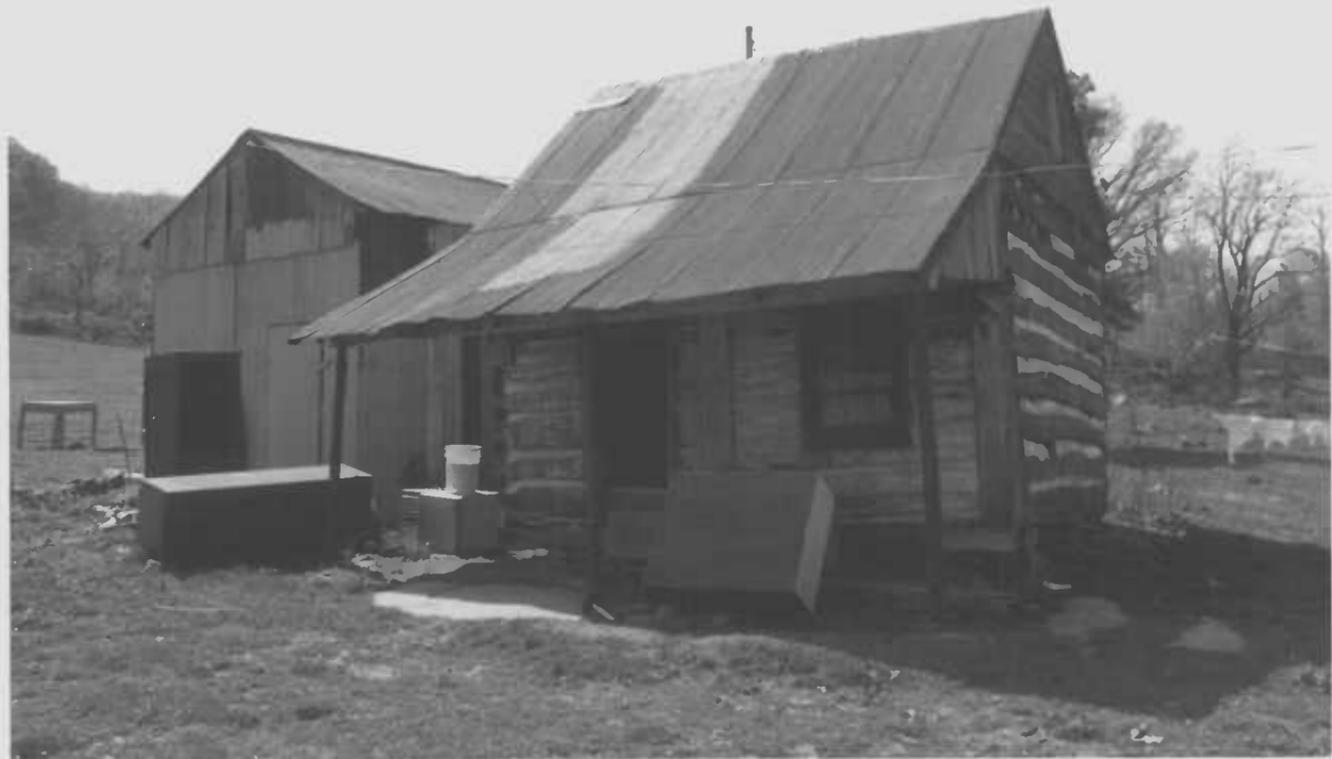
26

Summer kitchen and springhouse, northwest  
corner view

Summer kitchen: The log summer kitchen is a 1-1/2 story building located about 20 feet east of the south log section of the dwelling. It probably dates from about the same period as the house, although the present tenant, Mrs. Rippeon, has been told by other local residents that it is the oldest structure on the farm and served as the original dwelling in the last quarter of the 18th century. Title research has not been completed to confirm this as the chain becomes obscure in the late 1840's; however, the use of a small outbuilding as a residence while a larger dwelling was completed would not be uncommon in the period around 1800. The building has two bays on the north elevation with a one-story shed roofed porch. The walls show that the structure was whitewashed in the past. The roof is covered with corrugated metal. The door is flanked by a 6/3 window. The chimney has been removed, but was probably an exterior stone and brick construction. The interior fireplace opening is boarded. The plan is one room with an open stair to the upper

Springhouse: The springhouse is located immediately east of the summer kitchen. The stone lower level probably dates from about 1800, but the frame upper level was probably replaced in the last quarter of the 19th century. It has vertical and board and batten siding and a corrugated metal roof. The door in the north elevation is tongue-and-groove. Mrs. Rippeon has been told by a former owner that this structure was also used as a dwelling, perhaps by a hired hand, in the late 19th century.

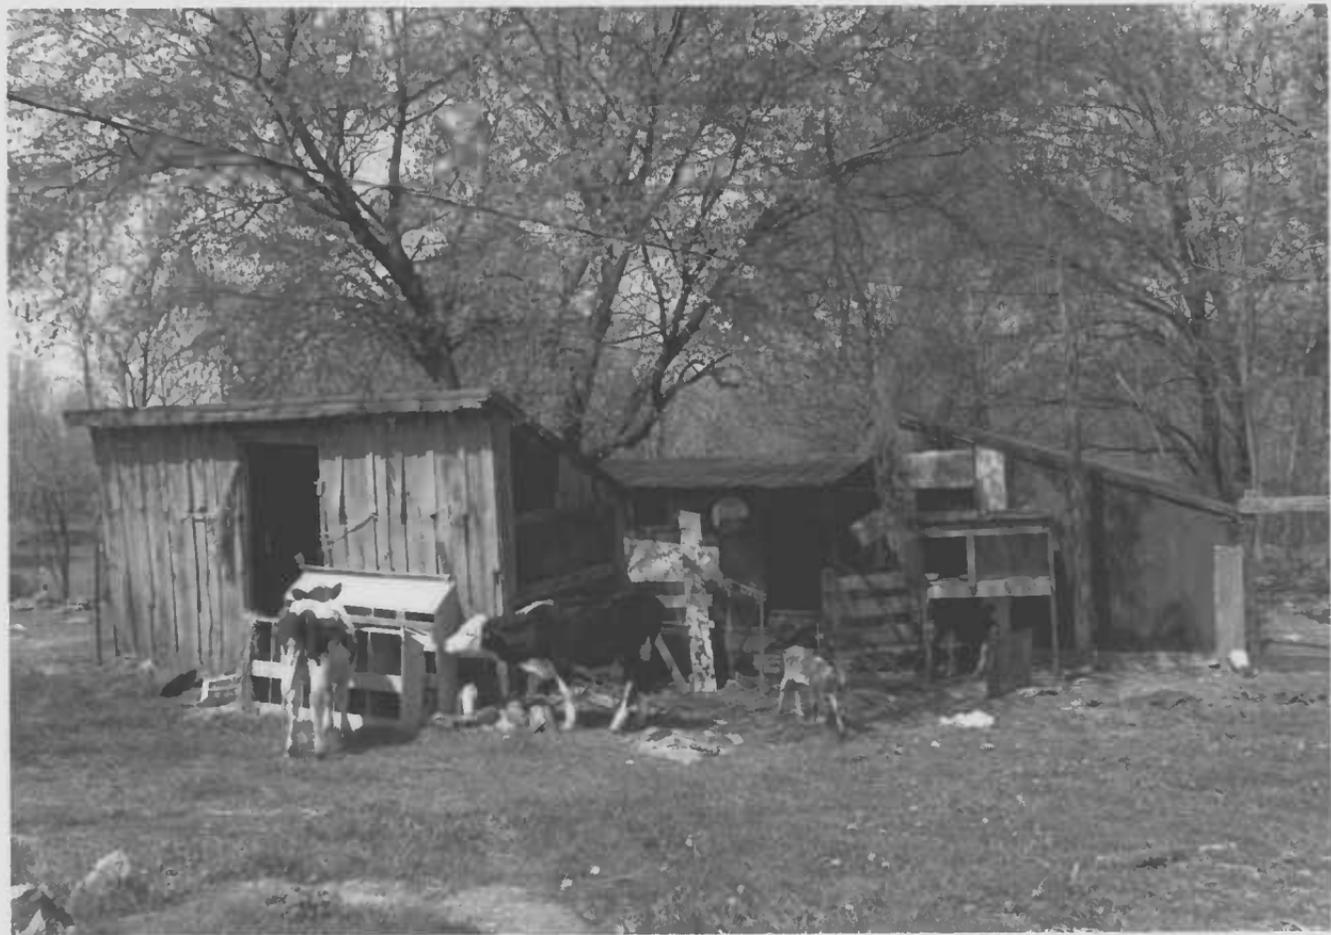
3/7

Cricket houses (row goat sheds) east  
elevations

Chicken houses: Three frame chicken houses with standing seam metal shed roofs are located between the dwelling and the barn. Each has vertical siding. They are currently in use as goat sheds, but appear to have been built about 1900-1920.

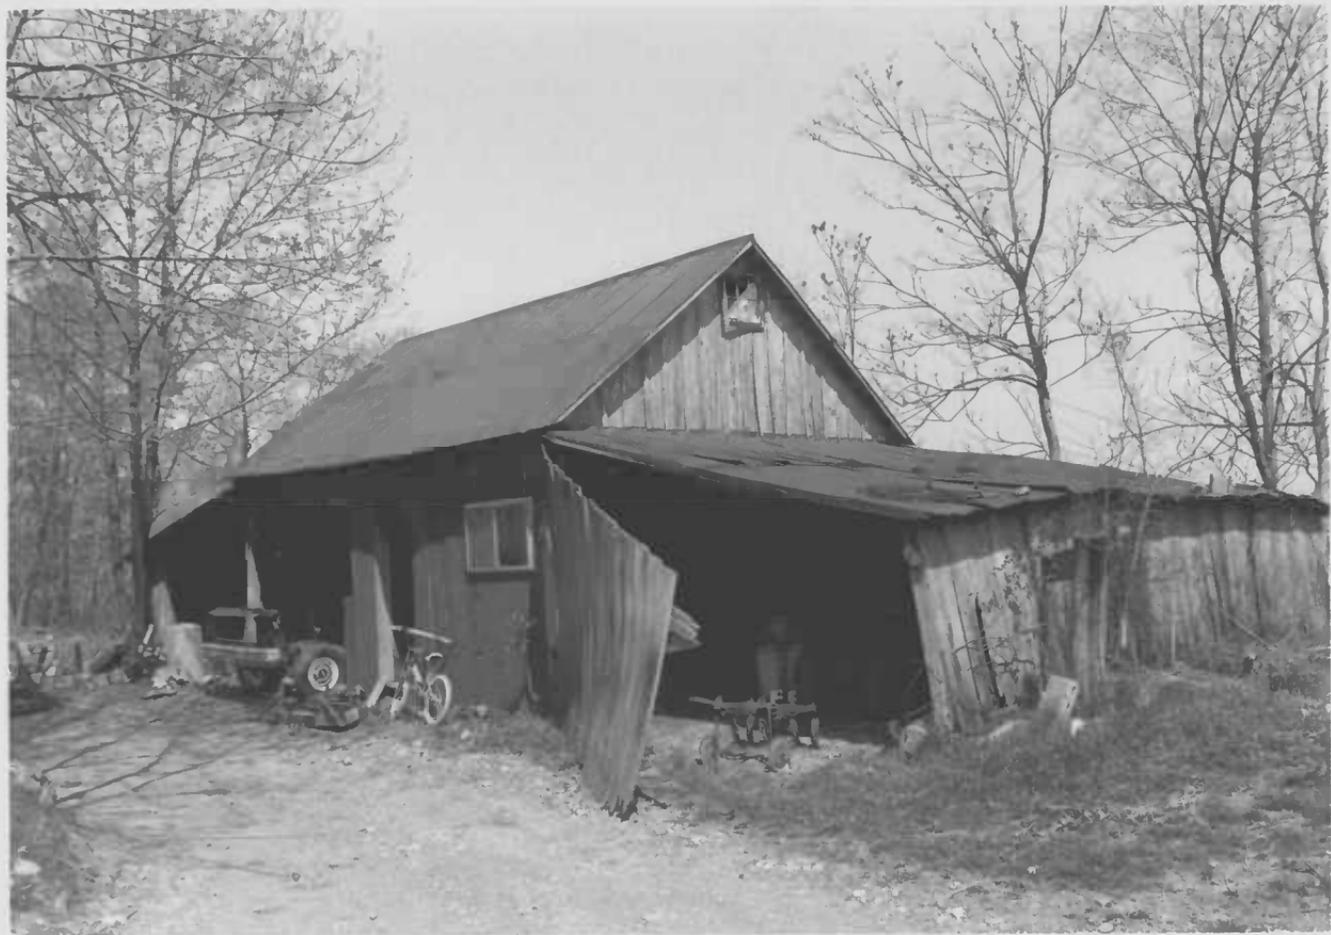
617

Wagon shed, southeast corner view

Wagon shed: The frame wagon shed is located just northeast of the barn. It was probably built about 1900. Its siding is vertical boards and the roof is covered with corrugated metal. Shed additions on the east and west elevations extend the roof from the eaves of the main structure.
