F-8-77

Ernst-Duncan Farm

Woodsboro vicinity, Maryland

Maryland Historical Trust State Historic Sites Inventory Form

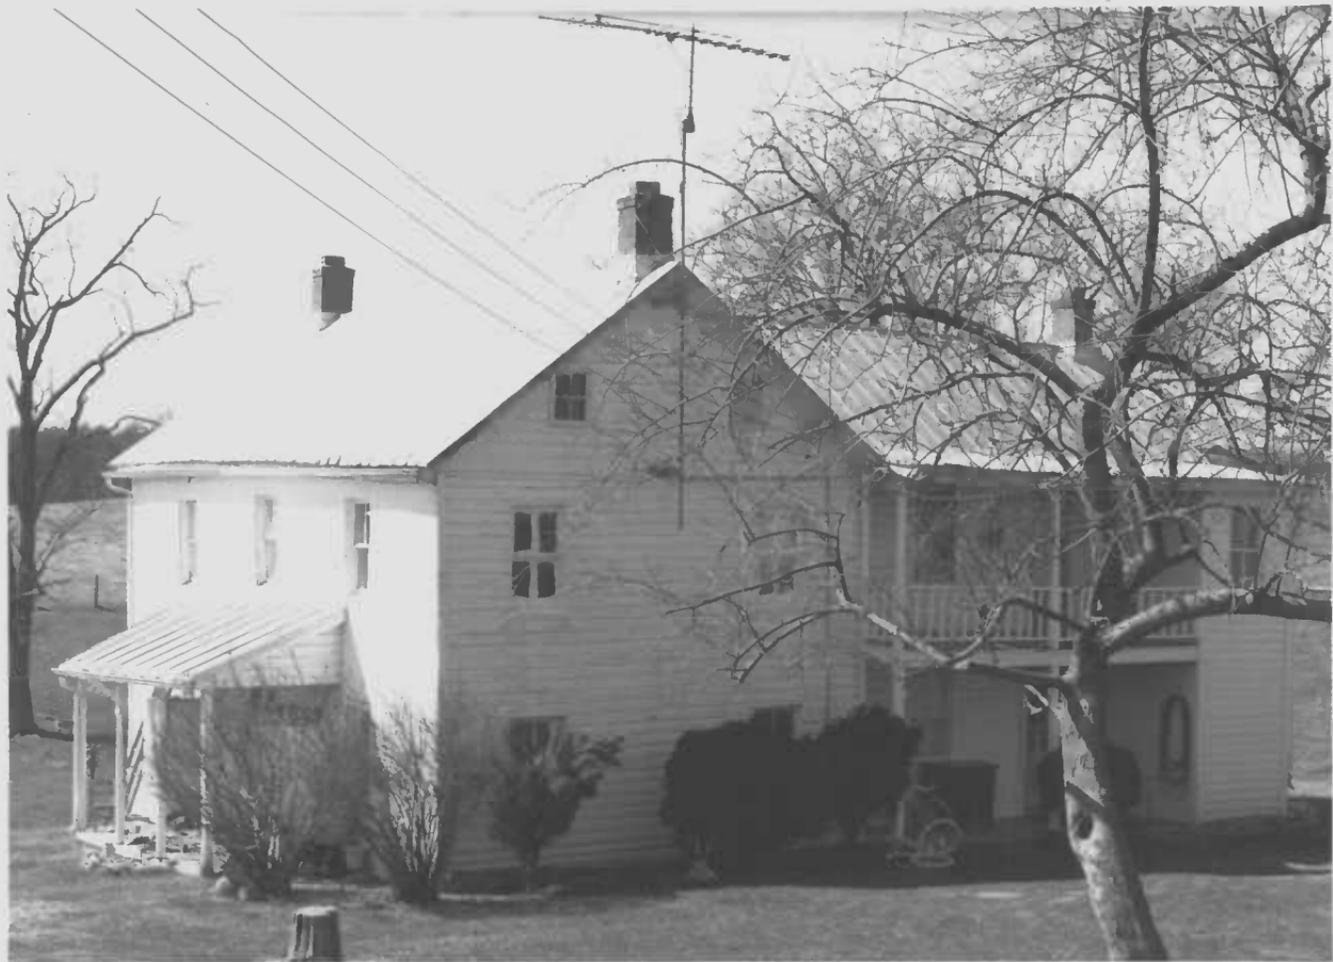
1/3

The principal facade is stuccoed and contains an center door with sidelights which is flanked by 2/2 light windows. The second story is symmetrical to the first with three 2/2 light windows. A one story open porch covers the entry bay with a shed roof and simple, turned columns. The gable roof runs east to west and contains two interior end brick chimneys. The west elevation contains stucco to the gable eaves and then has beaded siding to the peak. A two story ell addition extends from the north elevation and rests on a stone foundation. On its west side, it contains three bays with 2/2 light windows and one first story 6/6 light window with center placement. On its north elevation, the ell is stuccoed to the gable eaves and then german-sided to the peak. The east elevation consists of the main block gable end and the ell extension. The gable end is german sided and has two symmetrical windows of 2/2 lights on two stories with two 4 light fixed windows in the attic. The german-sided ell is recessed from the main block which is flush with a 2 story open porch that covers most of the ell. It is enclosed at the end bay with a 2/2 light window in the second story. Both stories have center door openings; the first floor door with a transom light.

Southeast Corner View

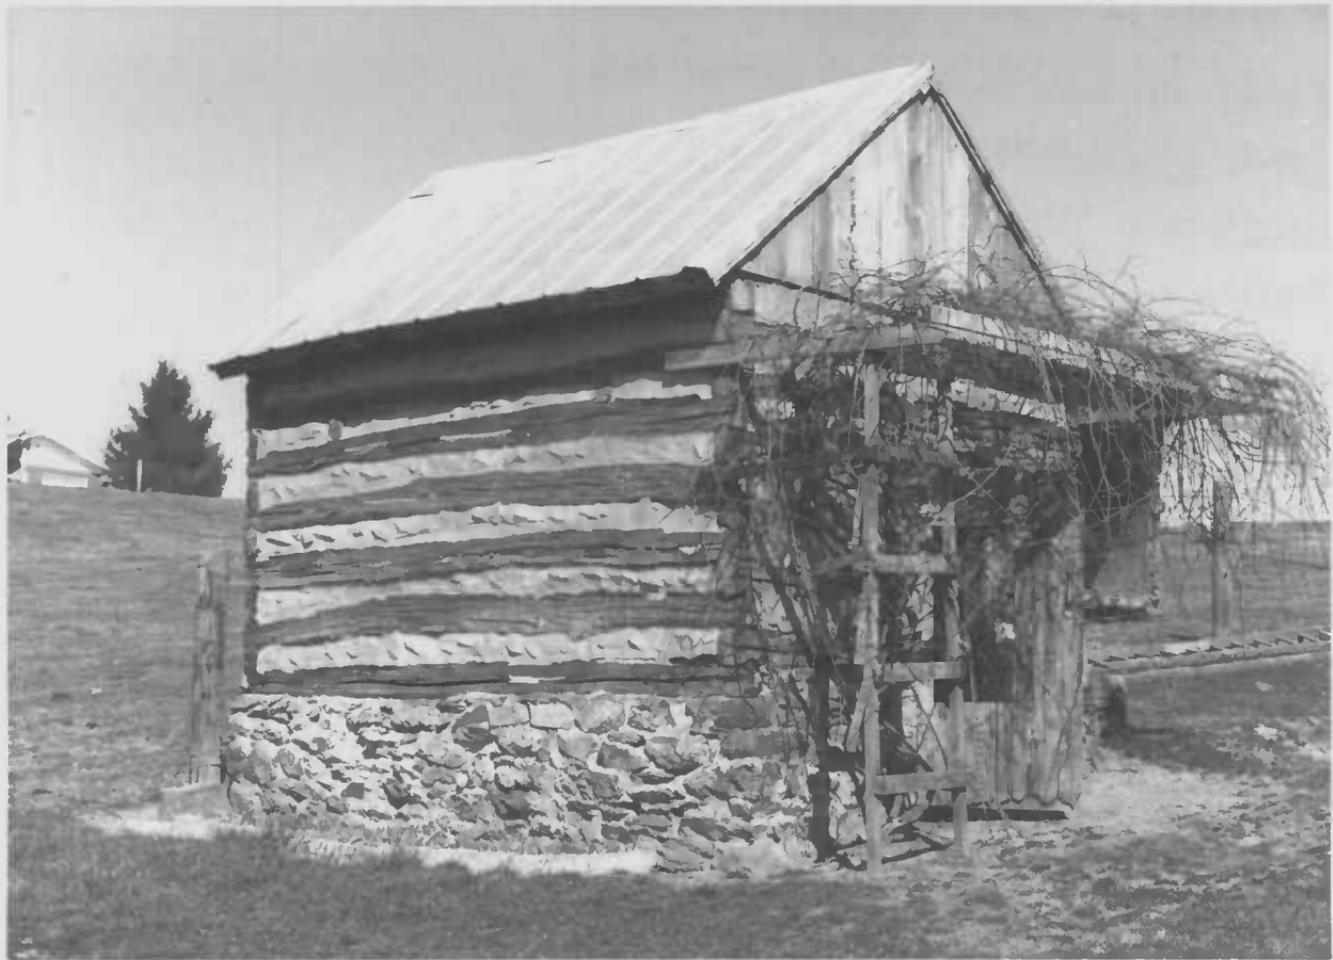
2/3

A cluster of domestic and agricultural outbuildings accompany the main house. A one story log smokehouse lies close to the northeast corner of the main house, facing south. The log construction has V-notching; the gable ends are vertical sided. The building rests on a raised stone foundation. The principal facade is comprised of a front gable roofline of standing seam tin with center door placement. Two horizontal posts run through the interior with the ends showing on the side elevations. A small domestic outbuilding adjacent to the smokehouse is one story with a side gable roofline of standing seam tin. Facing south, it is sheathed in tongue and groove siding. The facade has an off-center door opening. A large corral is situated beyond the small outbuilding. It is comprised of concrete block resting on a stone foundation. A side gable roofline of standing seam tin runs east to west. The principal facade, facing south, has side door placement and two window openings with heavy wood lintels.

log Smokehouse / Southwest corner

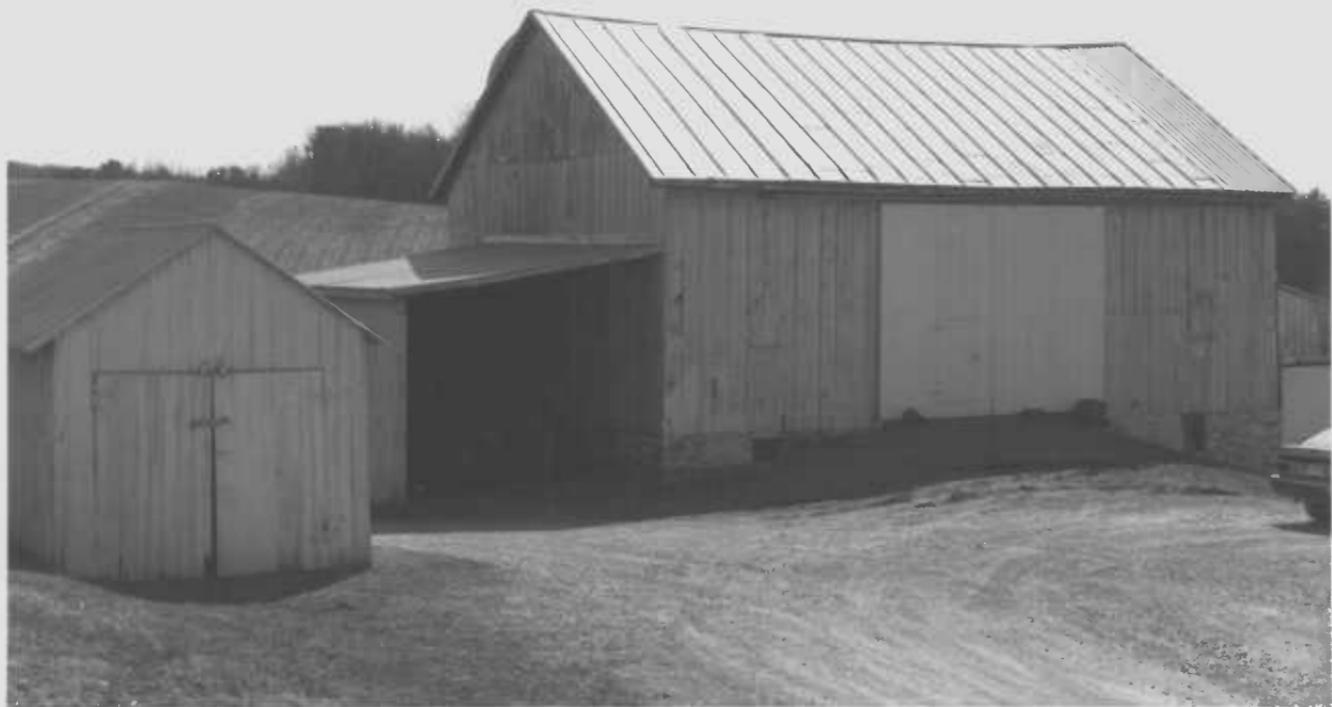
North Elevation 3/3

A barn complex is situated to the southeast of the main house. It includes a main barn, a silo, a dairy, a corral, and sheds. The bank barn has vertical siding and rests on a stone foundation. The gable roof of standing seam tin runs east to west. A two part sliding door opening and peaked window coverings in the siding comprise the main (north) elevation. The interior is mortised and tenoned and has hand-hewn timbers. The one story concrete dairy runs 8 bays in length with its principal facade on the east. It has a gable roofline of standing seam. Openings are composed of 4 light fixed windows. A small tractor shed lies to the northeast of the barn complex. Sitting on a concrete block foundation, it has board and batten siding and a side gable roof of standing seam tin.

Bank Barn & Tractor Shed
