Harry Davis House and Outbuildings

New Midway vicinity

F-8-87

Maryland Historical Trust State Historic Sites Inventory Form

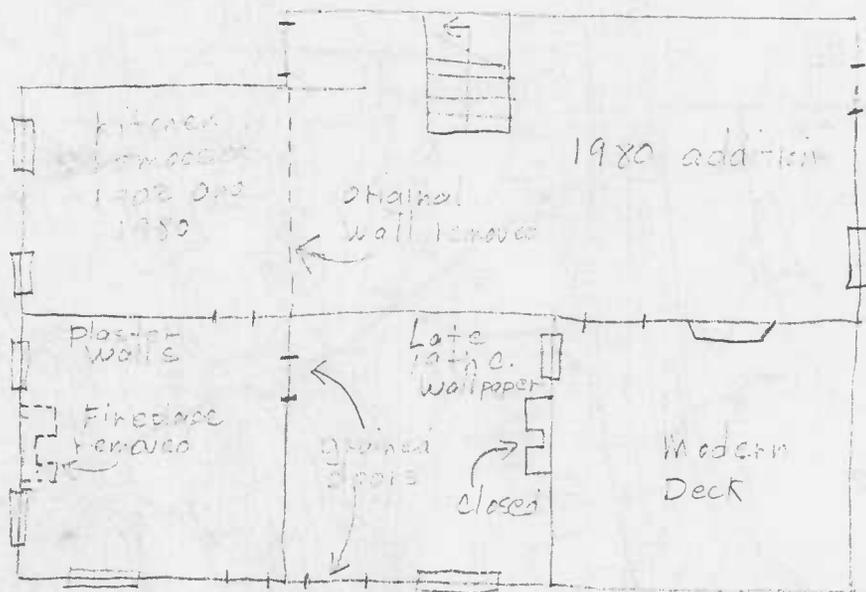
F-8-87
 Harry Davis House
 Frederick County

Not to scale

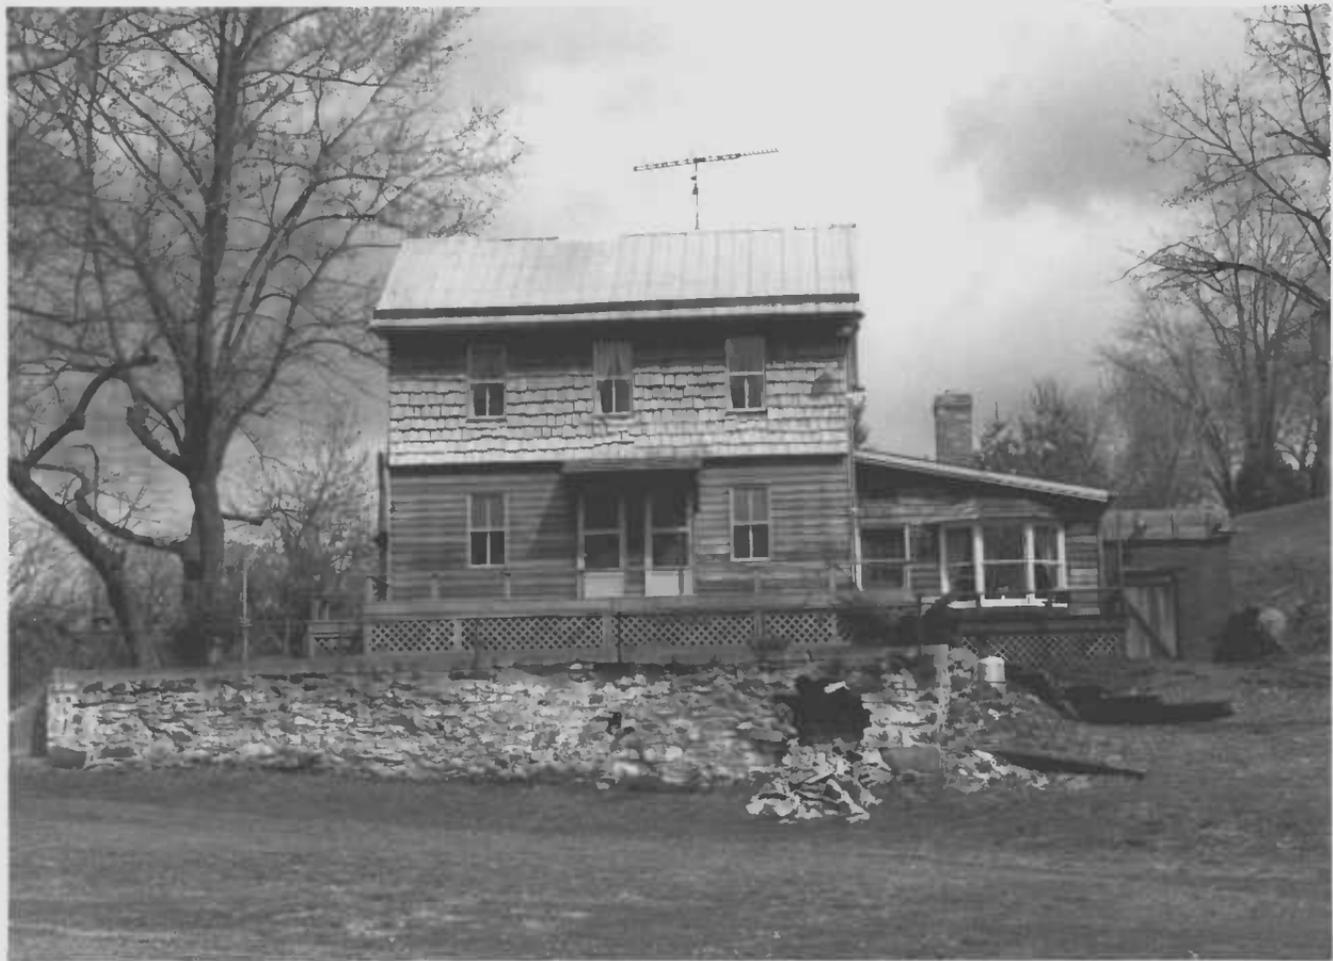
1/6

South elevation

The farm dates from the last quarter of the 19th century; however, the principal agricultural outbuildings date from about 1903 when a major period of alteration to the house took place. Alterations to the complex continued into the 1970's and 1980's. The house was built as a typical 3-bay two-story, gable roofed frame dwelling with two entrance doors in the center bay of the south elevation. The rear ell extended from the northwest corner of the two-room main section. Interior end chimneys were located in each gable end. In 1903, major updating and alterations took place in the ell, where the kitchen was enlarged. In the 1980's, a further major change took place in which an open deck was added on the east gable end and a one-story addition filled in the angle between the main section and the ell. Walls were removed, leaving an open floor plan which blurs the outlines of the original house. The stone foundation remains intact and certain features of the interior, including the plaster walls, grained doors, and some late 19th century wallpaper in the east parlor, remain intact. The interior fireplace openings were closed. In the ell, the only feature retained from the 1903 remodeling is the tongue-and-groove ceiling. The slate original roof was covered with standing seam tin in 1972. The exterior cladding of shingles on the second story and clapboards on the first story are unpainted and unstained.

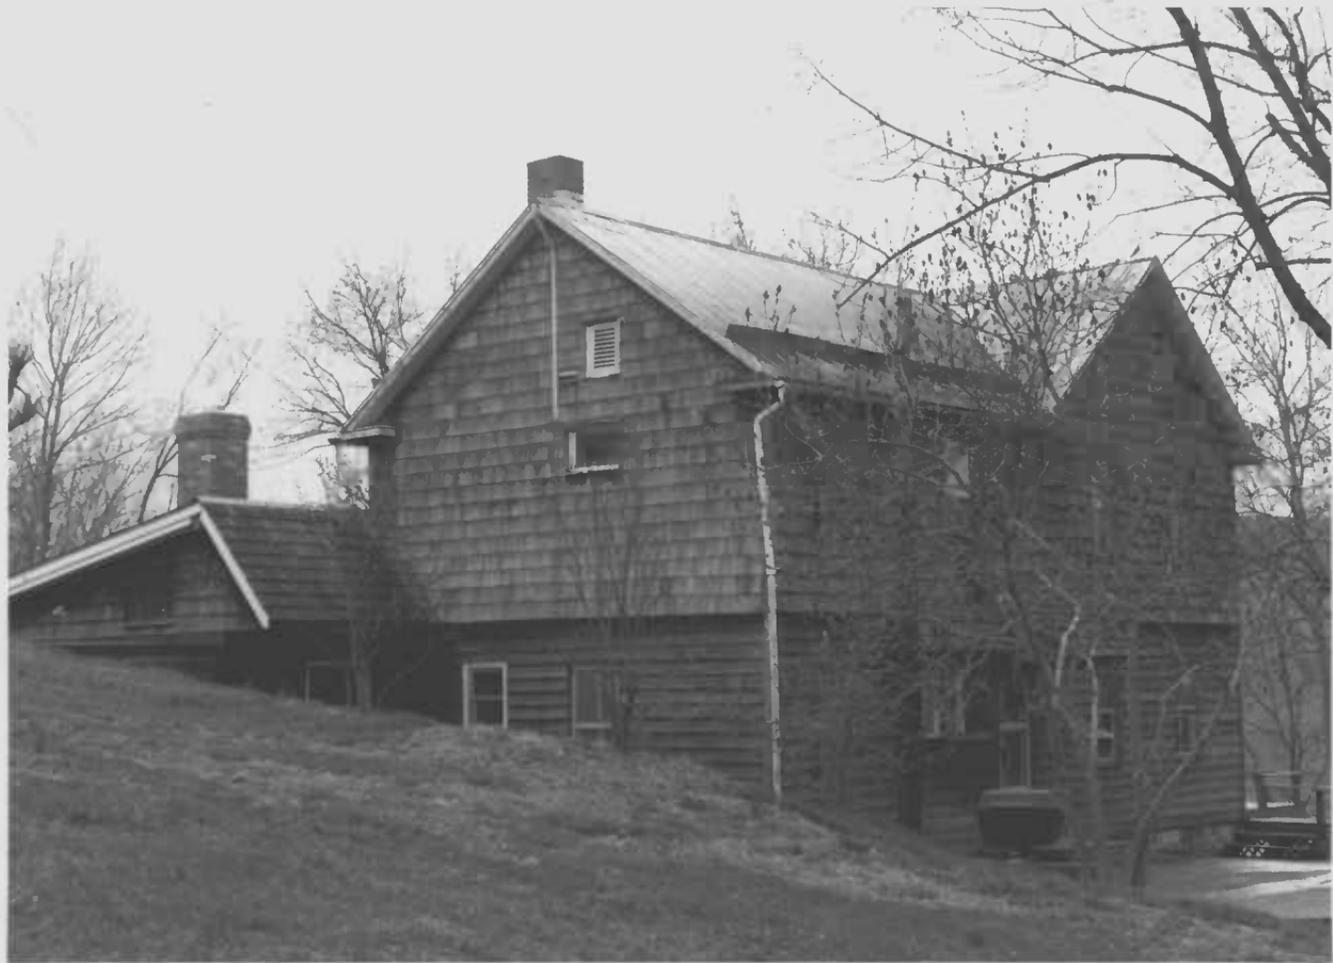
2/6

Northwest corner view

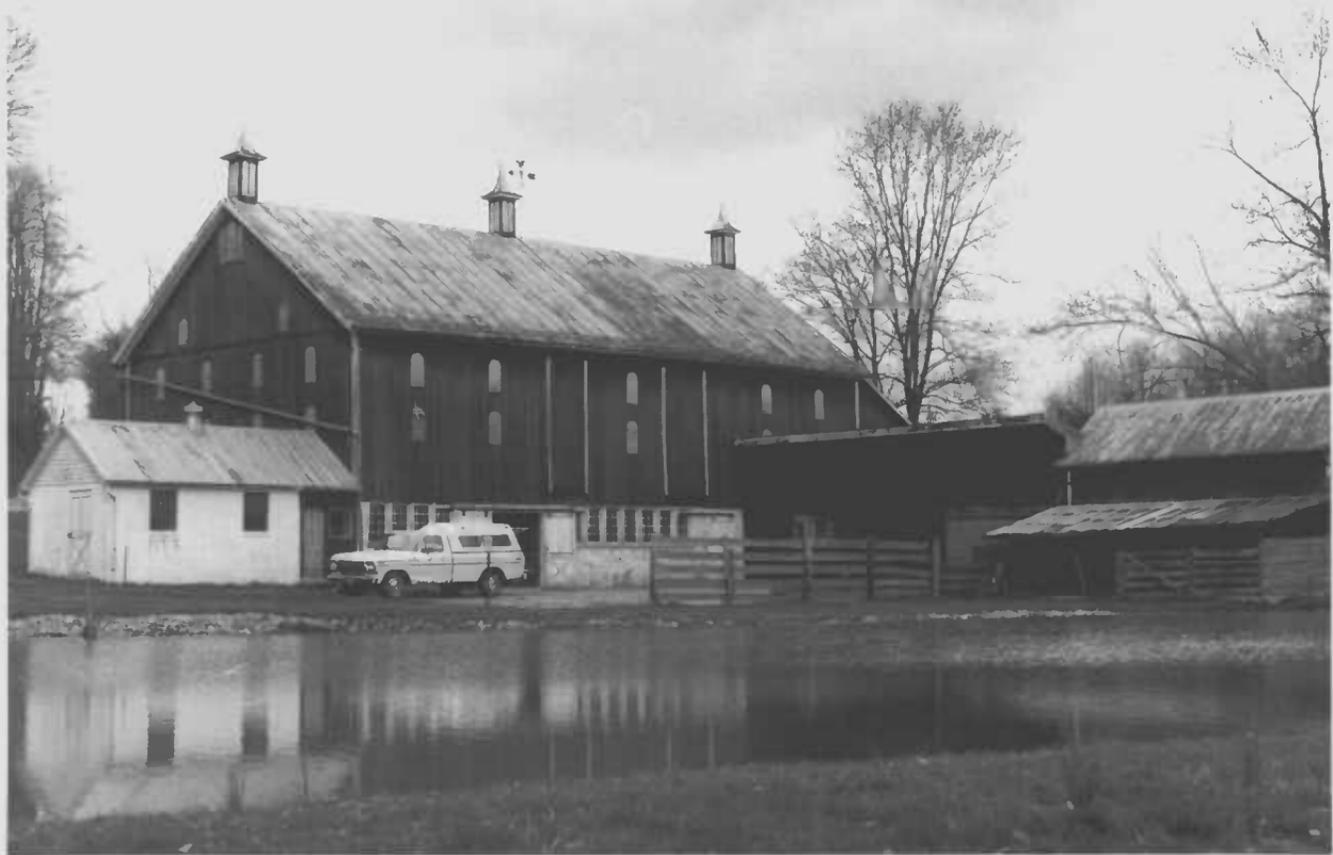
3/6

Barn, loafing shed and hog barn from south.

Bank barn: Built in 1903, the frame building has machine-sawn and hewn timbers, suggesting re-used old materials. The standing seam roof is topped by three louvred cupolas on the ridgeline. Painted "windows" include louvred vents in the vertical siding. Adapted for dairy operations in the early 20th century, the forebay was enclosed with concrete block and an adjoining concrete block milk can storage building was added.

Loafing shed and hog shed: The 1903 loafing shed and frame hog barn are attached to the southeast corner of the bank barn. The open side of the loafing shed and the hog wallow are on the west elevation.

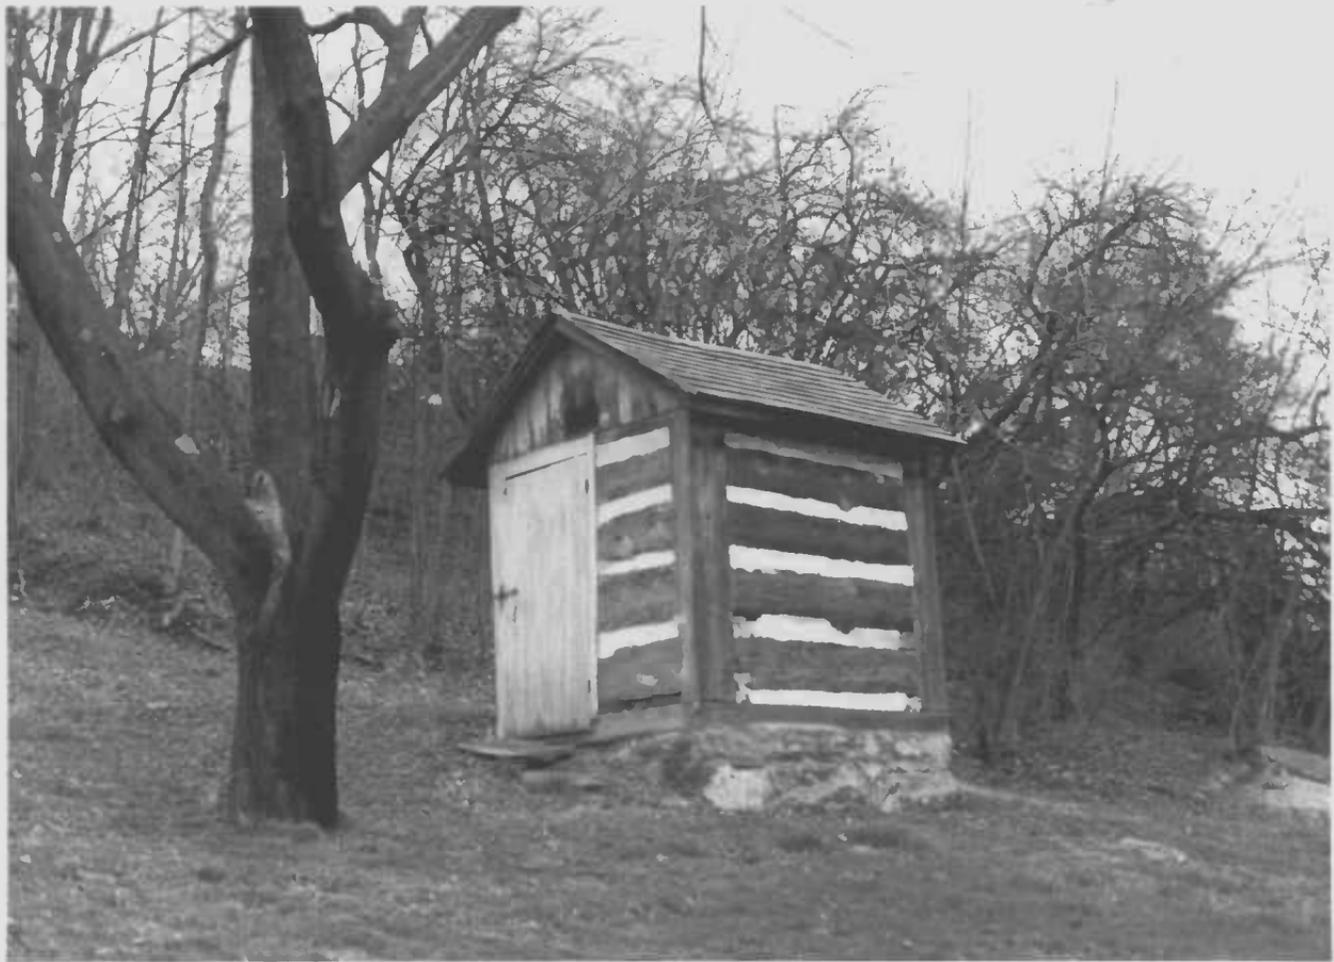
4/6

Smokehouse, southwest corner view

Log Smokehouse: Located about 35 feet east of the dwelling house, the smokehouse is about 10 feet square with a single door in the west elevation and a recently replaced shingle roof. The smokehouse is approximately the same date as the original house.

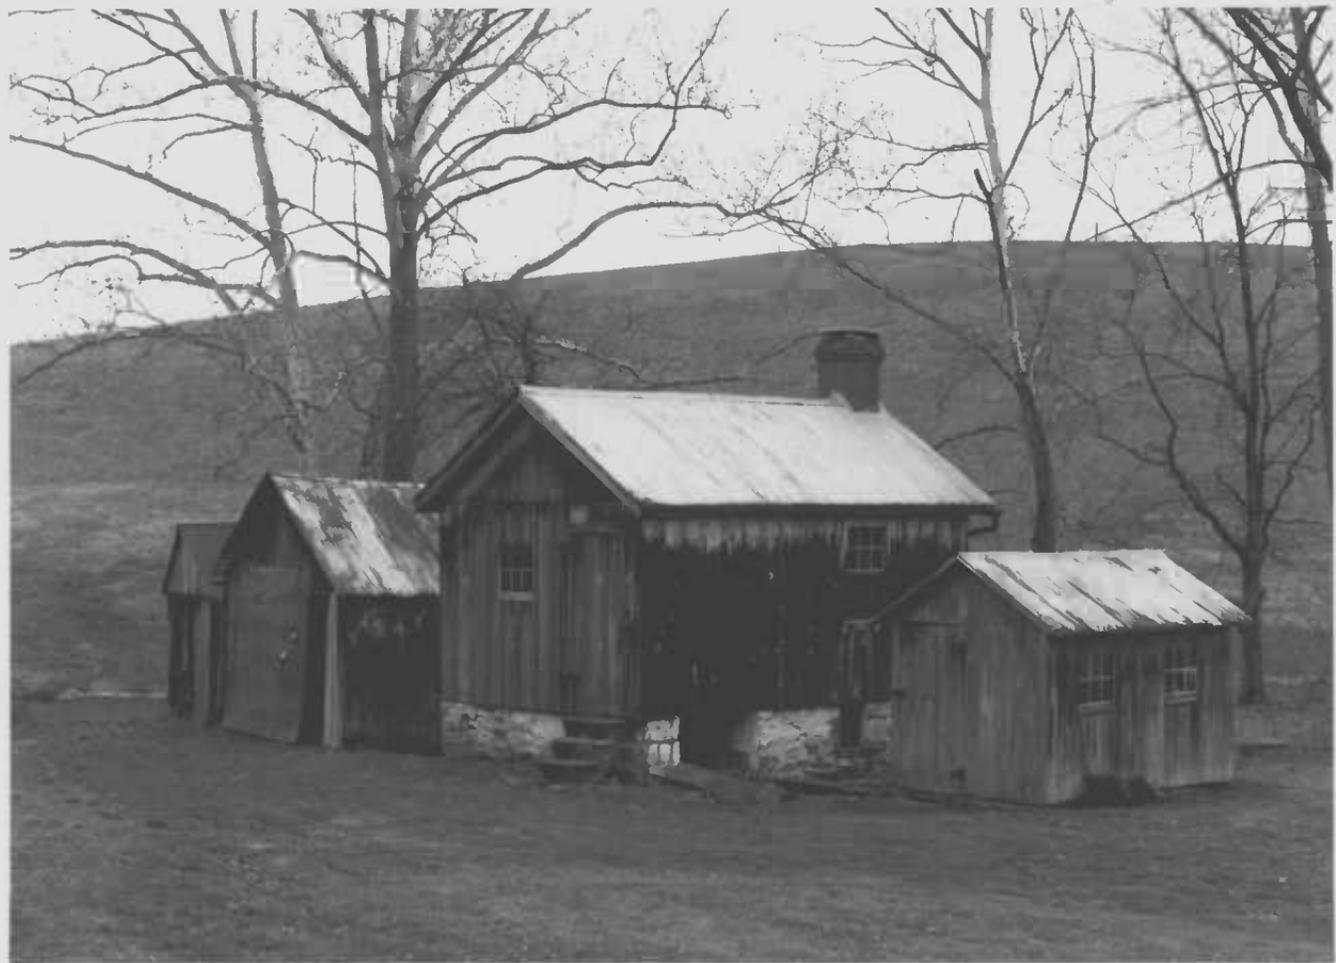
5/6

Blacksmith Shop, Garage, Springhouse, sterilization
Shed (L to R)

Domestic Outbuildings: These are four frame buildings located in a row about 25 yards southeast of the house. They include a milk can sterilization shed, a springhouse with board and batten siding on a stone base, a circa 1914 garage, and a blacksmith shop with hewn timbers, vertical siding, and a standing seam tin roof.

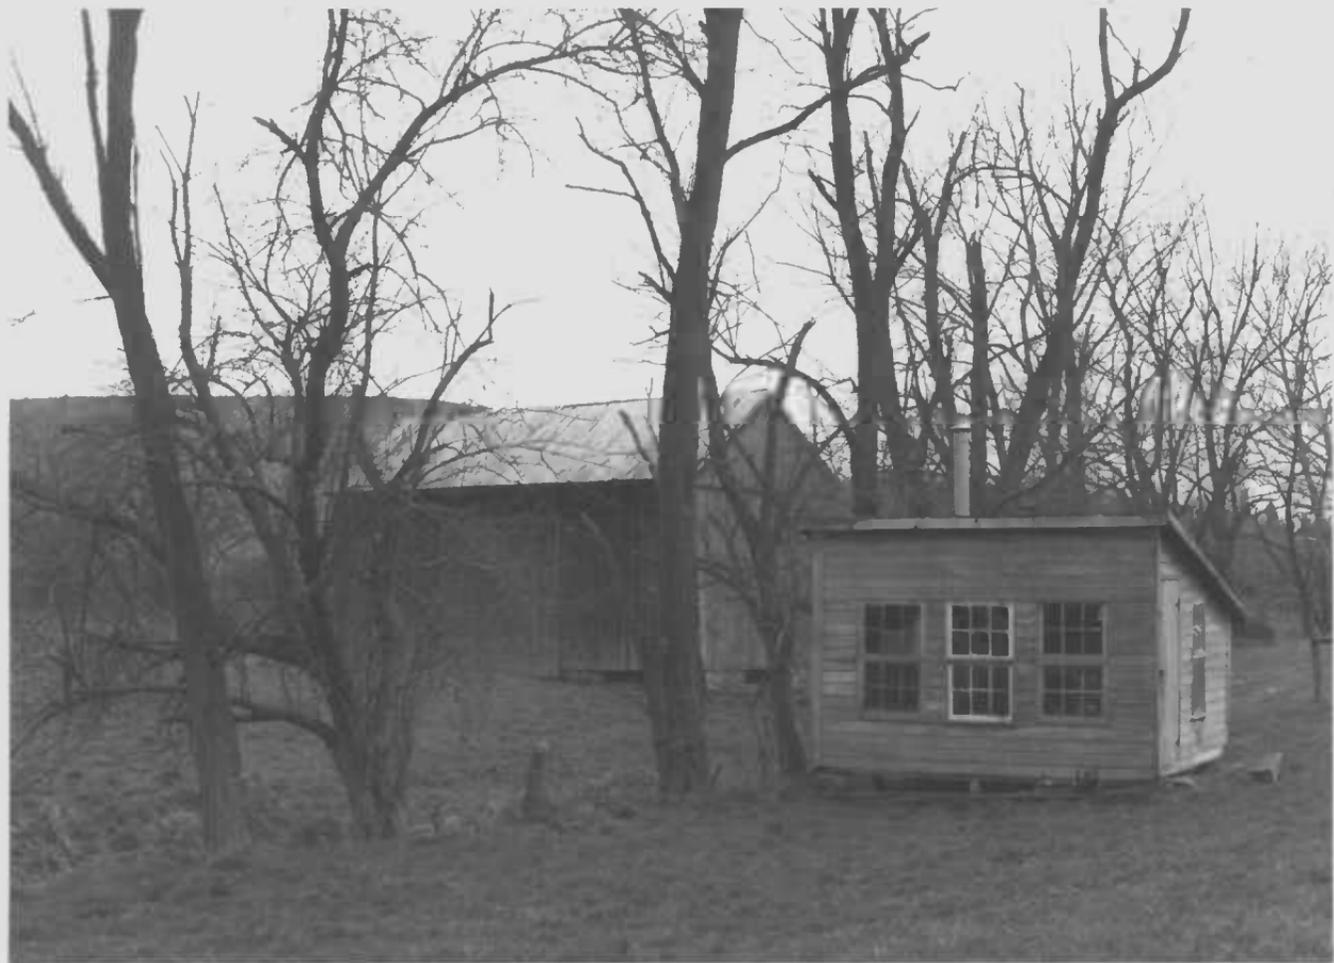
6/6

Hay barn and chicken house

Hay barn and chicken house: The two distant buildings are located on opposite sides of the Renner Branch. The hay barn has vertical siding and sliding doors on the east and west elevations. The chicken house, now used as a target shooting shelter, was originally located between the smokehouse and the outhouse and was much longer than its present size. The current owner moved it to the present location in the 1970's.
