F-8-118

Pearre-Ensor Farm

Frederick County, Maryland

Maryland Historical Trust State Historic Sites Inventory Form

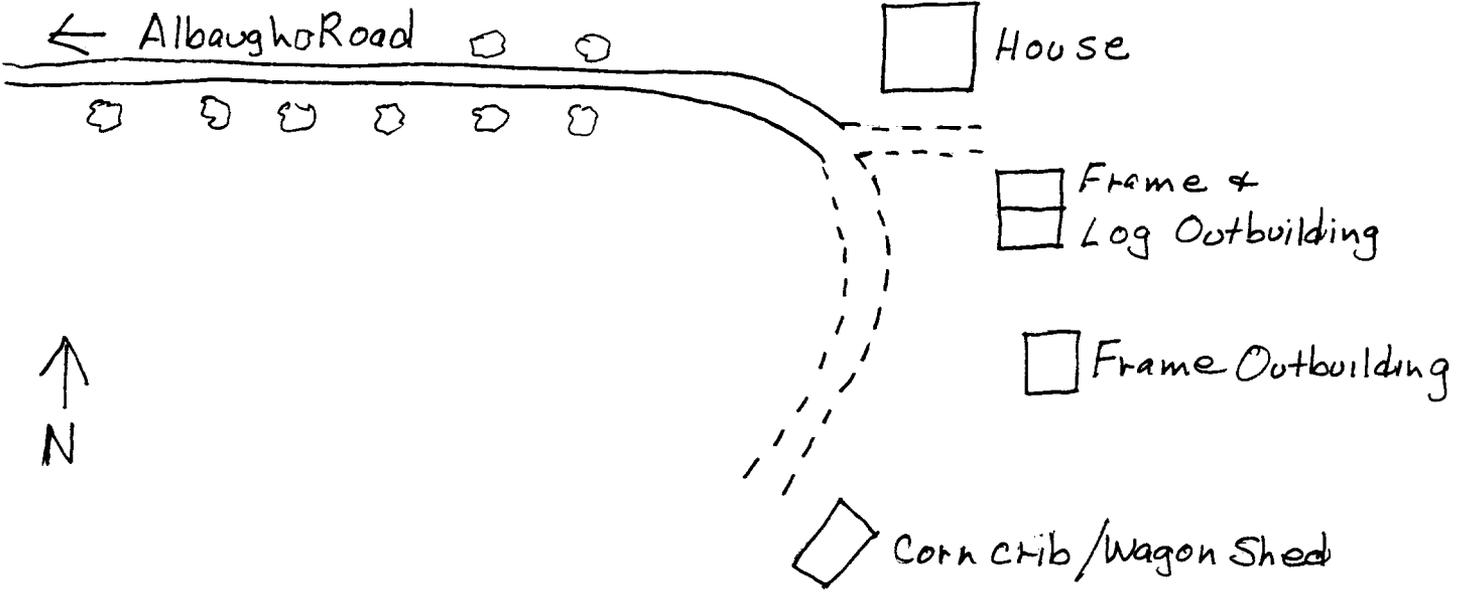
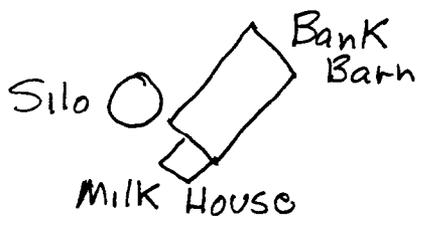
F-8-118
Peatte-Ensot Farm
Frederick County

Janet Davis
July 3, 1991
Not to scale

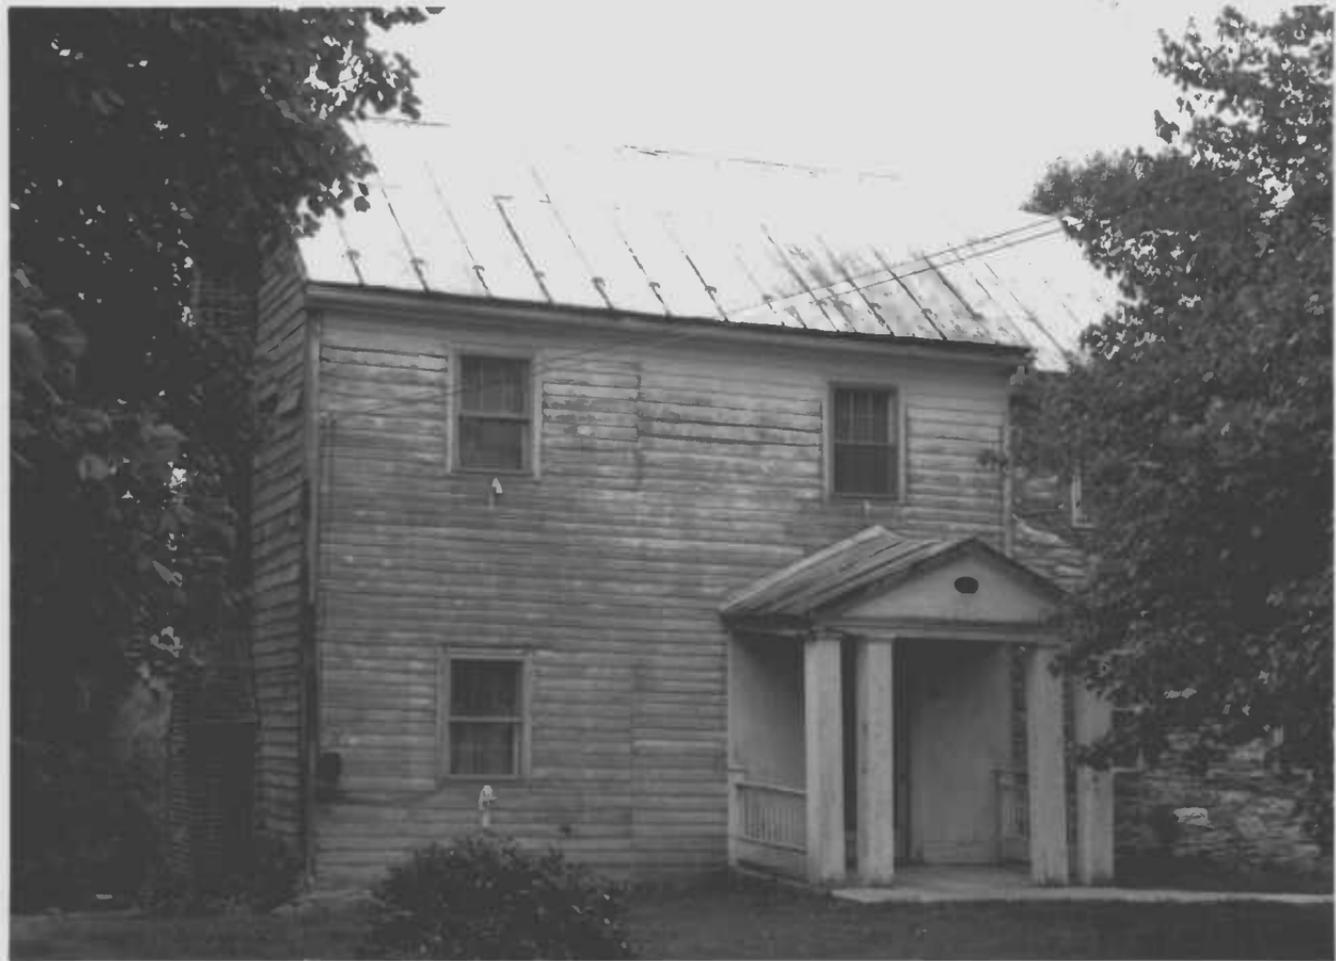
1/6

West elevation, log section

The house has two distinct sections clearly articulated by different structures and roof heights. The log section is two stories in height, with a probable three-bay original west elevation. The center opening of this elevation has been covered as breaks in the siding indicate, and the present doorway is located in the southernmost bay of the log section. The log part is covered with beaded clapboards. The window openings appear to have early 20th century architraves with 6/6 sash of the same period. The standing seam tin roof has a box cornice. An exterior brick chimney, probably a replacement since 1965 of the original, is located on the north elevation. The entrance is sheltered by a gable-roofed, pedimented entry porch with pairs of square columns at each corner. Centered in the pediment is a Frederick County Landmarks Foundation plaque, No. 94. The side balustrades of plain square balusters connect with the house wall and the columns. The door is a 6-panel type under a mid-20th century 12-light outer door. A 6-light transom completes the doorway. The stone section has a two-bay elevation adjoining the log section and extends eastward from the southeast corner of the house to form a two-story ell. The rubble stone has been repointed probably in the early 20th century in "gravevine" style. The windows in this section are 6/6 and have plain architraves. The cornice is boxed, as in the log section. On the south elevation of the main section is an exterior stone chimney with a brick top. It has been repaired and may be largely a reconstruction of the mid-20th century. The south elevation of the ell part has a two-story porch with a screened-enclosed upper level and a concrete deck. The stone foundation is exposed under the deck where the grade slopes away to the east. On the east elevation of the ell is an entrance to the cellar level with a modern entry porch with a gable roof and pediment. Above it is a recent 6/6 window and at the attic level are two small square windows. On the east elevation of the log section are three bays with a center entrance. A two-level porch enclosed by screens extends across the long section and the north elevation of the ell. A concrete patio is located at the cellar entrance of the ell. The ell windows on the north elevation have plain corner blocks and lintels. The interior of the house was inaccessible for this survey.

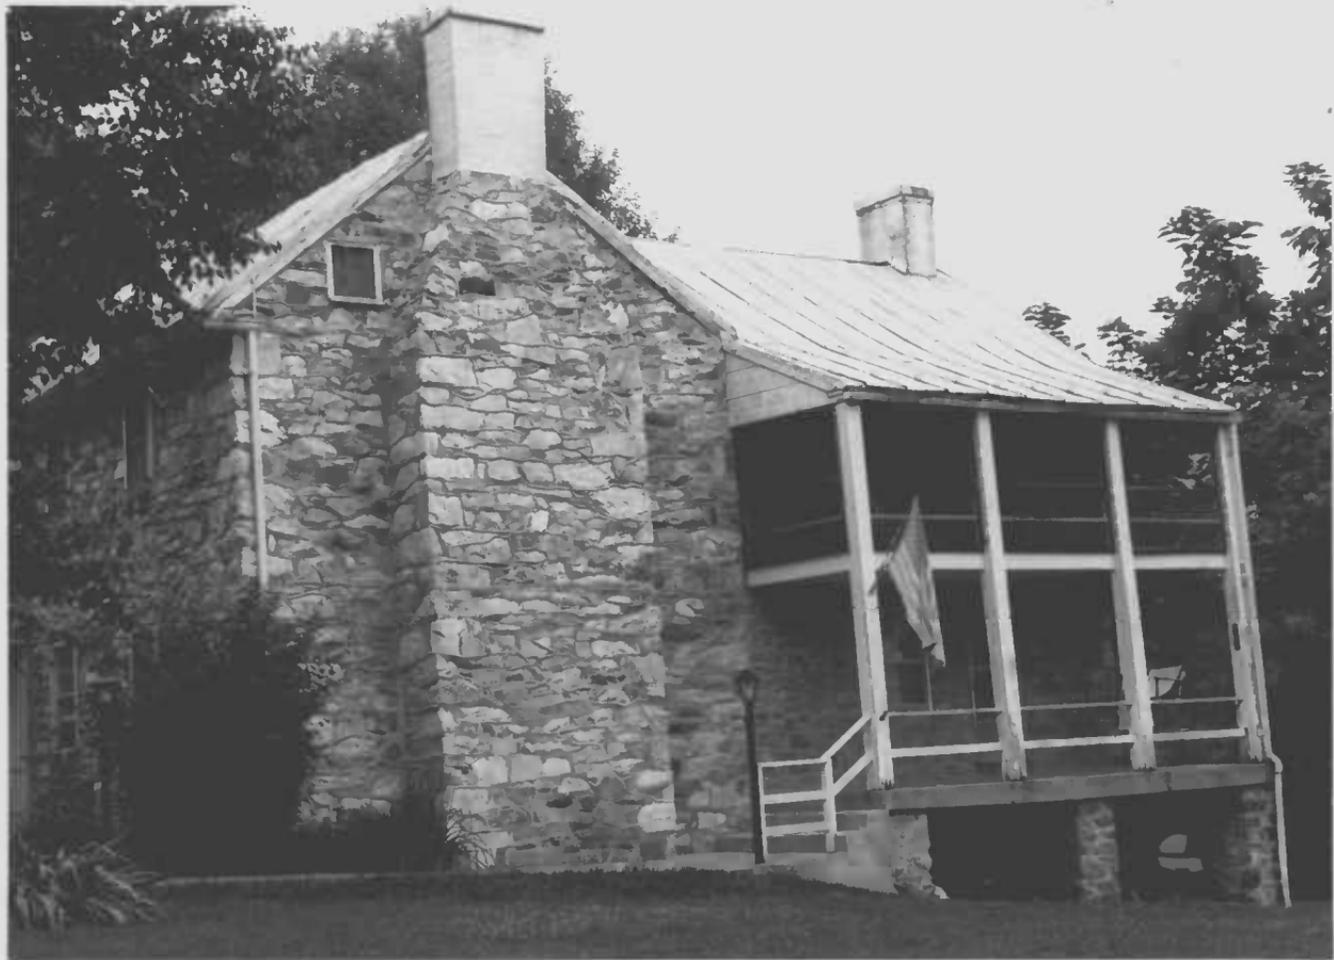
2/6

South elevation, stone section

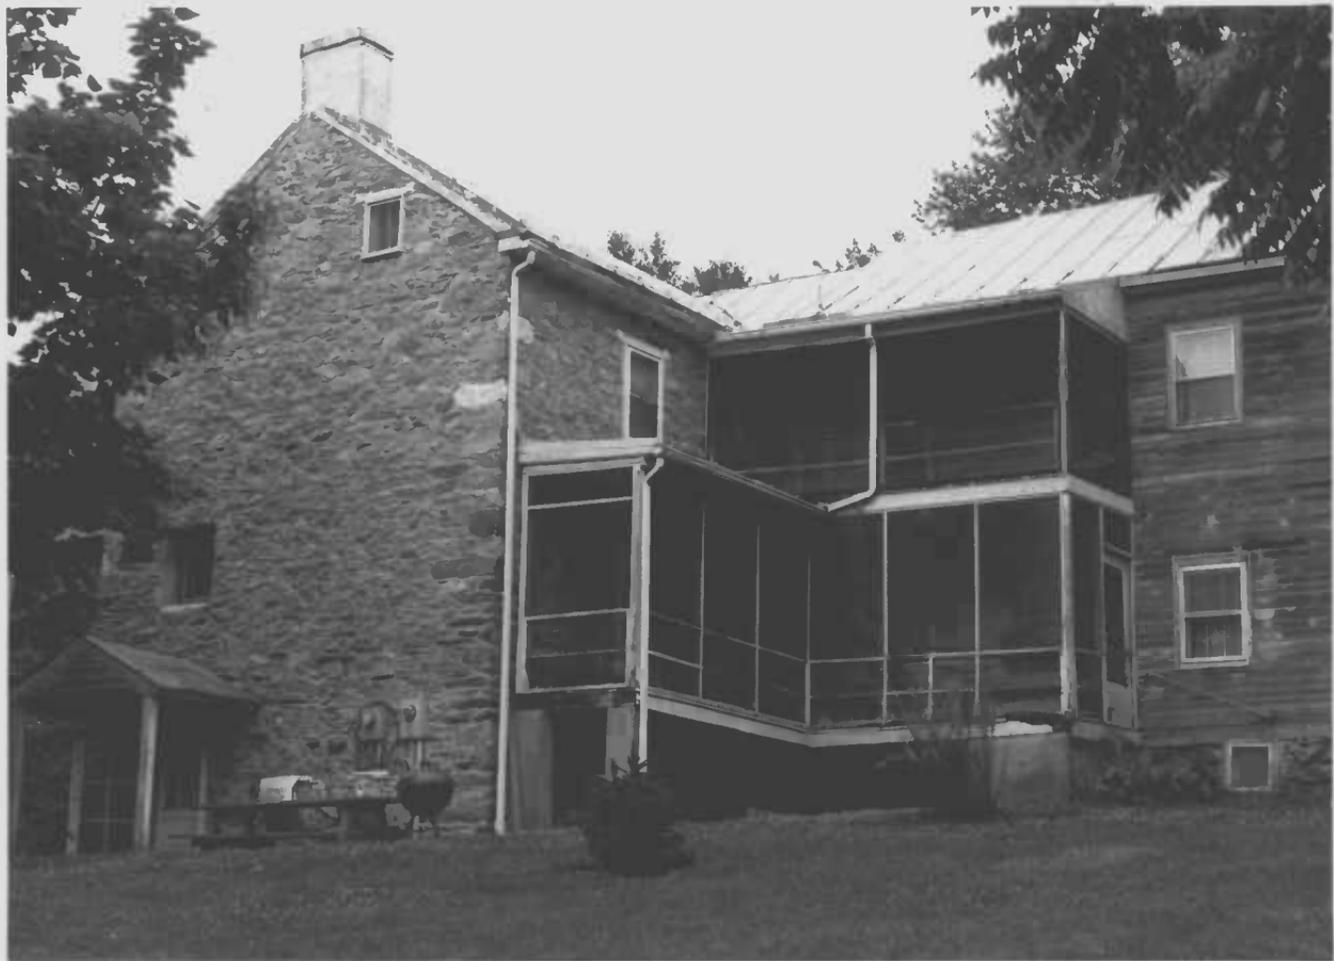
3/6

East elevation

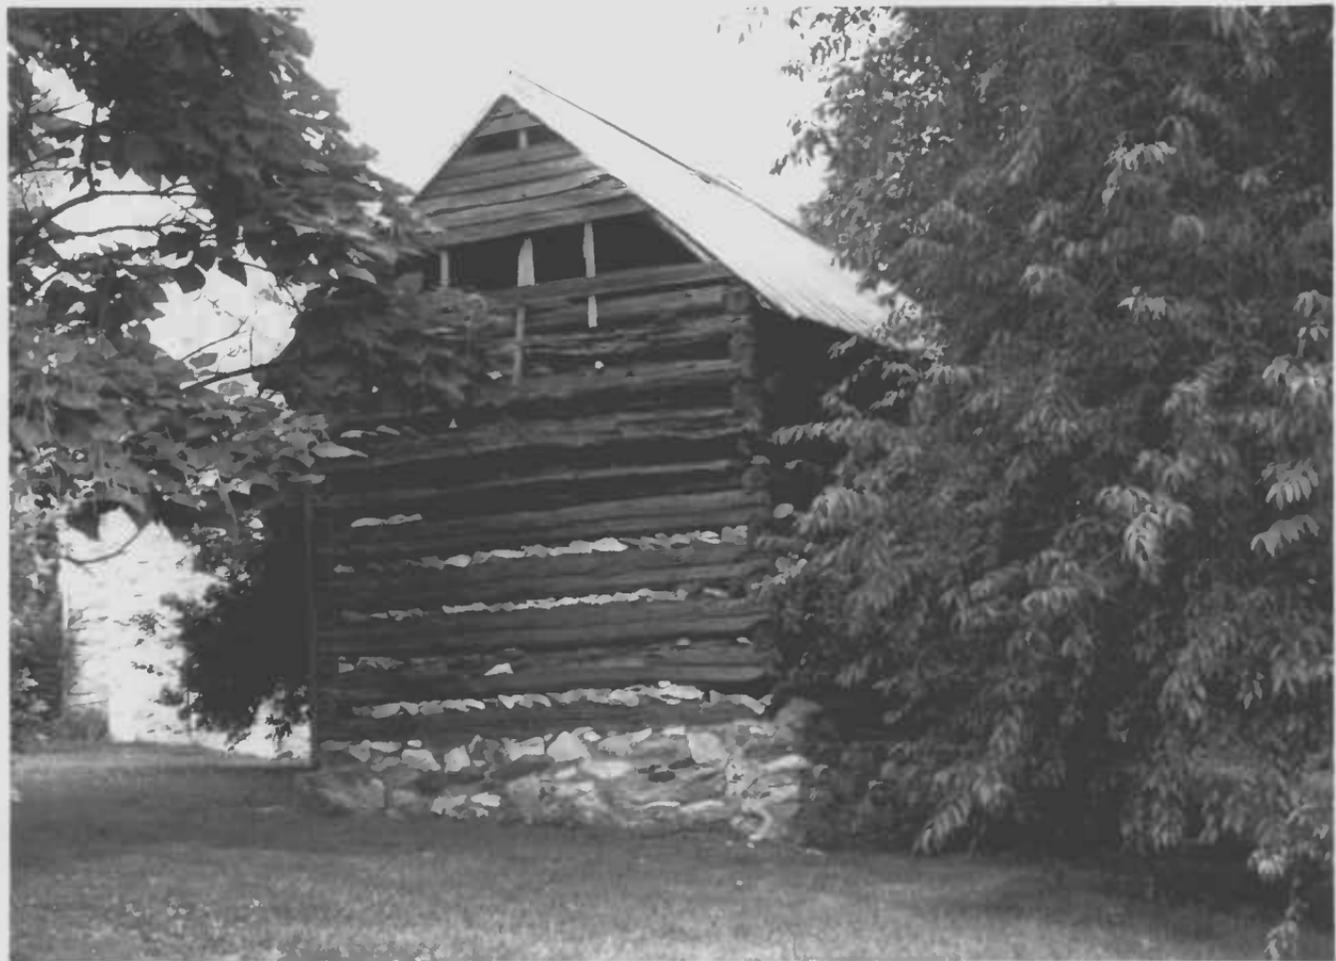
4/6

Smokehouse, south elevation

Log smokehouse and frame summer kitchen: This is a two-section single story building with the log section on the south end. The log structure has stone nogging. A single door is located on the west elevation. The upper walls of the log section are deteriorated and open to weather. The frame section is in better condition, with clapboard siding over plaster and lath walls. A standing seam tin roof covers both sections.

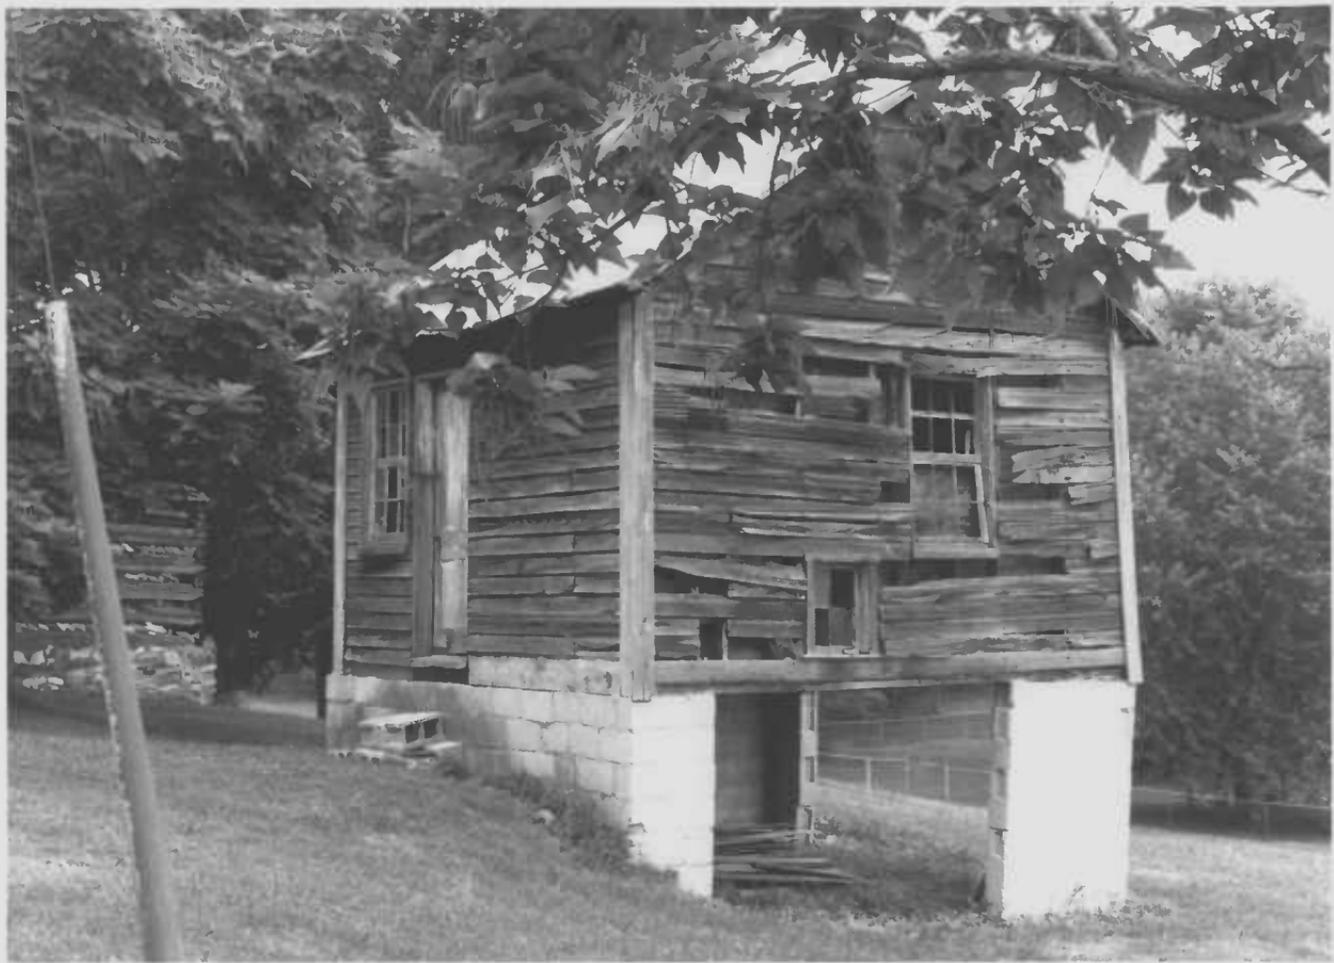
5/6

Frame outbuilding, southwest elevation

Frame building: This is a single story frame structure with a rectangular plan on a concrete block foundation, apparently a recent replacement of the probable original stone foundation. The slope of the site reveals the concrete block on the east where a storage area is formed under the building. The upper structure is covered with german siding and has a single four-panel doorway on the west elevation flanked by a 6/6 window. The gable roof is corrugated metal. Its function is unknown.

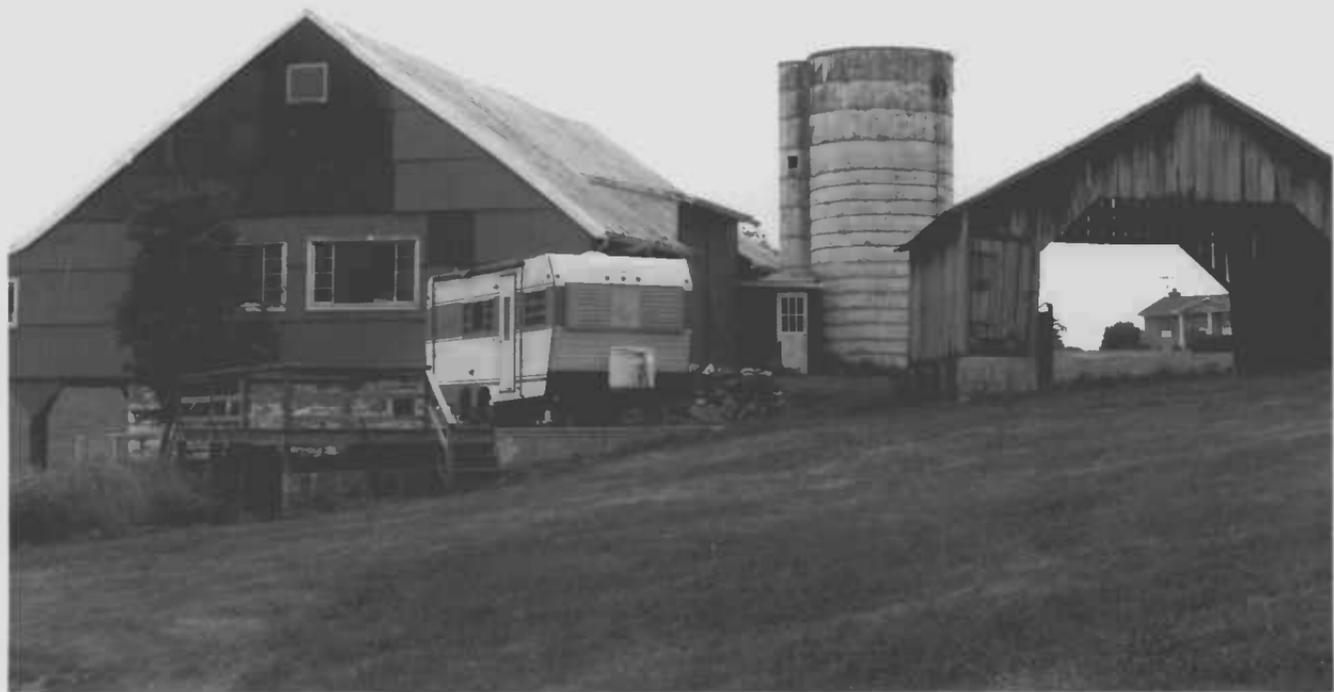
6/6

Barn and corn crib/wagon shed, view from
north east

Corncrib/wagon shed: The ca. 1875 pull-through corn crib has double granaries on each side and is covered with vertical board siding and a corrugated metal gable roof. The foundation is concrete block, undoubtedly a replacement of the original stone.

Bank barn: The ca. 1875 bank barn has been considerably altered with the addition of plate glass windows and the enclosure of the forebay on the southeast elevation. The building has horizontal siding and replacement doors on the west elevation.

A 1960's or 1970's shed addition is attached to the southwest elevation and a concrete block milk house of the 1940's is located near the southwest corner. Concrete block was also used to enclose part of the forebay for a milking parlor in about the same time period. This now has a band of windows running across the entire enclosed forebay. A dormer projects from the southeast roof which is covered with standing seam metal.
