F-8-128
Sollers-Maynard-Thomas Farmstead
Libertytown, Maryland
Private

F-8-128
Sollers-Maynard-Thomas Farmstead
Libertytown
Frederick County

Maryland Historical Trust State Historic Sites Inventory Form

7.1 Description

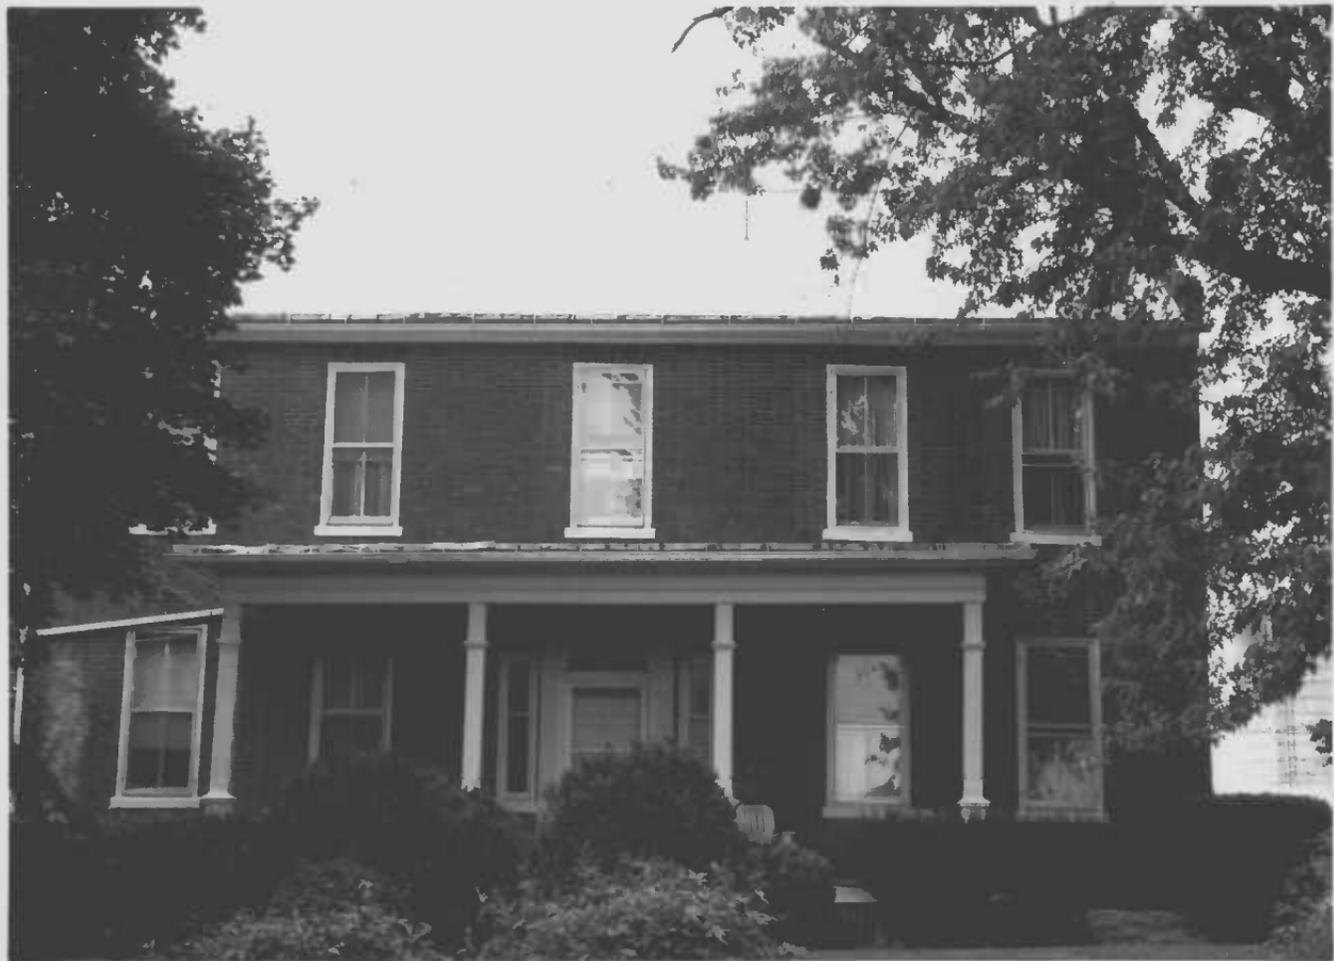
1/15

North elevation

The Sollers-Maynard-Thomas House is a circa 1825 two-story, five-bay brick structure with a symmetrical center-hall plan. The principal facade is the north elevation, which is Flemish bond. The gable roof is standing seam metal over wood shingles. Parapet walls are at each gable end with interior chimneys. The cornice is corbeled brick. A two-story brick wing or ell extends from the southwest corner. The window openings are 2/2 replacements of the late 19th century. The original windows were probably 6/6. The frames have a bull-nose profile. The doorway on the north elevation is elaborately ornamented with a pedimented and pilastered surround and a fanlight. Narrow 2/2 sidelights flank the doorway. The glass in the fan and sidelights is patterned colored glass of the third or fourth quarter of the nineteenth century. The pilasters are fluted, terminating in vaguely Tuscan order capitals suggesting the early Greek Revival influence. The outline of an entry porch is visible on the brick surrounding the doorway. The present one-story porch appears to date from the period of the 1870's, with chamfered square columns. Original shutters at the window openings have been removed, but are stored in the cellar. The sills are stone with chiseled edges.

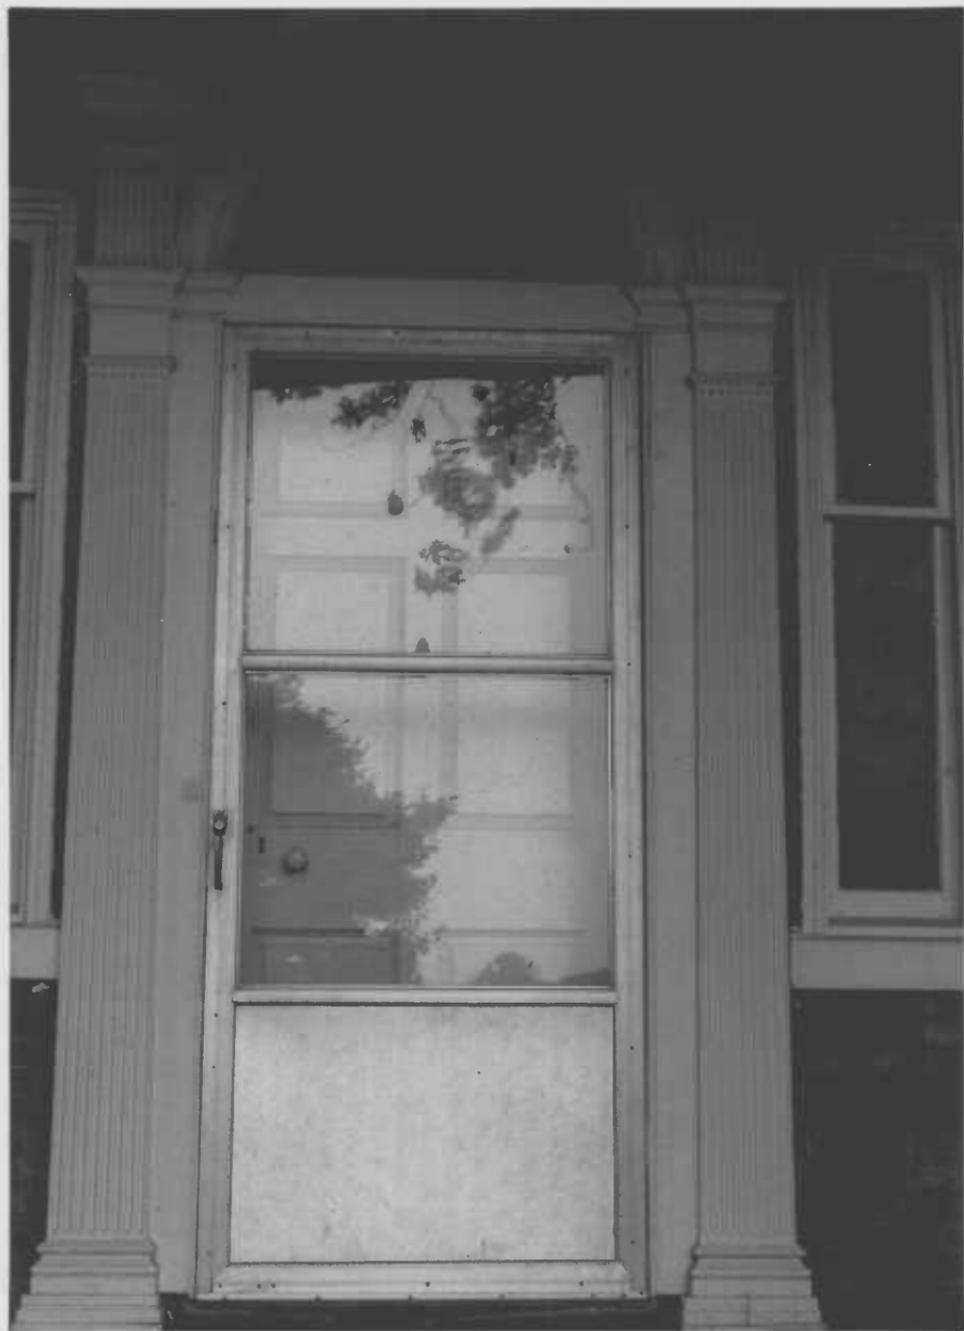
2/15

Main doorway, north elevation

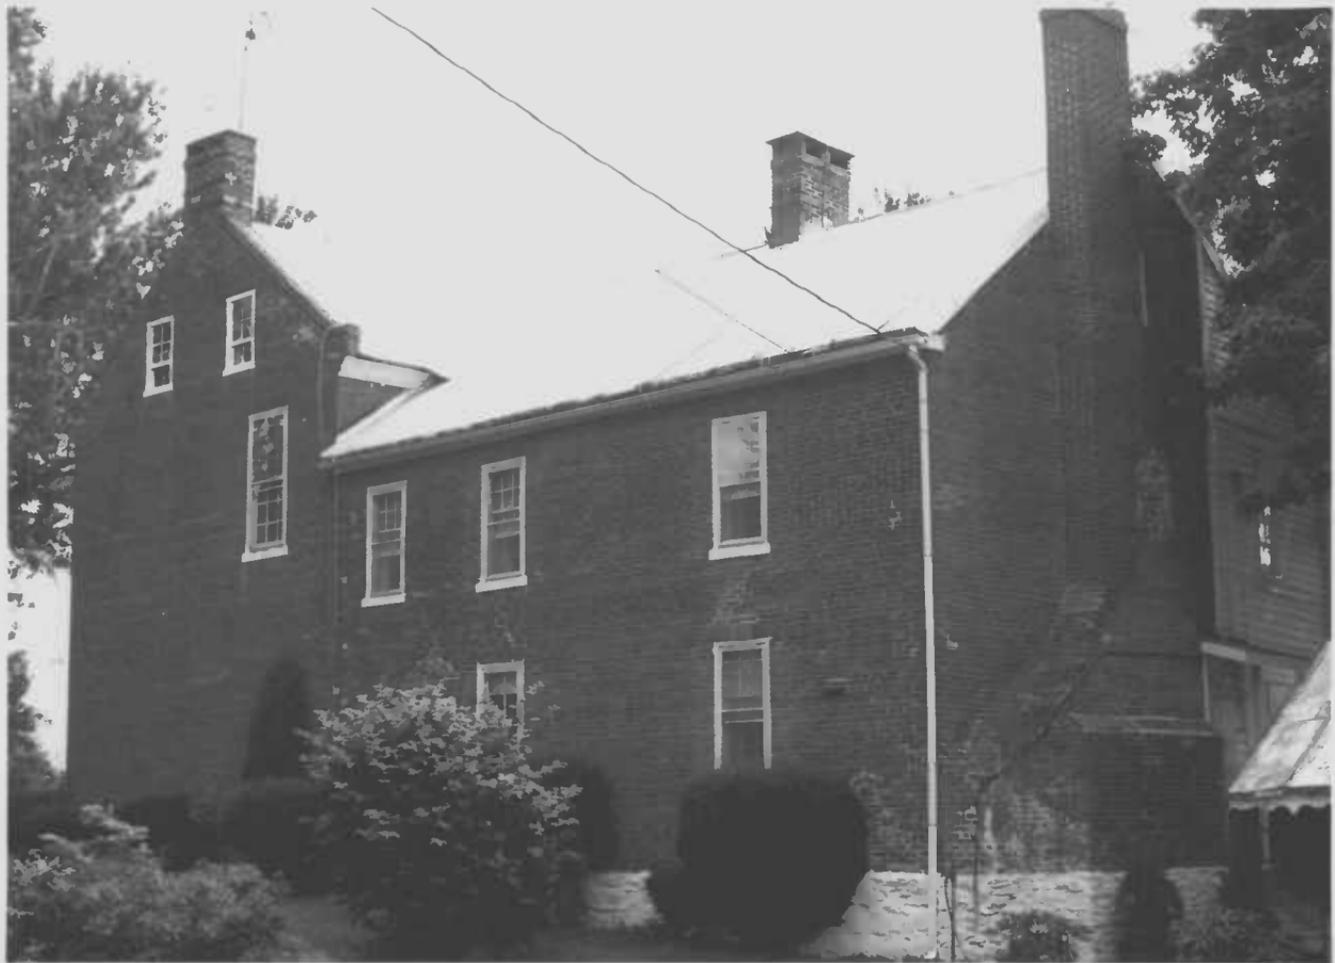
3/15

Southwest corner view

The east and west elevations have elongated attic level windows with 4/2 sash flanking the chimneys. In the west elevation is a tall narrow window with 9/9 sash. The side elevations are four-course American bond, a feature rarely seen in the northeastern part of Frederick County. A circa 1780 house in the Black's Mill Survey District (F-6-70) has 3-course bond, the only other identified structure with less than the usual 5 or 6 courses. On the east elevation of the Sollers-Maynard-Thomas House is a stone bulkhead giving access to the cellar.

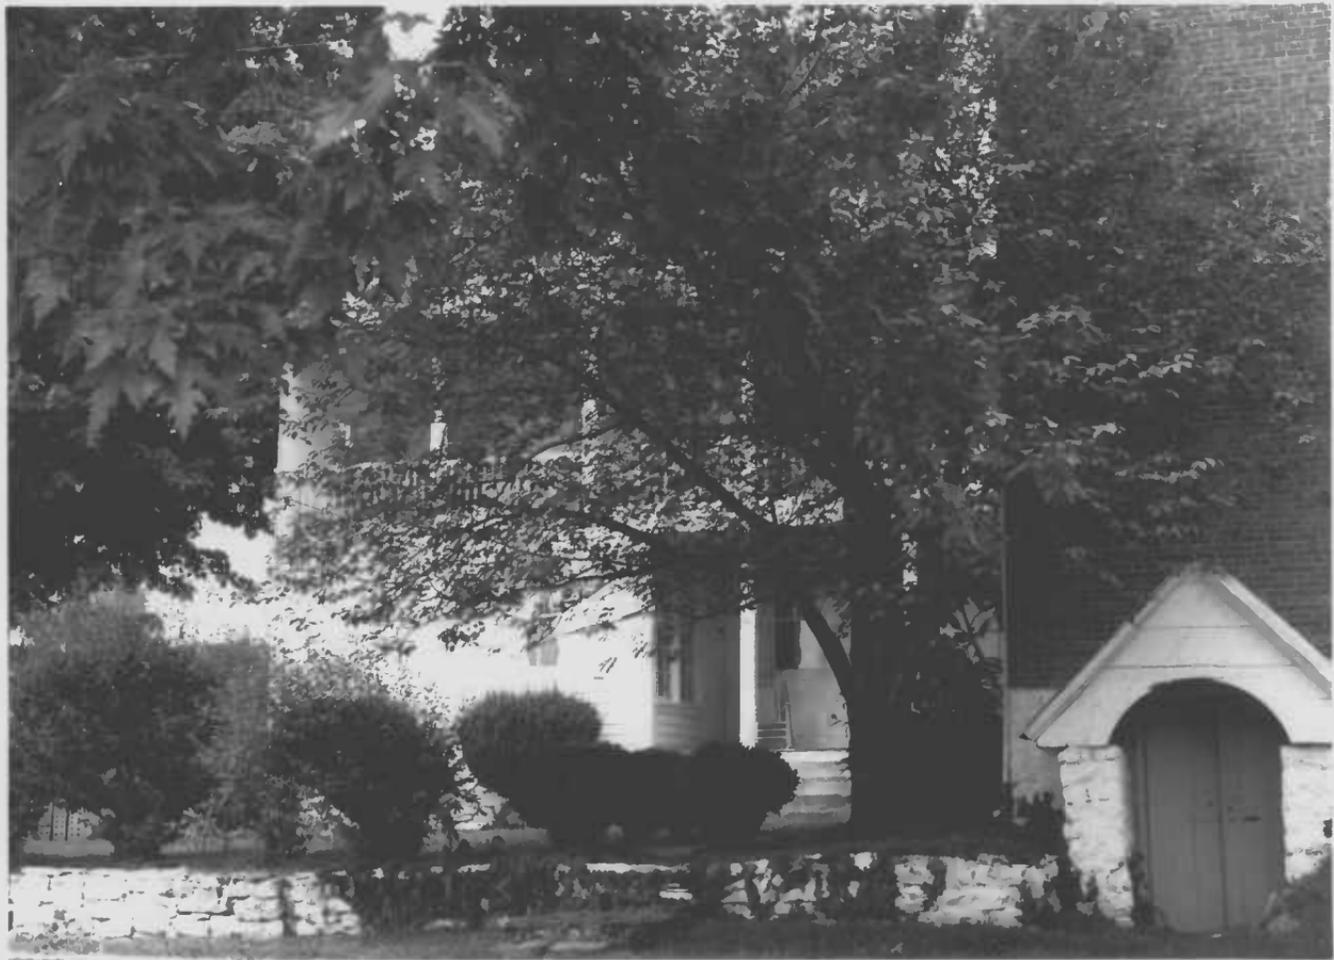
4/15

East elevation, rear ell

The ell appears to be a structure built in the 1850's. It has 6-course bond and a corbelled cornice. The window openings have flat gauged arches with plain stone sills. The 6/6 windows have bullnose frames. The ell is built over the approximate location of a stone structure which is said by the owners to be the first part of the house to be built, in the second quarter of the 18th century. No visible trace of the structure remains except in the stone foundation of the present ell on the east side below the porch. The present ell has two sections, indicated by the irregular spacing of the window bays. The date of the extension of the ell is not known. The south elevation terminates in an exterior brick chimney with the traces in the flanking bricks

on the west of a removed bake oven. An outdoor stone fireplace once stood on the site, according to the owners; this was part of the original stone structure. The east side of the ell has a two-story porch with a plain balustrade and a partial enclosure at the south end. The enclosure is covered with german siding. The first level of the porch has square columns.

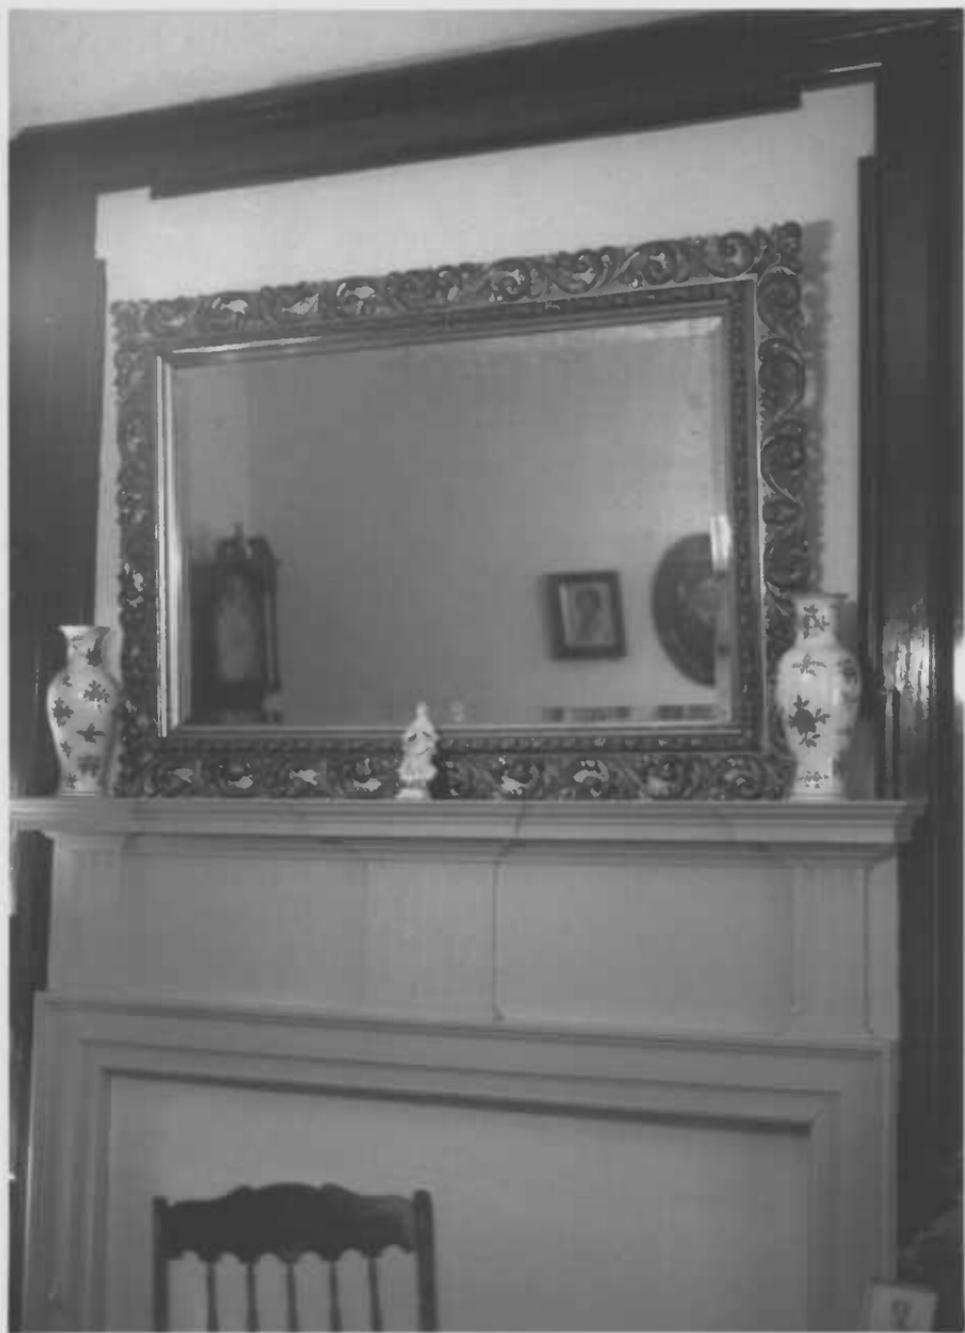
5/15

West parlor mantel

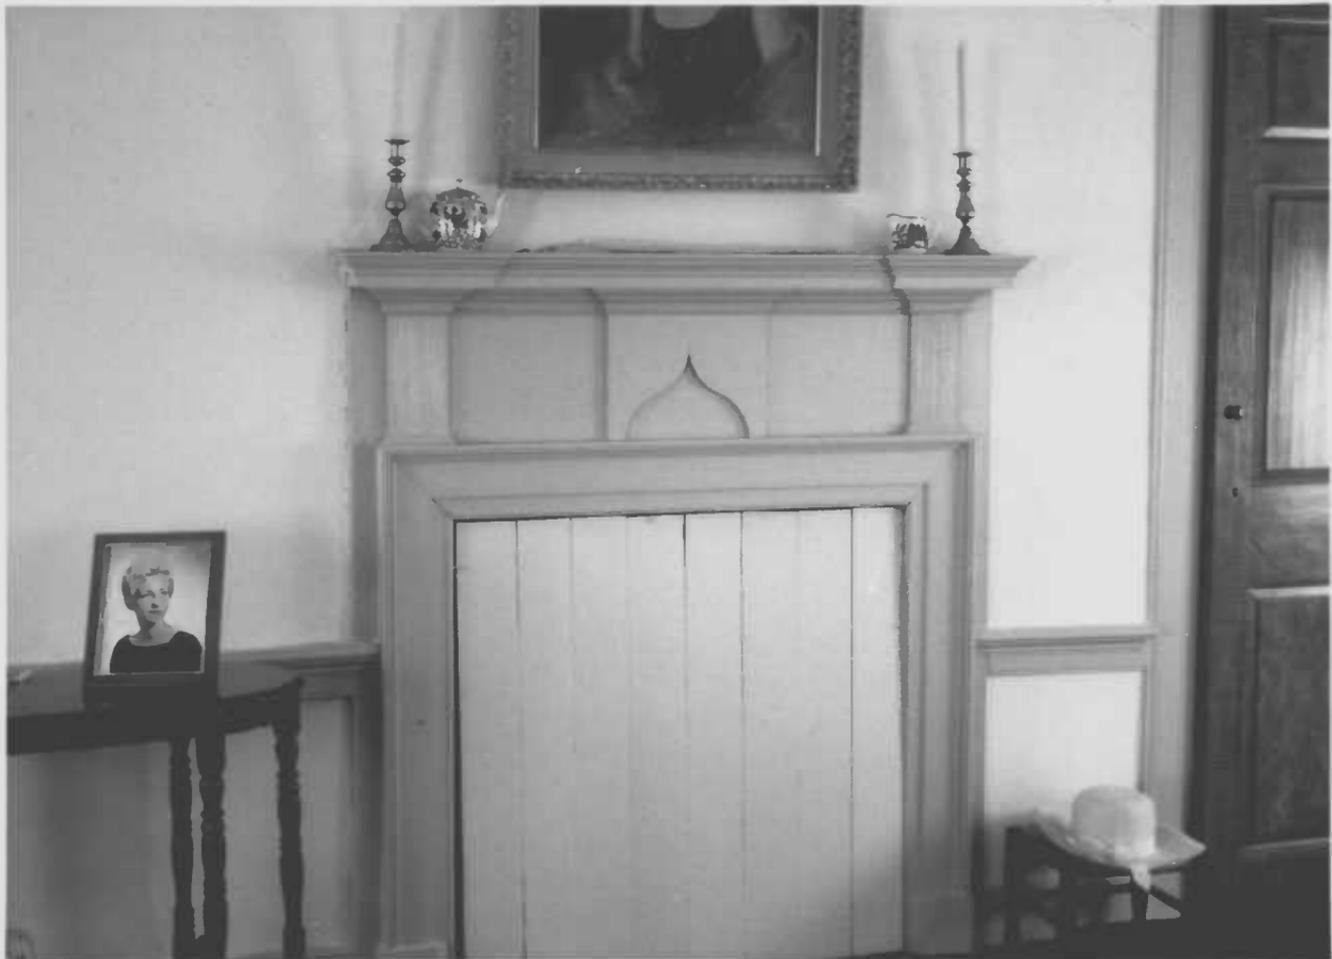
7/15

East bedroom mantel, 2nd floor

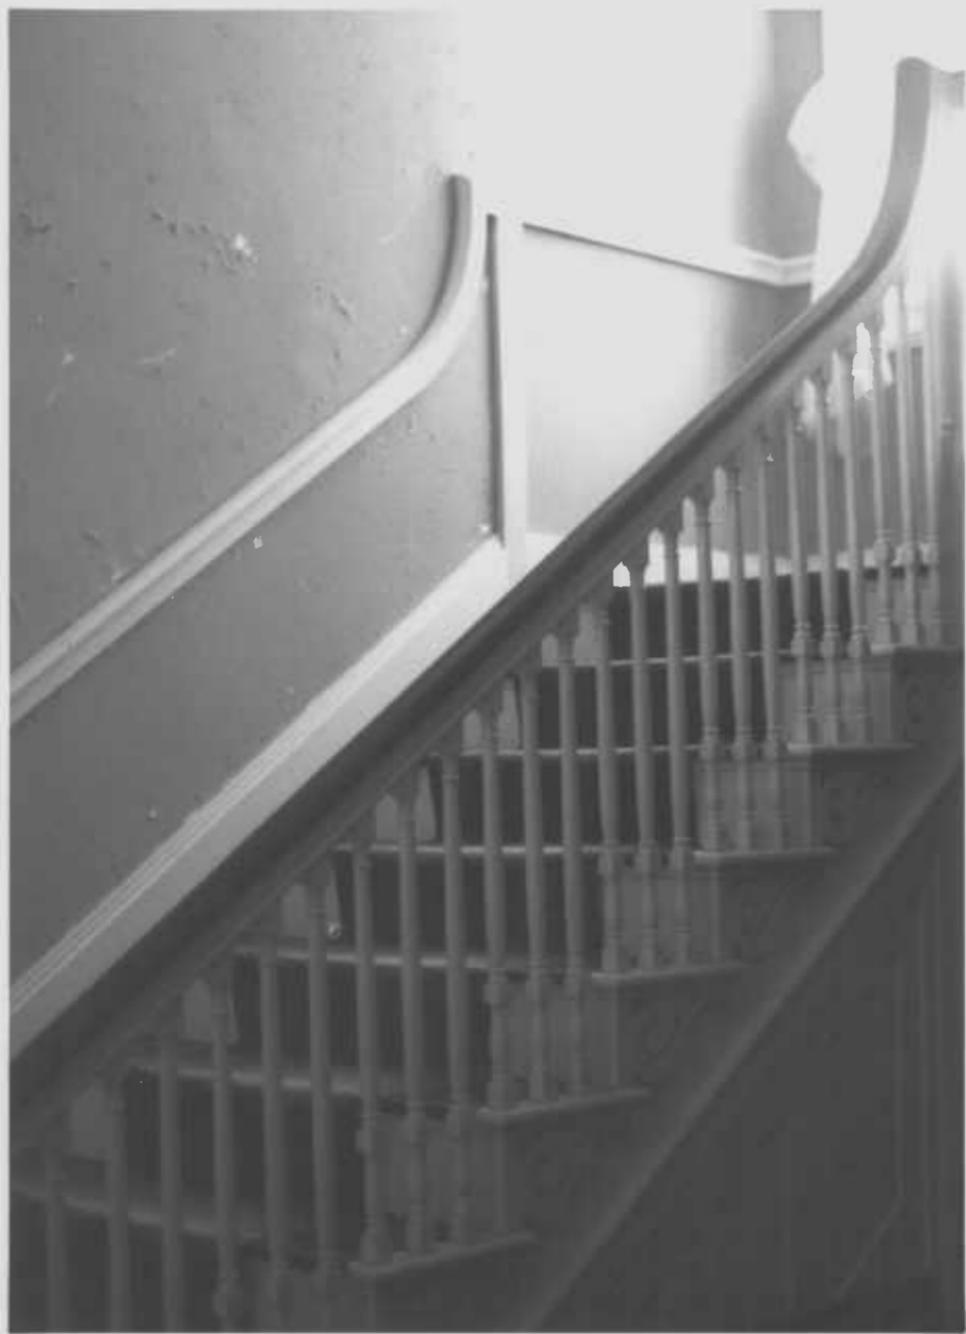
8/15

Main staircase

The interior plan has single parlors flanking the center hall. The staircase rises to a landing lit by a large south window. The hall has original flooring and Federal style molding, baseboards, and chair rails, with no cornice molding. The chair rail extends up the stair case in correspondence with the line of the railing. The door surrounds have paneled soffits and raised 6-panel doors. The fanlight of the doorway is ornamented by a keystone molding. The stair closers are decorated with a scroll motif. The front door has original box lock hardware and porcelain knobs. The walls are painted plaster with a continuous band of wood hooks, apparently dating from the last quarter of the 19th century. The east parlor has a Federal style mantel with paneled pilasters, fluted moldings, and a central elliptical panel. The chair rail, baseboards, and wall hook moldings are as in the main hall. Between the windows on the north and south walls are inverted metal sconces for hanging lamps. This is a feature seen in the Frees-Reifsnider House (F-8-74) in Woodsboro, a house of approximately the same date. The doors and windows have architrave trim. The walls are plaster under late 19th century wallpaper, in deteriorated condition. The west parlor has a more Greek Revival mantel with grouped fluting in the pilasters and central panel. The fireplace is flanked by cherry wood paneled cupboards with arched doors. The central panel above the chimney has crossettes outlined by molding. The walls in this parlor are painted plaster and a cornice molding finishes the ceiling. A vent opening above the hall doorway with spindles may be an alteration of the 1875-1900 period.

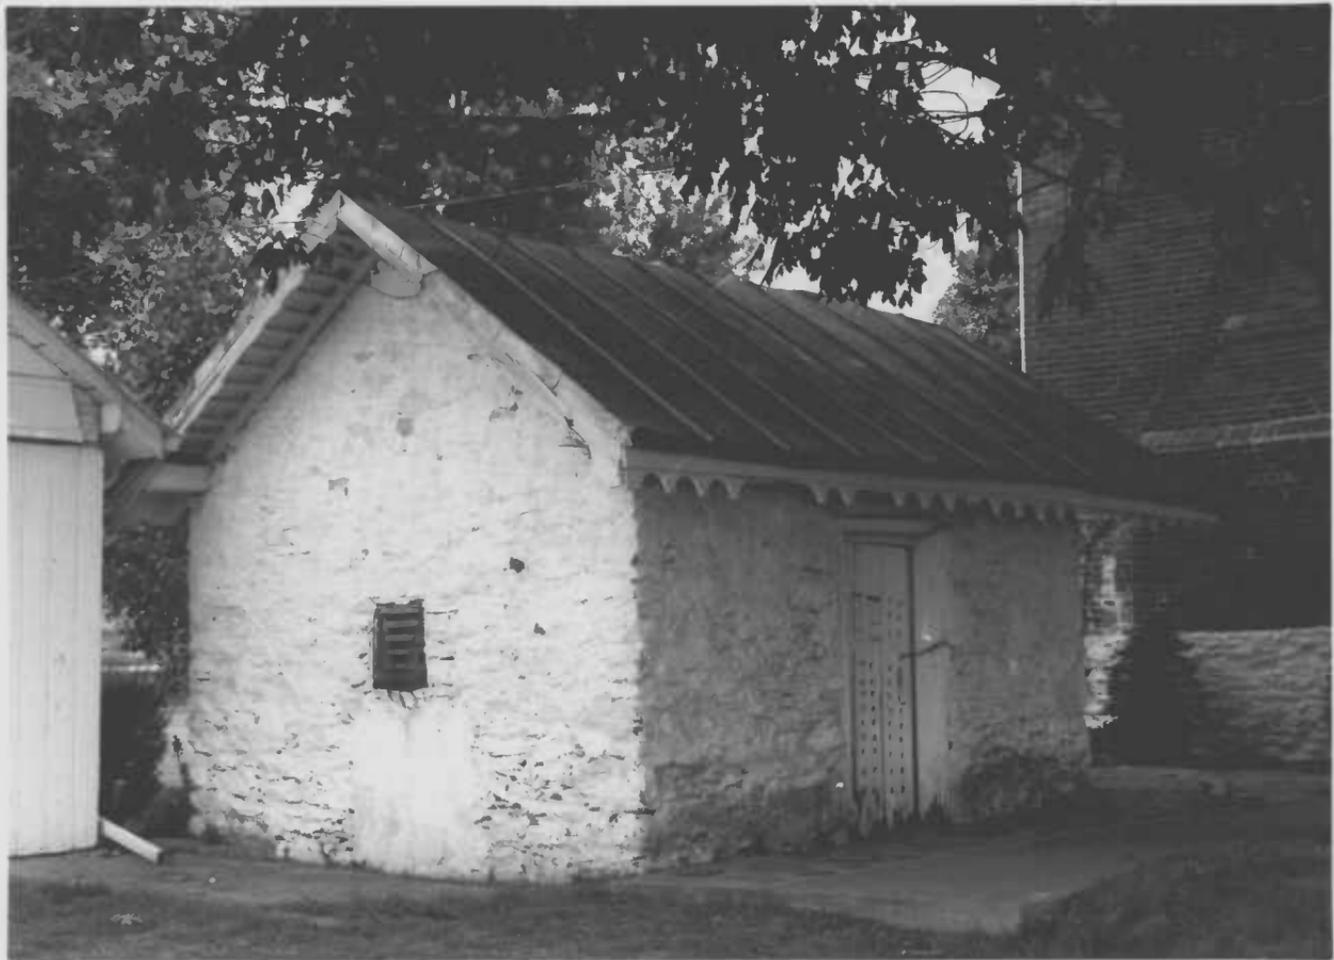
9/15

Springhouse, Southeast corner view

Springhouse: This is a one story stone circa 1825 building immediately south of the rear ell of the house. It has a standing seam gable roof with a scalloped bargeboard, a feature also found on the hog barn, suggesting a late 19th century attempt to unify the outbuildings of various dates with similar trim. The springhouse door is a vertical board type with vent holes; it opens on the east elevation. The other openings are small louvred windows in the other elevations.

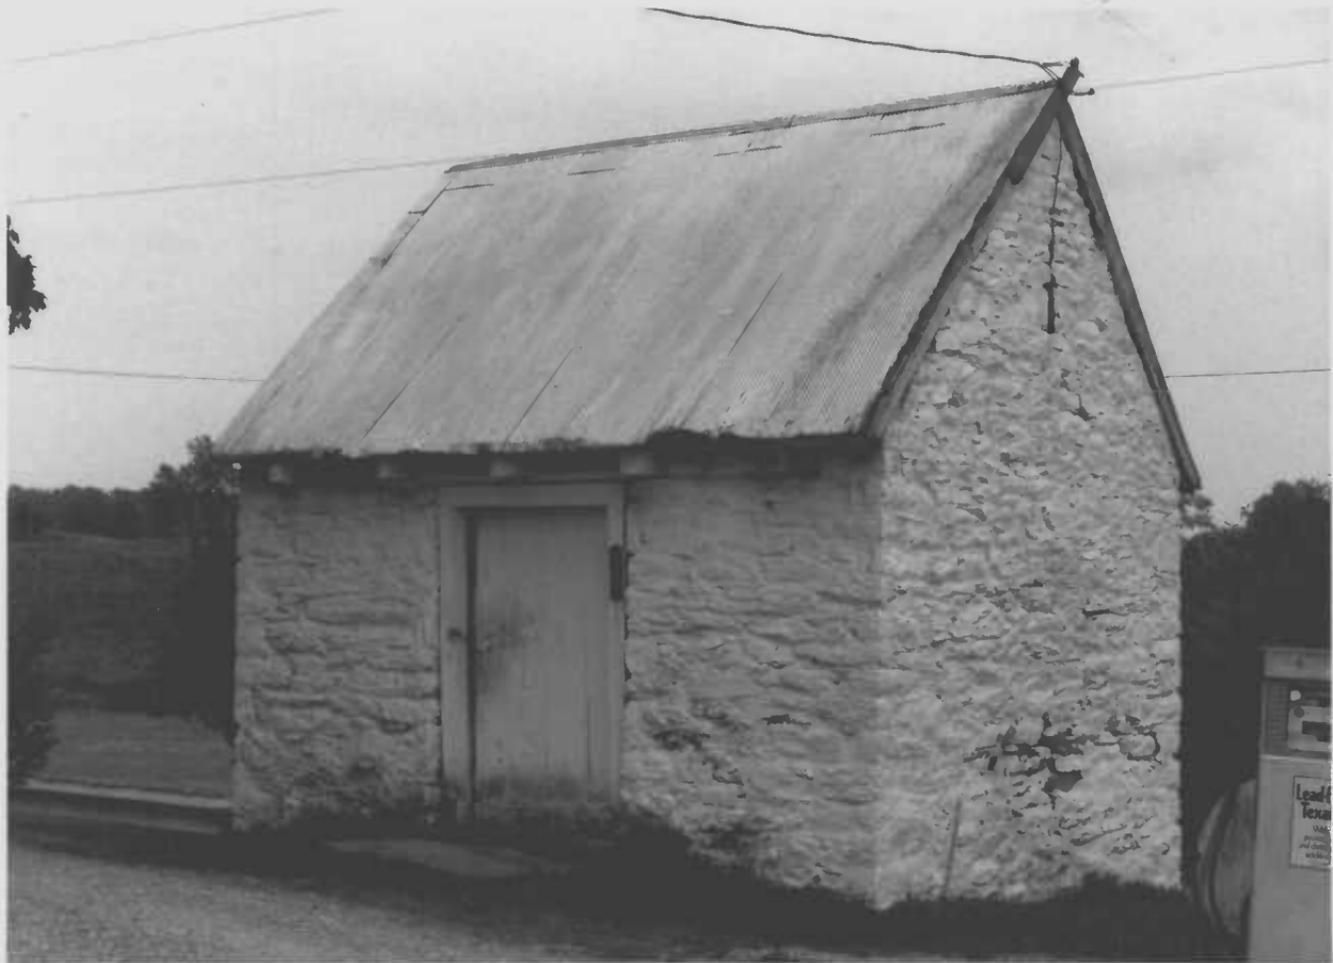
10/15

Smokehouse, west elevation

Smokehouse: Located across the access drive southeast of the house is the stone smokehouse. It is a one-story building with a vertical board door in the west elevation. The gable roof is corrugated metal. The smokehouse probably dates from the 1820's.

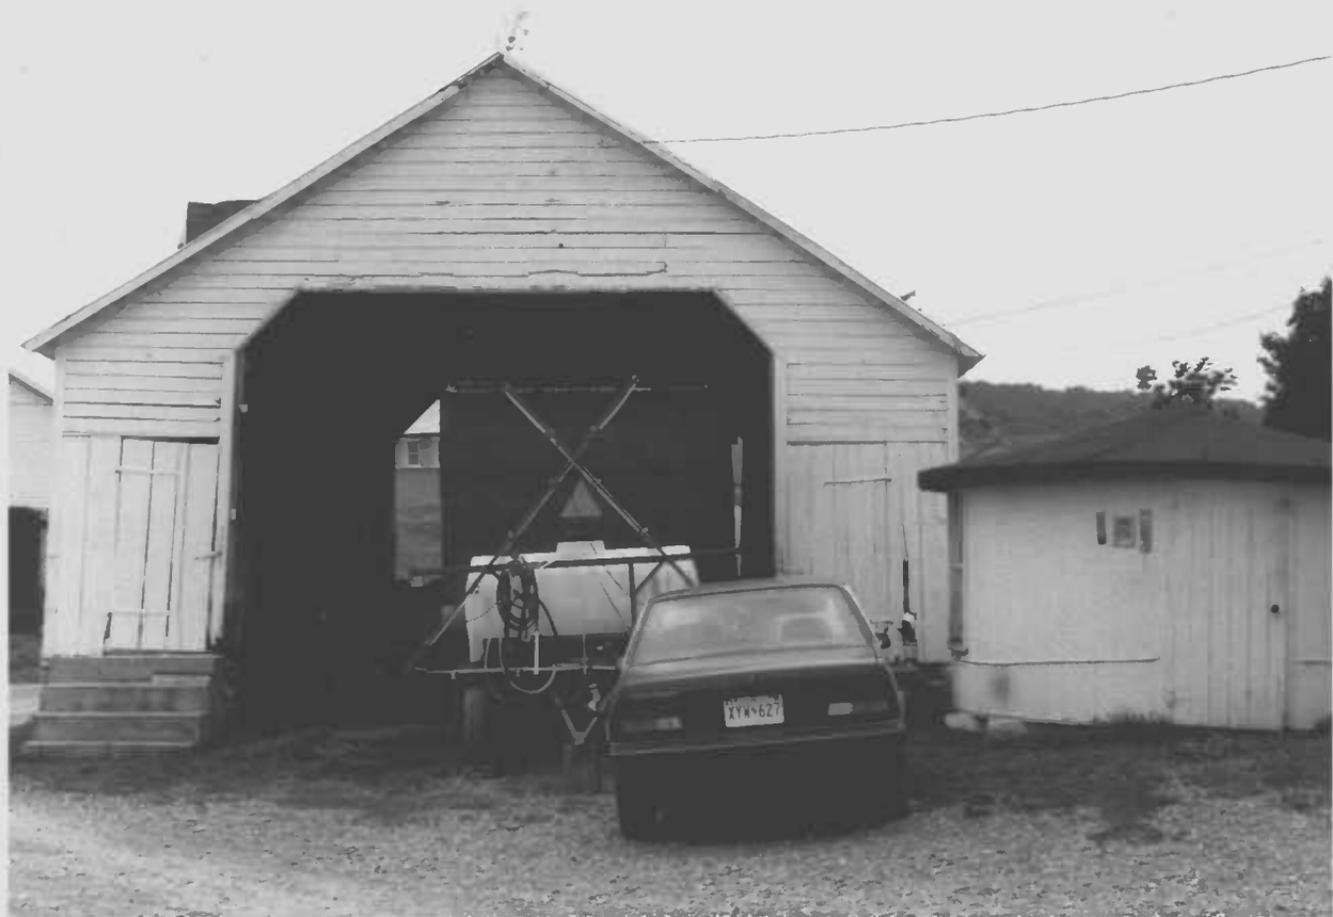
11/15

Corn crib and chicken house, east elevations

Chicken House #2: A circular wood frame chicken house is located south of a non-contributing concrete block garage near the springhouse. It has vertical siding and a conical composition roof. It dates from approximately 1910.

Corn crib/wagon shed: This circa 1875 structure is located near the circular chicken house and has double granary sides, horizontal siding, and a corrugated metal gable roof. Stone bases support the granary sides.

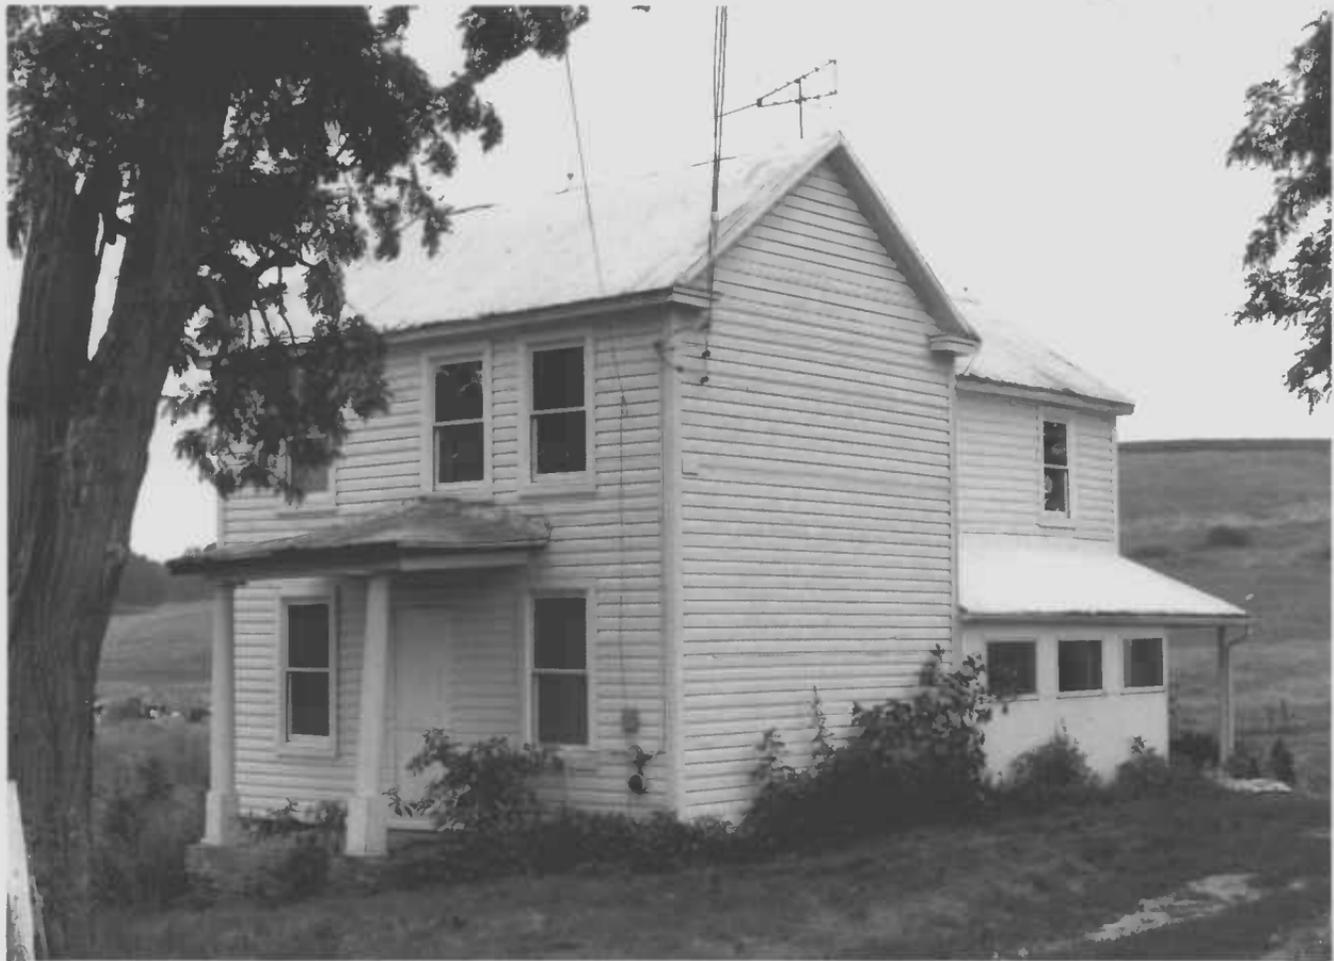
12/15

Tenant house, northwest corner view

Tenant House: The circa 1870 frame building is two stories, with three bays facing north. German siding and a corrugated metal gable roof. The sash is 1/1 replacement of modern date, with plain architraves. The front door is closed off; an entry porch with Tuscan columns is still in place. The rear ell has a one-story shed porch on the west.

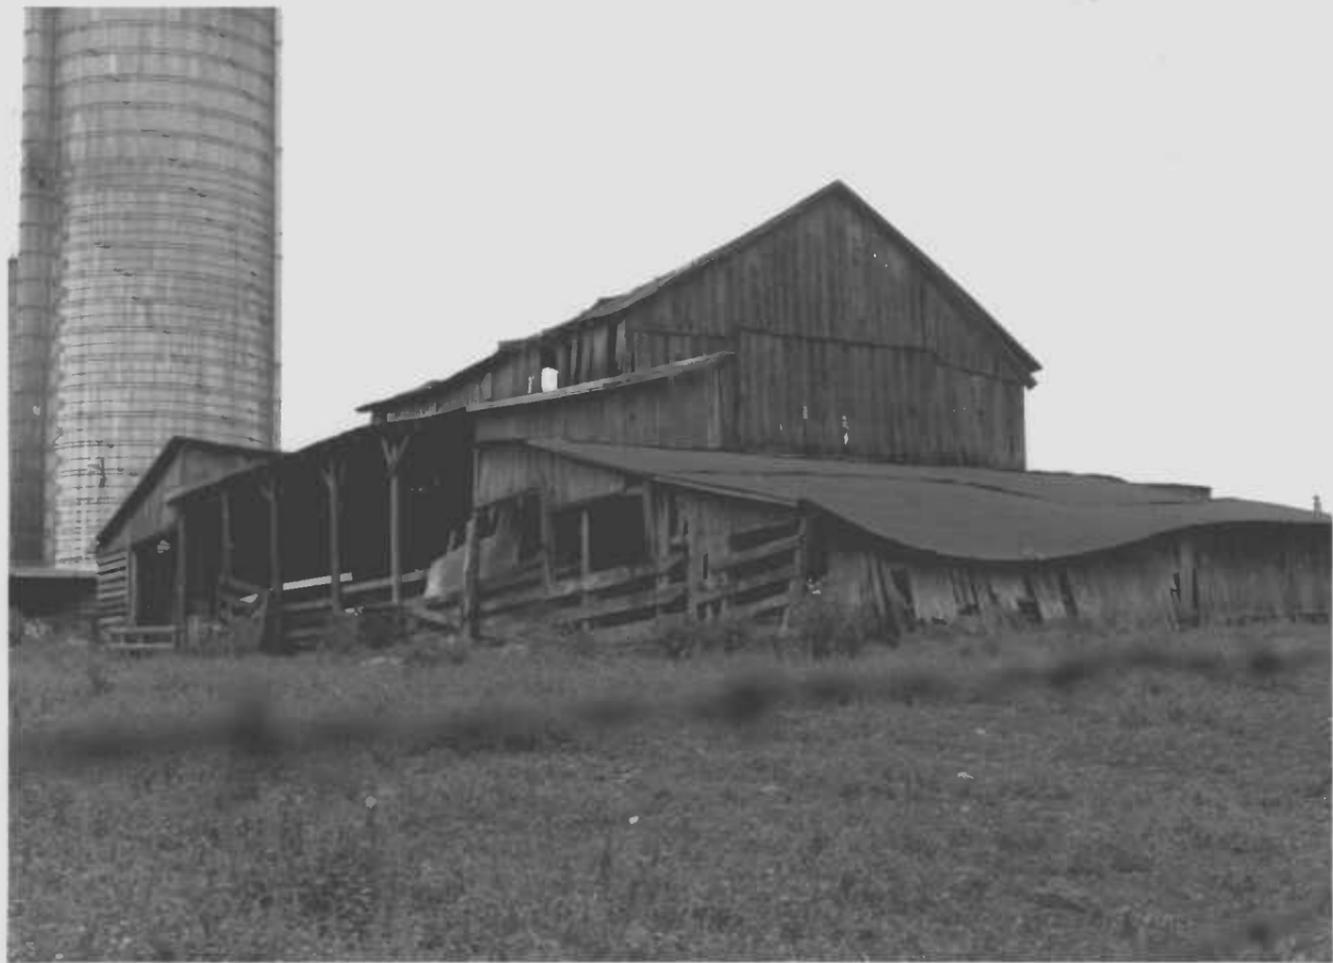
13/15

Hay barn/horse barn, southeast elevation

Horse barn/hay barrack: Originally used as a hay barrack and located in a pasture, this circa 1870 wood structure has tongue-and-groove siding, a standing seam gable roof which is much deteriorated. It was moved to the present location in the early 20th century. It is scheduled for demolition in August 1991.

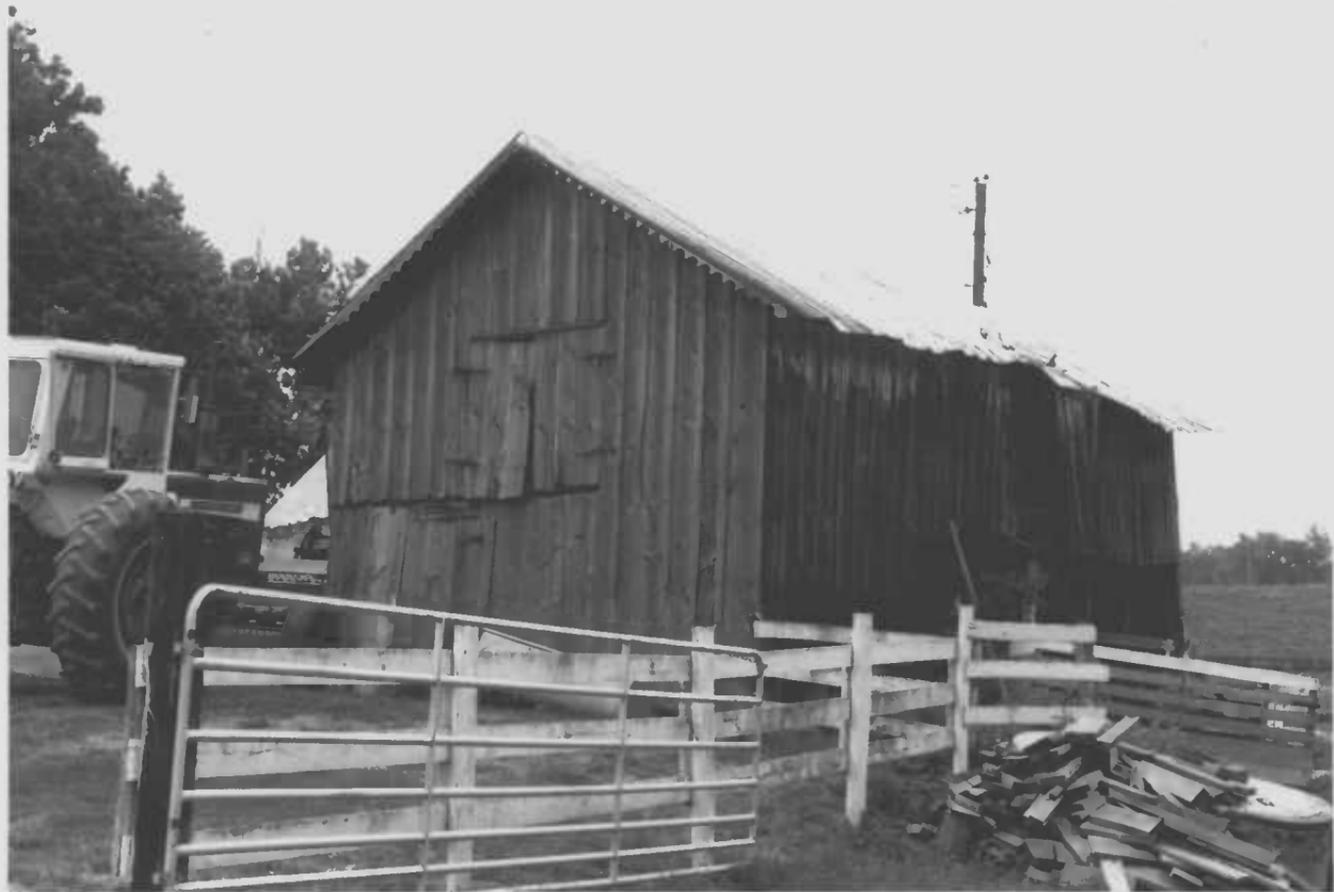
14/15

Hog barn, southwest corner view

Hog Barn: The frame hog barn was built about 1870 and has board and batten siding with fragments of the scalloped wood bargeboard as found on the springhouse. The rectangular structure has a standing seam metal roof.

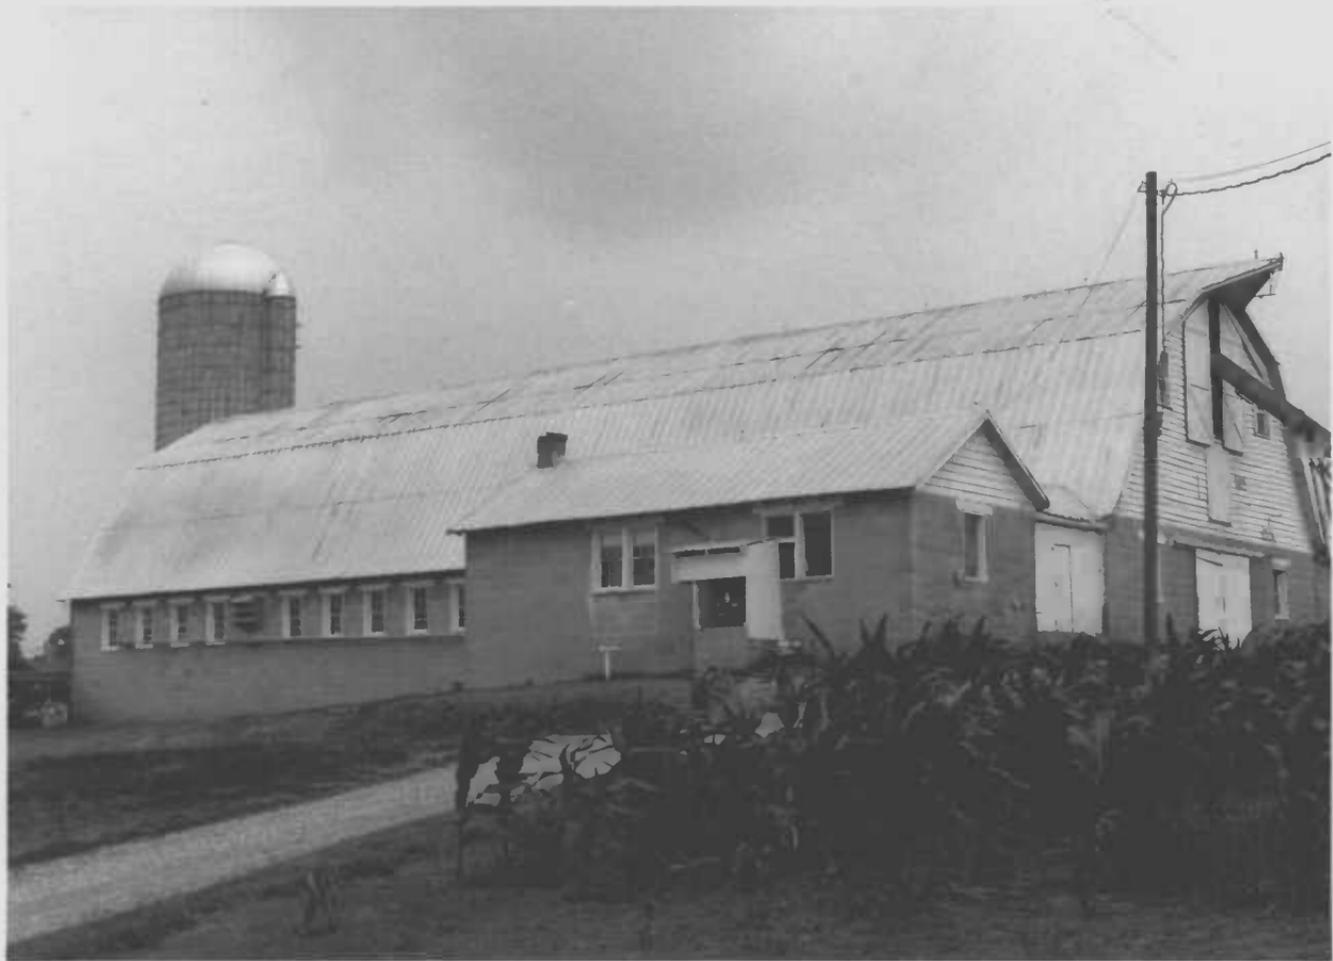
15/15

Dairy barn and milk house, east elevation

Non-contributing agricultural outbuildings: The present barn is built on the stone foundation of the original bank barn which burned in 1959. Associated with the barn are three metal loafing sheds, and three concrete silos. The agricultural group also contains a concrete block dairy barn, milk house and silo at the west end of the group, all built in 1945.
