G-II-A-114
John Burgess House
Sand Spring
Private

ca. 1880

INVENTORY FORM FOR STATE HISTORIC SITES SURVEY

John Burgess House

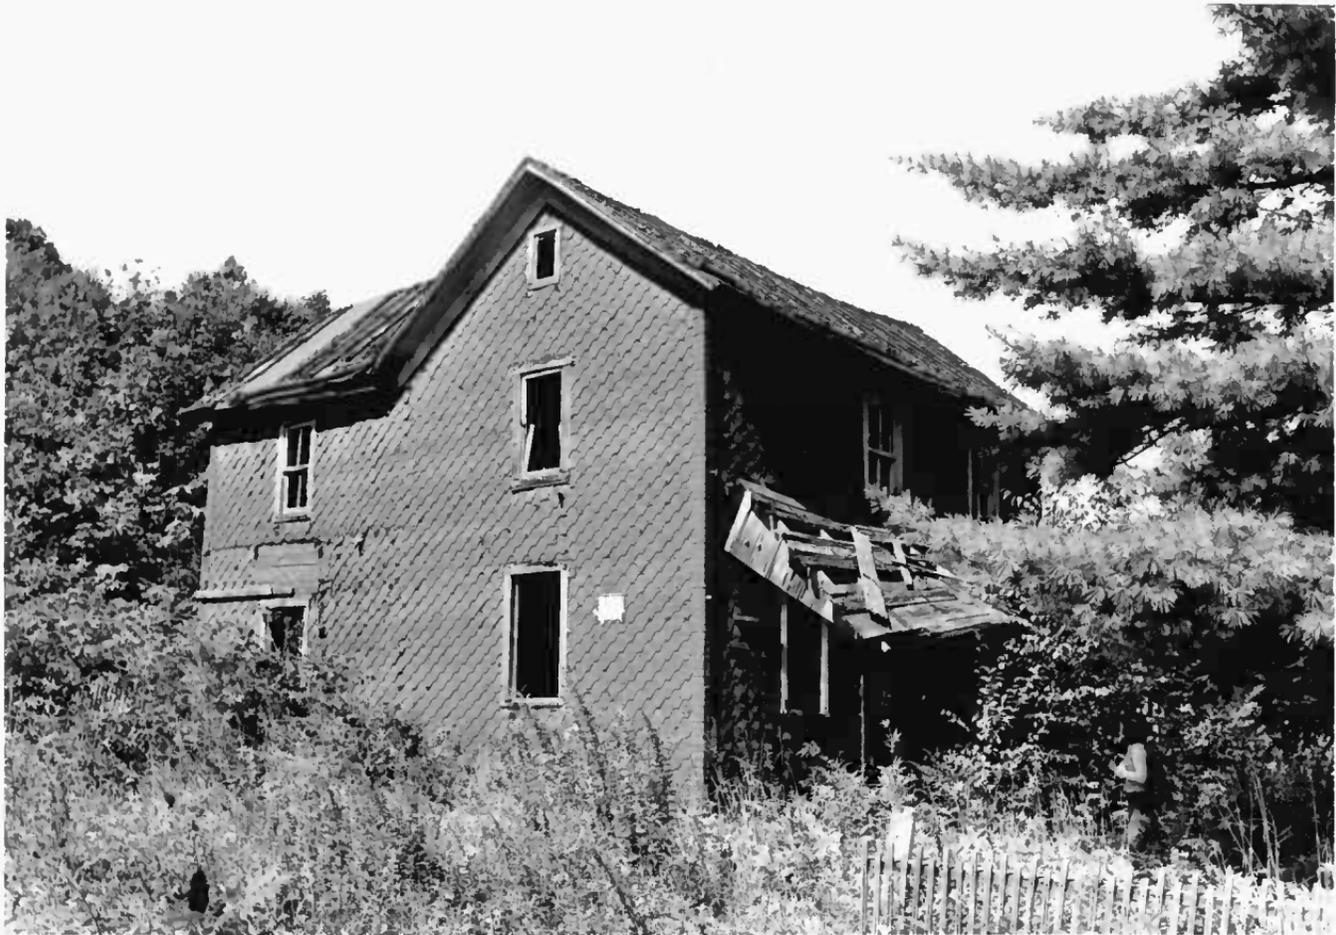
G-II-A-114

The house is a two-story gable-roofed ell-plan dwelling, measuring three bays across the facade and one bay on the sides of the main block. The facade points E. The gable ell measures one bay by one bay and a shed-roofed addition fills in the ell on the N and W elevations. A one-story shed-roofed porch runs the length of the facade.

S elev.; Facade E elev.

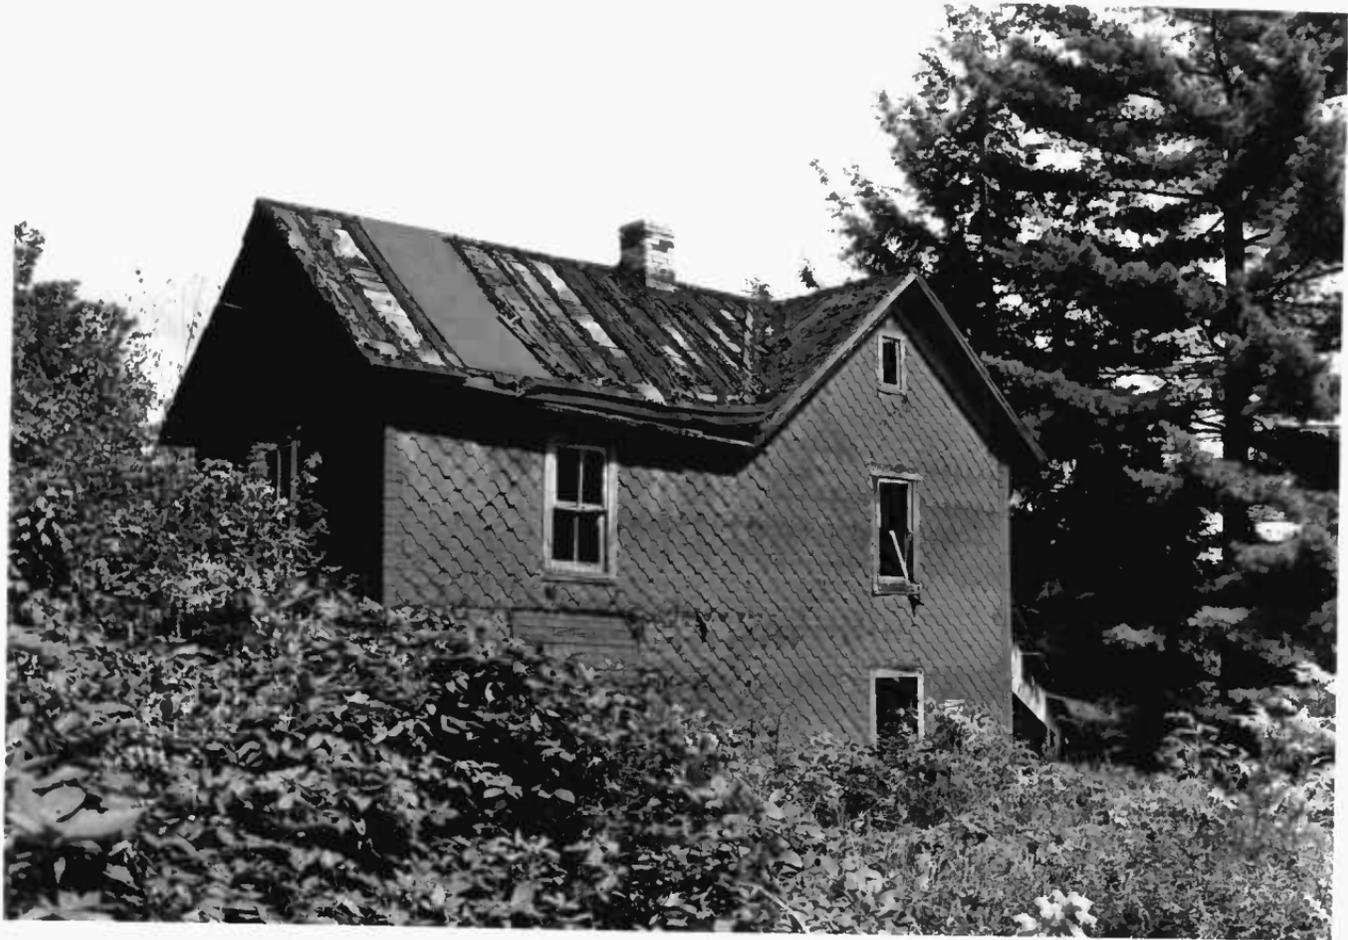
G-II-A-114

S elev.

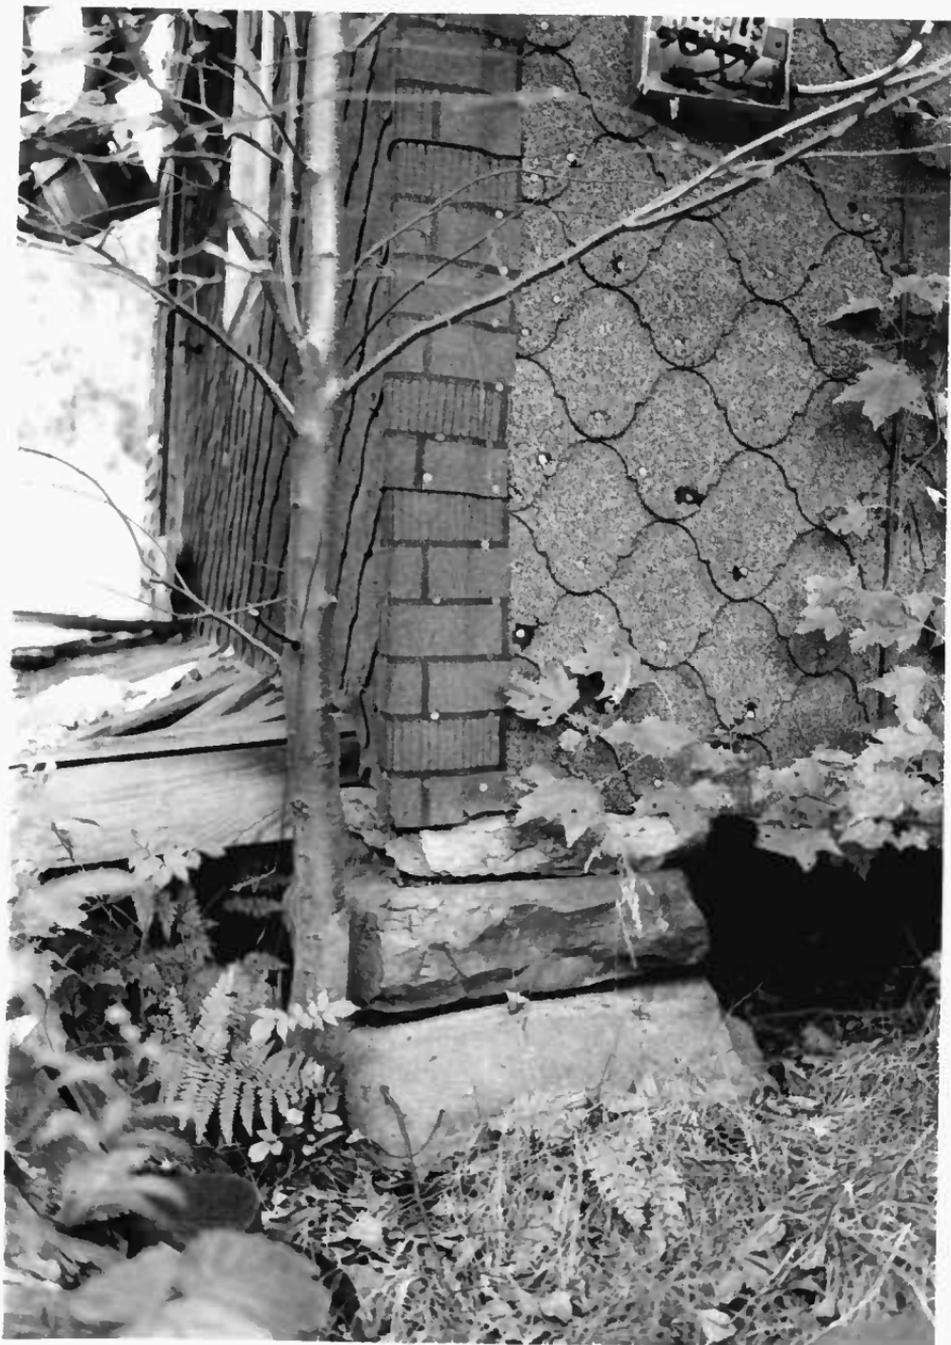
G-II-A-114

The house rests on dry stone footings. The plank-constructed walls are covered in red diamond-shaped asphalt shingles. Several of the windows are missing their sashes, but several have two over two sash. All windows have plain board surrounds.

Footing, NE corner

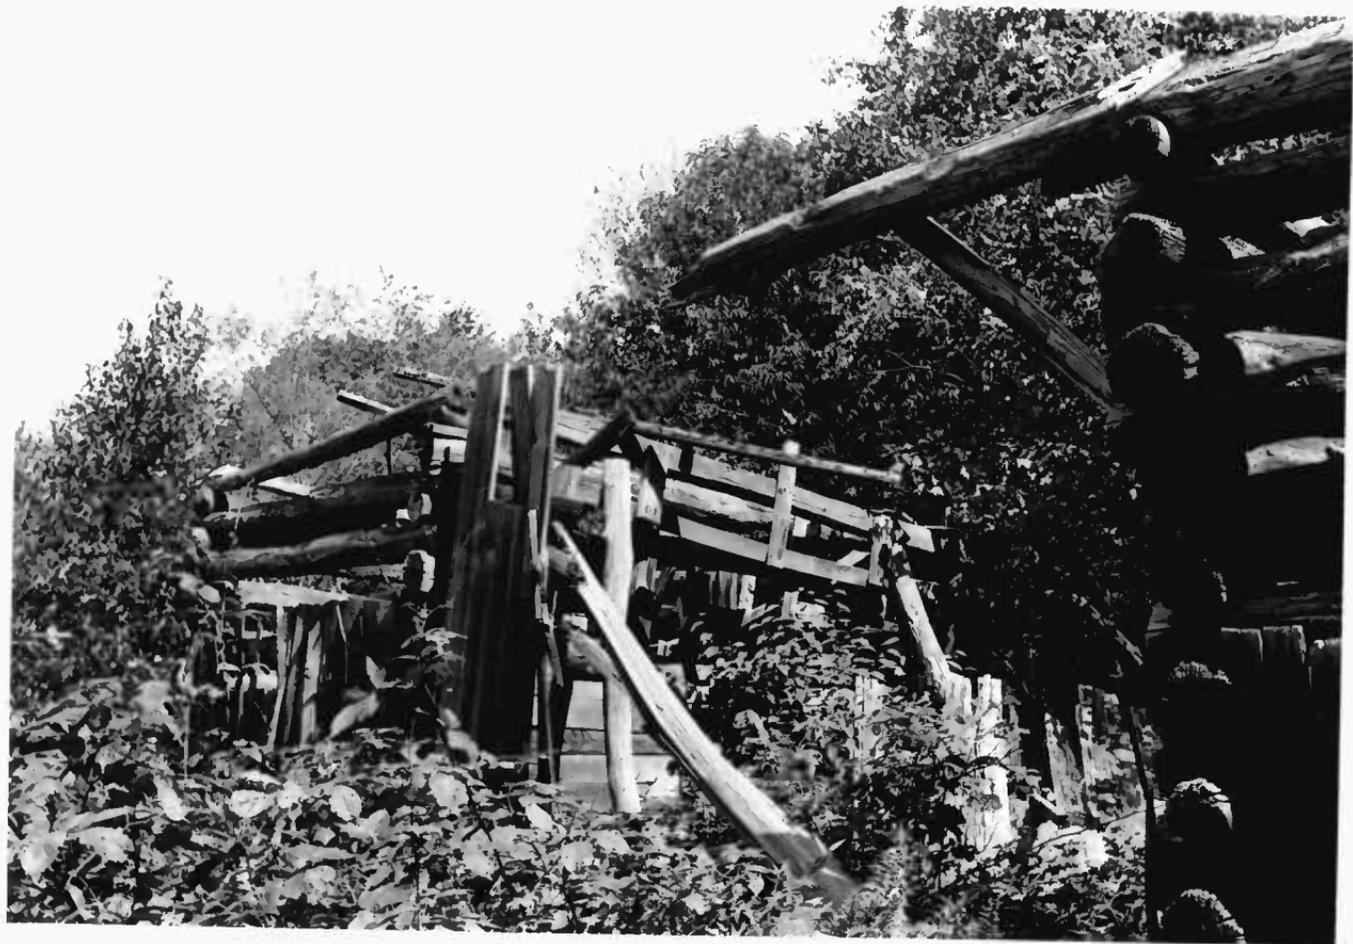
G-II-A-114

Across the road to the SE is a double-pen log barn. The logs are widely spaced and are saddle-notched. The walls were once covered with vertical boards, some of which remain on the N and W elevations. There is no trace of chinking remaining.

The ground slopes down from W to E. There is an entrance to the lower level of the S pen on the W elevation, and an entrance to the lower level of the N pen on the N elevation. In the center are the remains of the original entrance doors, which were built of planks. Part of the door, with its hinge, remains attached at the SW corner of the N pen.

W & S elevs. N pen

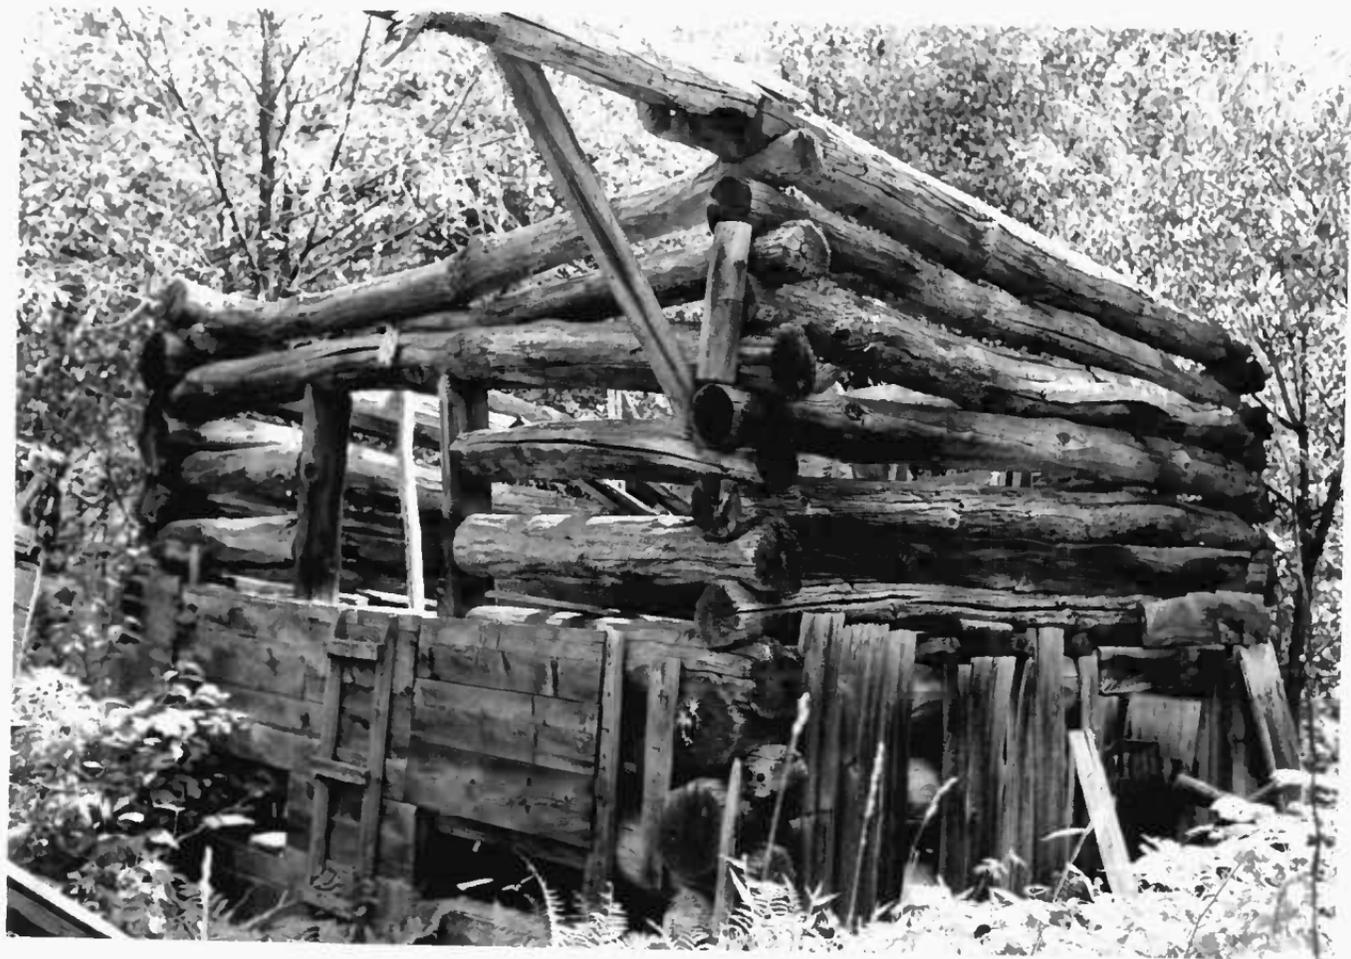
G-II-A-114

In the central portion of the barn, the floor has collapsed. On the N wall of the S pen, a small ladder, nailed to horizontal boards and leading to an opening in the wall, remains. A similar opening is visible on the S wall of the N pen.

N&W elevs. S pen

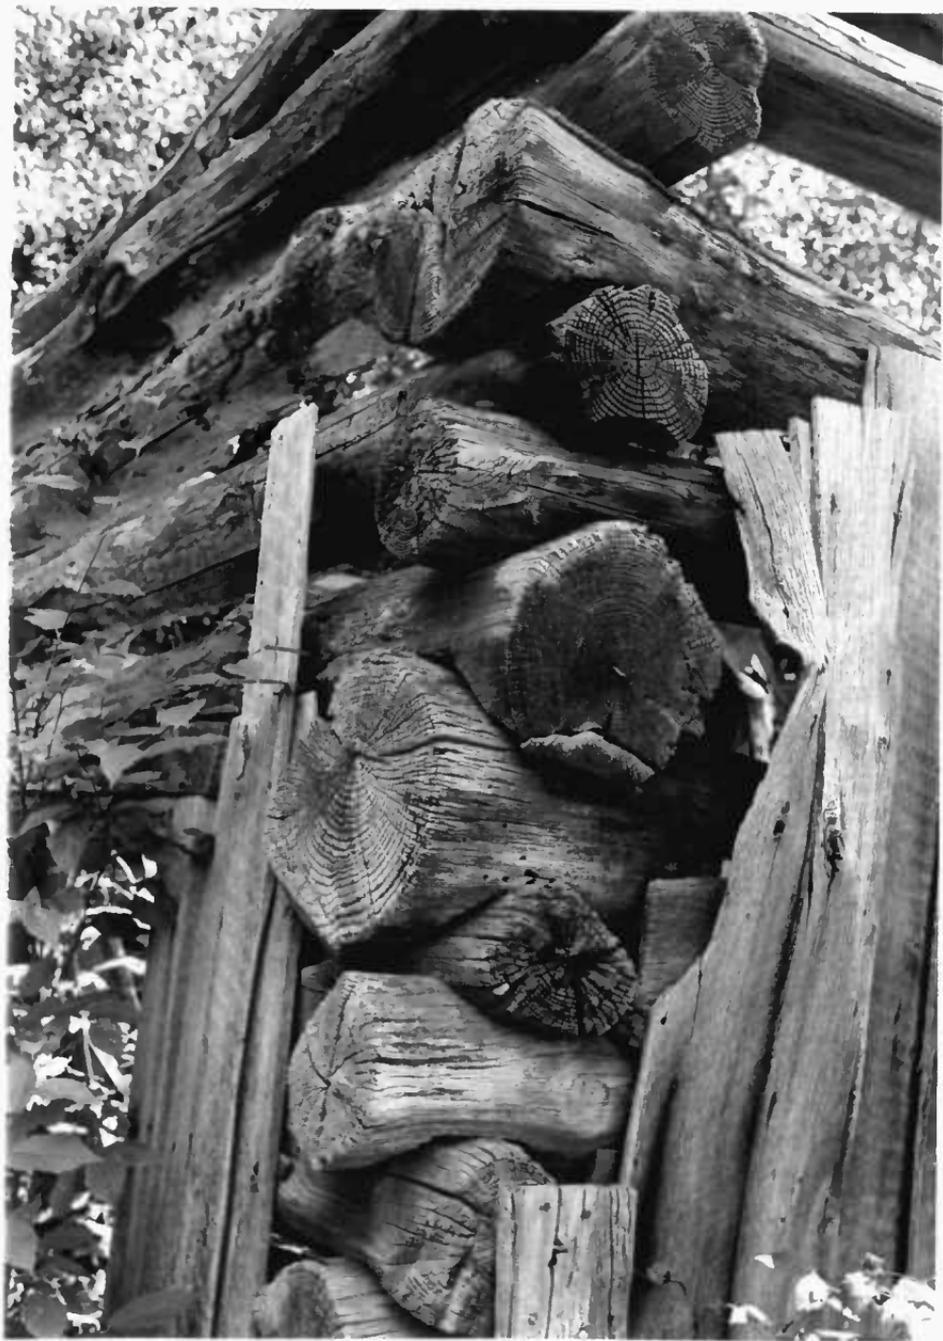
G-II-A-114

NW corner, N pen
