MARYLAND HISTORICAL TRUST WORKSHEET

NOMINATION FORM
for the
NATIONAL REGISTER OF HISTORIC PLACES, NATIONAL PARKS SERVICE

1. NAME					
COMMON: Aiken-Miller House					
AND/OR HISTORIC:					
2. LOCATION					
STREET AND NUMBER: Aiken-Miller Road, .8 mile east of U.S. Route 219					
CITY OR TOWN: Southeast of Accident					
STATE Maryland			COUNTY: Garrett

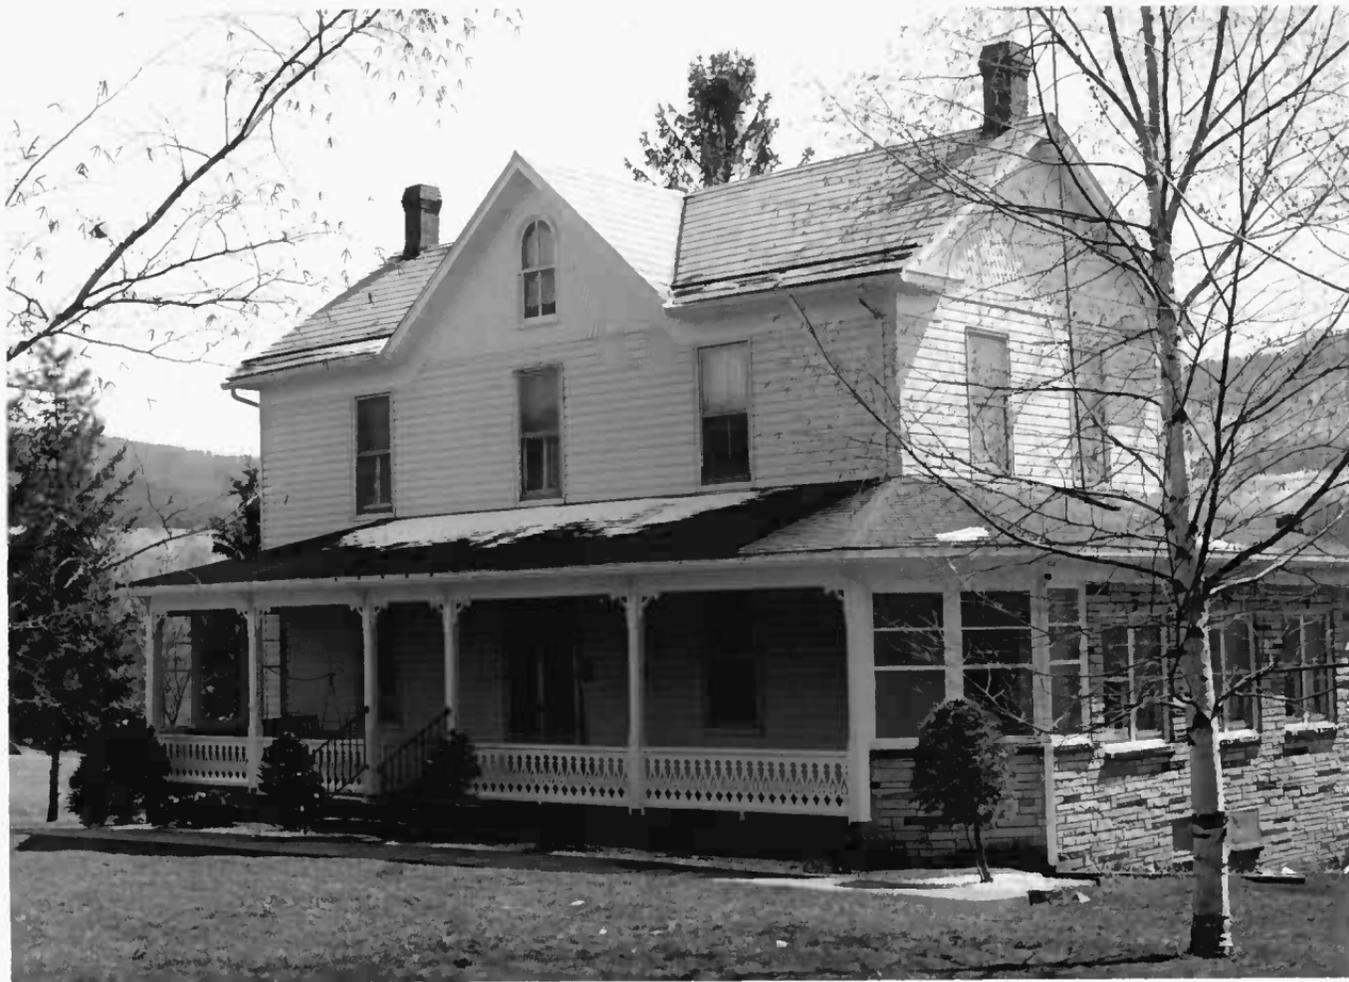
Aiken-Miller House

NW view

The house is a two and a half story, frame structure in a style commonly referred to as Italiniate. The building is L-shape and has a gable roof with a cross-gable on the facade (north side), a stone foundation, and two internal, end chimneys constructed of brick. The main portion of the structure has three bays with a center, double-door entrance on the front and two bays. The exterior side walls are covered presently with aluminum siding, but the present owner who had the siding installed says that the original siding is chap-boarding. The surfaces of the gables are covered with small wood shingles. The building has a flat, broad cornice under the roof overhang, the eaves, and the returns on the end gables. The roof of the house is covered with slate shingles.

The original windows are double-hung wooden sashes with two-over-two sashes. The top of the window in the front gable is round. The windows have a narrow piece of plain trim outlining them. The main entrance has double, wooden doors with lights and a transom. The windows and doors of the principal floors have modern aluminum storm windows and doors.

A one story, frame porch, one bay deep, stretches the length of the facade and the west side. The west side of the porch is enclosed with several windows and covered with a modern perma-stone siding. The porch columns and balustrade are ornamented with scroll work.
