INDIVIDUAL PROPERTY/DISTRICT
MARYLAND HISTORICAL TRUST
INTERNAL NR-ELIGIBILITY REVIEW FORM

Property/District Name: Blenheim, OsbornLa, Havre de Grace Survey Number: HA-107

Project: MD 155 from I-95 to US 40, Havre de Grace Bypass Agency: SHA

**Maryland Historical Trust
State Historic Sites Inventory Form**

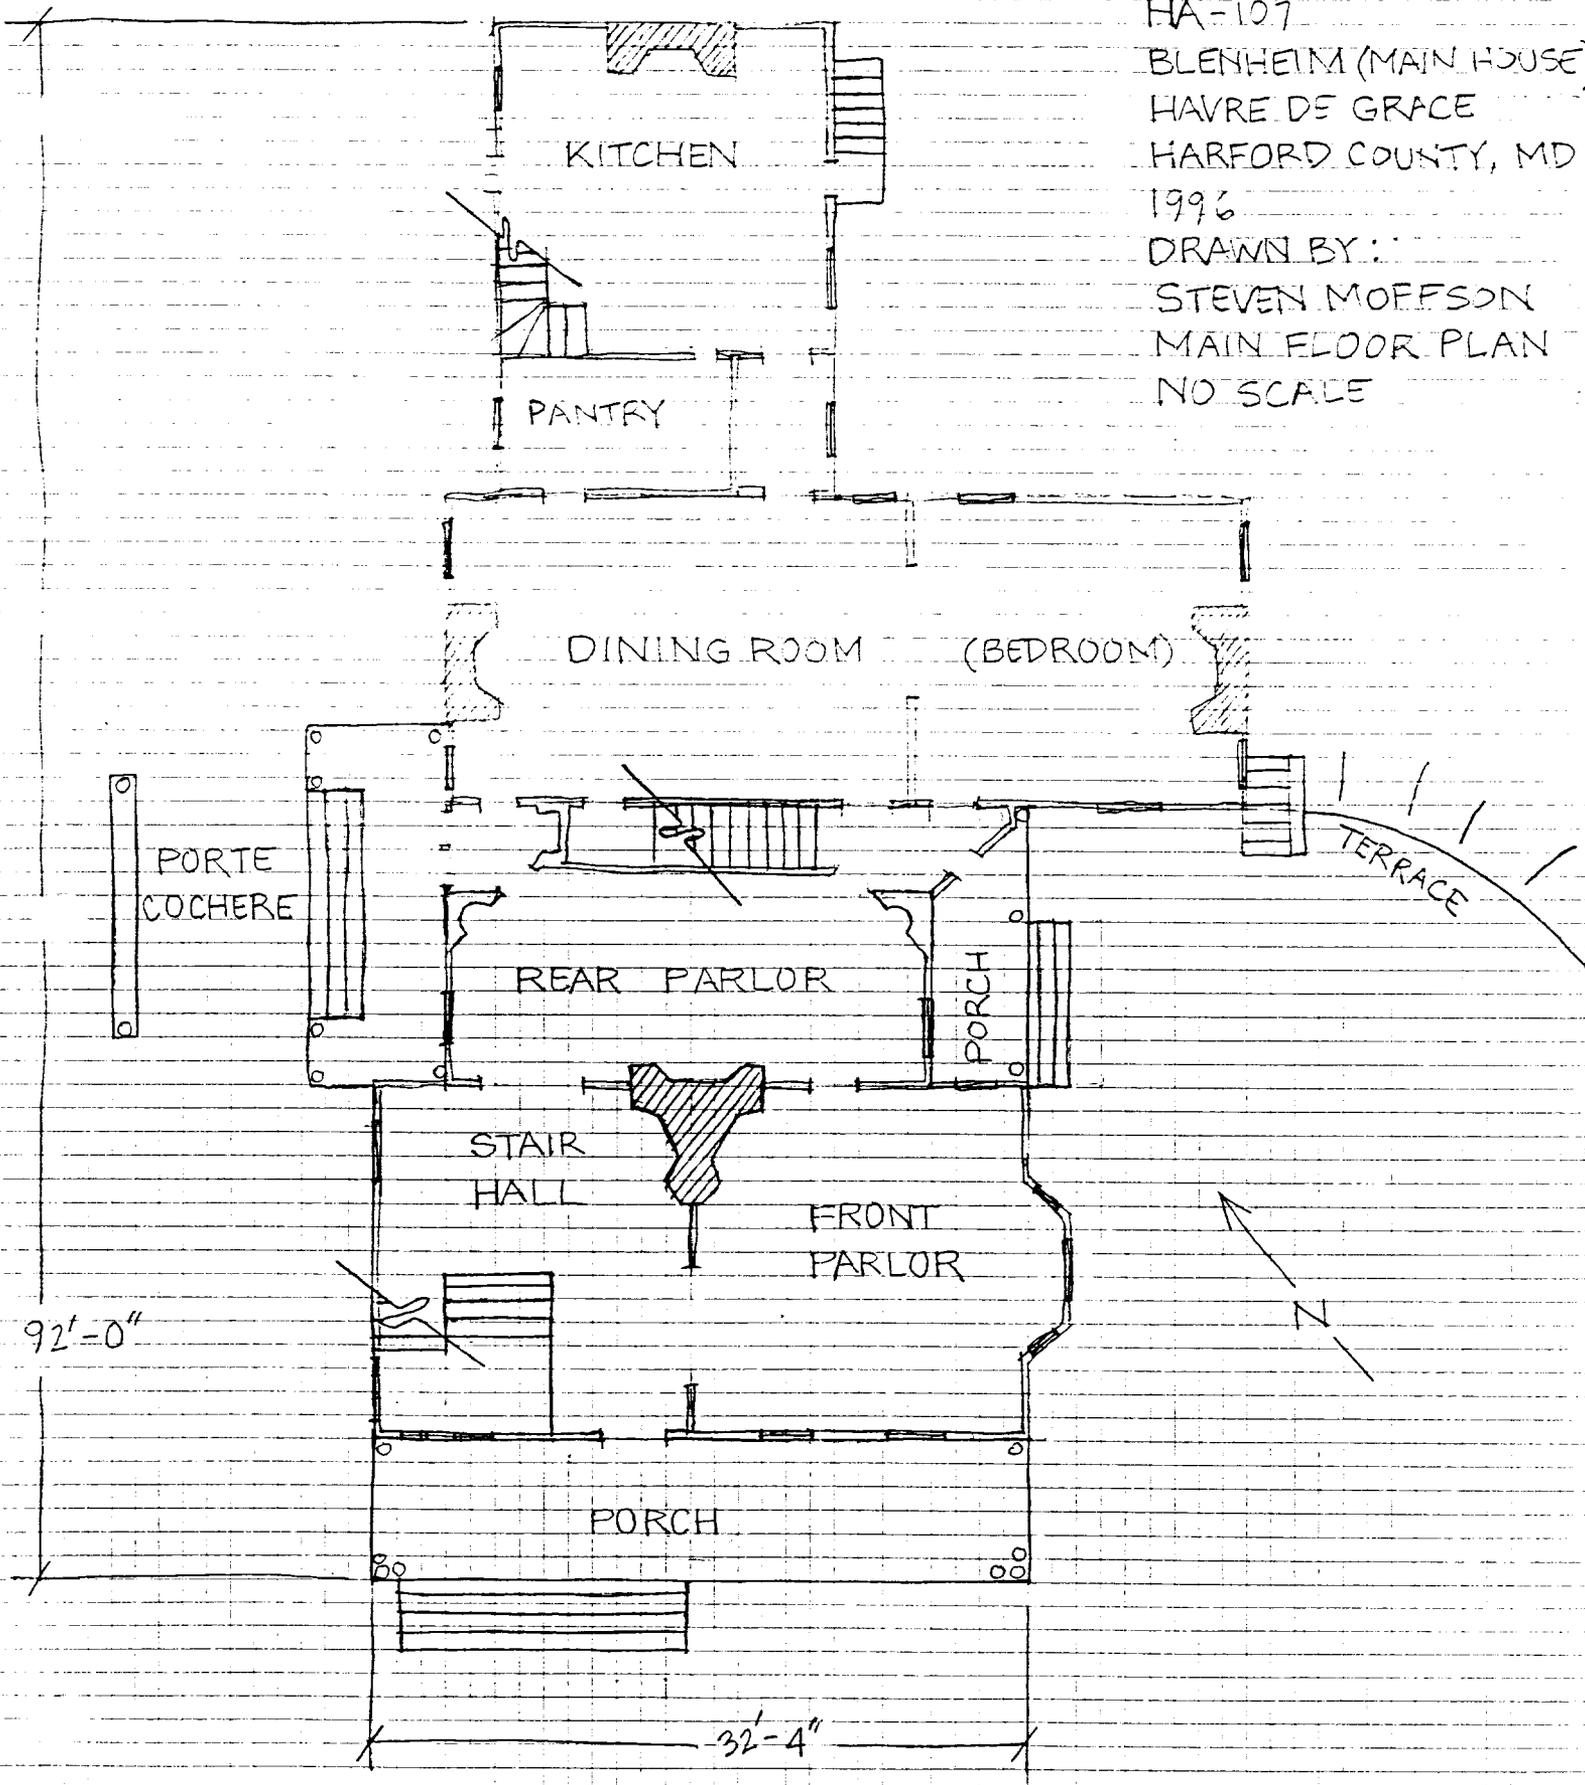
HA-107
BLENHEIM (MAIN HOUSE)
HAVRE DE GRACE
HARFORD COUNTY, MD
1996
DRAWN BY: STEVEN MOFFSON
MAIN FLOOR PLAN
NO SCALE

The interior plan of the main floor features three sets of stairs and six principal rooms: stair hall, front parlor, rear parlor, dining room, pantry, and kitchen. The front-half of the house is divided among the stair hall in the west corner, the front parlor in the east corner and the full-width rear parlor. An interior chimney provides each the rooms with a fireplace. The stair hall is the most highly ornamented room in the house. It features a grand, two-flight stair with turned posts and balusters and wood composite capitals and arches. Leaded, stained glass tripartite windows are located in the west corner at the stair landing. The room features a panelled oak dado and two sets of large oak pocket doors that lead to the front and rear parlors. The mantle is elaborately carved and includes a lion head and oak leaves and a bevelled mirror overmantle. Molded door and window surrounds, baseboards and cornices, corner blocks, ten-foot ceilings, wood floors, and radiators are located in the stair hall and throughout the house.

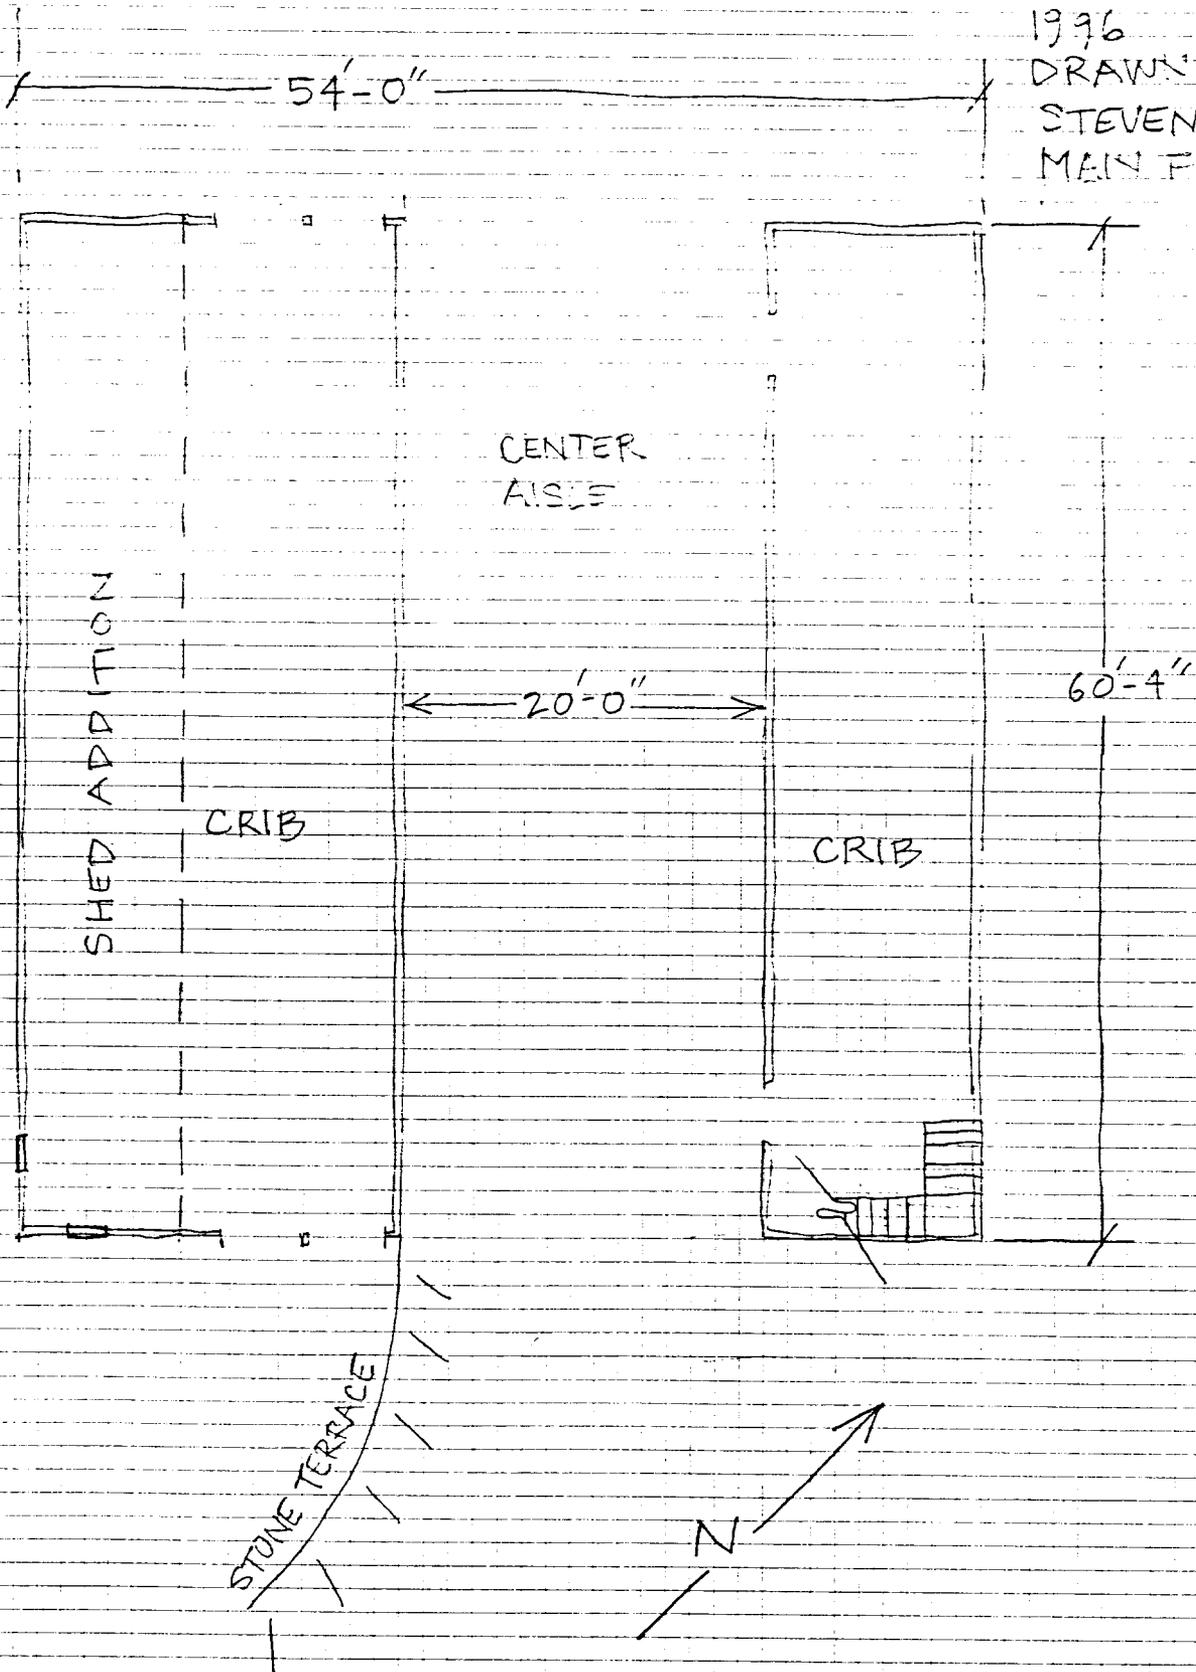
HA-107
BLENHEIM
UPPER BARN
HAIRE DE GRACE
HARFORD CO., MD
1996
DRAWN BY:
STEVEN MOFFSON
MAIN FLOOR
NO SCALE

Upper Barn (late 19th century). A large, 54 x 60-foot, 2-story, frame, double-crib barn. It features a 20-foot-wide center aisle and is six bents deep. The barn is transversely banked into a hill, though the second level is accessed only by crane or an interior winder stair in the west corner. The barn is framed with hewn, mortise and tenoned timbers and set on an uncoursed rubble foundation. Doors are hung with large, wrought-iron strap hinges. The interior wall of the northeast crib is slatted for corn storage. The second story provides open access to this crib. The larger southwest crib features a vertical board interior wall. Its exterior wall was removed when the 1-story, 1-bay shed addition was added. The second floor features an open rafter framing system and double-hung sash and casement windows. Grain separating and processing equipment is still located on the second level. The southwest shed addition has largely collapsed.

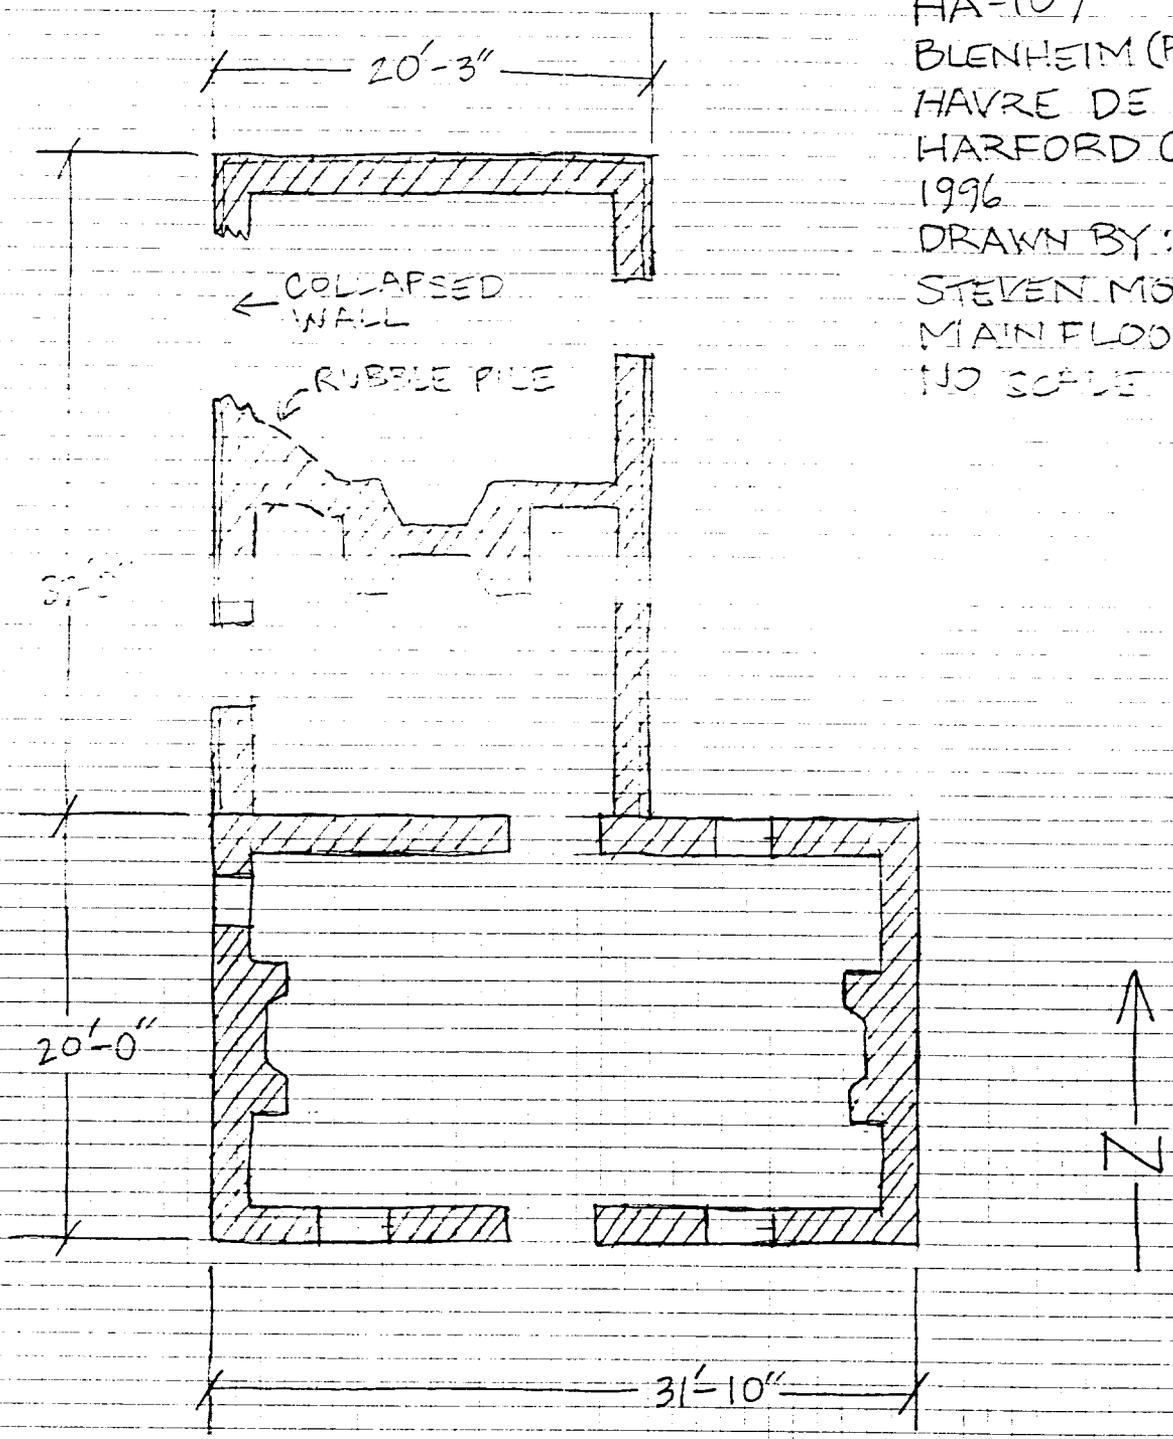
HA-107
BLENHEIM (RUINS)
HAVRE DE GRACE
HARFORD CO., MD
1996
DRAWN BY:
STEVEN MOFFSON
MAIN FLOOR PLAN
NO SCALE

The ruins of the rear ell indicate a 1-story, 2-room structure with a large double fireplace that heated both rooms. It is constructed of mostly smaller stones, which are not keyed into the main block. This suggests that the rear ell was built after the main block was originally constructed. The rear ell was entered from a doorway in located in the northeast corner and directly from the center passage of the main block. The deteriorated condition of the structure has made it difficult to determine if the two rooms in the ell were connected.

The condition of the ruins is fair. The building has been poorly repointed and trees have and other vegetation have taken root near the foundation. The condition of the walls is sound though they should be stabilized. Dimensioned lumber has been used shore up several of the window openings, though most remain in fair condition.

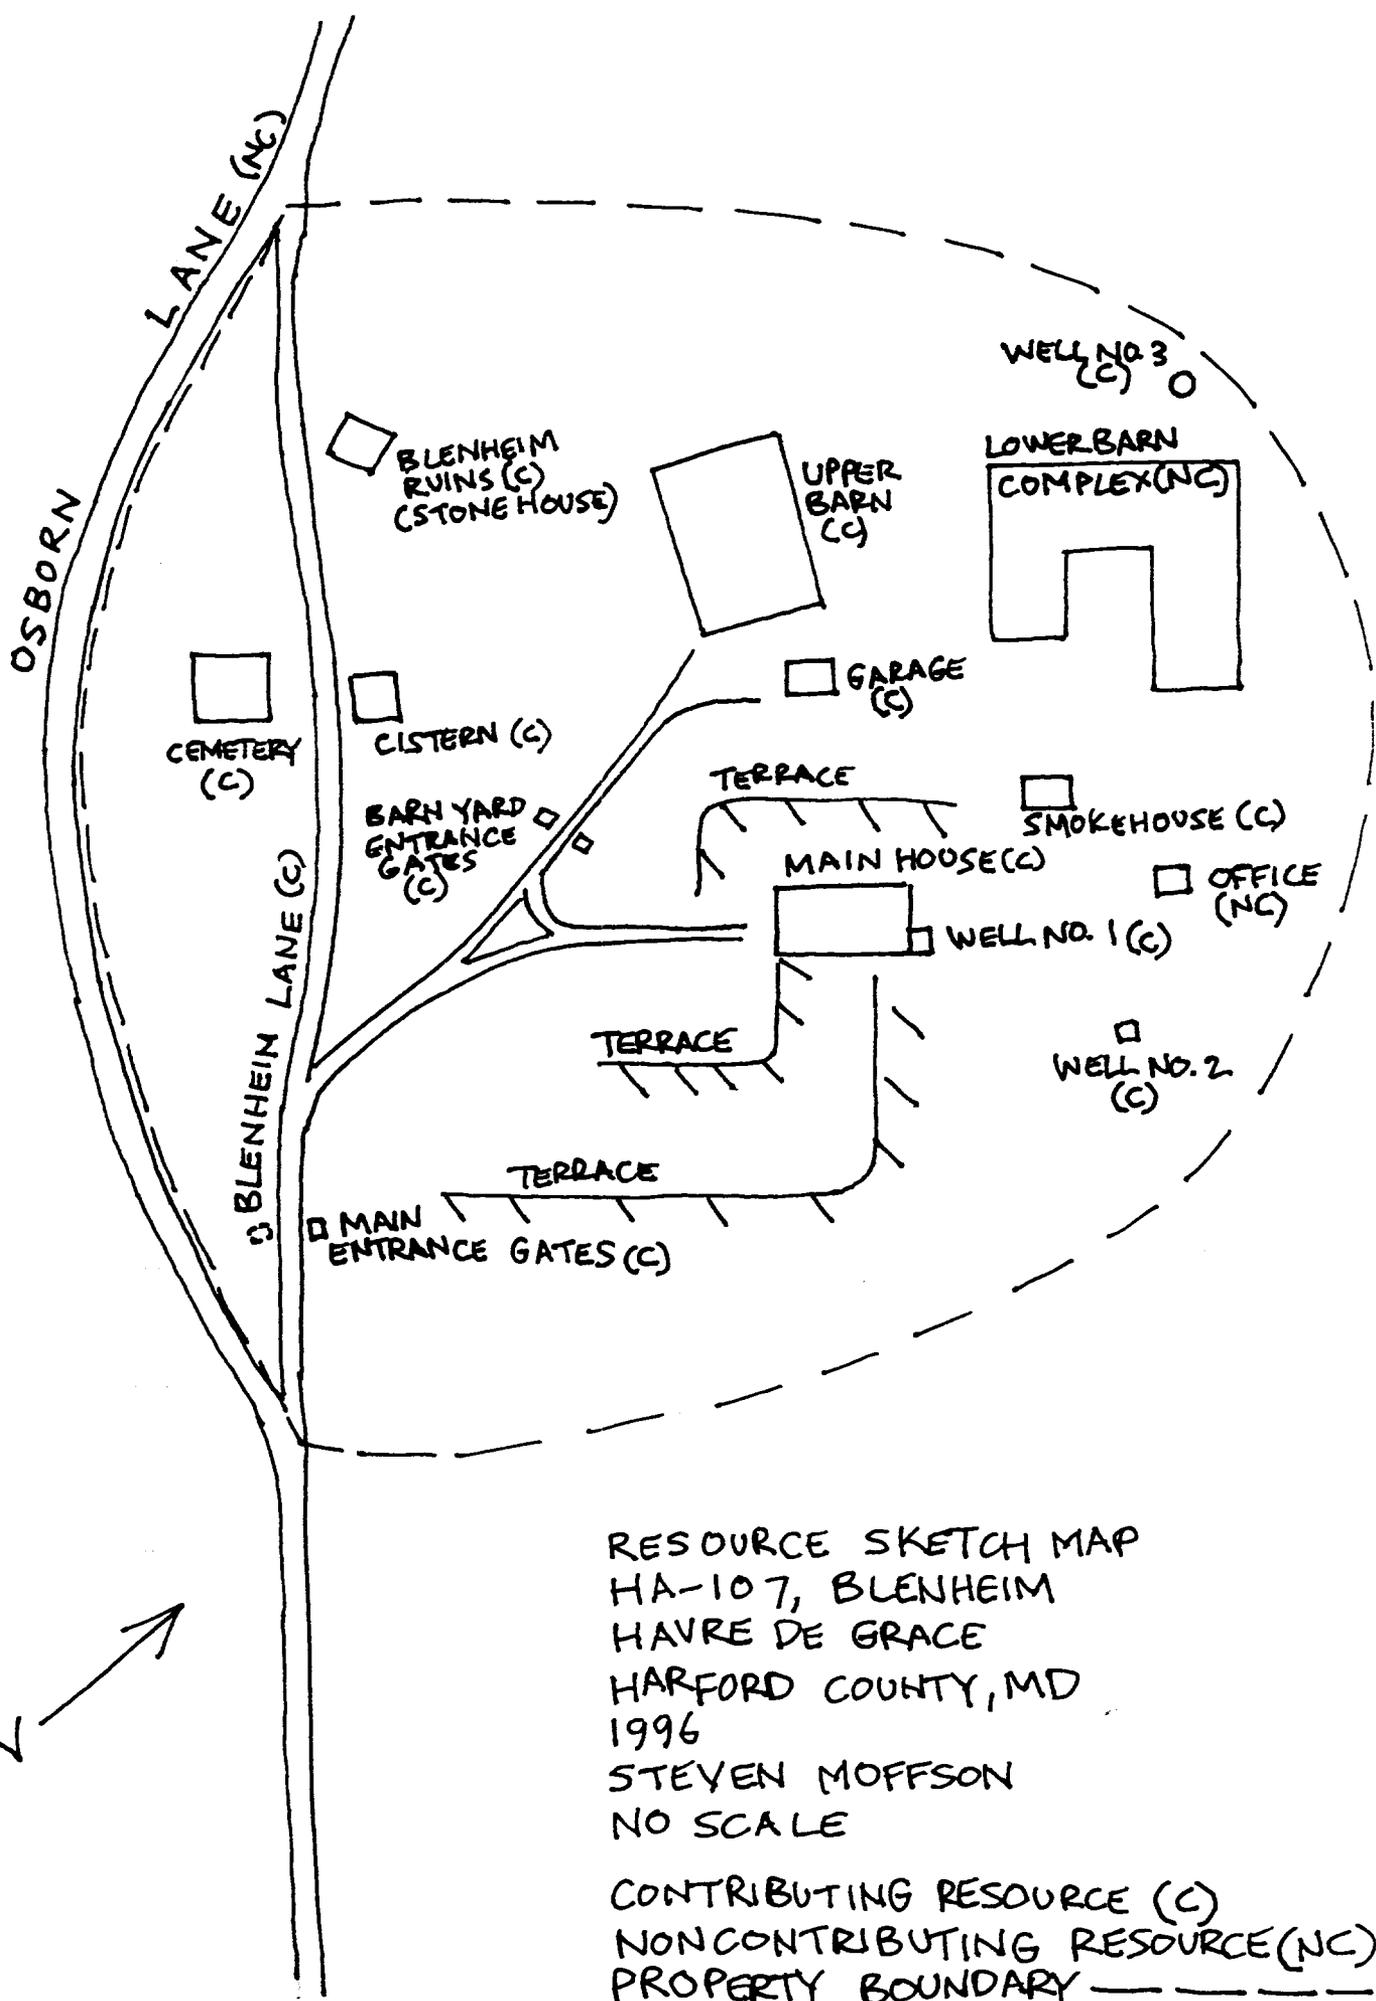
Cemetery (early 19th century). A small, private cemetery that contains the marked graves of the Smith and Sappington families, previous owners of Blenheim. The six graves are marked with large horizontal tablets set on stone blocks. Several of the tablets have fallen to the ground and one has broken. The cemetery wall measures 29 x 44-feet and is approximately 5-feet tall. It is constructed of coursed rubble with brick and concrete coping. It is entered through a wrought iron gate located on the northeast side, adjacent to Blenheim Lane. Two marked graves of servants who served at Blenheim are located outside the cemetery, along the southwest side of the wall. A depression in the ground suggests a third unmarked grave along the southwest side.

- ① SARAH KNIGHT SMITH (3/8/1770-5/30/1828)
- ② PACA SMITH (12-2-1779-8/25/1830)
- ③ DR. WILLIAM SAPPINGTON (2/3/1789-12/1/1849)
- ④ LILLI SAPPINGTON (4/11/1792-2/7/1843)
- ⑤ MRS. CASSANDRA SAPPINGTON (5/14/1786-9/25/1852)
- ⑥ DR. RICHARD SAPPINGTON (1755-4/21/1824)
- ⑦ UNIDENTIFIED GRAVE
- ⑧ NATHAN RAMSEY, SERVANT OF J.K. SAPPINGTON (7/12/1836-12/7/1864)
- ⑨ LUTHER HOWARD, SERVANT OF THE OSBORNS (d. 12/6/1942)
