**MARYLAND HISTORICAL TRUST
DETERMINATION OF ELIGIBILITY FORM**

Property Name: Herold House Inventory Number: HA-262
 Address: 4114 Flintville Road Historic district: yes no
 City: Darlington Zip Code: 21034 County: Harford
 USGS Quadrangle(s): Conowingo Dam
 Property Owner: HEROLD GEORGE M K TRUSTEE Tax Account ID Number: 1305018455
 Tax Map Parcel Number(s): 34 Tax Map Number: 13
 Project: Herold House Proposed Tower Agency: FCC
 Agency Prepared By: ATC Associates
 Preparer's Name: William Riggs Date Prepared: 5/19/2003
 Documentation is presented in: _____
 Preparer's Eligibility Recommendation: Eligibility recommended Eligibility not recommended
 Criteria: A B C D Considerations: A B C D E F G
Complete if the property is a contributing or non-contributing resource to a NR district/property:
 Name of the District/Property: _____
 Inventory Number: _____ Eligible: yes Listed: yes
 Site visit by MHT Staff yes no Name: _____ Date: _____

SITE VISIT MAY 9, 2003

HA-262
Herold House
Flintville Road
Darlington, Maryland 21034

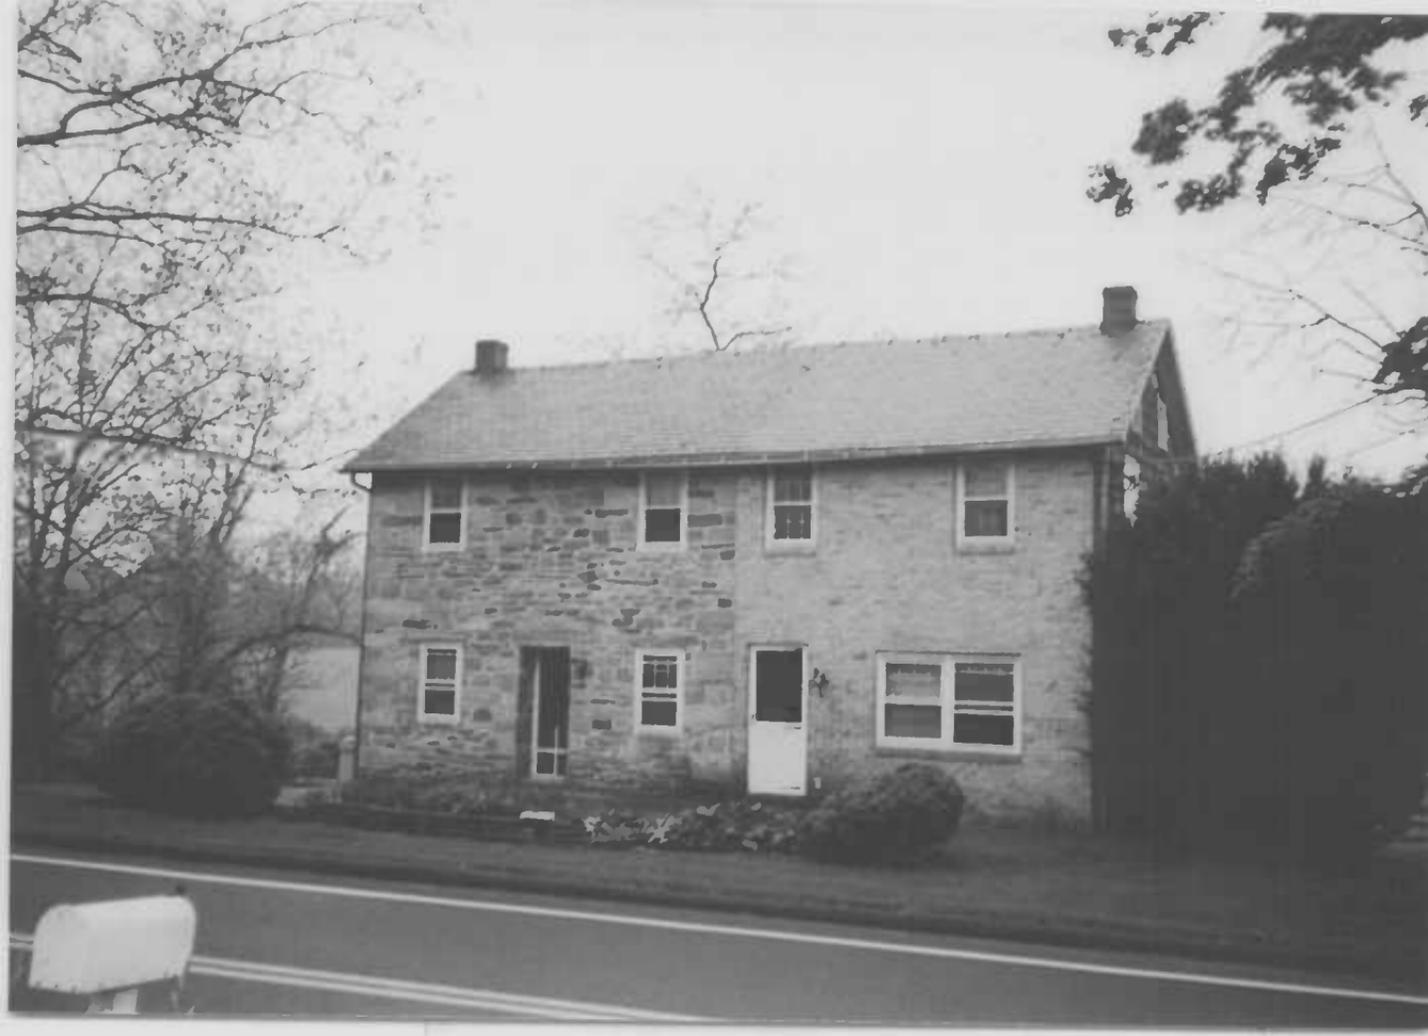
Photo 1

- East front façade
- Building is 2 story plus basement.
- Left side of façade is stone cladding; right side is newer brick in running bond.
- Main gable roof running in north to south direction is slate shingles.
- Brick chimneys protrude main gable at north and south ends.
- Windows are predominantly single hung wood windows in wooden frames. Storm windows are single hung metal.
- Front patio is brick pavers, which appeared deteriorated.

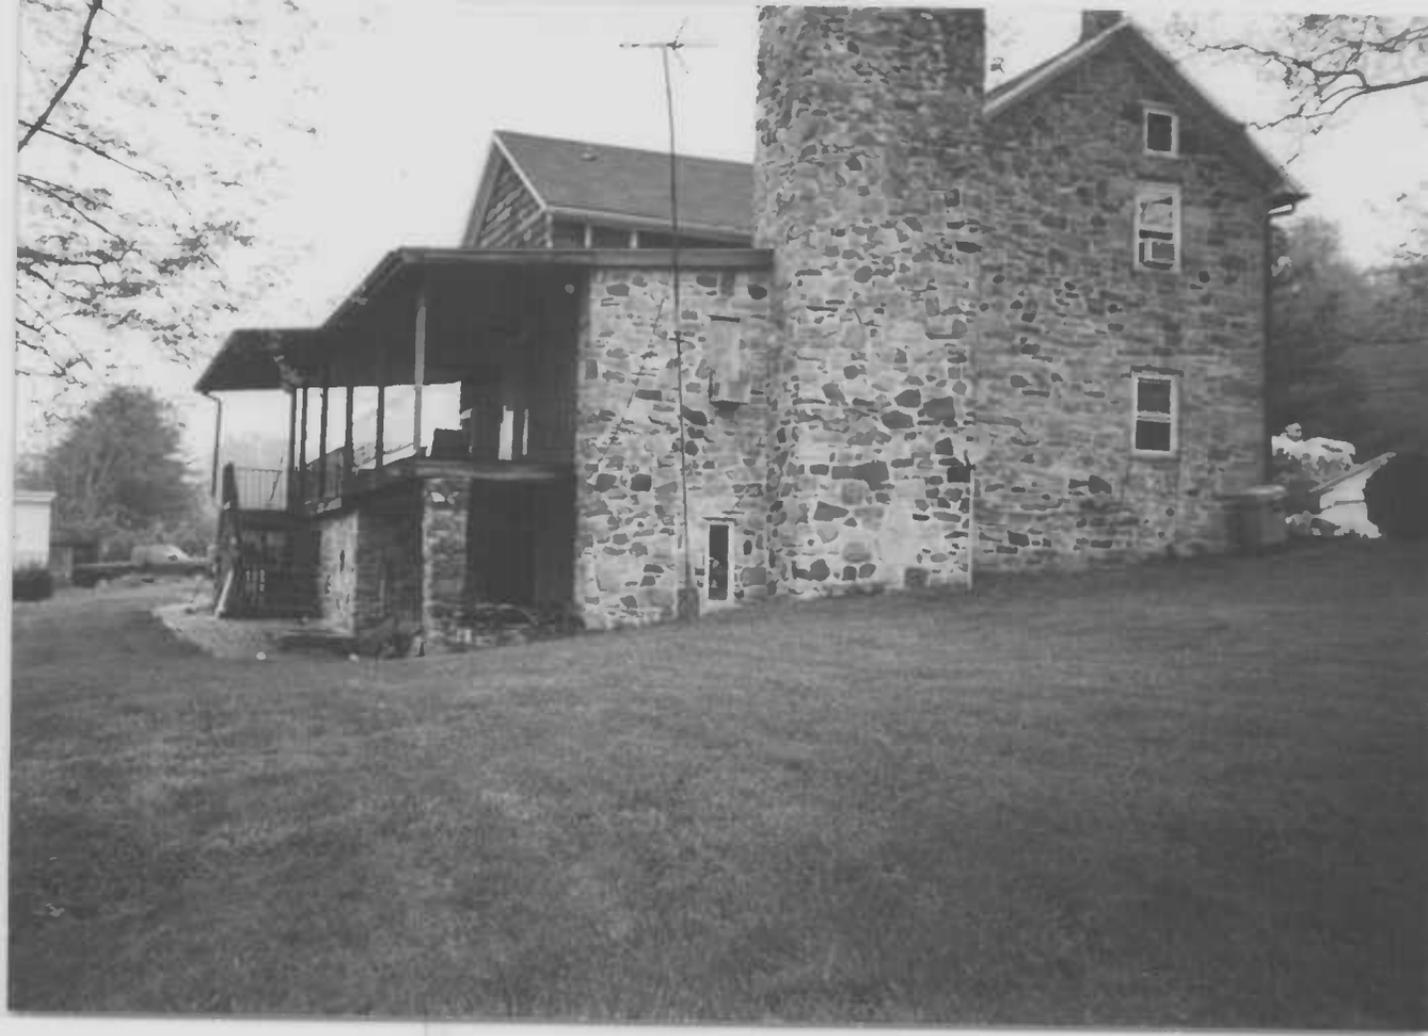
Photo 2

- South and west back façade
- South façade is stone cladding.
- Large brick side chimney.
- Minor gable roof (east-west direction) and shed canopy over back porch are clad with asphalt shingles.
- Steel beam between stone pillar and bearing wall supports wood beams and portion of wood decking.
- Open frame wood steps with metal railings.
- Metal picket railings are around north deck at top of stairs.
- Wood picket railings surround southern portion of deck.
- North deck wall clad in wood shakes. Southern deck wall clad with vertical wood boards.
- Brick pavers under deck and at stair approach.

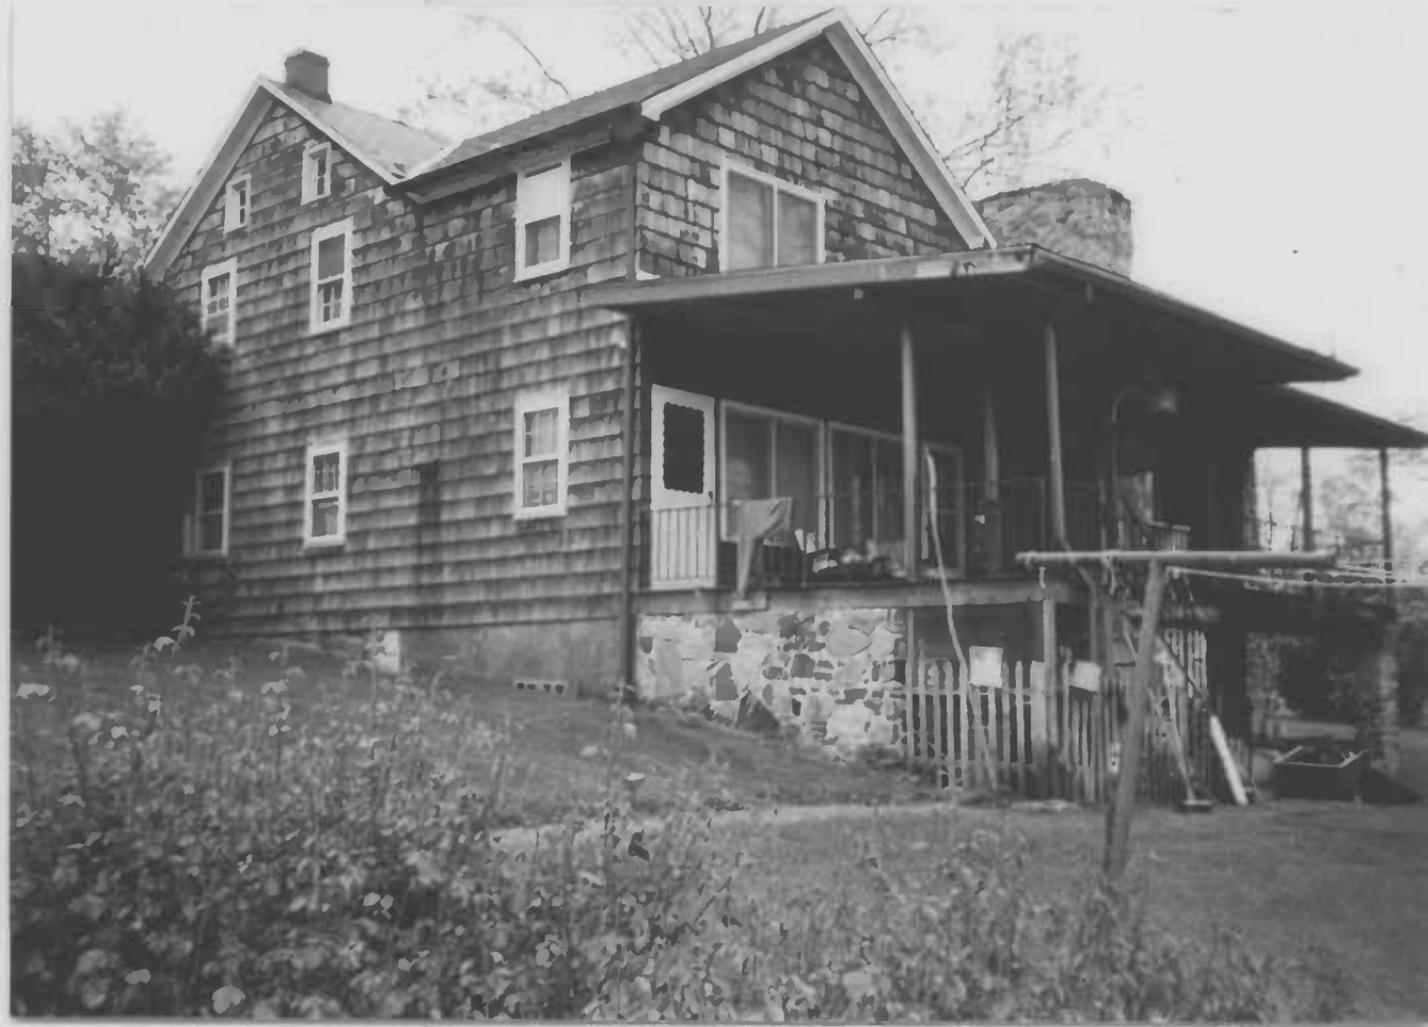
Photo 3

- North and west back façade
- Wood shakes covers north façade and 2nd floor rear. Wood shakes in need of refurbishing and staining.
- Foundation wall –CMU and stone veneer.

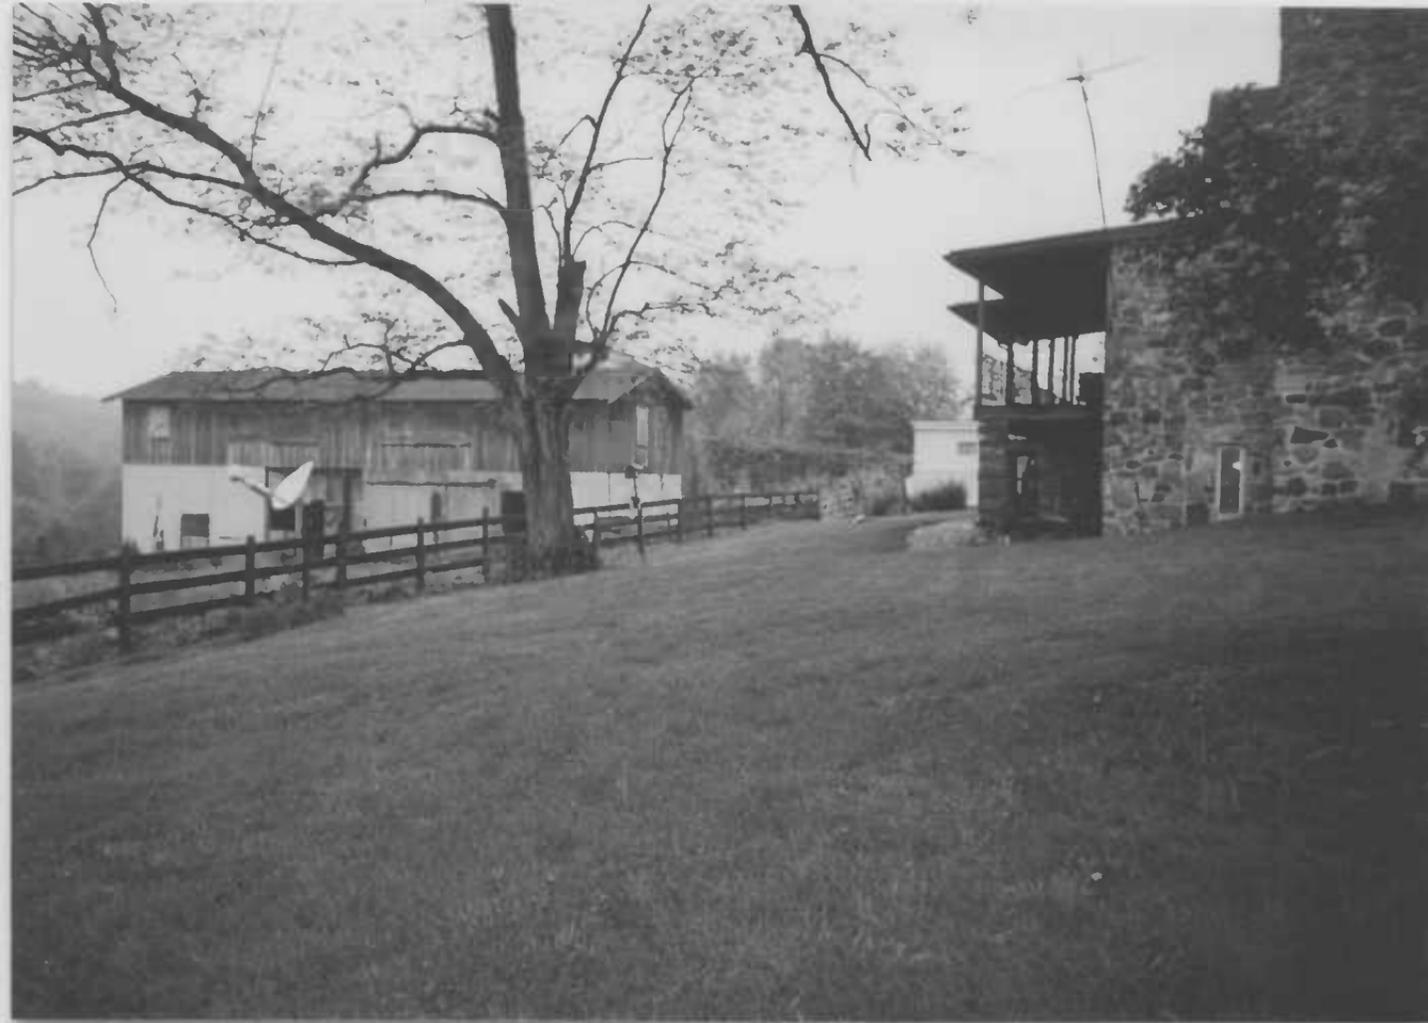
Photo 5

- Front view of horse stable.
- Gable roof clad with asphalt shingles.
- Façade is CMU at lower level; vertical wood boards at upper level.
- Wood fence surrounds stable.

VIEW OF BIRN FROM ELEVATION

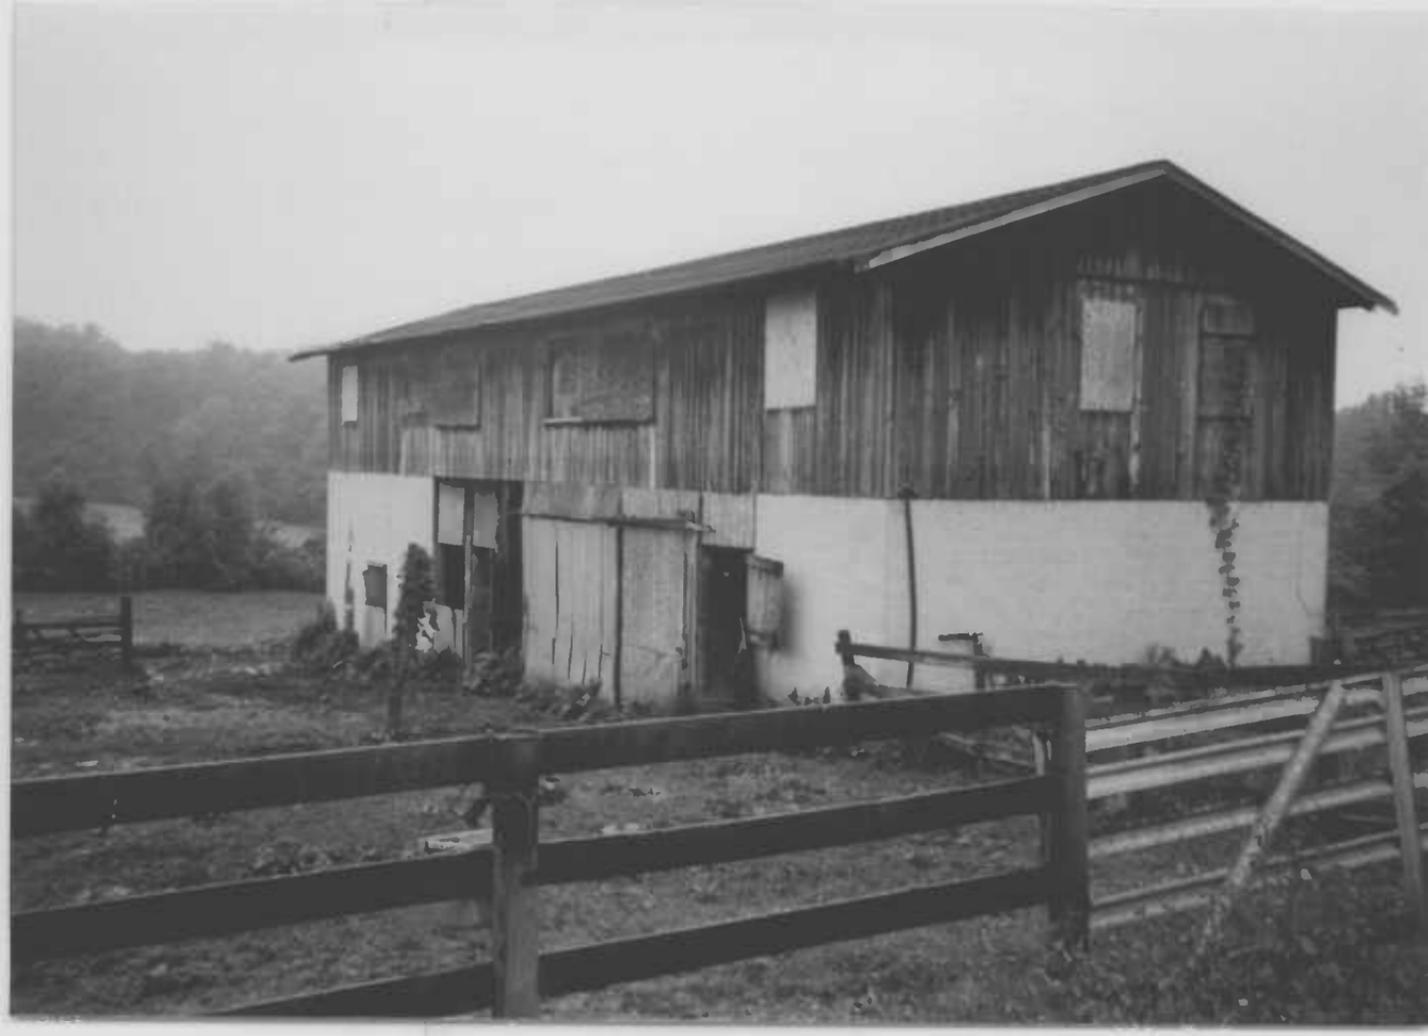
Photo 6

- Rear view of horse stable.

BARN, SOUTH 40° 23' ELEVATION 115
F/15

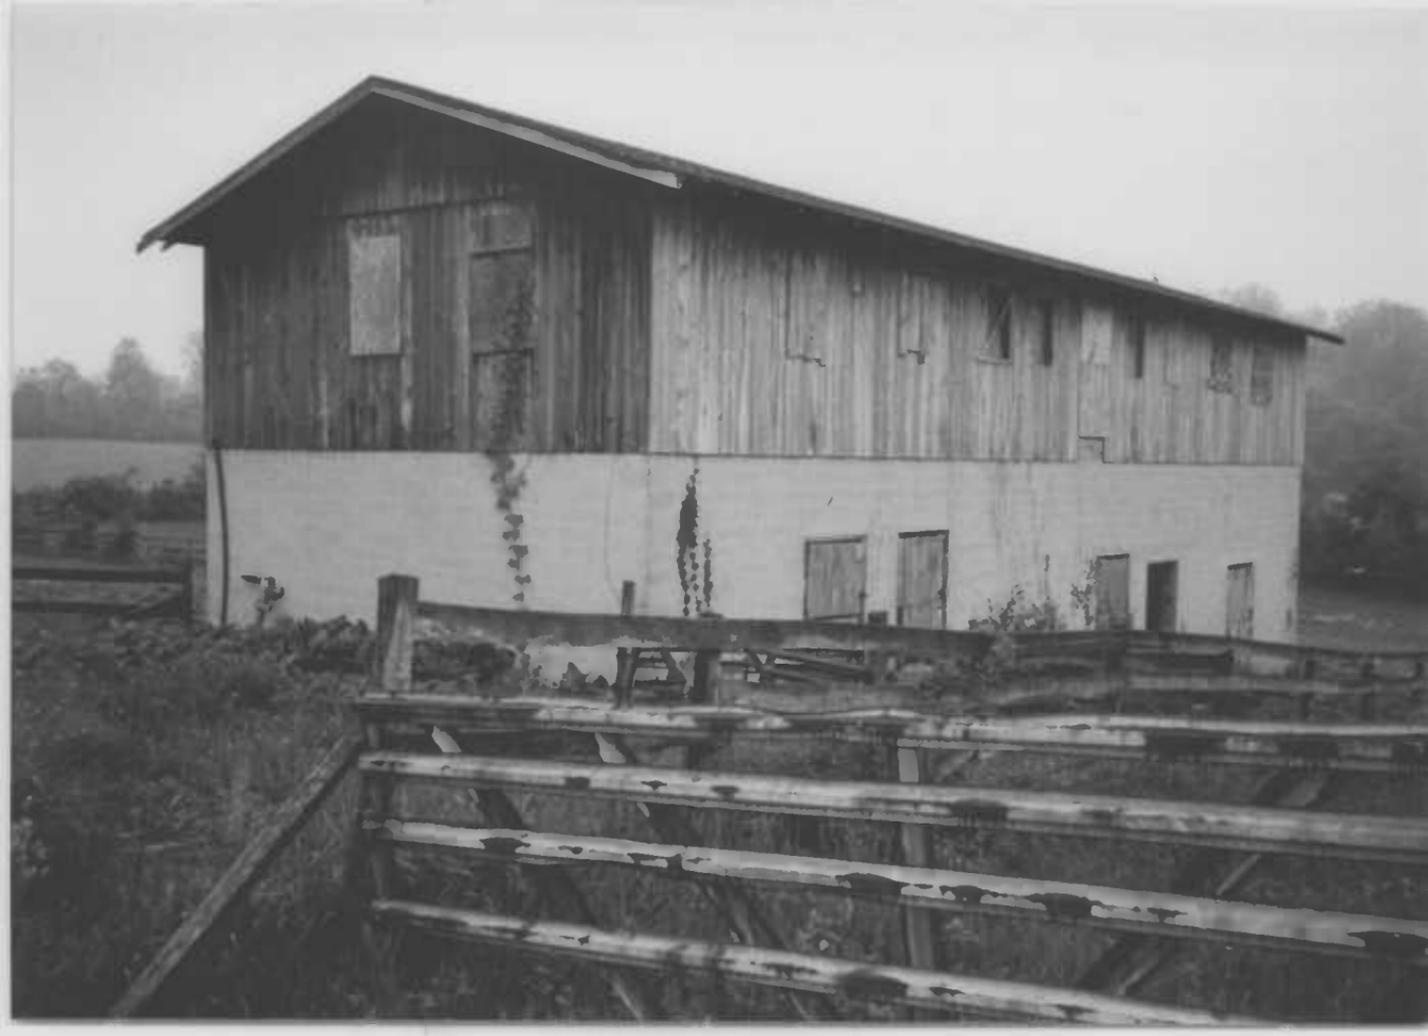
272 (NORTH) ELEVATION OF HERON

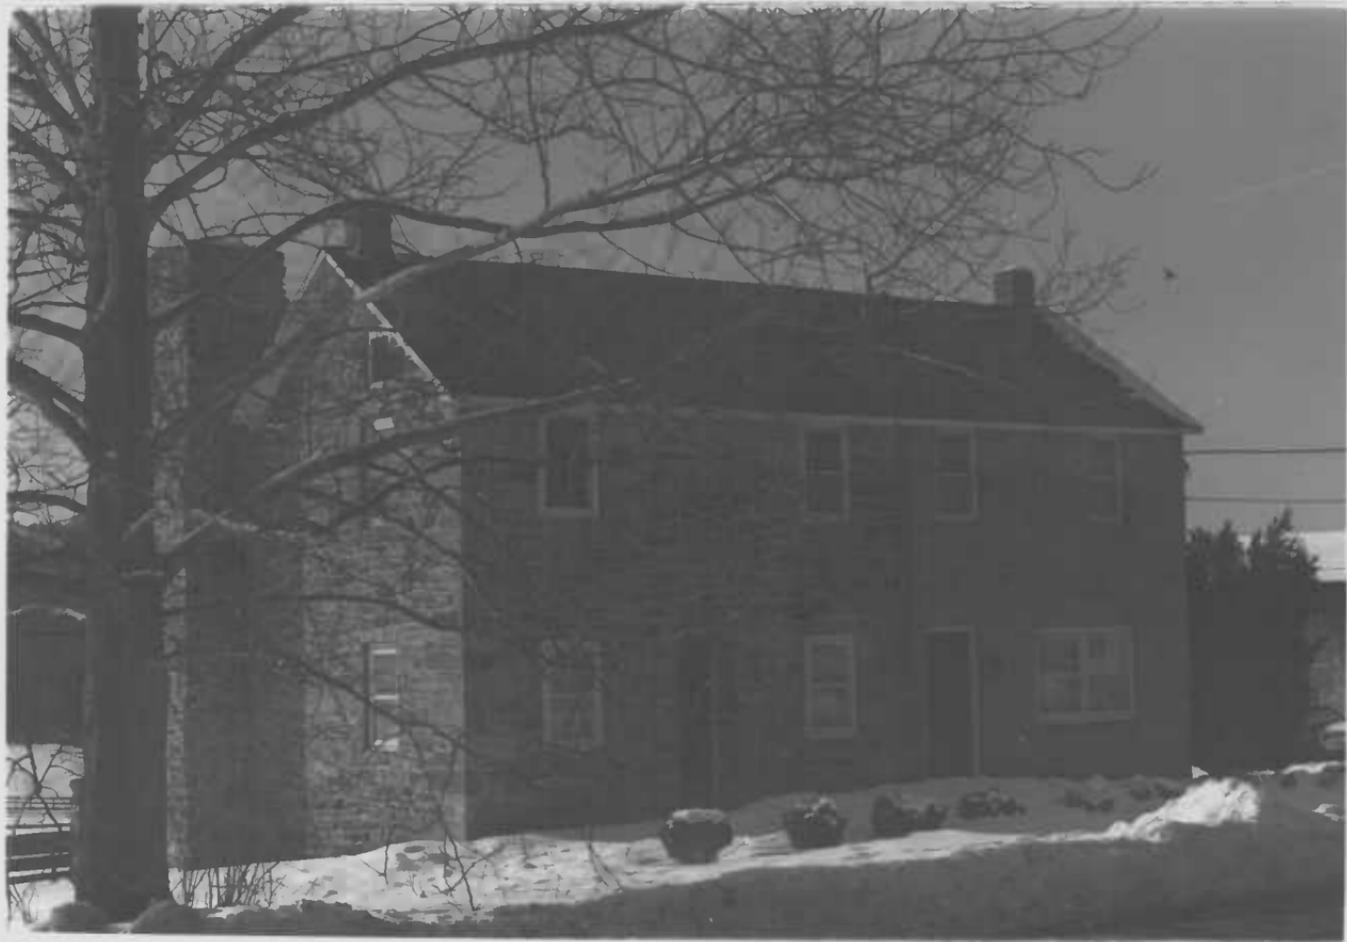
Herold House HA-262
Darlington, MD 21034
Susan M. Deeney
February, 1978
East

This structure is located on Flintville Road and faces east toward the Susquehanna River. The house consists of two main units, one of which is rubblestone, the other being frame construction.

The stone unit makes up the southern half of this rural apartment building. This unit is two stories high and is three bays by two. It has a gable flank, slate covered roof with a new, corbeled brick chimney located at the south, inside gable end. Windows in this unit are six lights over six. The principle entrance is in the center bay of the east facade. There is a stone addition on the west. This consists of an additional bay, a huge stone chimney and a porch across the west facade.

The frame unit of this house is covered with cedar shake shingles on all but the eastern exposure. This side is faced with a brick facade. The unit is two bays by two. The door and window sashes are replaced. This unit is also two stories high and covered with slate shingles. A new brick chimney is located on the north inside gable end.

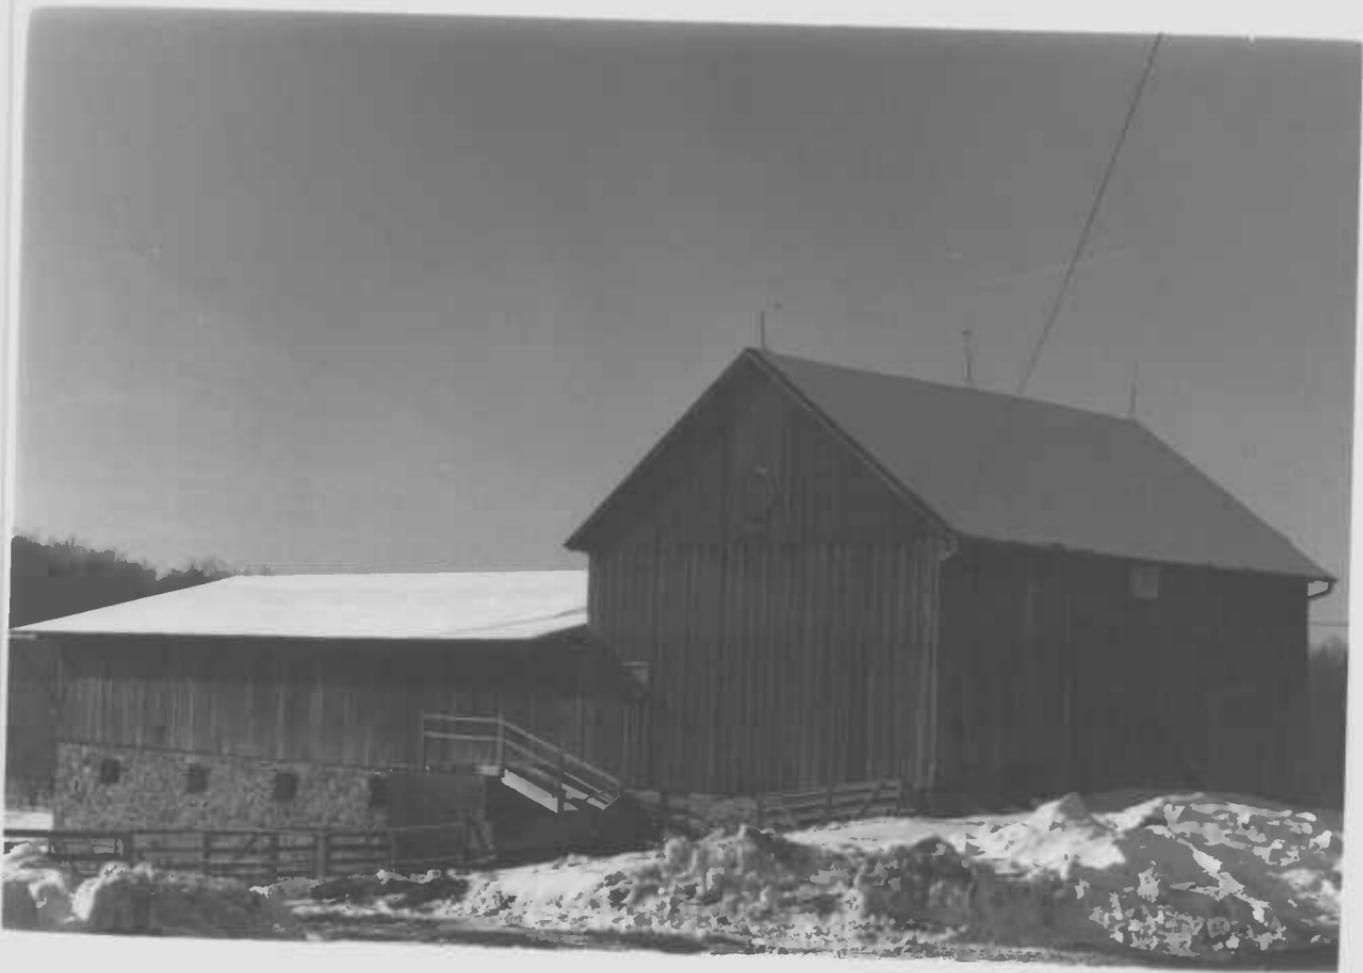
Herold's Barn HA-262
Darlington, MD 21034
Susan M. Deeney
February, 1978
East

A large rubble stone and frame barn is located to the north of the house. The main part of this barn is constructed of vertical board.

The roof is slate. The foundations are rubble stone. In the section to the west, the rubble stone foundations make up the ground floor level. There are four small windows and a door on the south side of the rubble wall.
