HA-1164  
QUIRK HOUSE  
Havre de Grace, Md.

INVENTORY FORM FOR STATE HISTORIC SITES SURVEY

Quirk House

550 Congress Ave.

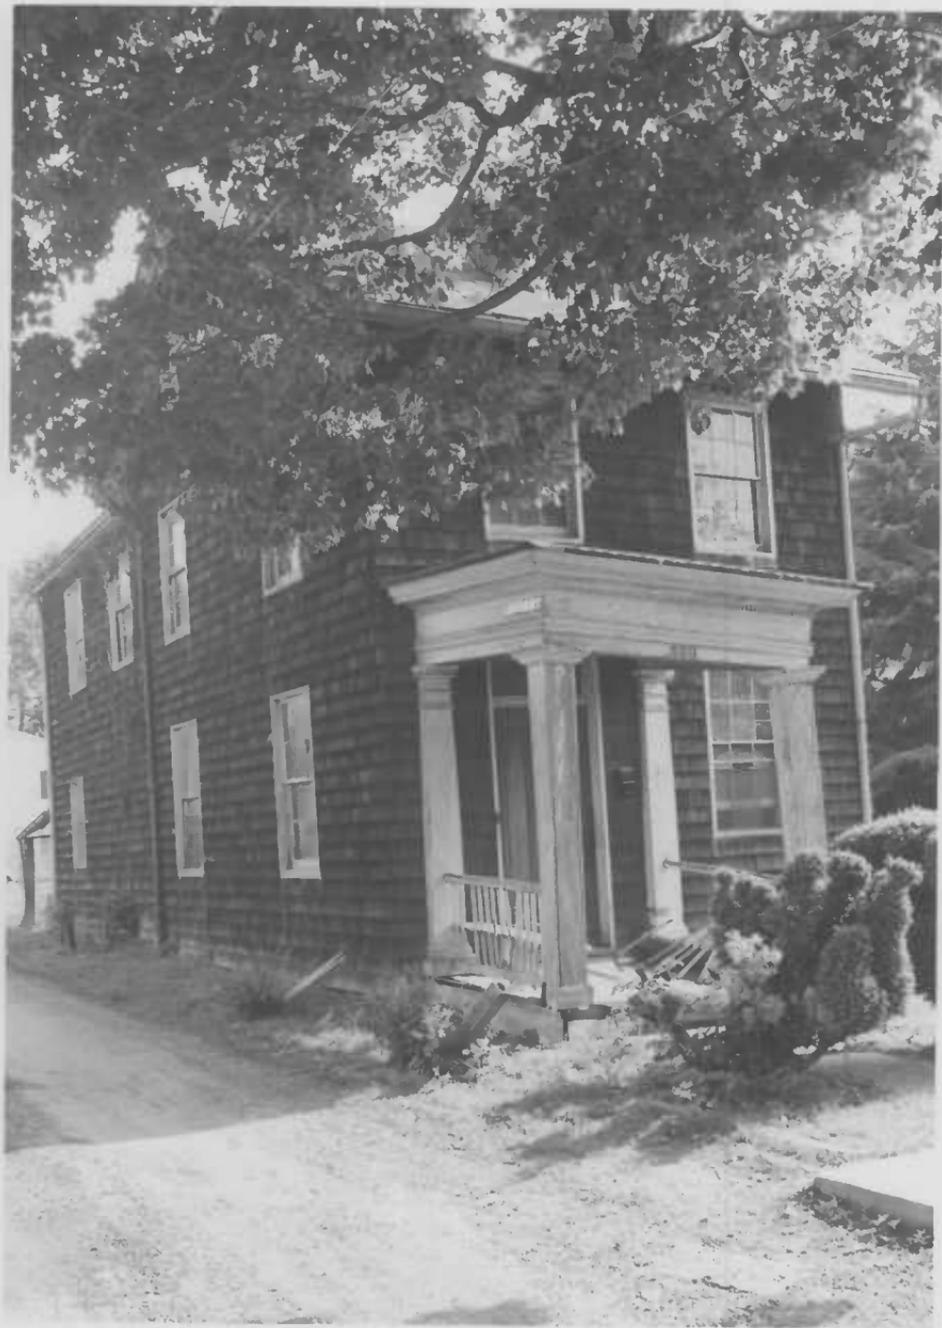
N. E. Elev.

The Greek Revival portico sheltering the entrance in the east bay, front elevation is in perilous condition. It has a flat roof with a molded cornice, dentil band and a plain frieze barely supported by square pillars with balustrades-most of their balusters missing, on each side. The porch's wood floor is also falling in.

Quirk House  
N. E.

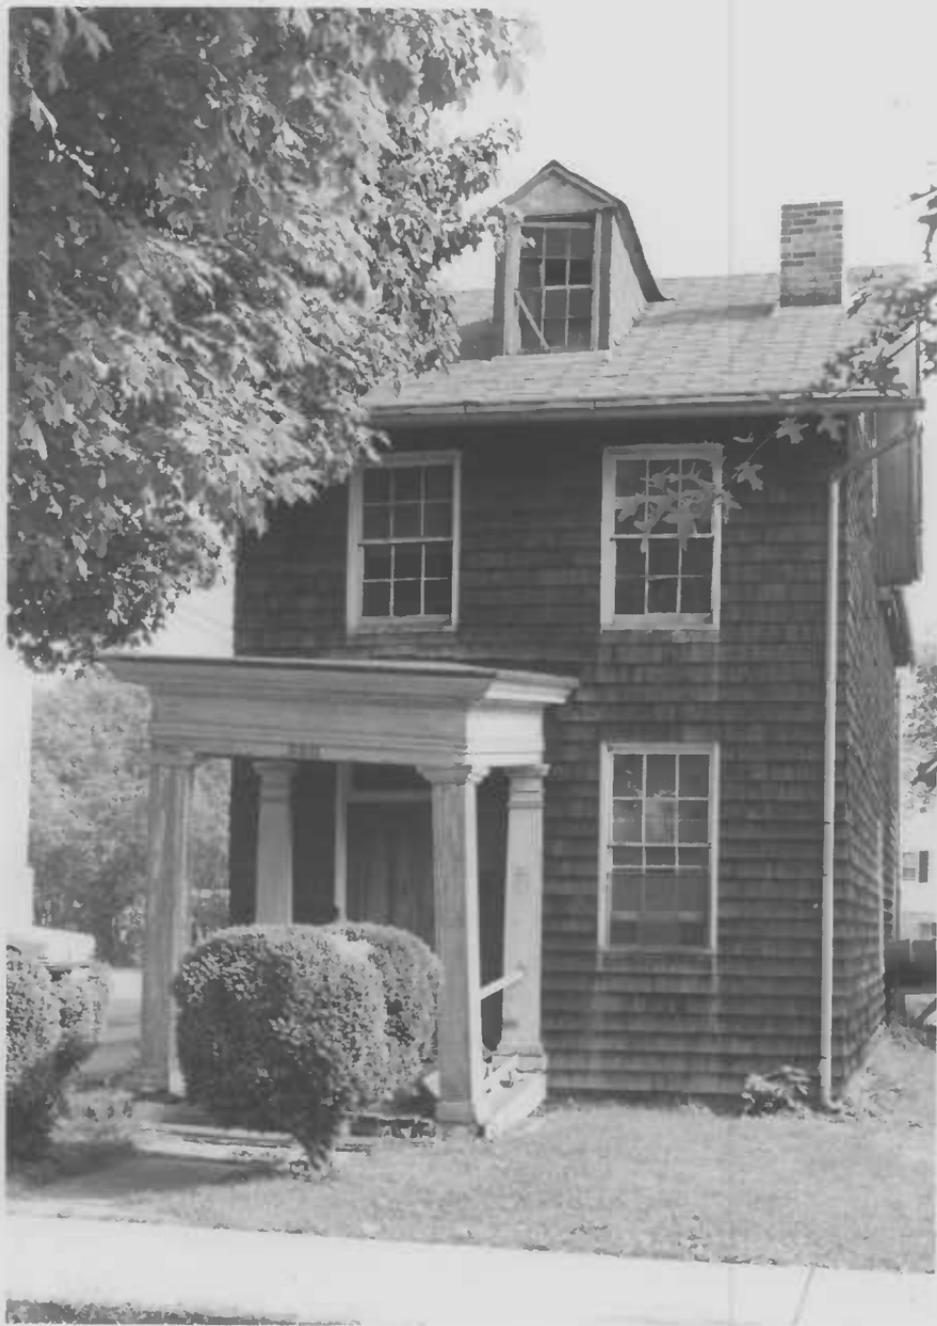
N Facade

550 Congress Avenue is a two and a half story two bay by two bay frame dwelling (c.1858) with a two story wing flush with the rear wall. Built in a vernacular Federal style, the house is in very poor condition and covered with brown wood shingles. The front of the dwelling faces north on Congress Ave., while the east elevation runs along Freedom Alley.

Quirk House  
North f.
