INVENTORY FORM FOR STATE HISTORIC SITES SURVEY

William Silver Farm

Glenville Cross Road

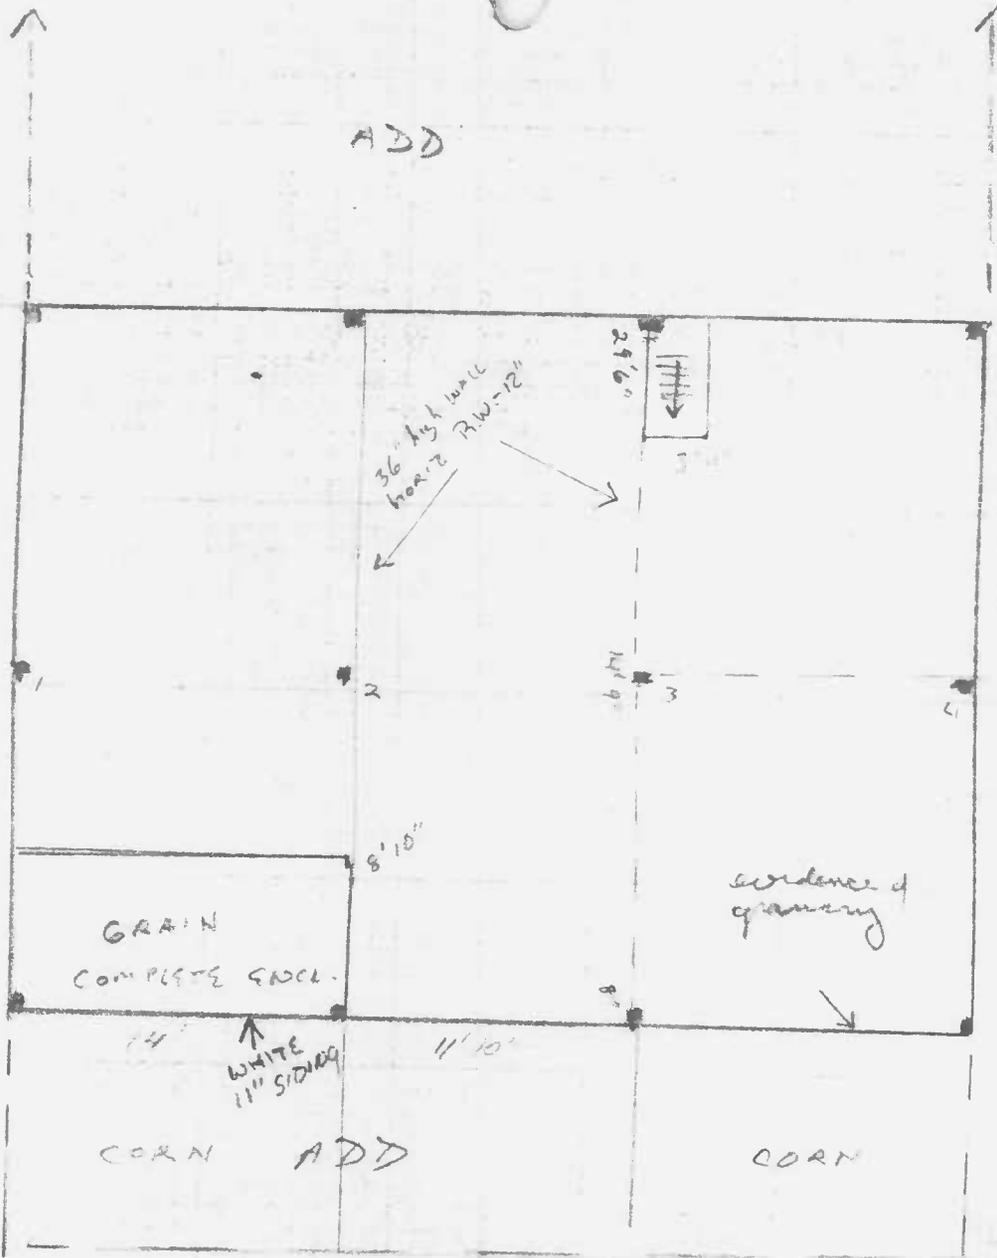
SUBJECT Silver Barn

36" high wall  
Horiz R.W.-12"

GRAIN  
COMPLETE ENCL.

14' ↑  
WHITE  
1" SIDING

evidence of  
granary

4" posts

loop end straps  
FROM ORIG DOORS

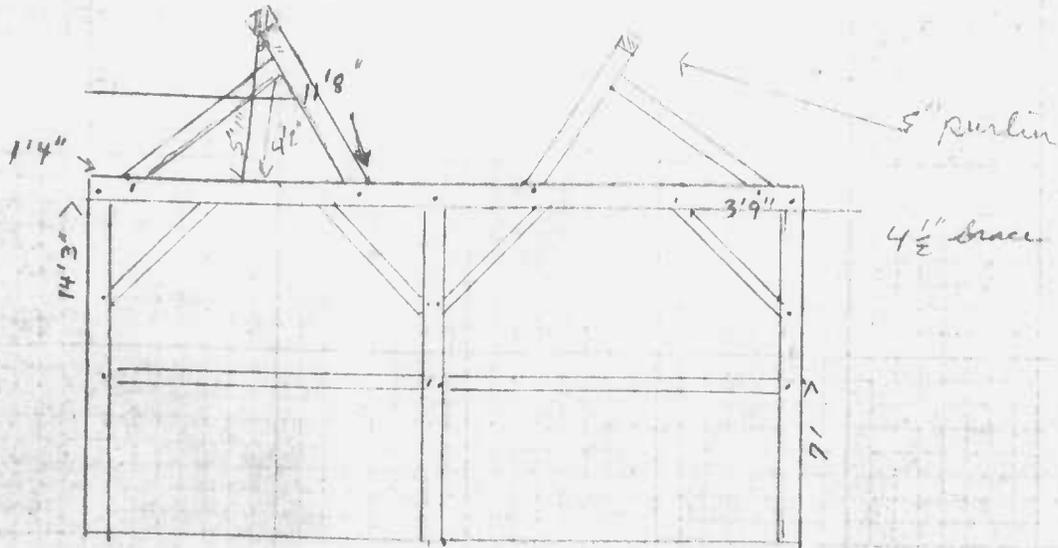
SUBJECT Silvers  
Bent # 3

The bank barn has a stone lower portion which originally probably had a byre and stable. The end supports curve inward and with the extended puncheons create a cantilevered overhang on the west side.

The upper level is a post-and-beam construction providing a single large room that is subdivided for granaries and the mow.

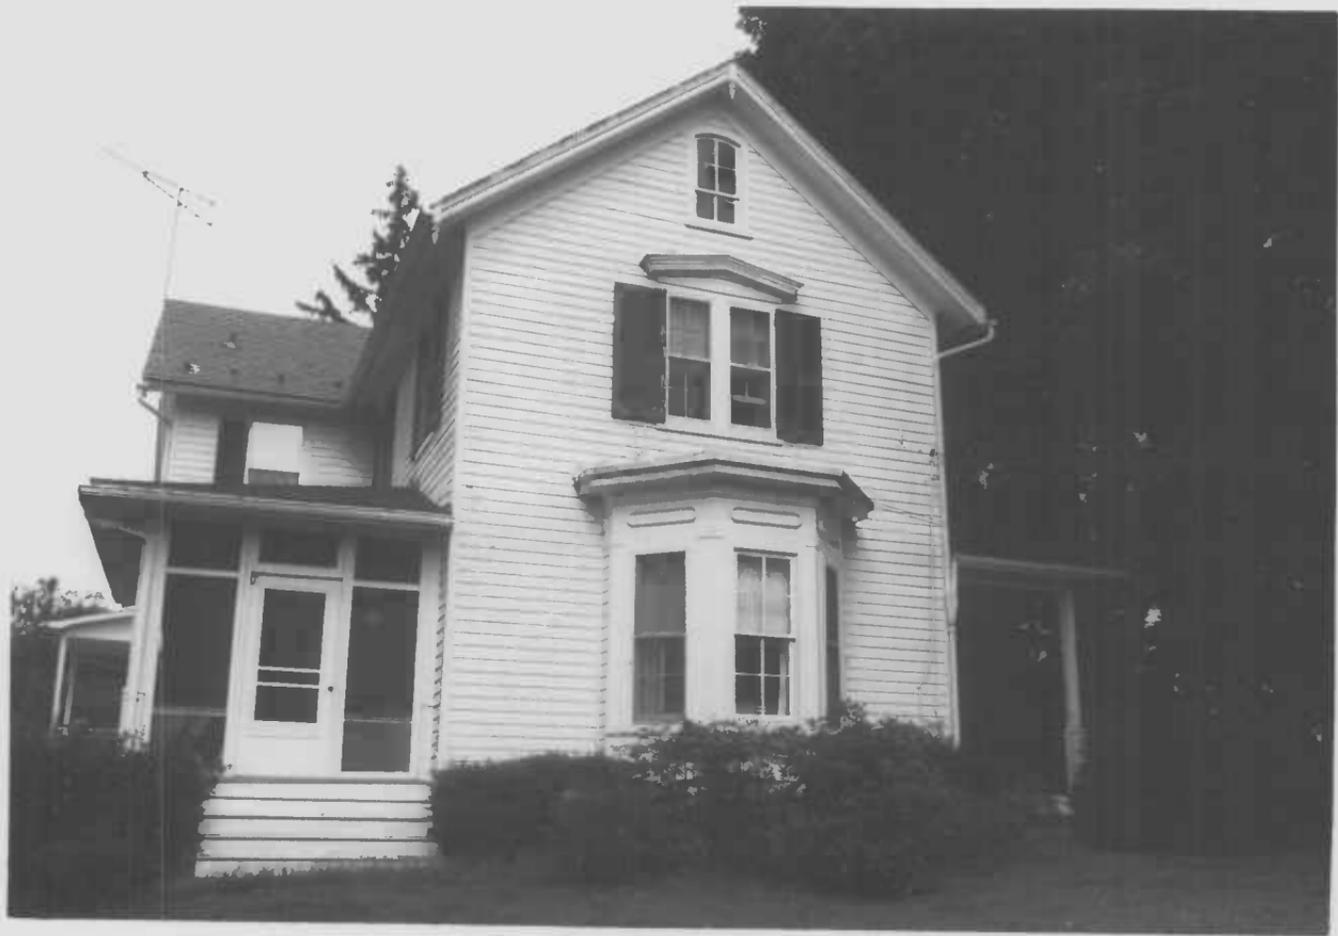
Phillip R. Lord  
South

When the south wing is viewed from the south it is obvious that the design of this area is very conscious of light and air. There are porches on both sides and many light catching devices. There is a polygonal bay window on the first level that is made decorative by raised loops and sunken panels similar to the Italianate door on the west side.

The second level is vented by a pair of tall 6/6 sash that exist beneath a pedimented hood mould.

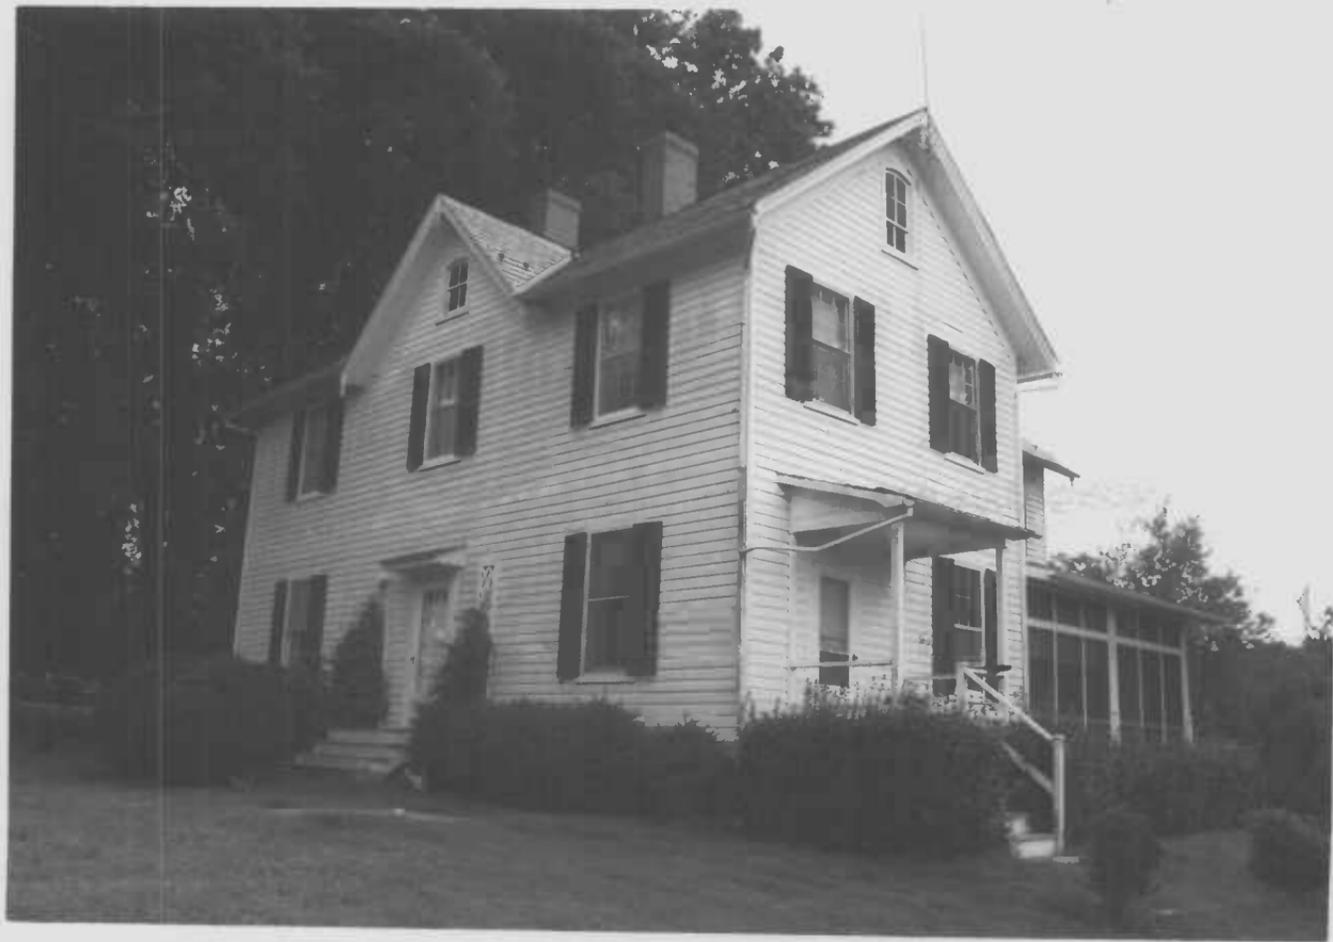
North

This was the main facade and its missing porch is documented by a tin-type photograph in the possession of the present owners, the Silvers; they relate the detailed "ginger-bread" which decorated it and the other porches.

This is a three bay facade centralized by the placement of the entrance as well the cross gable. The entrance is surrounded by moulding with an exaggerated seeding and bulls eye corner blocks. The cross gable is of the broken pediment variety although it is not integrated into the cornice line so much as it interrupts it by protruding downward 6-8". The ends of the cross gable and all of the other gables are decorated with pendants.

The gable is vented by a 2/2 sash window with a segmental arch.

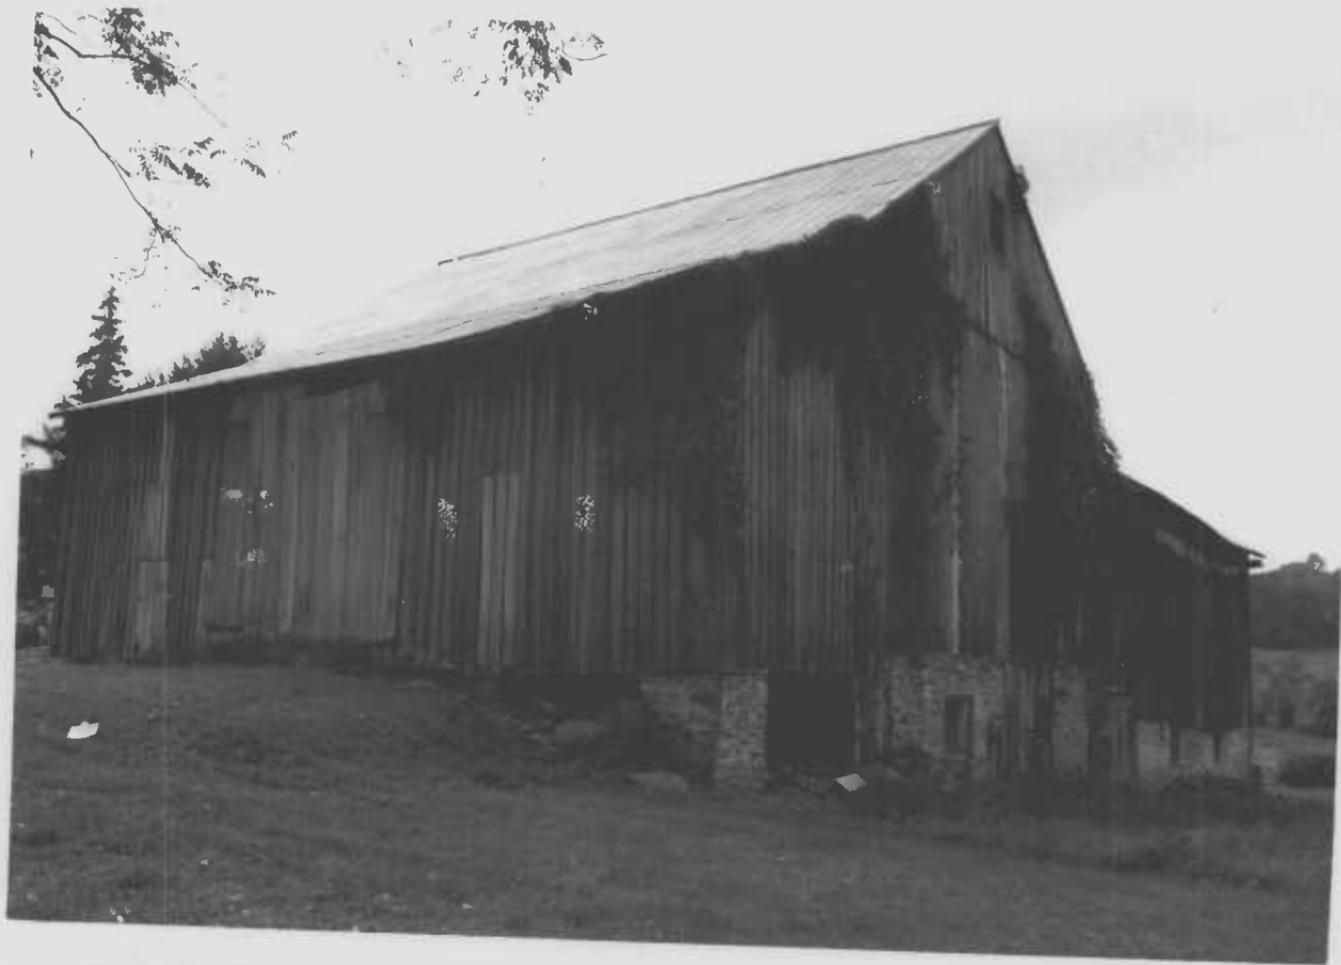
Barn

This huge barn consists of a post-and-beam bank barn that was doubled in size by an addition. The upper levels of each section are mows and the lower areas for animals. Each has been converted in modern times specifically for keeping horses.
