HA-1596

J. Street Farm
Rt. 24
Rocks, Maryland

INVENTORY FORM FOR STATE HISTORIC SITES SURVEY

Description Continuation Sheet #1

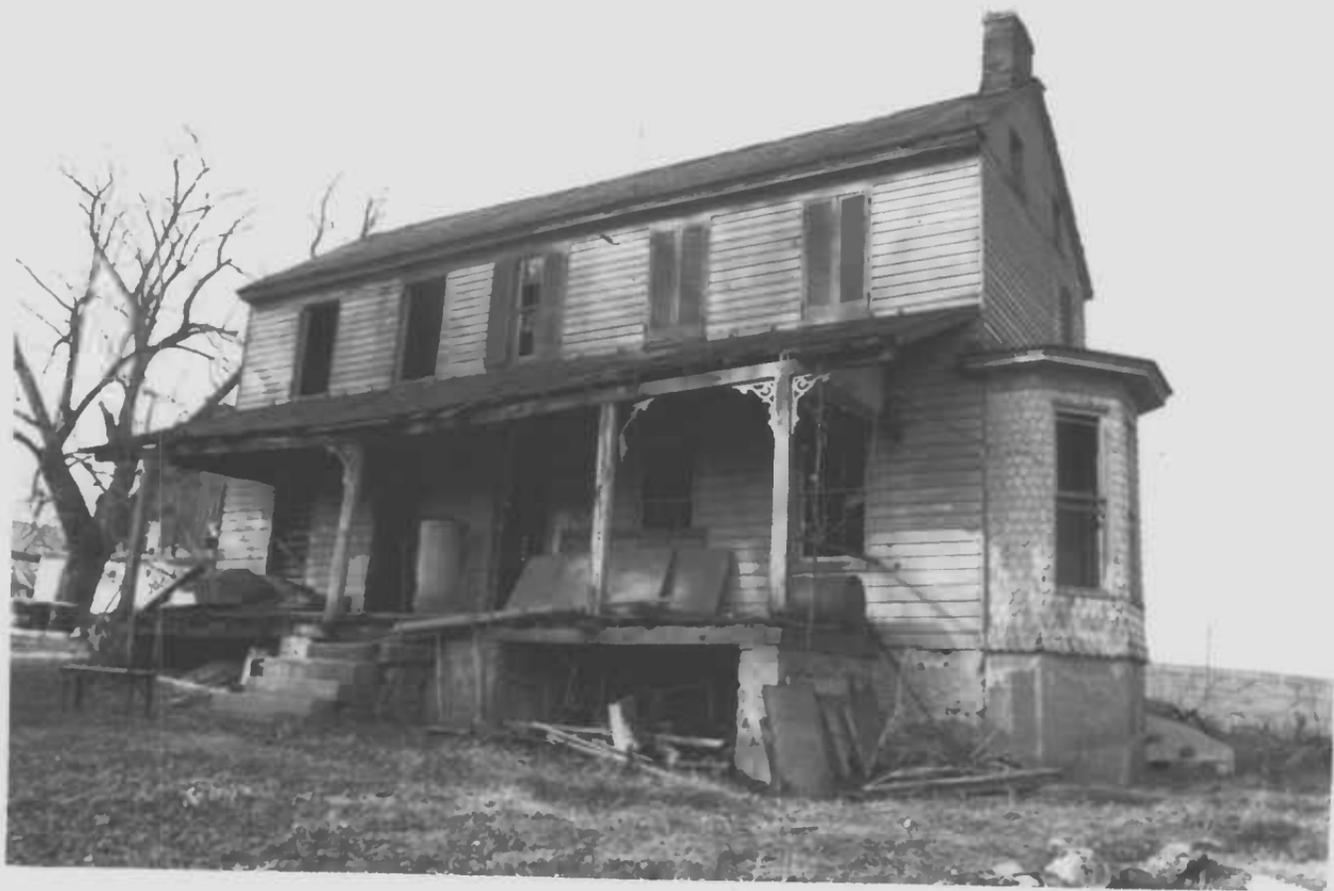
Abandoned Farmhouse - South

The house sits on a rubble foundation and is 5 bays wide (42'3") by 2 bays deep (18'3") with a slate shingle gable end roof. An interior brick chimney rises through the east gable peak. A 2-story log bank house, measuring 22'X19' was attached at the northeast corner, but has been demolished, with some of the materials left lying in the basement space. A 1-story polygonal swell with 3 1/1 windows and a shallow pitch metal roof was added at the southeast corner. This has a concrete foundation, and is covered with wooden covebutt shingles.

The southwest elevation has a center entrance window-window-door-window-window plan, with 5 symmetrically aligned windows in the 2nd story. Above the door is a 4 light transom with a simple architrave moulding. A one story shed roof porch runs across the southwest elevation, supported by 4 1/2" X 6 1/2" chamfered posts which are mortised into the porch sill and plate. There are decorative sawn wood brackets at the juncture of the posts and the plate. The porch floor is supported by 4 rubble knee walls, and the floor is of 3" tongue and groove planks. The porch steps are large stone monoliths 9" X 14" X 5', laid on top of one another. The porch sills, plate, and joists are all hewn. The entire porch area was painted "barn red".

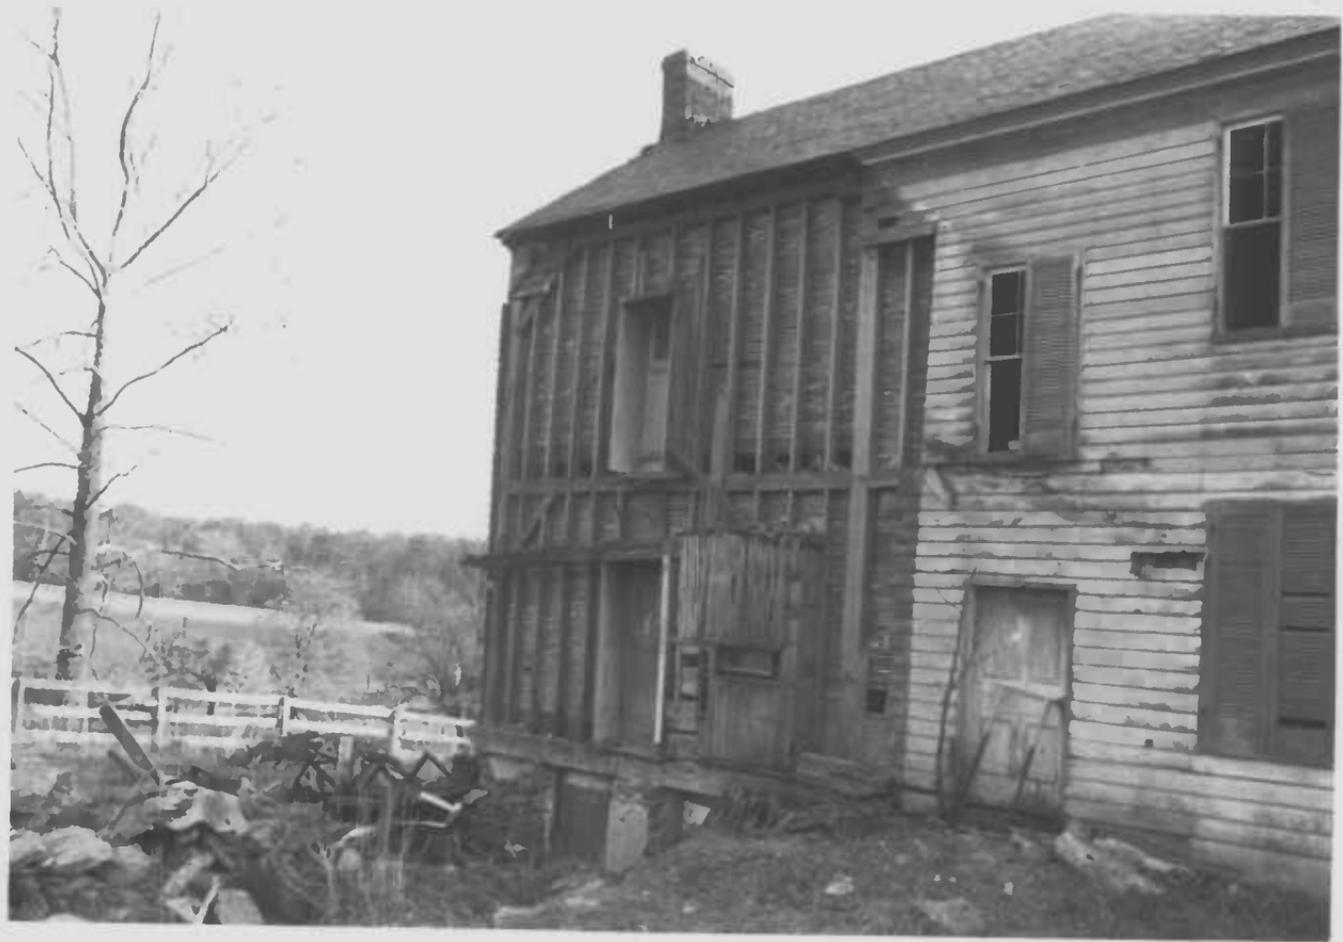
Abandoned House - Northeast Corner

The north elevation has symmetrical fenestration in the west bay (door-window-window) but in the east half, has only entrances at first and second floors, which served to connect the later house with the now demolished log section. This log section was approximately 22' X 19', 2 stories in height, and apparently had a longitudinal plan (see HA-1585). The remains of a massive interior end chimney, 4' X 8' 6" are visible in the north end. Wall logs measuring 10" - 11" wide by 8" thick, with V-notches were also observed. A portion of the mantle trim was found, and it contained cut nails. A double struck nail was found in one log, which probably held an earlier piece of trim. Plaster was observed at the first floor level. In the vicinity of the log section, many pieces of a fused glass-like substance were found, ranging in color from dark green to black, and having apparently been created by some man-made process. The current owner as well as his son recall these objects as always having been there.

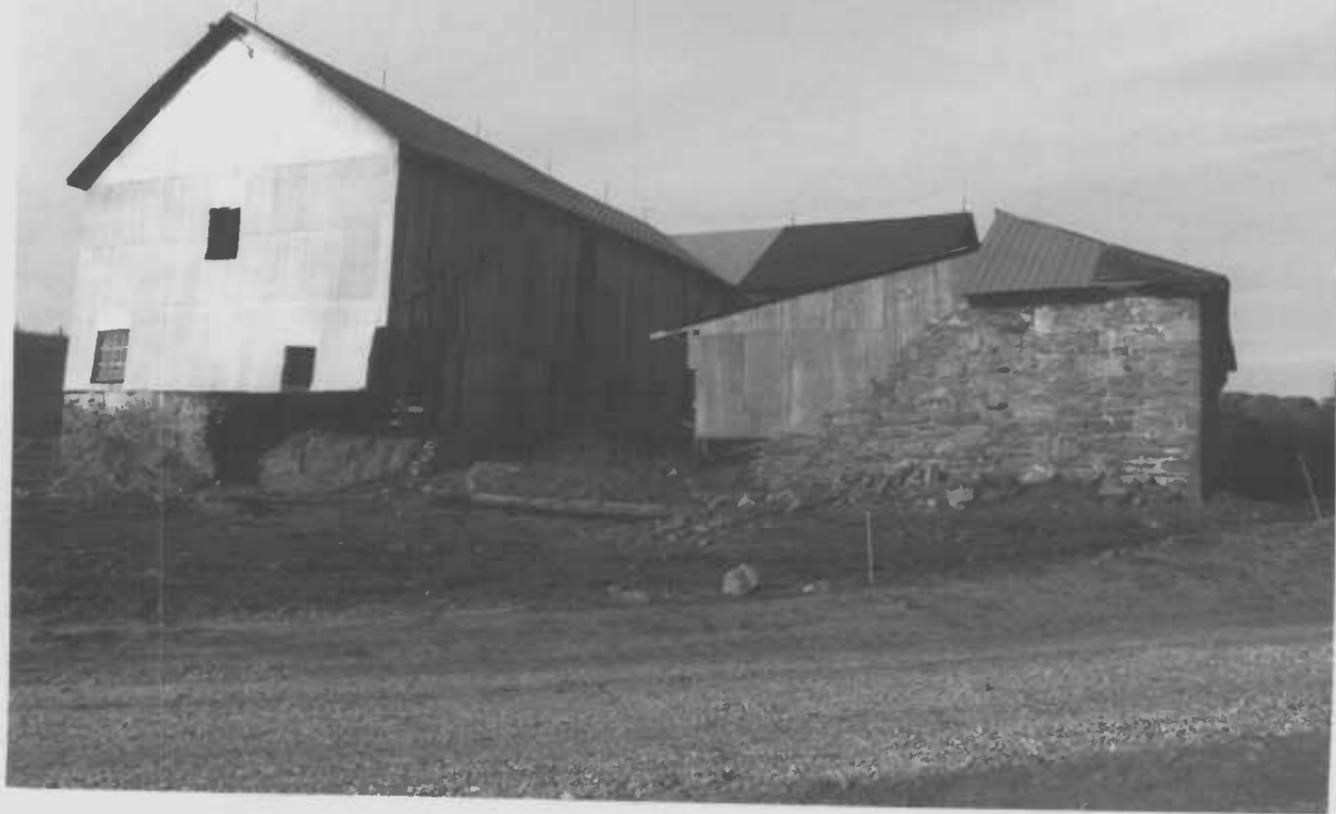
J. Streett Farm
Rocks, Maryland
Phillip R. Lord 11/80
Barn Complex - South

There are at least two periods to the oldest barn represented by two distinct sections. Section "A" is a two story post-and-beam structure which has much replacement material. Its lower portion was designed for milking cows while the upper level was/is a mow. Alterations to the north end and physical evidence along the south wall of section "B" suggests that this building may have been moved.

Section "B" is a bank barn with a tripartite mow entered from the north and a byre below. It is also a post-and-beam structure on a full story stone foundation. The east-west ridge of this section is at a right angle to the north-south direction of "A". Paint on vertical siding attached with cut-nails is visible on the south wall of "B" both below, above and behind the north plate of section "A". This evidence suggests that this wall was once exposed.

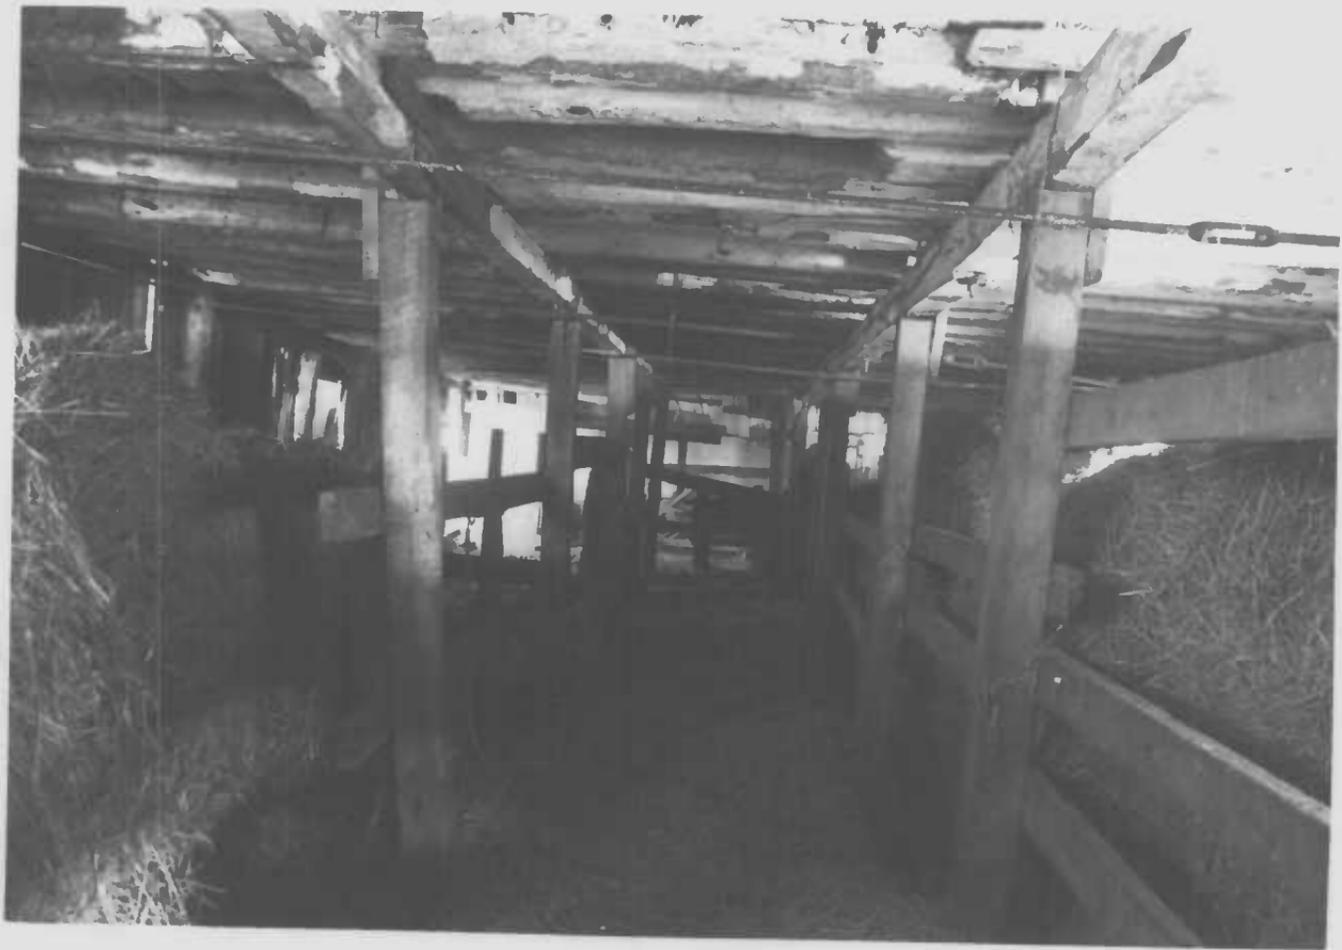
Barn - Bier looking north

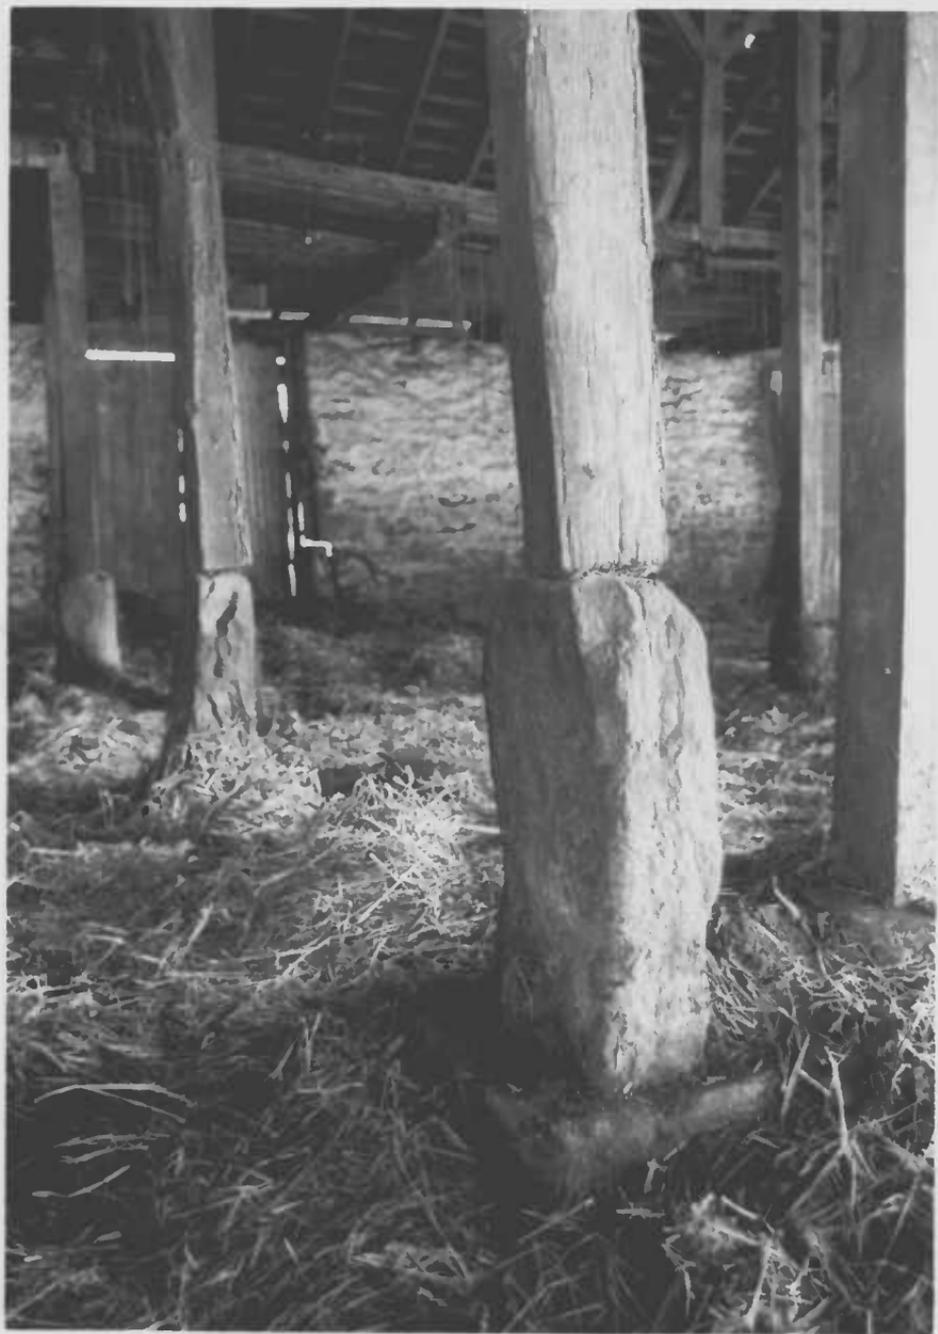
J. Streett Farm
Rocks, Maryland
Phillip R. Lord 11/80
Courtyard - stone pilings

Perhaps the most impressive feature of this complex is its barnyard which is enclosed by a ten foot high stone wall which is 57' long on its south side and 75' on its east side. This latter side has two large access openings. The north, east and south sides are capped by a shed roof supported on the inside of the barnyard by wood posts resting on 2' high stone piers. This partially enclosed area sheltered animals and stored hay.
