HO-176

Glenwood Country Club Building
Glenwood
Private

INVENTORY FORM FOR STATE HISTORIC SITES SURVEY

HISTORIC Glenwood Country Club Building

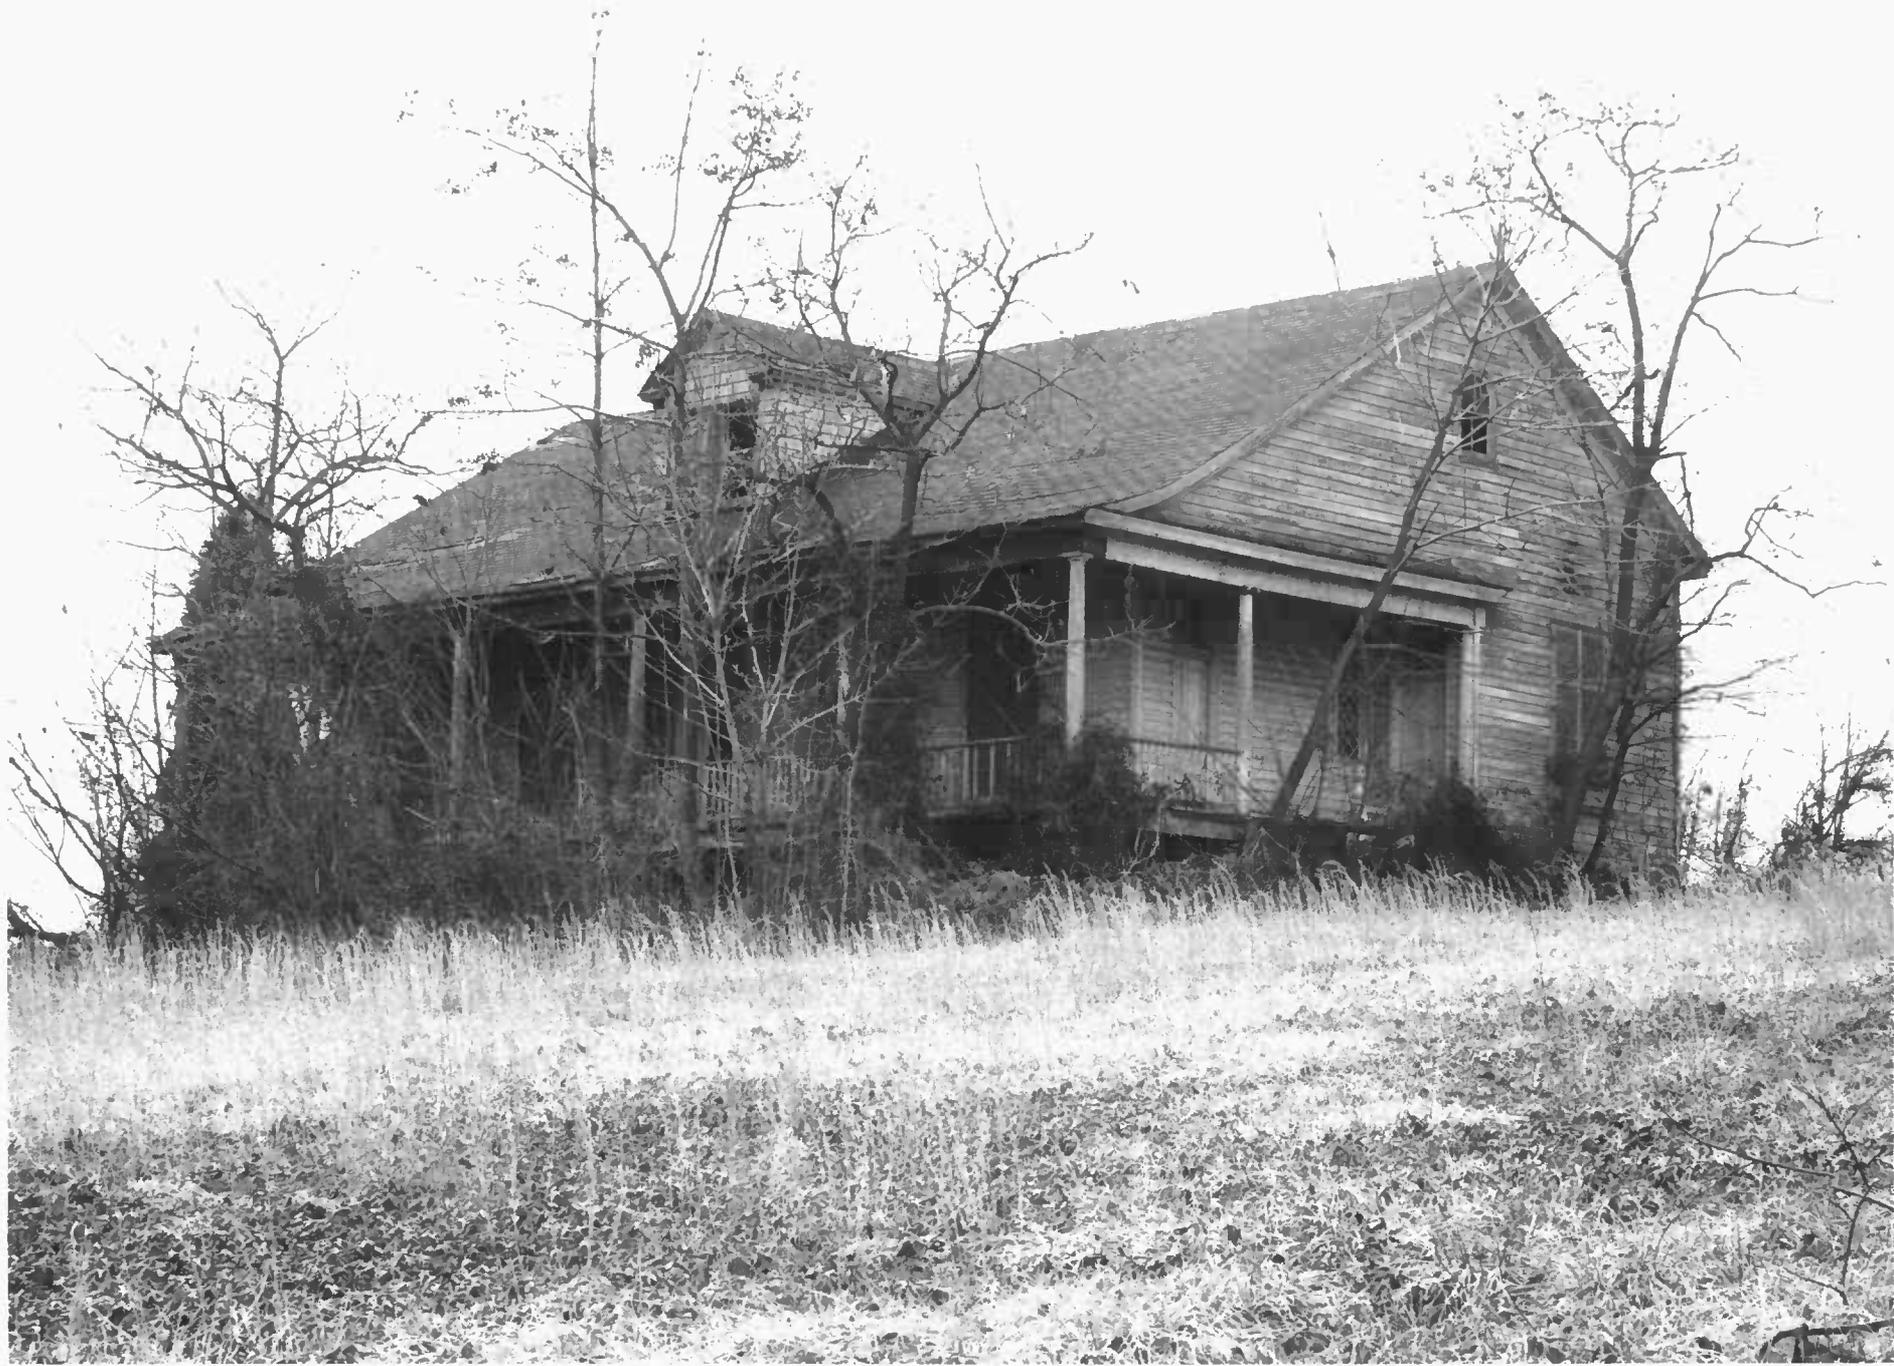
The Glenwood Country Club Building faces east on the west side of Rt. 97, just south of its intersection with Union Chapel Road. It is a six bay wide, two bay deep, one and a half story high, gabled roof (running north-south) frame structure, resting on a stone foundation, with central, intersecting gabled roof (running east-west) dormer window holding a double window on its east elevation, holding four-over-four lights. That on the north side has been broken. Its gable roof on the east elevation slopes downward, creating a one story high, open porch, supported by seven wooden doric columns and two half columns, running along the entire east elevation and half of the north elevation. It is decorated with a simple box cornice.

The east elevation holds a recessed north end bay, holding a rectangular, cross-paneled entrance, decorated by a row of dentils and an egg and dart molding, surmounted by a large, square transom. This door is identical to that on the north elevation, located diagonally across from it.

The recessed east bay of the north elevation holds a rectangular cross paneled entrance door, similar to that on the end bay of the east elevation, which is decorated with a row of dentils and a row of egg and dart molding, and surmounted by a large squarish transom. West of the entrance is placed a tall, rectangular window, featuring diamond shaped and triangular lights. An additional first floor window, similar to that on the south elevation, is found in the west bay, with a roman arched, double-hung, attic window centered into the "A" formed by the gable roof, also repeated on the south elevation.

Due to the dilapidated condition, no examination of the interior was made. The building is placed in the middle of a large meadow and is very close to a state of collapse.

Since it is representative of the Bungaloid style, has played an important role as a social focal point for the Glenwood area, and is presently in a deteriorated condition, it is recommended that this building be considered for inclusion to the National Register, the State Critical Areas Program and any local landmark ordinance the citizens of Howard County may seek to initiate, should its owners so desire.
