HO-369, Pocock's Store I
5721 Main St., Elkridge
Surveyed by: Kristin Hill
February 2003

ADDENDUM

HO-369
POCOCK'S STORE I
Elkridge
Private

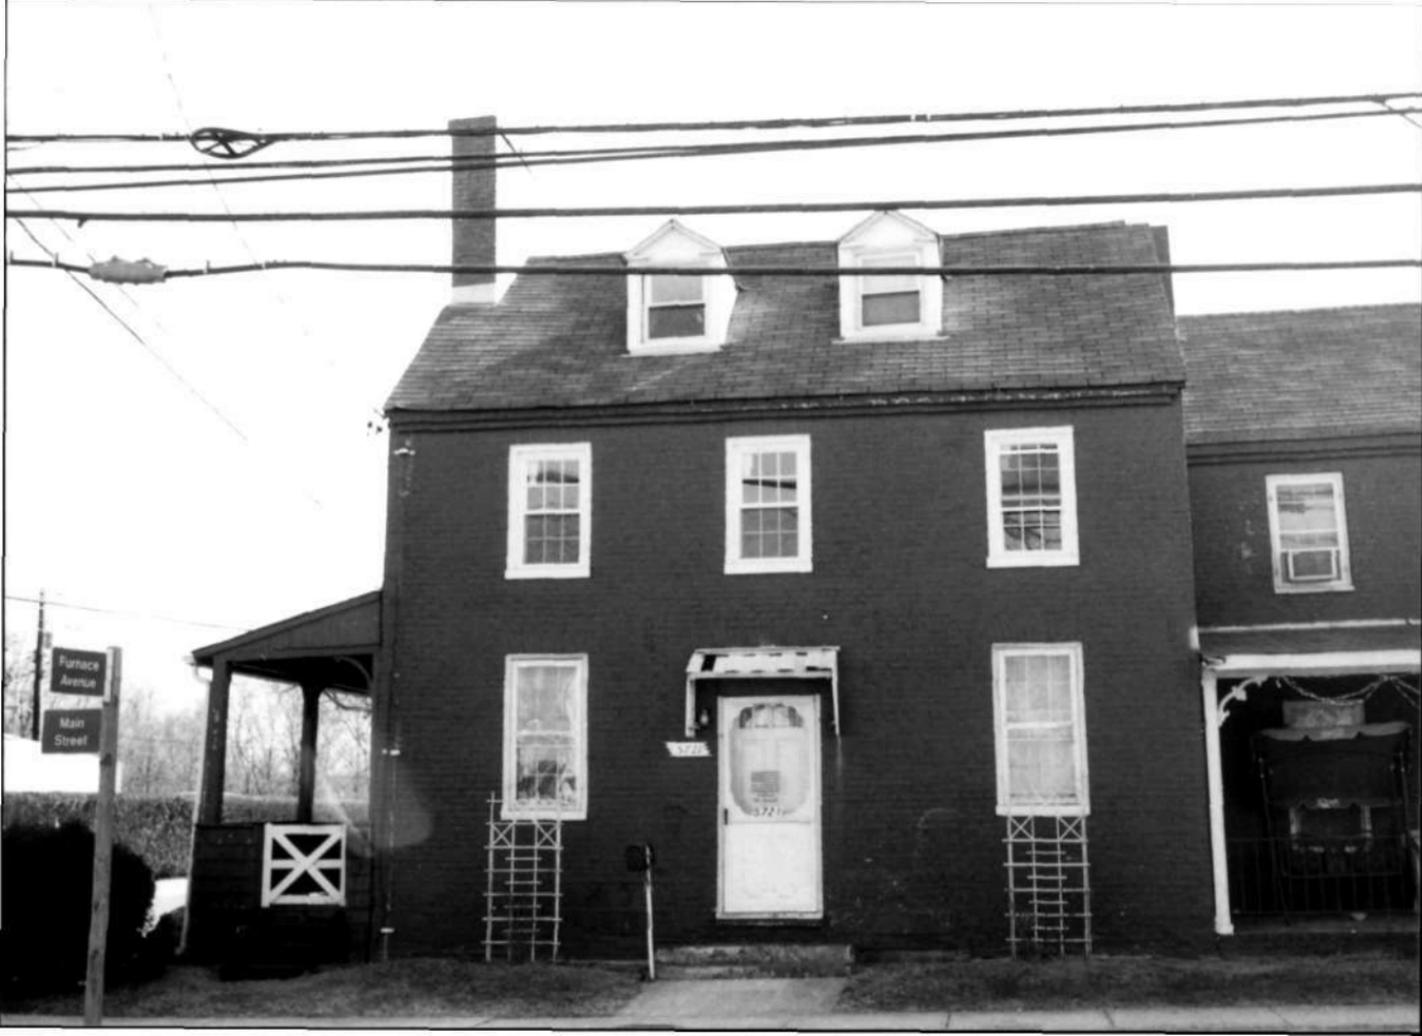
1 of 4

The three-bay front façade of the structure has a central door flanked by two windows on the first story and three windows vertically aligned above the first story openings on the second story. The door is slightly to the left of center, implying that it enters into a room rather than a central hall. The two windows on the first floor, one on either side of the door, are original 9/6 sash and have smooth stone sills which are currently painted white. These windows are covered with wooden storm windows on the exterior. The three windows on the second story are all replacement vinyl with snap-in

muntins. The front entry was originally surmounted by a transom which has since been removed and replaced with a piece of plywood. (In the 1978 photo a four light transom is shown in place above the front door.) There is a modern aluminum screen door covering the existing front door which was not visible. A makeshift aluminum hood currently covers the entry. All the windows and the entry are surmounted by flat brick arches which, along with a simple corbelled brick cornice, comprise the only decoration on this façade. There are two pedimented gabled dormers in the roof with 1/1 vinyl windows. Two flat arches below the first story, one on either side of the front door, indicate that there were originally windows into the basement on the front façade. These openings have been closed but the arches remain. Iron straps near the top of the first story are the ends to tie rods. These straps are approximately a foot high and affixed to the building at their center and possibly at the ends. There is one located on either side of the front door, equidistant from it. There is another identical strap at the same height located to the far right approximately a foot from the western edge of the building. A larger strap is located just below this one.

North (Front) facade

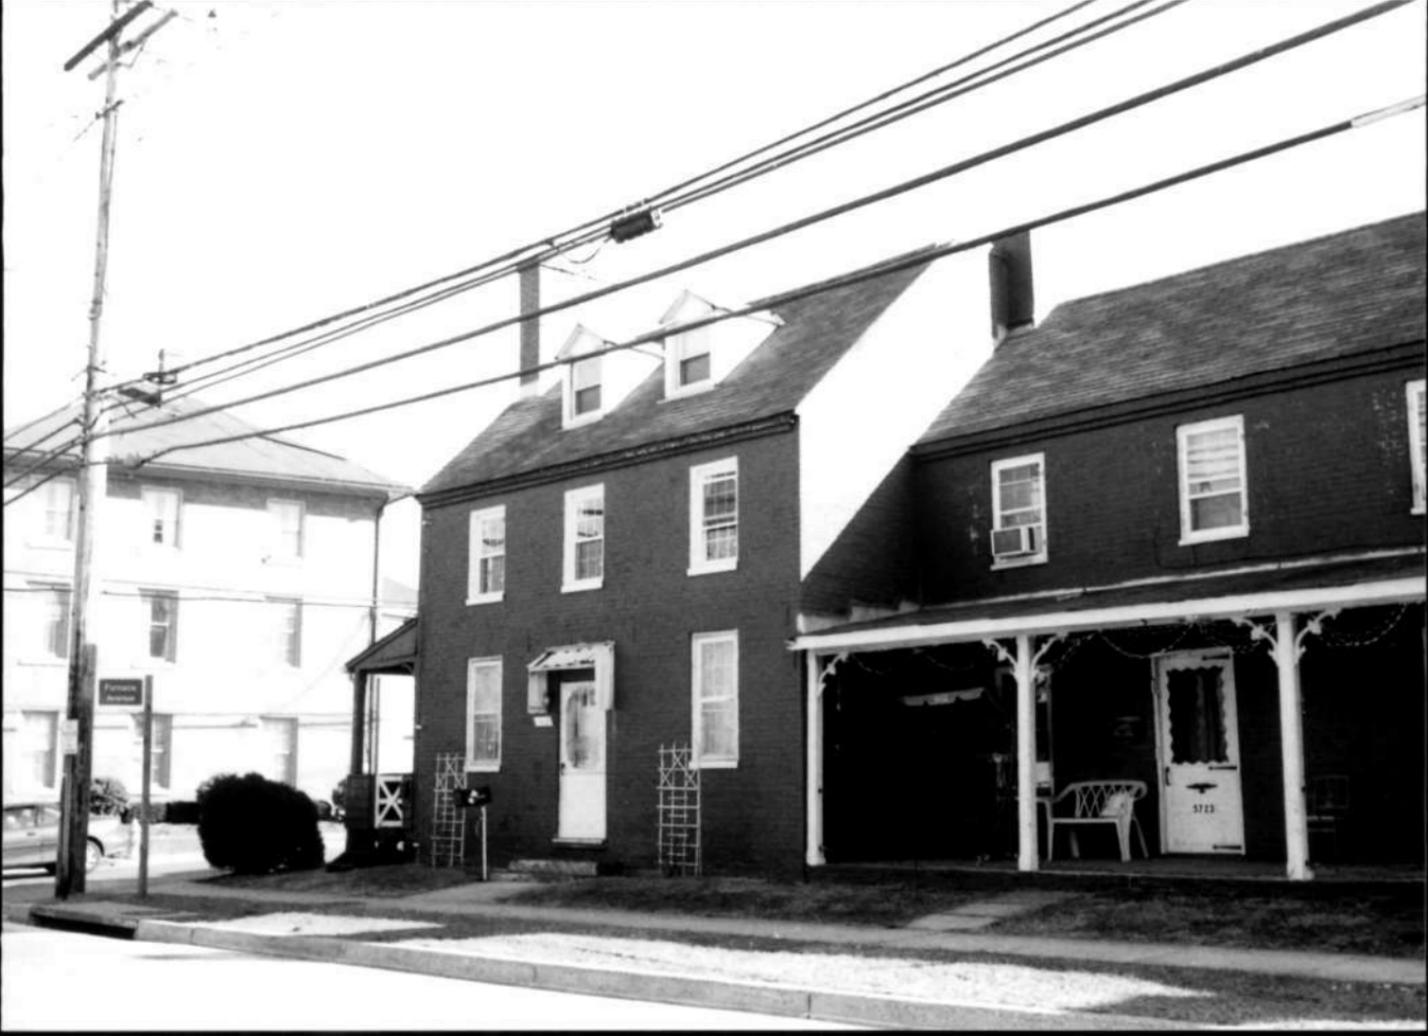
NW facade; HO-370 is on the right in the photo
2 of 4

Most of the western façade of the building is obscured by the adjoining dwelling, but since the front of that dwelling is set back from the front of 5721, about five feet of the western façade is visible. This visible portion reveals two or three closed windows. In the gable end, there is a closed square window set at a 45 degree angle surrounded with headers. This opening may be original, but many coats of paint on the exterior of the building make it difficult to discern differences in mortar or brick color that would indicate an alteration. On the first story there is evidence of a full sized window that has been bricked up and stuccoed over. On the second story, there is an area of patched brick work that indicates some sort of alteration, but the patched area is the wrong size for a window. The patch is only eight courses high but is about three feet long and is located towards the bottom of the second story wall space.

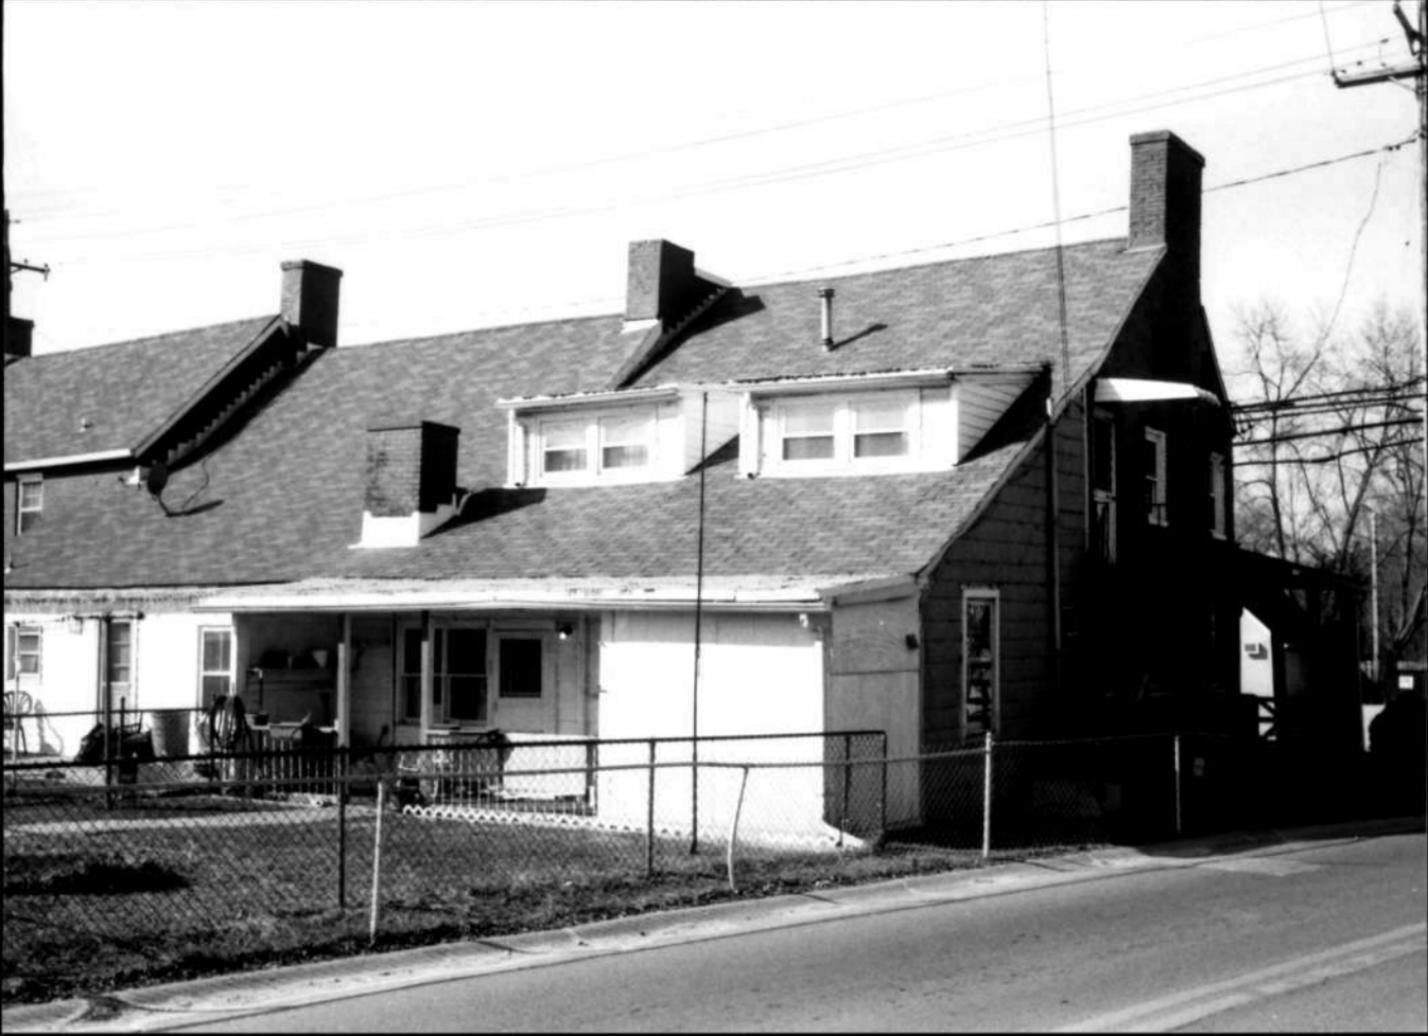
3 of 4

The rear façade is dominated by the shed roofed frame addition which has obscured the original brick façade. Wide clapboard siding covers this side of the frame addition. A relatively recent full façade porch with a very shallow pitched shed roof runs the width of the building. On the first story, this façade has double 6/6 windows, a modern doorway, and a closed doorway with beaded trim. An enclosure of approximately 1/3 of the porch then obscures the eastern most end of this façade. This enclosure is comprised of modern plywood. Two shed-roofed double dormers with 1/1 sash project from the roof of the addition at the second story level. A large, short, square chimney rises from the addition on the western side. Part of this chimney intrudes into the adjoining building next door and the buildings may share the flue. Based on the 6/6 windows, wide clapboard siding, and beaded trim on the closed doorway, the frame addition itself may date to the end of the 19th century, though many modern changes have been made to it.

SE facade

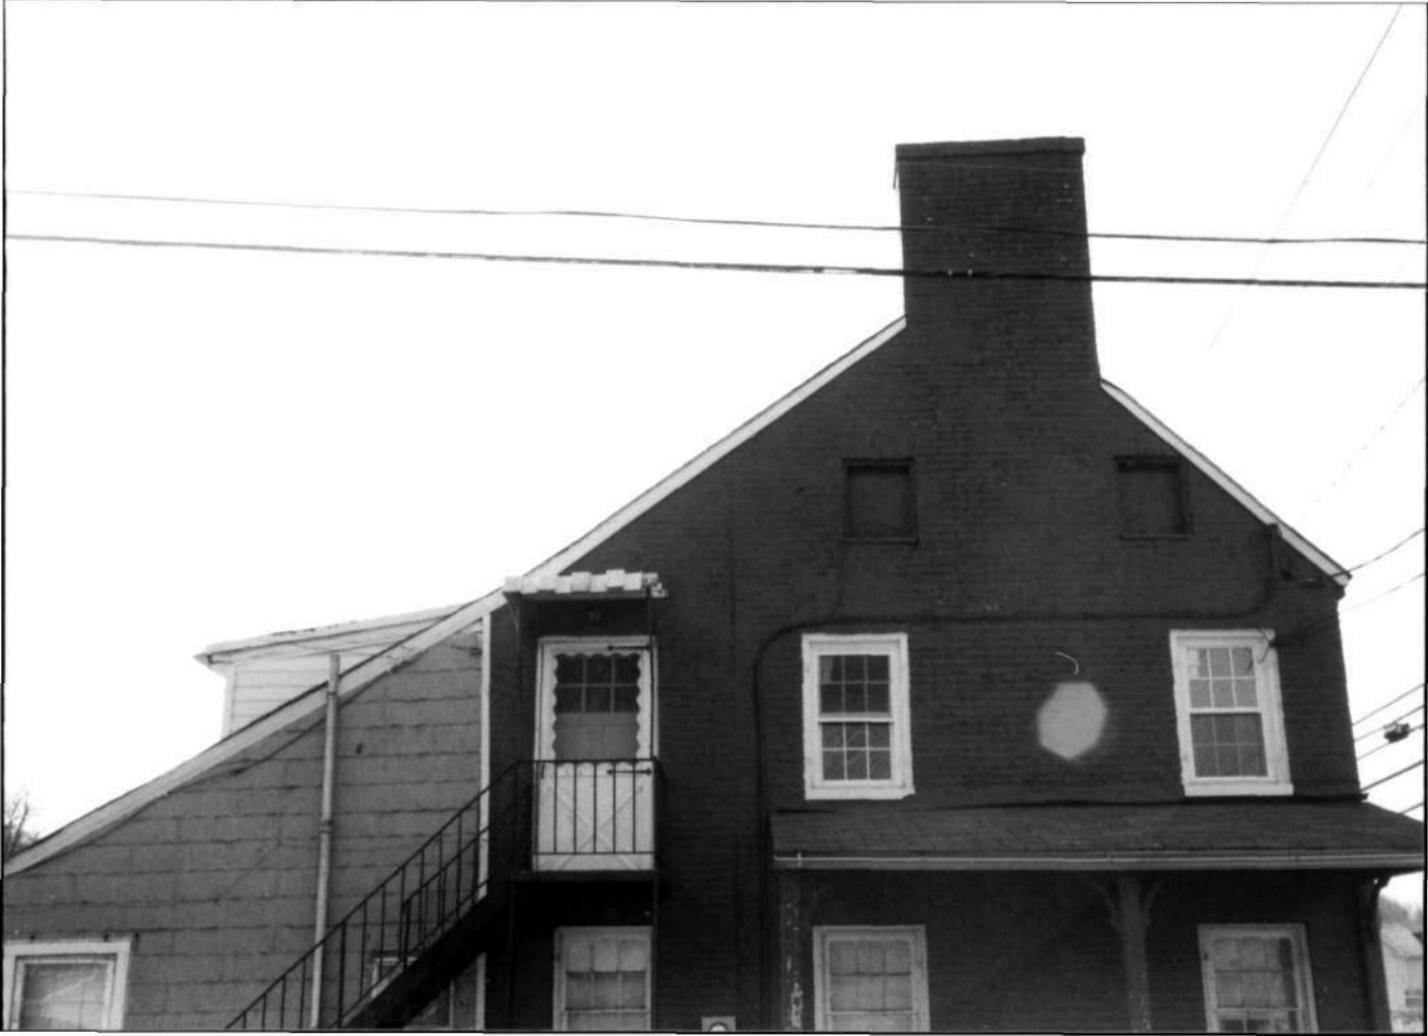
#4 of 4

The east façade reveals that the building has had more than one major addition. This façade shows a three bay brick portion at the front of the house and the frame shed roofed addition, which, on this side, is covered with asphalt shingles with a faux-wood

pattern. There is one 6/6 window and one small rectangular window at the first story level within the frame section. In the brick section, there are three windows on the first story and two windows and a door on the second story. The brickwork around the door opening reveals that it was originally a window. This door is currently accessed by an exterior metal stair. The windows are original wood double hung 6/6 sash on the first story and replacement vinyl 6/6 on the second story. There are two small square window openings in the gable end, one on either side of the chimney. These openings are original but have been closed up. All of the original window openings in the brick portion of the house are surmounted by flat brick arches.

A seam in the brick work running from the ground up to the roof indicates that the rear-most six feet of the brick portion of the building (containing a single bay) is in fact an addition. The brick bond on this entire façade is an irregular common bond in both the original portion and the addition. Prior to the addition, the original building would have been only one room deep with a fireplace centered in the western wall. The use of the flat arch and the 6/6 windows indicates that the brick addition probably occurred fairly early. The roof line is continuous from the ridge of the roof to the rear of the frame addition, but this façade reveals that the chimney is not quite centered in the wall (the edge of the roof meets the chimney at a higher point on the rear of the chimney than it does in the front). The rear pitch of the roof may have been raised when the brick addition was made but no seams or major alterations in the brick work are immediately visible. Once again, the multiple layers of paint may be obscuring the evidence.

A single story porch shades the front-most two bays of the structure on the east façade. The porch sits on cinder block piers about two feet off the ground and is not accessible from inside the house. The porch supports are heavy square posts with chamfered corners and decorative brackets, more reminiscent of the Gothic Revival or Italianate styles than the Victorian, run from the support to the porch ceiling. The supports and brackets on this porch are nearly identical to the front porch on 5723 Main Street (HO-370; adjoins this building on the west).

East elevation
