# Maryland Historical Trust State Historic Sites Inventory Form

Survey No. T-56

historic Wickersham

and/or common Wickersham, Dawson Baker Farm

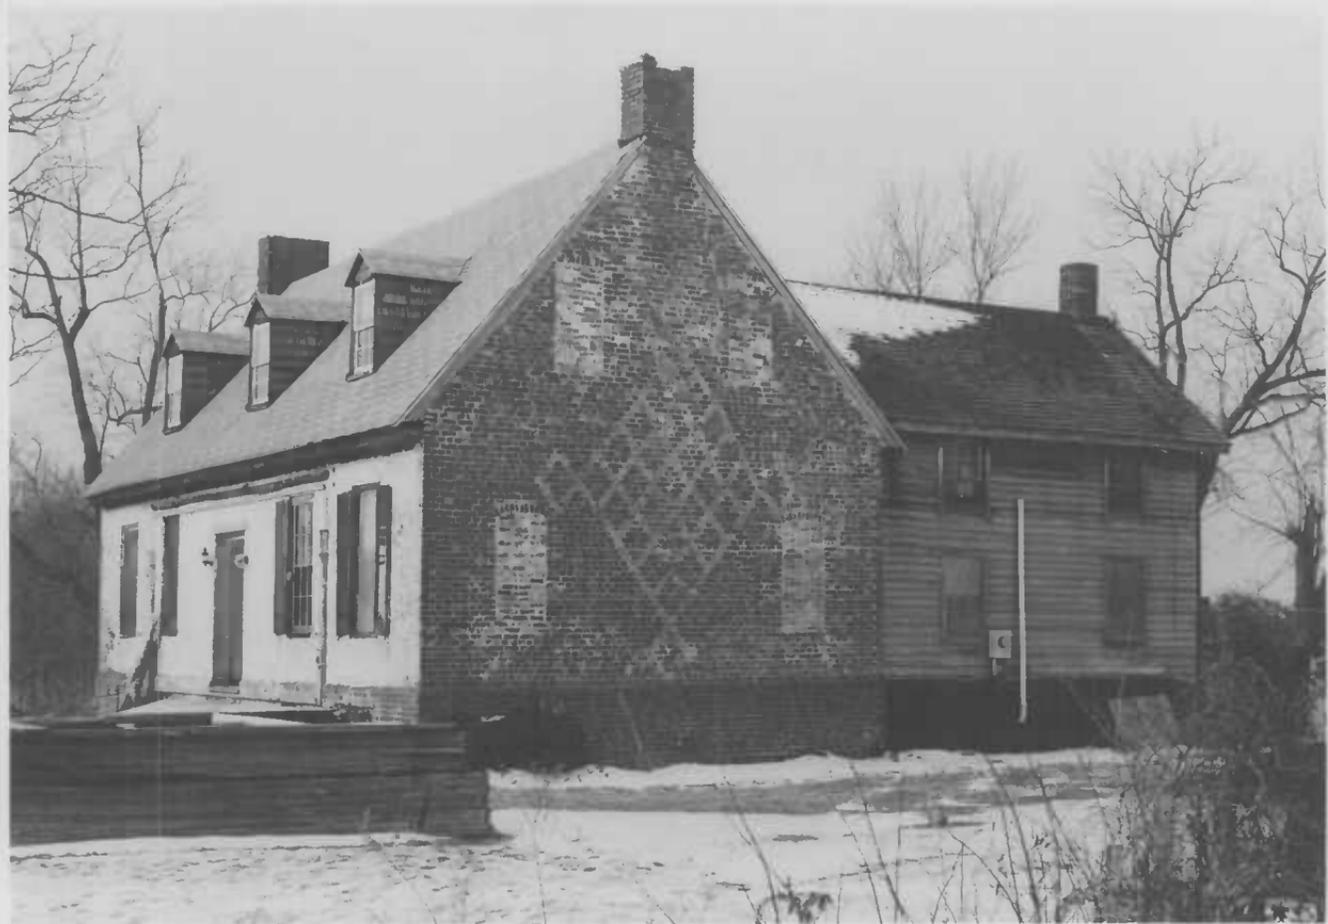
T-56

E. facade (gotta)

The east gable originally had two small windows on both storys which have been bricked in. Between the four windows is a large diamond design in glazed headers. It consists of a large diamond composed of sixteen smaller diamonds with a small diamond at top and bottom. Its design is similar to, though more ambitious than, Orem's Delight on Ferry Neck. Wickersham, also, boasts three bricks dated 1750 on the east gable. One reads only 1750 while the other two have June 26, 1750 and R R 1750 respectively.

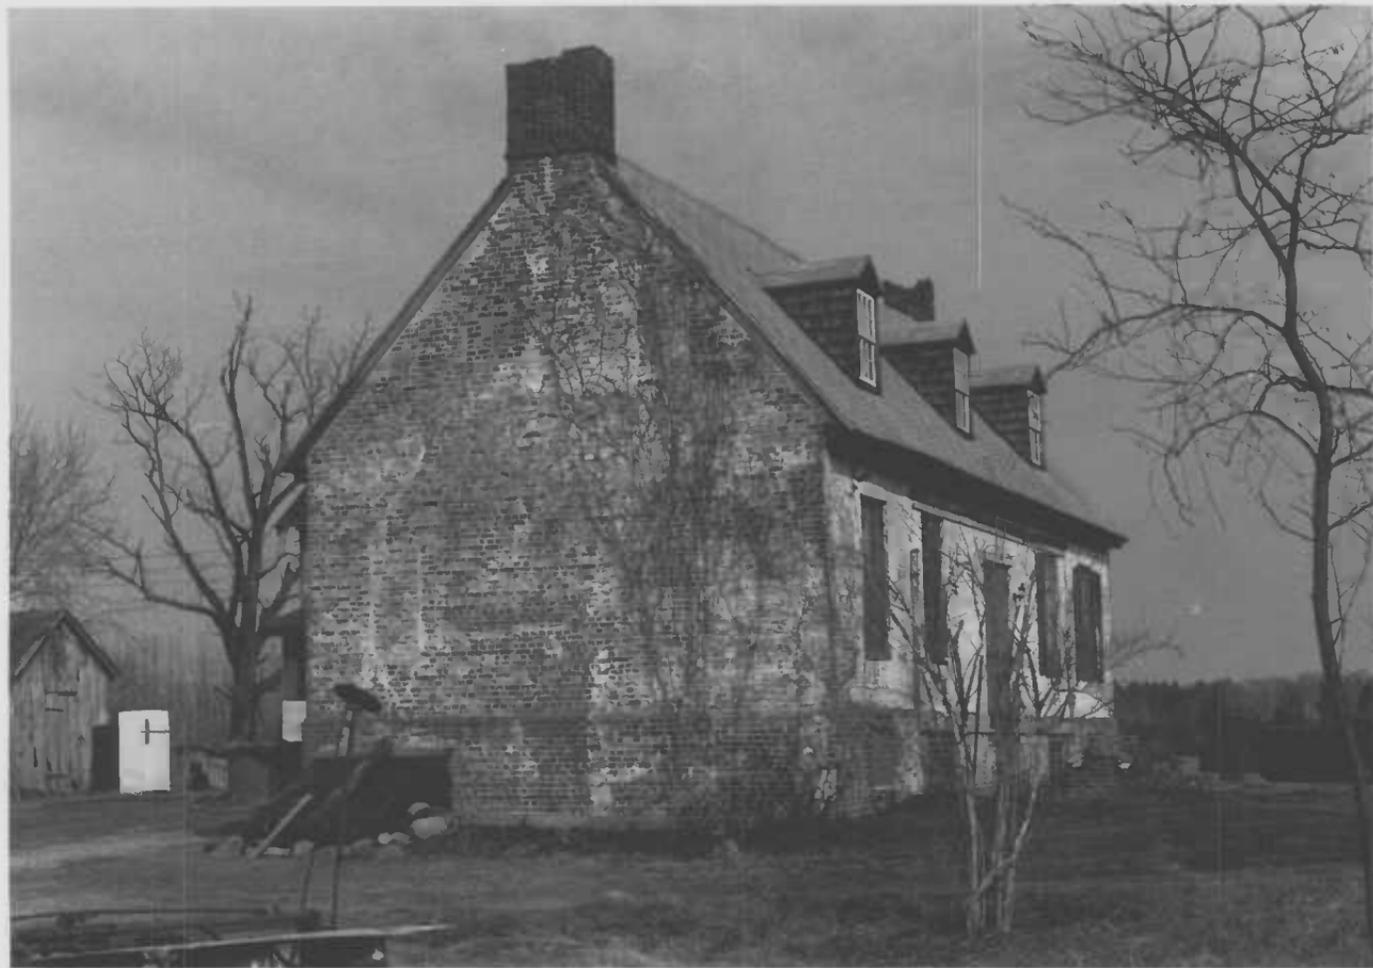
2 of 6

Southwest gable elevation, also

showing south (front) facade.

The brickwork on the west gable facade is laid in English bond above a beveled water table and English bond foundation. The upper gable is laid in three-course common bond. This change in bond is almost certainly original. It is not uncommon for the bonding pattern to change in the upper gable, but this is a particularly early example of the use of three-course bond. A corbeled drip course is carried around three sides of the chimney. The gable eaves are trimmed with beaded and tapered rakeboards.

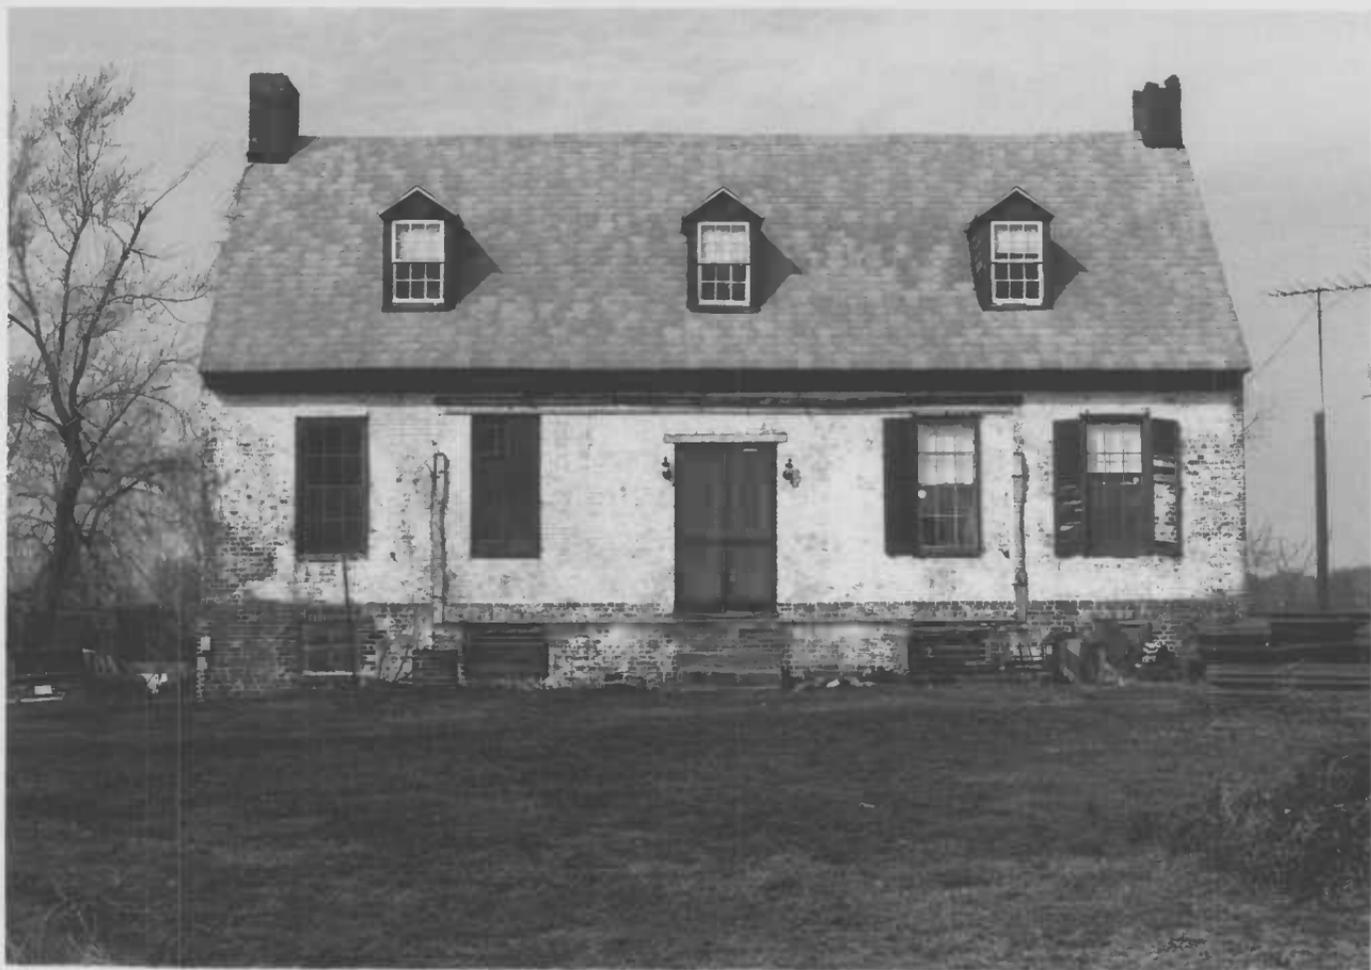
1 of 6

South (front) facade

The front facade, as noted, faces south to the road. A broad, double door is located in the center bay. flanked by two large 6/6 windows on each side. Queen closers are evident on both jambs of the door, and on at least one jamb of each window. The window openings may have been enlarged slightly by cutting them down one or two courses, an alteration implied by the evidence of original interior chairrail above the existing sill level. The dimensions of the original openings are 3 feet 2 inches wide by approximately 6 feet high, suggesting original sash of either 9/9 or 12/12 configuration. There are three 6/6 pitched roof dormer windows on the second story. These date to the Greek Revival period but may replace earlier dormers. Cellar window openings are located below each of the four first story windows; there is no cellar opening below the door. The two cellar window openings flanking the center bay remain undisturbed but the east and west windows have been reduced in size with 20th century brick. The original cellar openings are quite decorative with three-centered brick segmental arches that include alternating glazed headers.

The brickwork on the front facade is laid in Flemish bond above a beveled water table and Flemish bond foundation that changes to English bond for the five courses closest to grade. The cornice is boxed in and trimmed with a complex crownmold applied to a plain fascia and complex bed mold applied to a beaded firze board. The cornice appears to be constructed with machine nails and probably was rebuilt during the Greek Revival renovation of the interior. The dormer windows are sheathed with wood shingles and trimmed with simple Greek Revival details; the roof of the house is covered with asphalt shingles. Louvered wood shutters dating to the 19th century survive on three of the first story windows. They are hung on standard manufactured hinges and are fitted with simple hand forged shutter dogs. Two half-columns survive from a late 19th century porch that extended across the center three bays of the house until a few years ago.

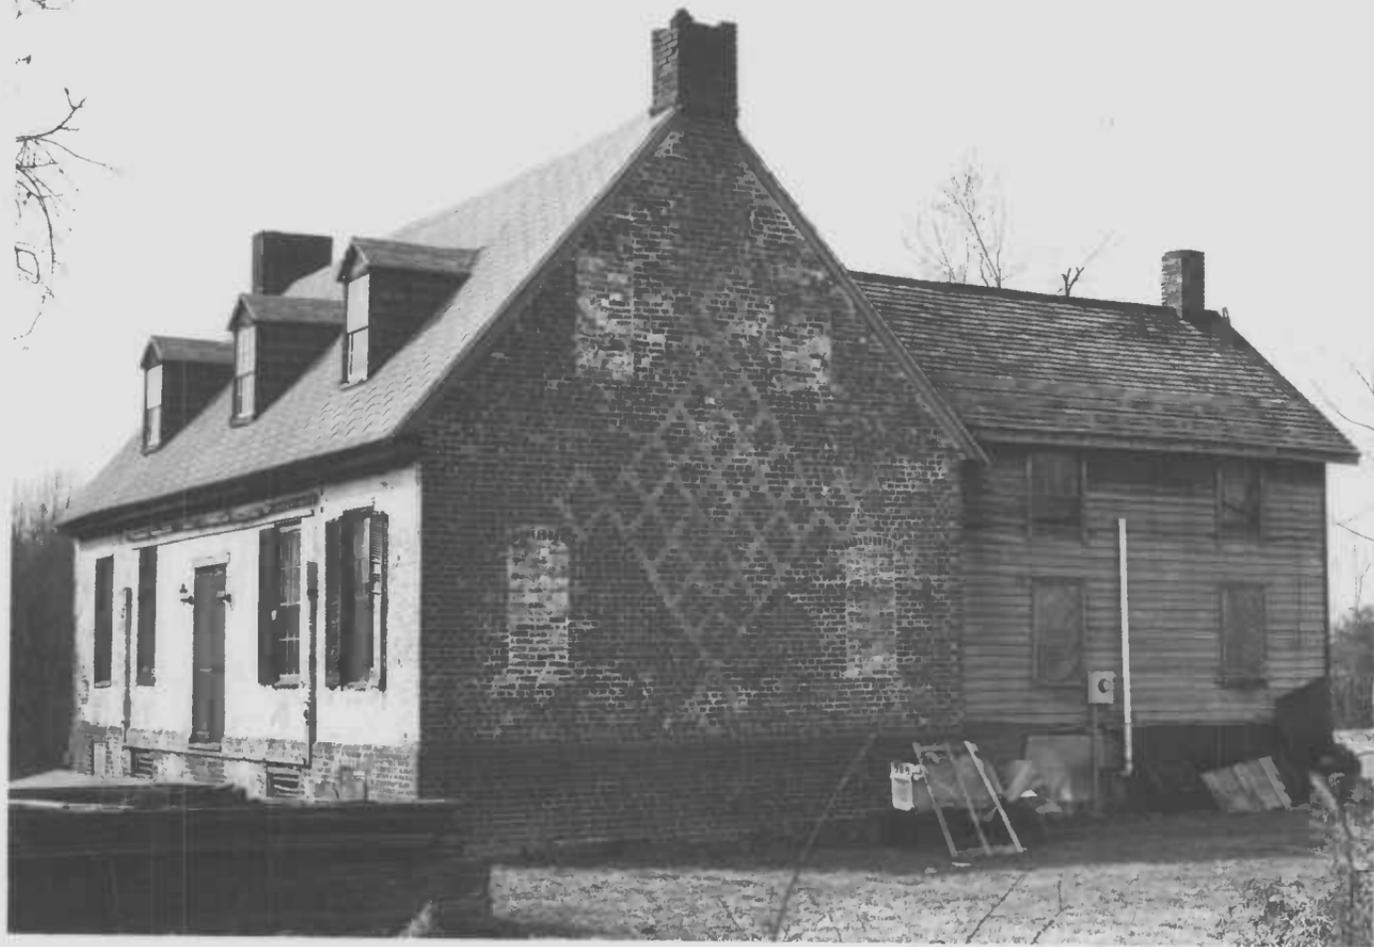
3 of 6

Southeast elevation, also showing

east facade of frame addition.

The rear wing measures 16 feet wide by 20½ feet deep. It rests on a continuous brick foundation and is covered with plain weather-board siding secured with wire nails. The pitched gable roof is covered with wood shingles; the eaves oversail and are boxed in. On the east facade, there are two 6/6 windows on the first story and two 6/3 windows on the second story. A brick stove chimney is centered on the interior of the north gable wall. A door at the extreme east end of the first story is the only opening in the north gable. The next facade is similar to the east facade except there is a door in the south bay, opening into a one story lean-to porch that extends across most of this facade of the wing.

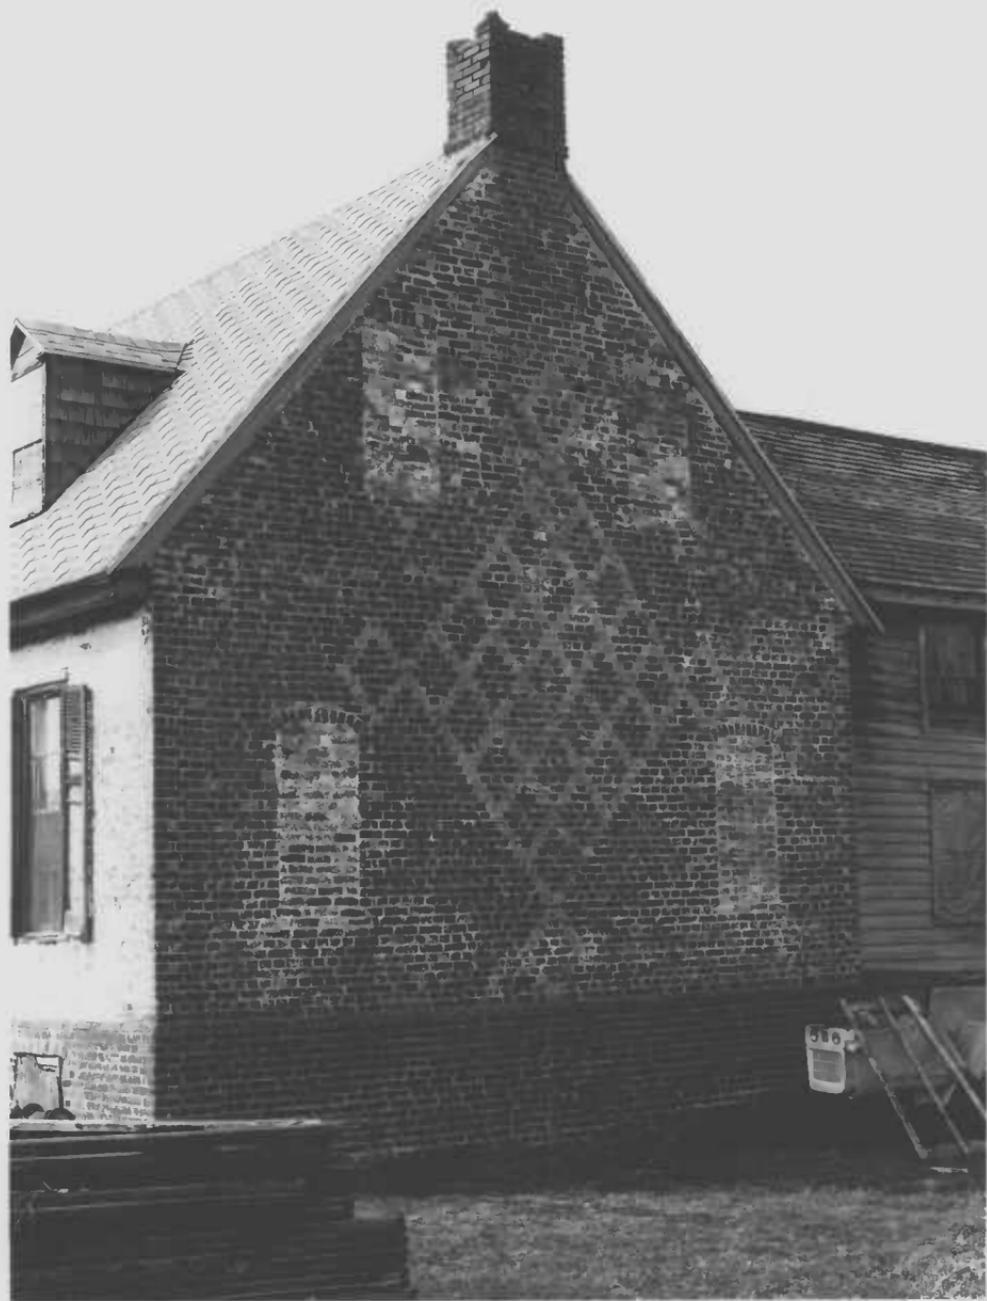
4 of 6

Detail of glazed header diaper

pattern

The east gable wall of the house is embellished with a handsome pattern of interlocking diamonds executed with glazed header bricks. This pattern consists of 29 small diamonds arranged so that 25 of them form a single large diamond with one additional diamond at each corner. This diamond pattern is flanked by a pair of window openings on the first story and a record pair in the upper gable. These window openings are similar to the west gable, having segmental lintels on the first story and flat soldier course lintels on the second story. The brickwork on this facade is laid in English bond above and below the beveled water table; the upper gable is random bond. The chimney on this gable is only a single flue in contrast to the larger double flue chimney on the west gable. The eaves are trimmed with beaded and tapered rakeboards.

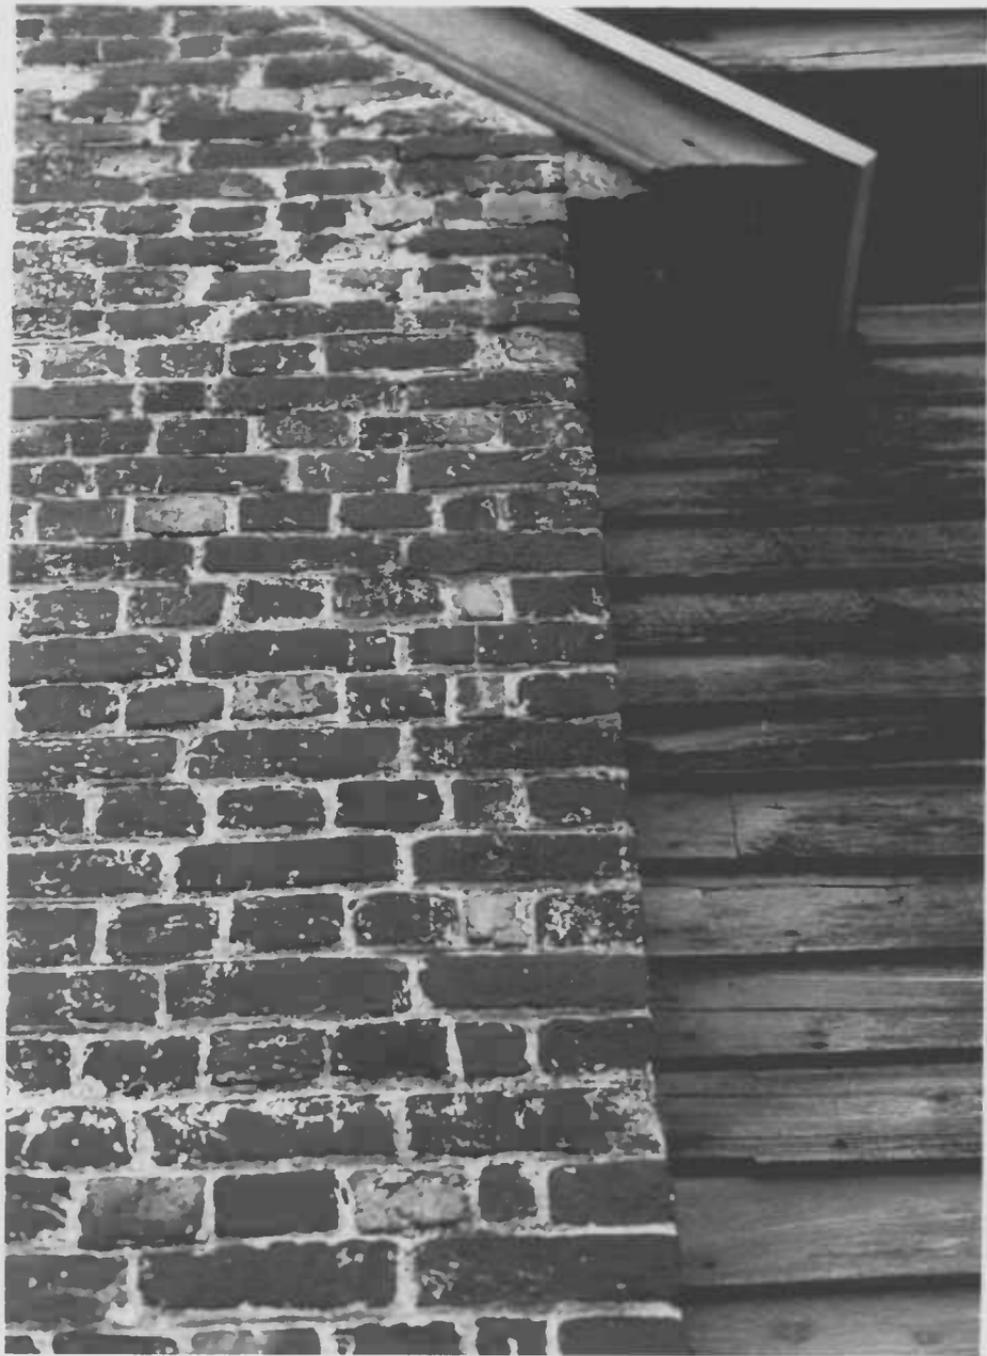
5 of 6

East gable end, detail of cornice at  
northwest corner, showing dated and  
inscribed brick: "HRR 1750"

Of particular significance are three inscribed bricks found in this gable end of the house. One, dated June 26, 1750 is located within the small diamond at the base of the larger overall pattern. A second, dated 1750, is located in the next diamond up and to the right. A third brick inscribed

H  
R R 1750

is located on the north corner, 35 courses above the water table. The initials are assumed to stand for Robert Harwood, who acquired the property from his father in , and his second wife, Rachel, whom he married in .

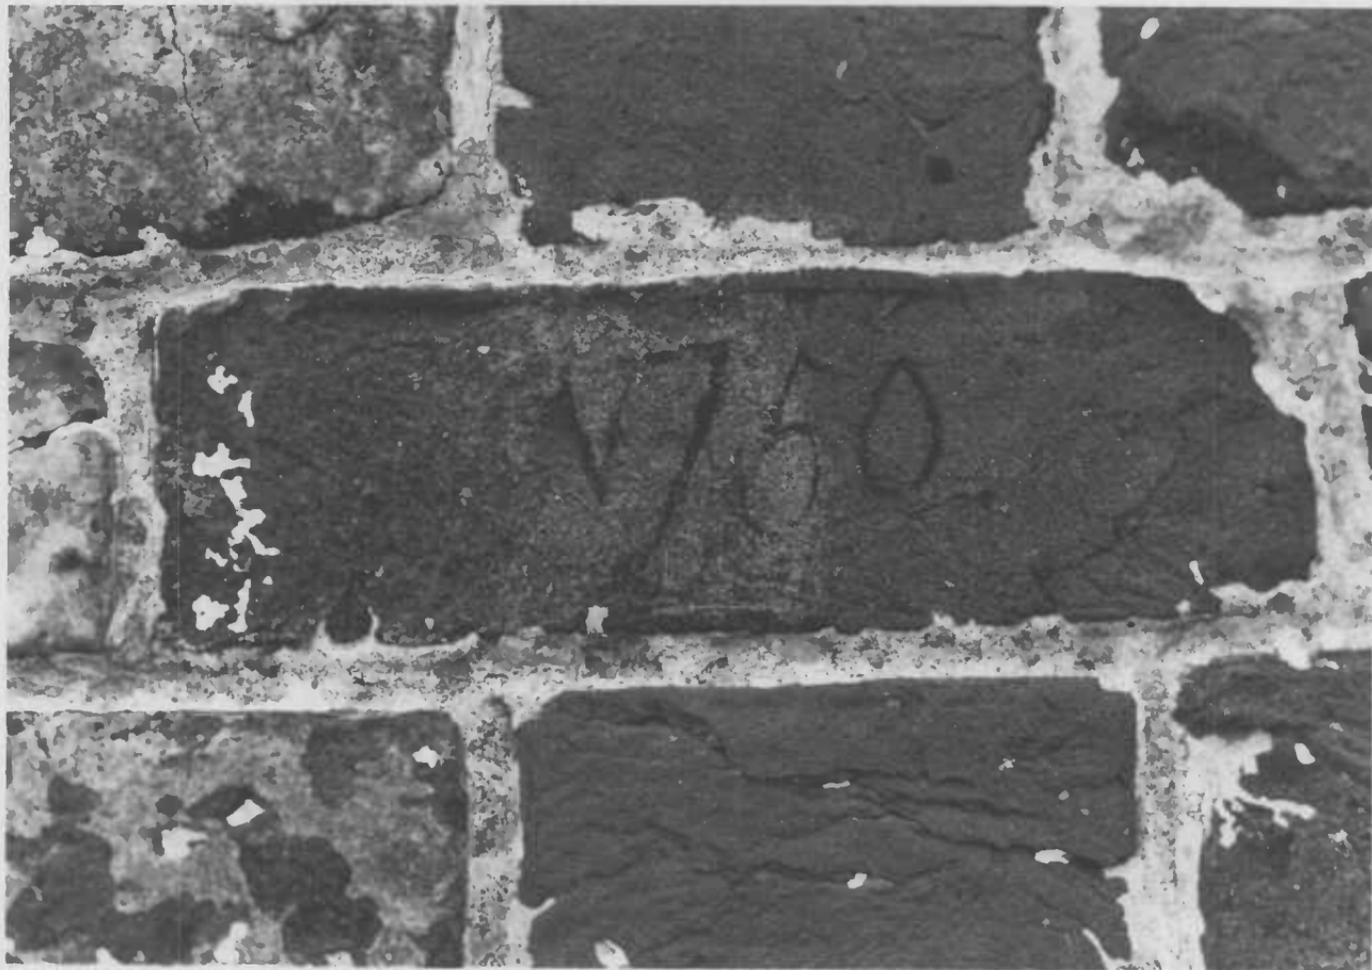
6 of 6

One (of three) dated bricks: "1750"
