Maryland Historical Trust State Historic Sites Inventory Form

Survey No. M: 11-27

and/or common Ira Jones Barn

street & number 25601 Kings Valley Road not for publication

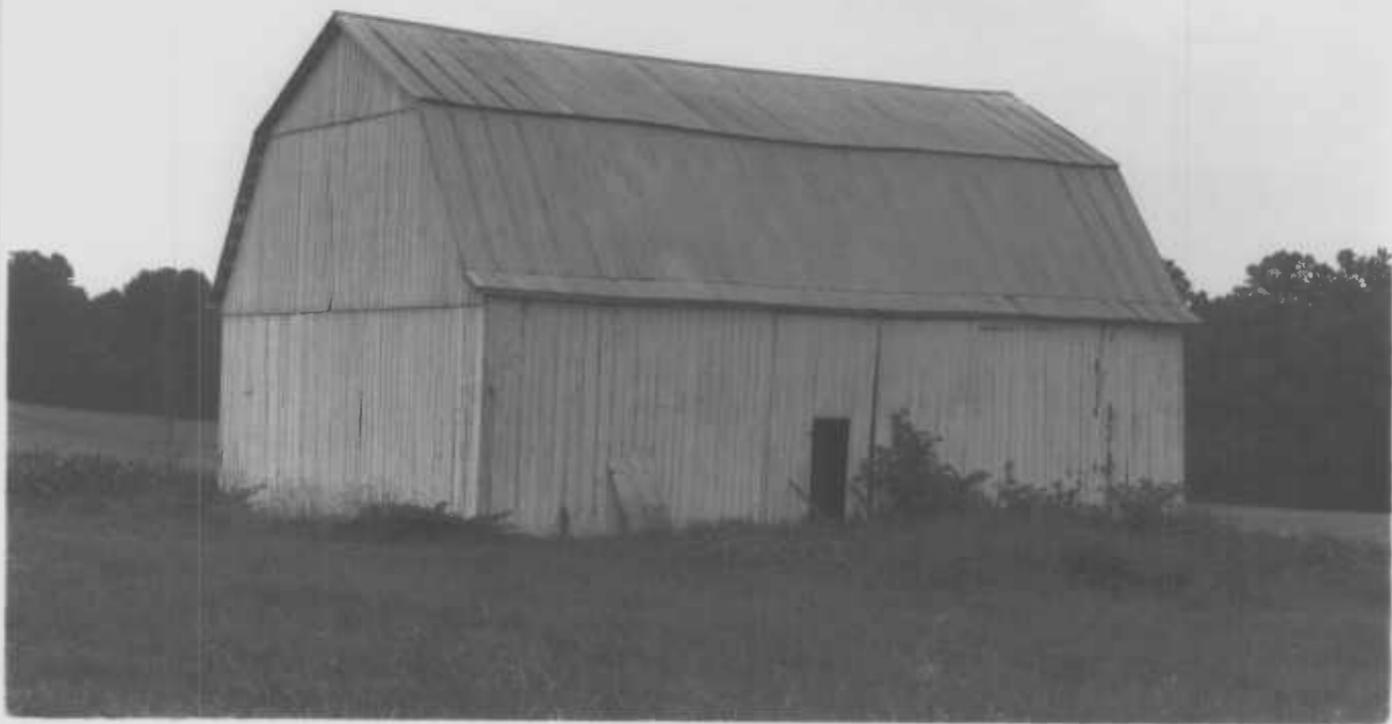
M: 11-27

North elevation

The Ira Jones barn, built c. 1921, appears from the exterior to be a plain, medium sized, gambrel roof bank barn. Its roof is covered with sheet metal and its walls with vertical boards spaced slightly apart. The stabling area is deteriorated but looks typical of bank barns of the 1910's. The north (retaining) wall is fieldstone set in mortar; the east wall is poured concrete. The other two walls are wood, with the south wall containing the doors to the stabling area. The hayloft, however, contains a surprise, for this barn makes use of the self-supporting truss or braced rafter frame advocated by farm manuals published in the 1910's and 1920's. Small dimension lumber, typically 2x6's, are used to form the structure of the roof: "The distinguishing feature of the braced rafter frame is the fact that each set of four rafters is braced at all angles, to form a light truss, which supports the roof through a length of 2 feet, which is the spacing of the rafters, no purlins or extra framing being necessary. Each truss consists of two lower rafters, two upper rafters, a collar beam, or tie, and upper and lower braces."¹

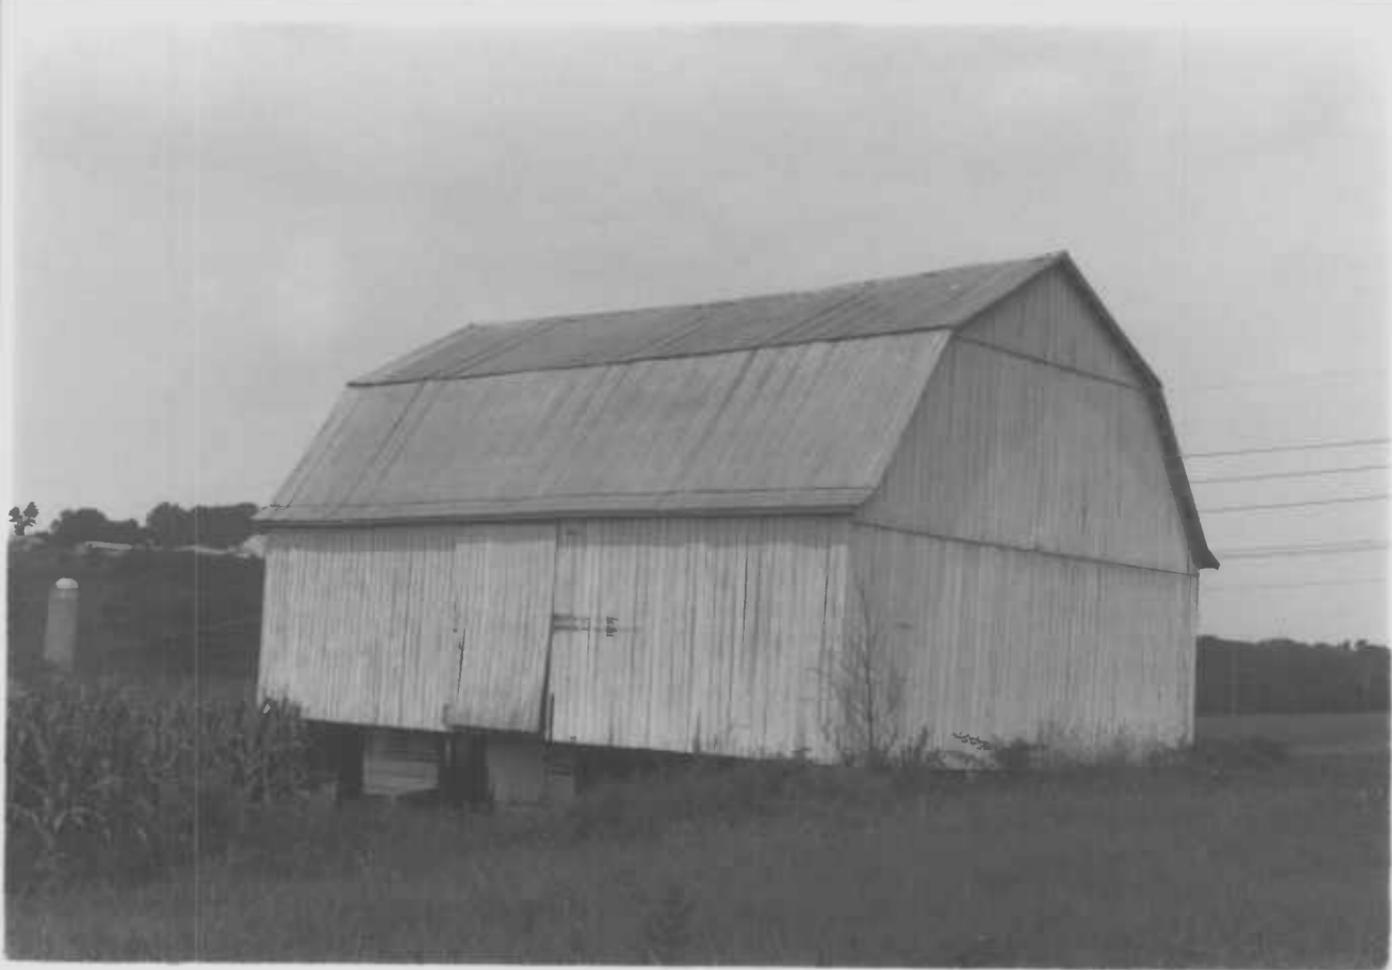
M: 11-27

Looking northwest
