MARYLAND HISTORICAL TRUST
DETERMINATION OF ELIGIBILITY FORM

Property Name: Horace Waters House Inventory Number: M: 19-3

1. Name Waters Brick House/Horace Waters House
2. Planning Area/Site Number 19/3
3. MNCPPC Atlas Reference Map 7
B-13
4. Address Waters Road, Germantown, Maryland

INVENTORY FORM FOR STATE HISTORIC SITES SURVEY

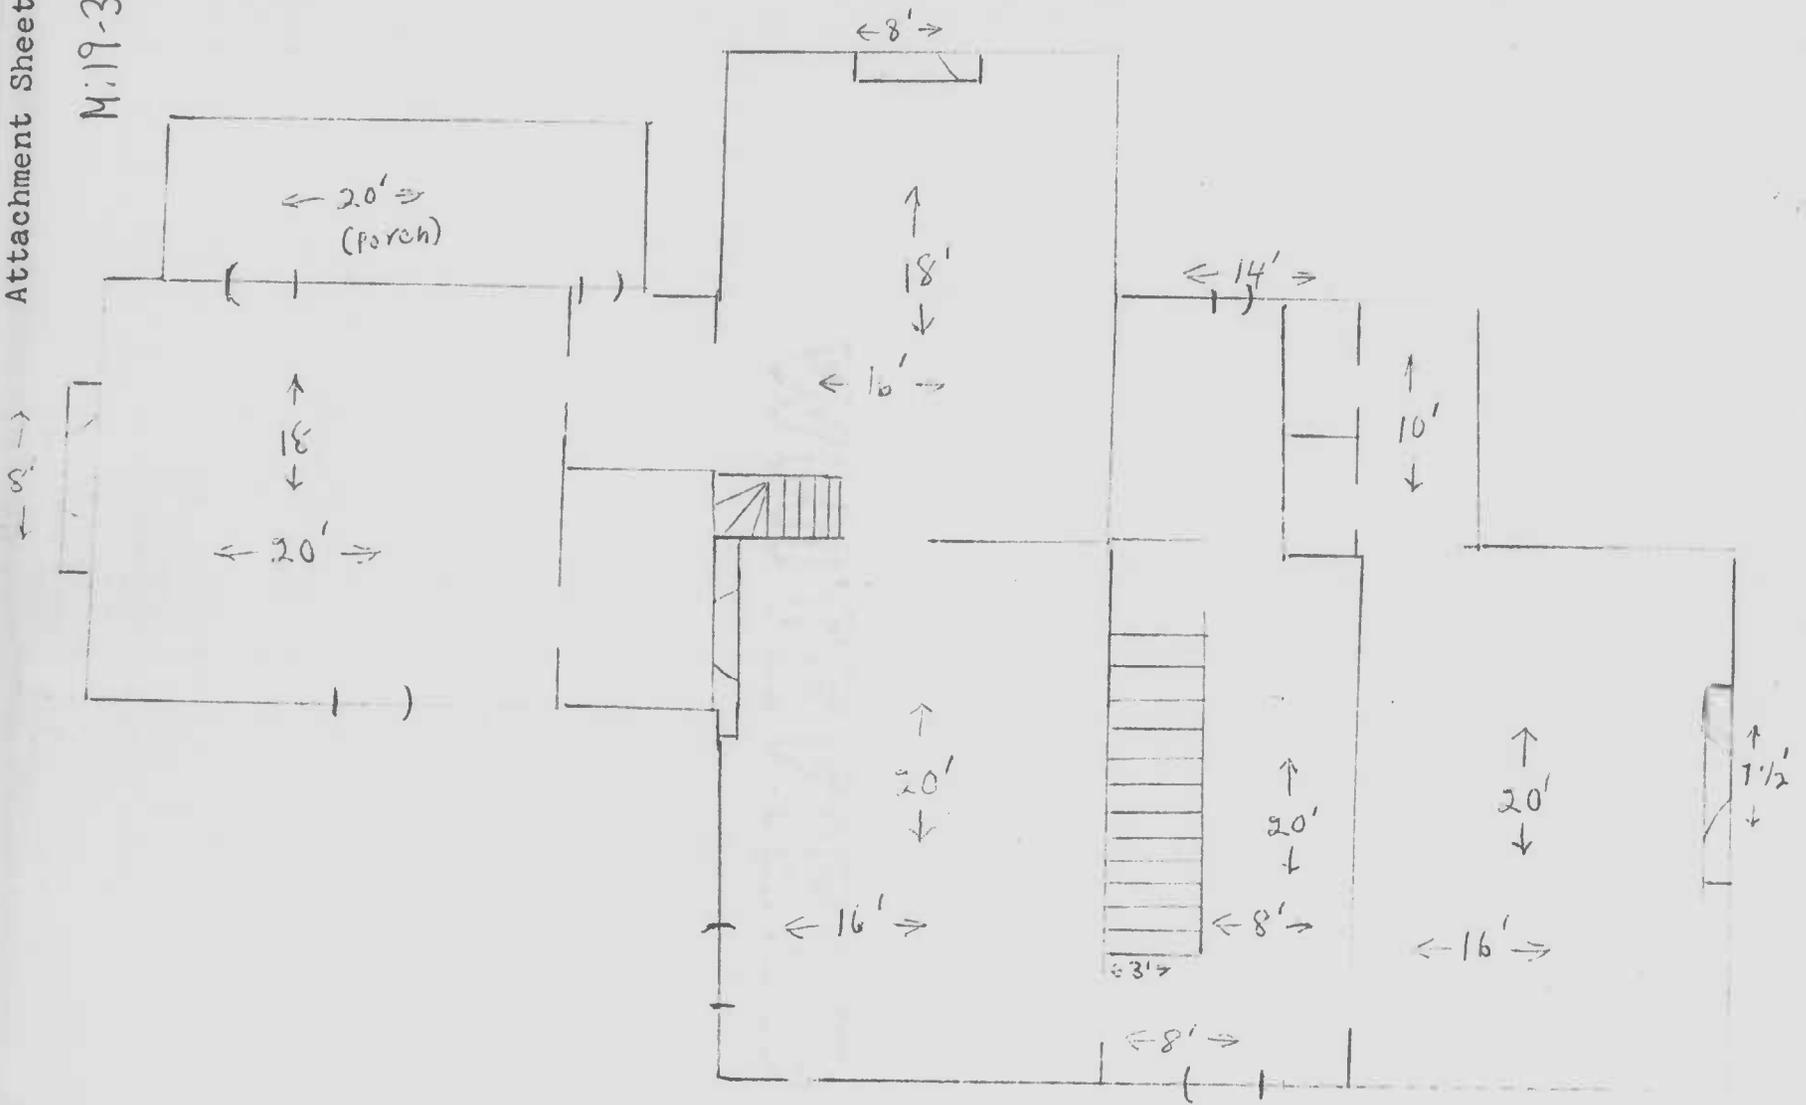
Horace Waters House
first floor plan

The floor plan of the house consists of two large rooms separated by a central stair hall in the main part, a single room with enclosed stair in the north wing, and the kitchen composed of the kitchen proper and two small cell-like rooms. There are four chimneys.

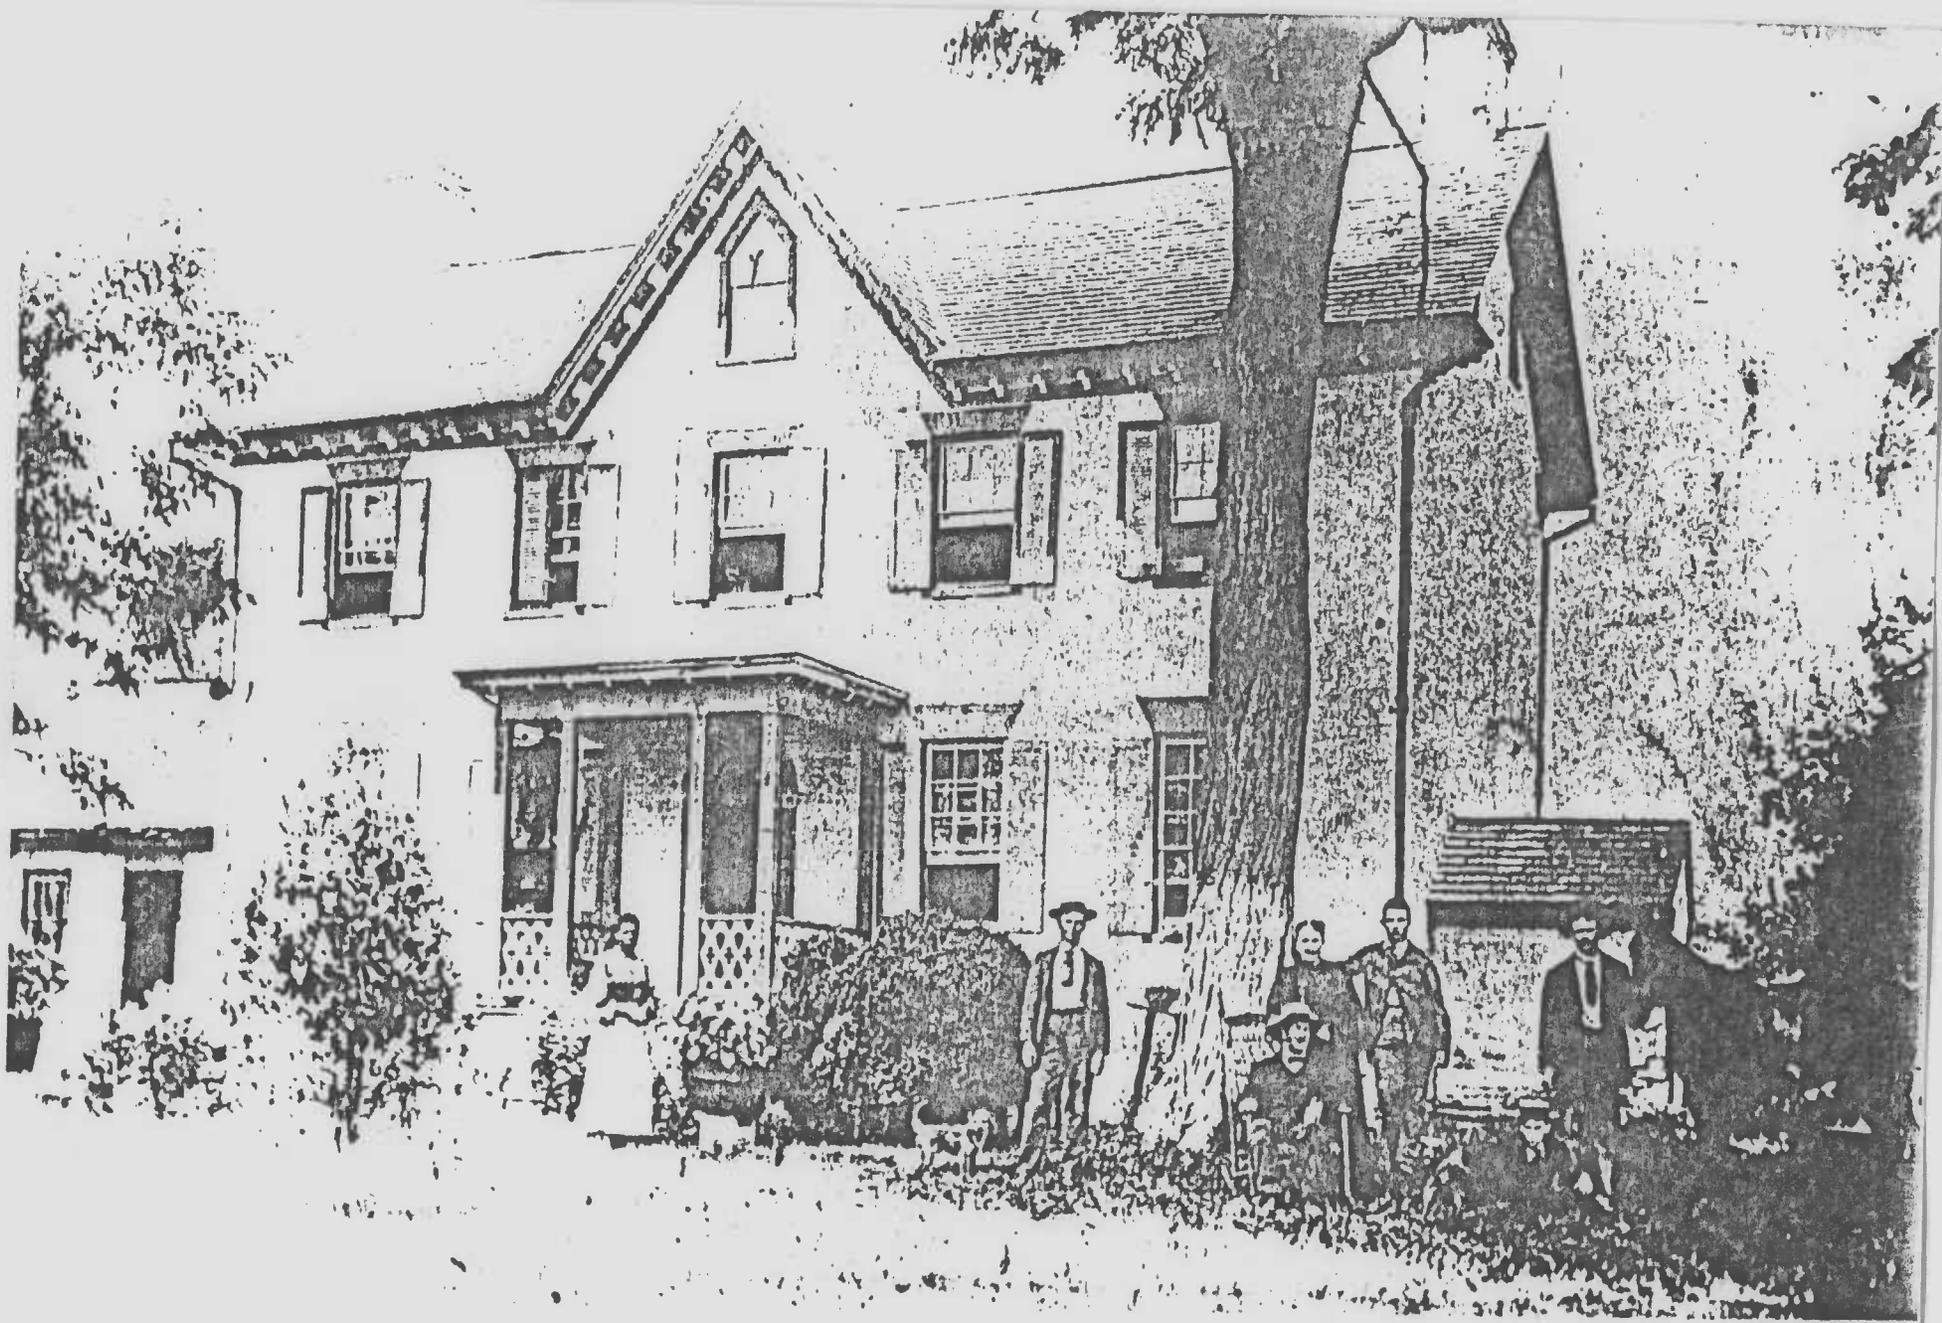
Horace Waters house, c. 1900
(large porch added c. 1908)

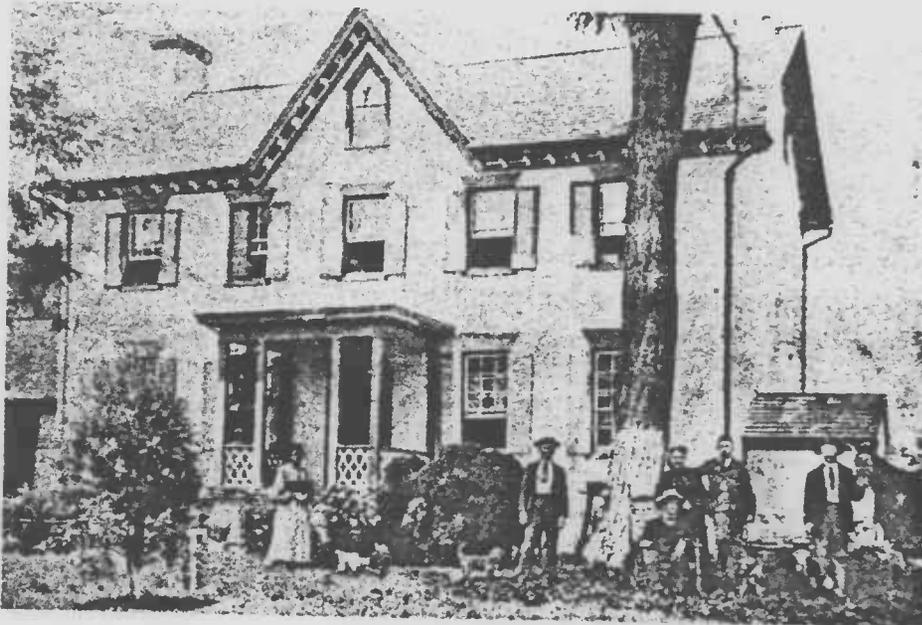
In 1962 the land was sold to a developer; it stood empty until 1981 when it was burned to make way for town houses, thus completing the march of progress. Courtesy of Ella Virginia Waters Gochenour
