Montgomery Country Club

16 Williams Street

Maryland Historical Trust State Historic Sites Inventory Form

Survey No. ^M26/10/36

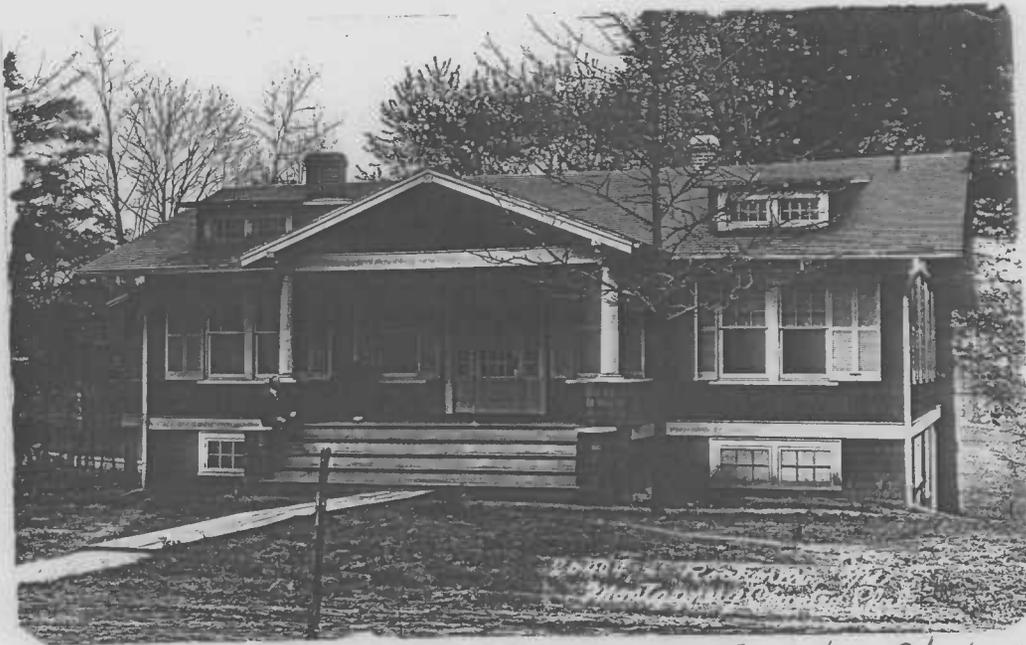
Montgomery Country Club, c. 1920

The accompanying photo shows the clubhouse in the mid-1920's. That there has been little change is a testimonial to the bungalow's endurance as a functional style.

M: 26/10/36
Montgomery Country Club
16 Williams Street
Photo c. 1920
Courtesy of Montgomery County
Historical Society

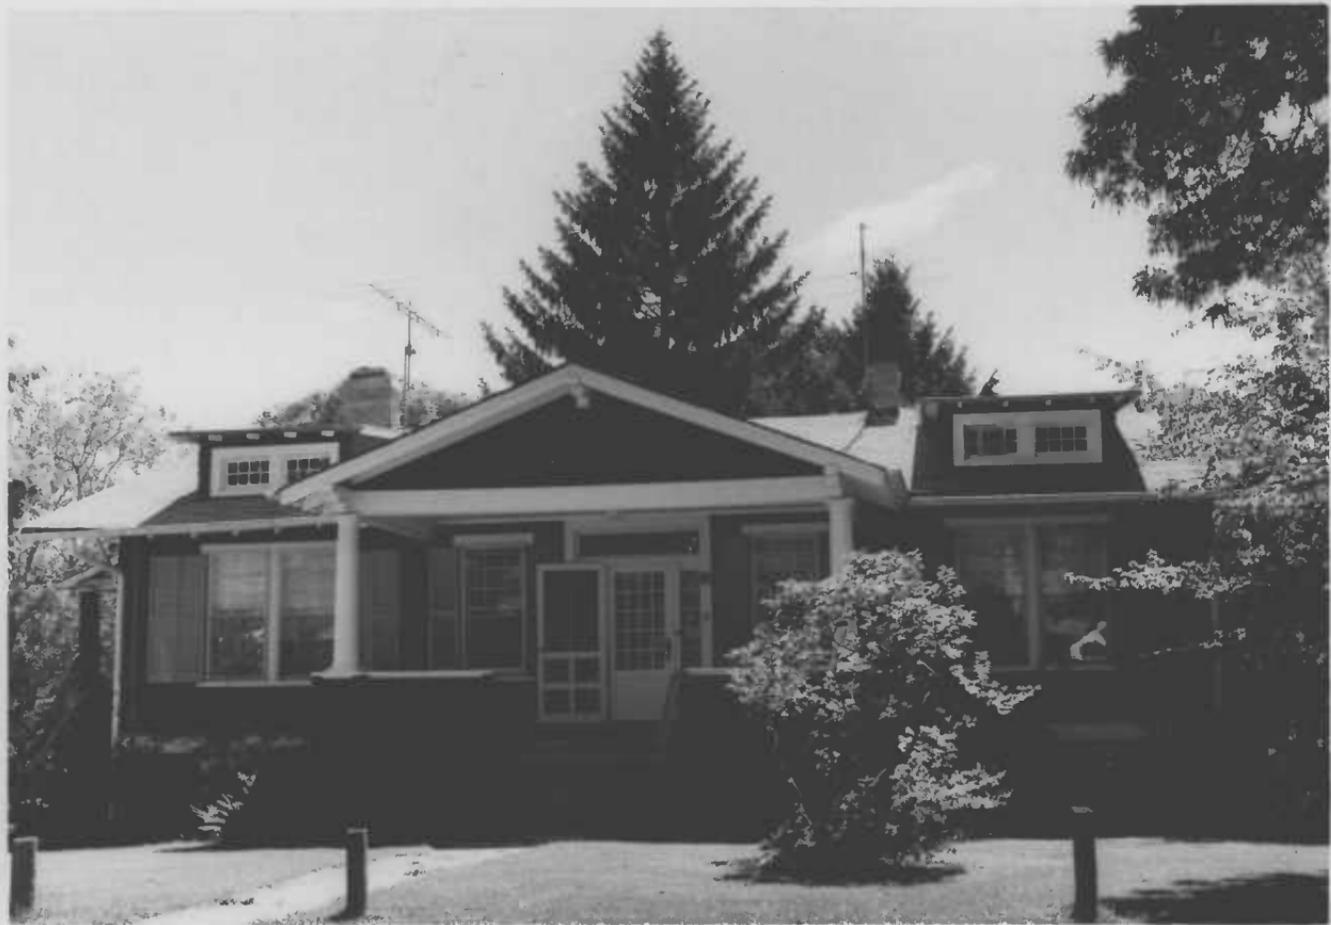
Montgomery Country Club
16 WILLIAMS STREET
WEST ELEVATION
AUGUST, 1984

Steps on the front (west) facade lead to a gabled porch three bays in width. The gable is supported by round tapered columns. A multi-paned door with transom and side lights is present. There are two shed dormers with paired horizontal windows on this facade; these almost flat dormer roofs are also carried out on open rafter end supports. The outer double and inner single windows on the first floor are six over six, the two outer windows having double shutters and the two interior windows in the line having single shutters.

The entire house is covered with dark brown shingles, laid in an imbricated shape on the main block and common square on the dormers, porch piers and supports. On the front facade a wide wooden band above the basement level creates a wooden "stripe" contrasting with the brown shingles.
