Site: M:26/21/3

Halpine Store/Radio Shack

1600 Rockville Pike

State Historic Sites Inventory Form

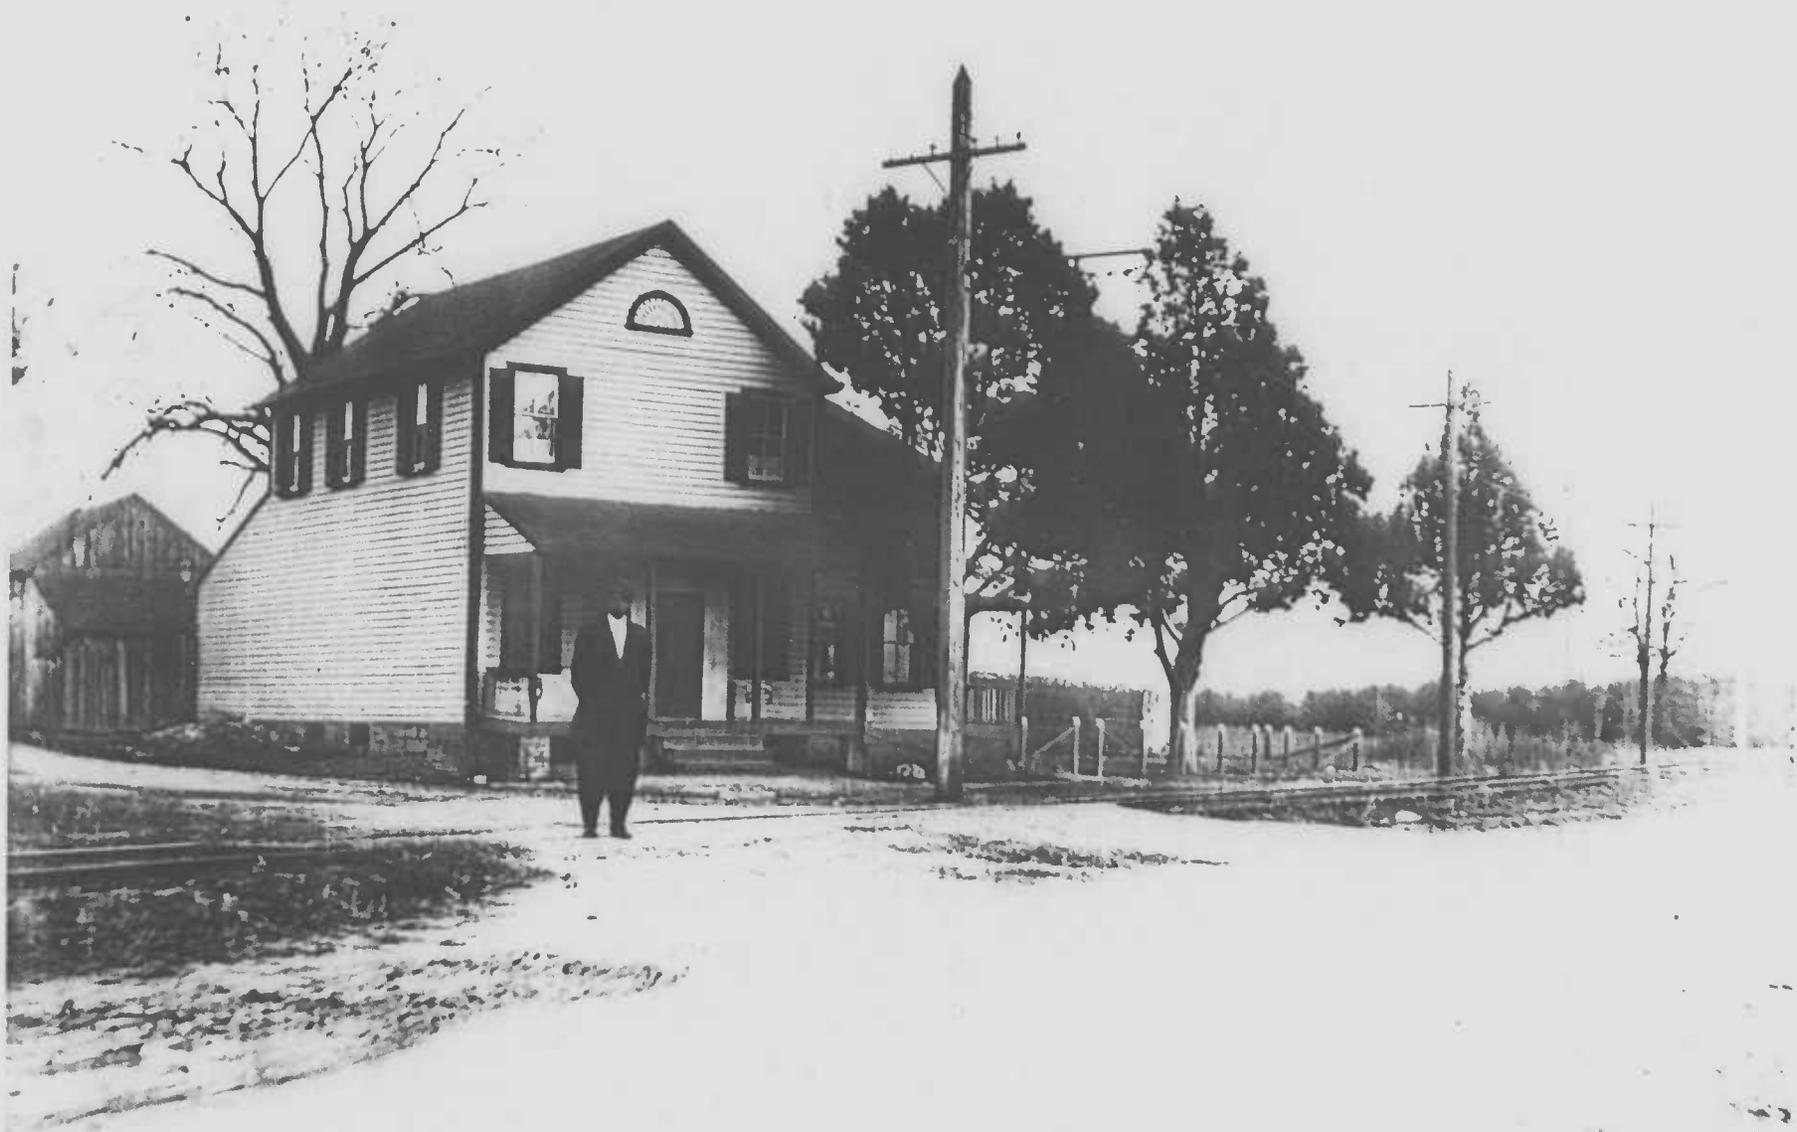
M:26/21/3
Radio Shack
Attachment 8.2

ROCKVILLE PIKE AND HALPINE ROAD c. 1910
(courtesy of Charles Brewer)

A subdivision named "Halpin" (or "Halpine") was platted in 1889 by Washington speculator Leonard Chapman in anticipation of the proposed trolley line to Rockville, and to take advantage of this location south of the B&O railroad tracks. 1/ Before it could reach Rockville, the trolley company failed, taking with it hopes for development of the Halpine area. Judge John Vinson foreclosed the mortgage on the 51 unsold lots in 1894. 2/ Benjamin and Anna Lenovitz purchased the subject lot at the corner of Halpine and the Rockville Pike in 1898 for \$125. A small frame combination store building and dwelling house was constructed on this site in the same year, valued on the Assessment Records at \$800. 3/ (See attachment 8.2 photograph, ca. 1910).

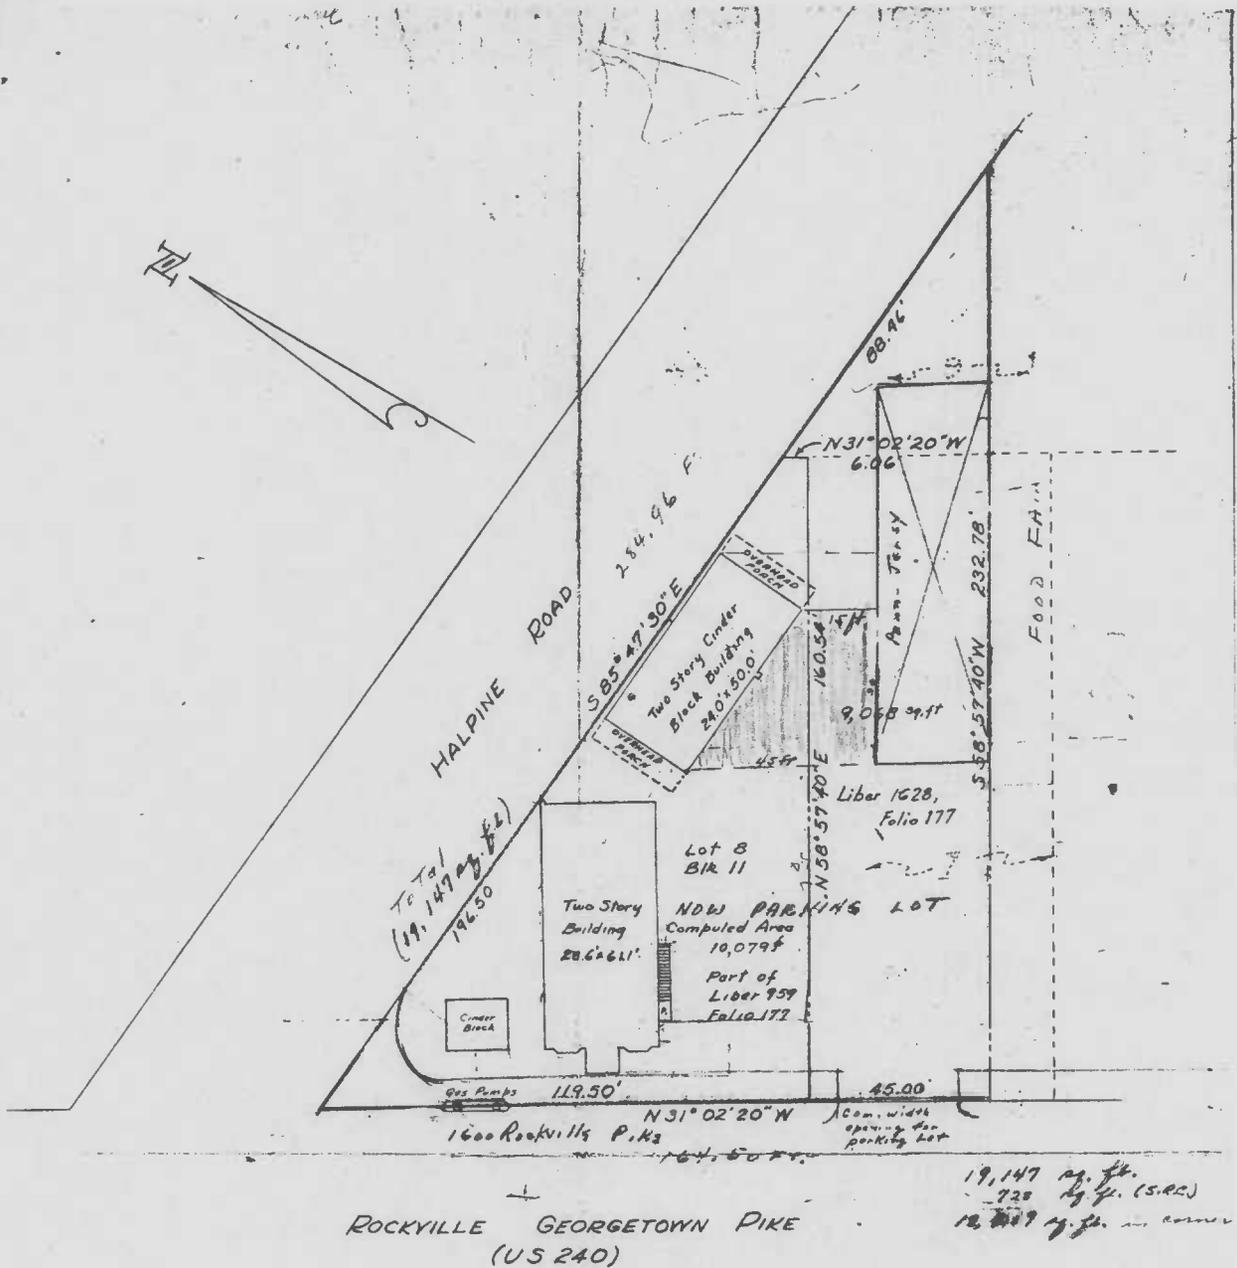
Plat Of
 Lot 8 & Parts of Lots 7 & 9, Block 11
 "HALPINE"
 Montgomery County, Maryland
 Scale: 1" = 30' November, 1954
 R. K. Maddox
 County Surveyor
