Maryland Inventory of Historic Properties number: M:37-7
Name: Sligo Creek Bridge, MD 195 over Sligo Creek

Maryland Inventory of Historic Properties
Historic Bridge Inventory
Maryland State Highway Administration
Maryland Historical Trust

SHA Bridge No. 15033 Name: MD 195 over Sligo Creek (Sligo Creek Bridge)

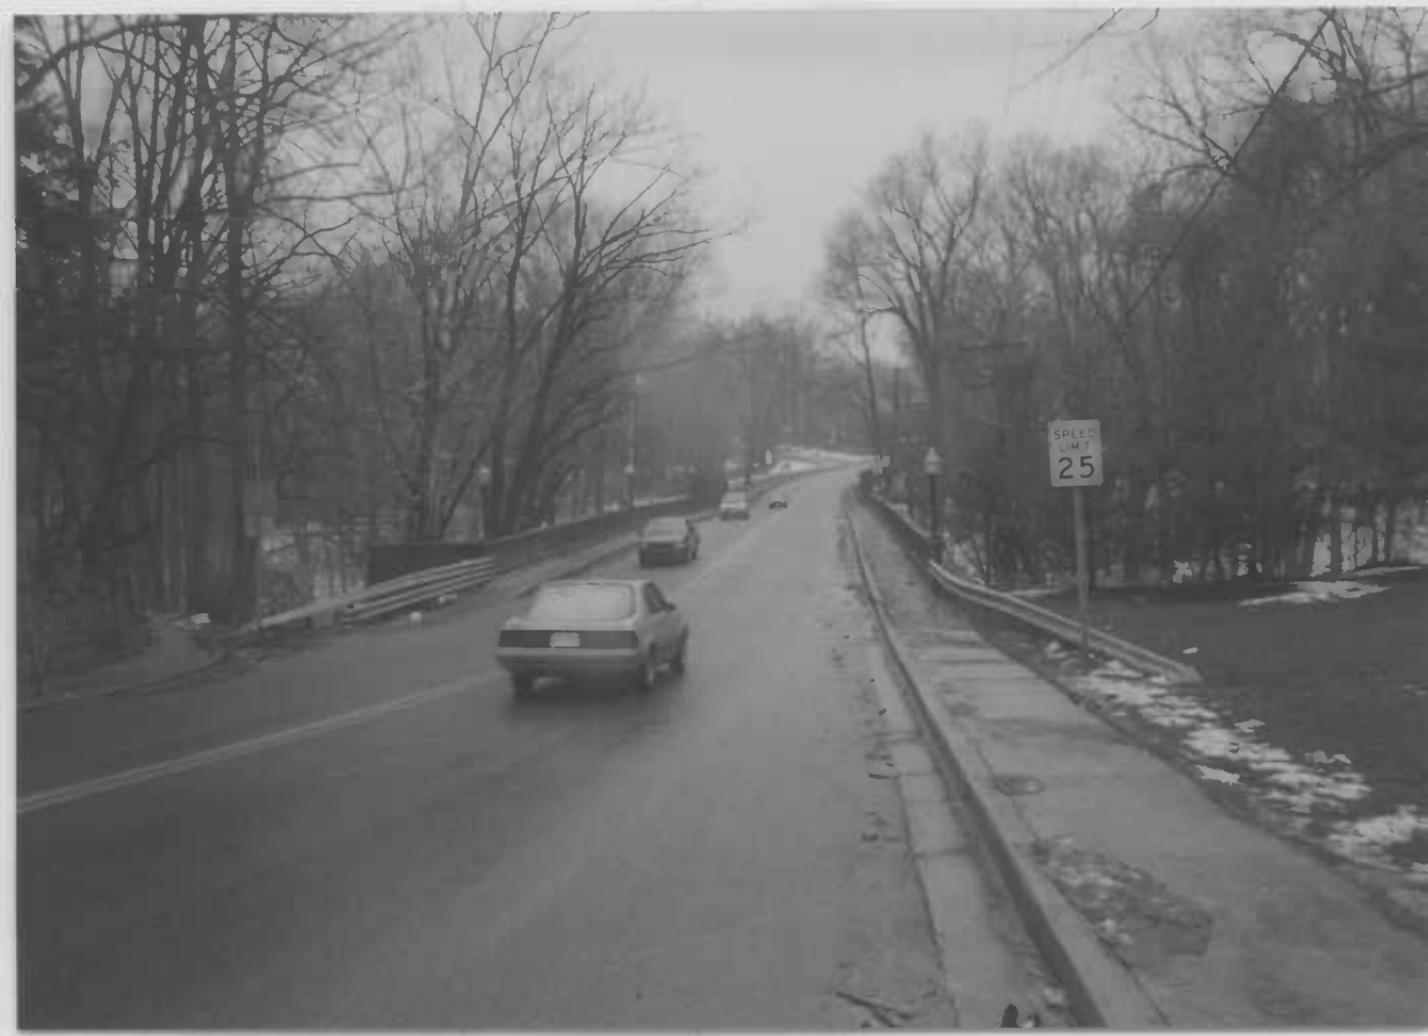
Number 1 of 31 ~~49~~ 7

A black and white photograph of a two-lane road winding through a wooded area. The road is paved and has a double yellow line on the left side. A silver car is driving away from the camera in the left lane. Further ahead, another car is visible in the same lane. On the right side of the road, there is a concrete curb and a speed limit sign. The sign is rectangular with a white background and black text that reads "SPEED LIMIT 25". The trees are bare, suggesting a winter or late autumn setting. The sky is overcast and grey. The overall scene is quiet and somewhat desolate.

Description APPROACH WEST

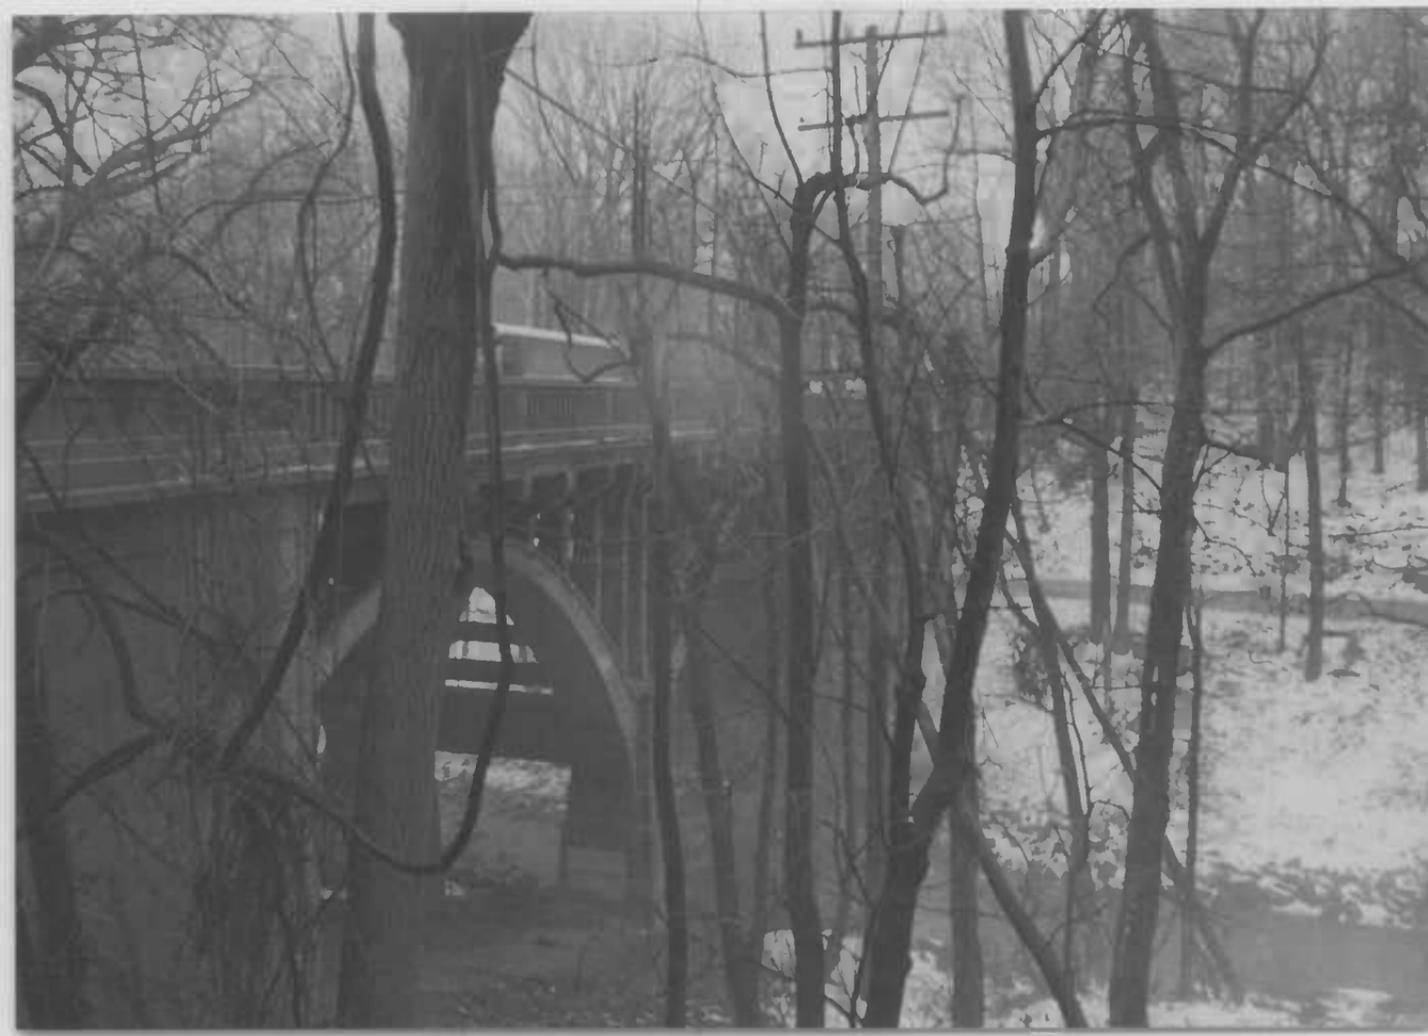
Number ²~~28~~ of ~~34~~ ⁹⁹⁷

Description ELEVATION SOUTH

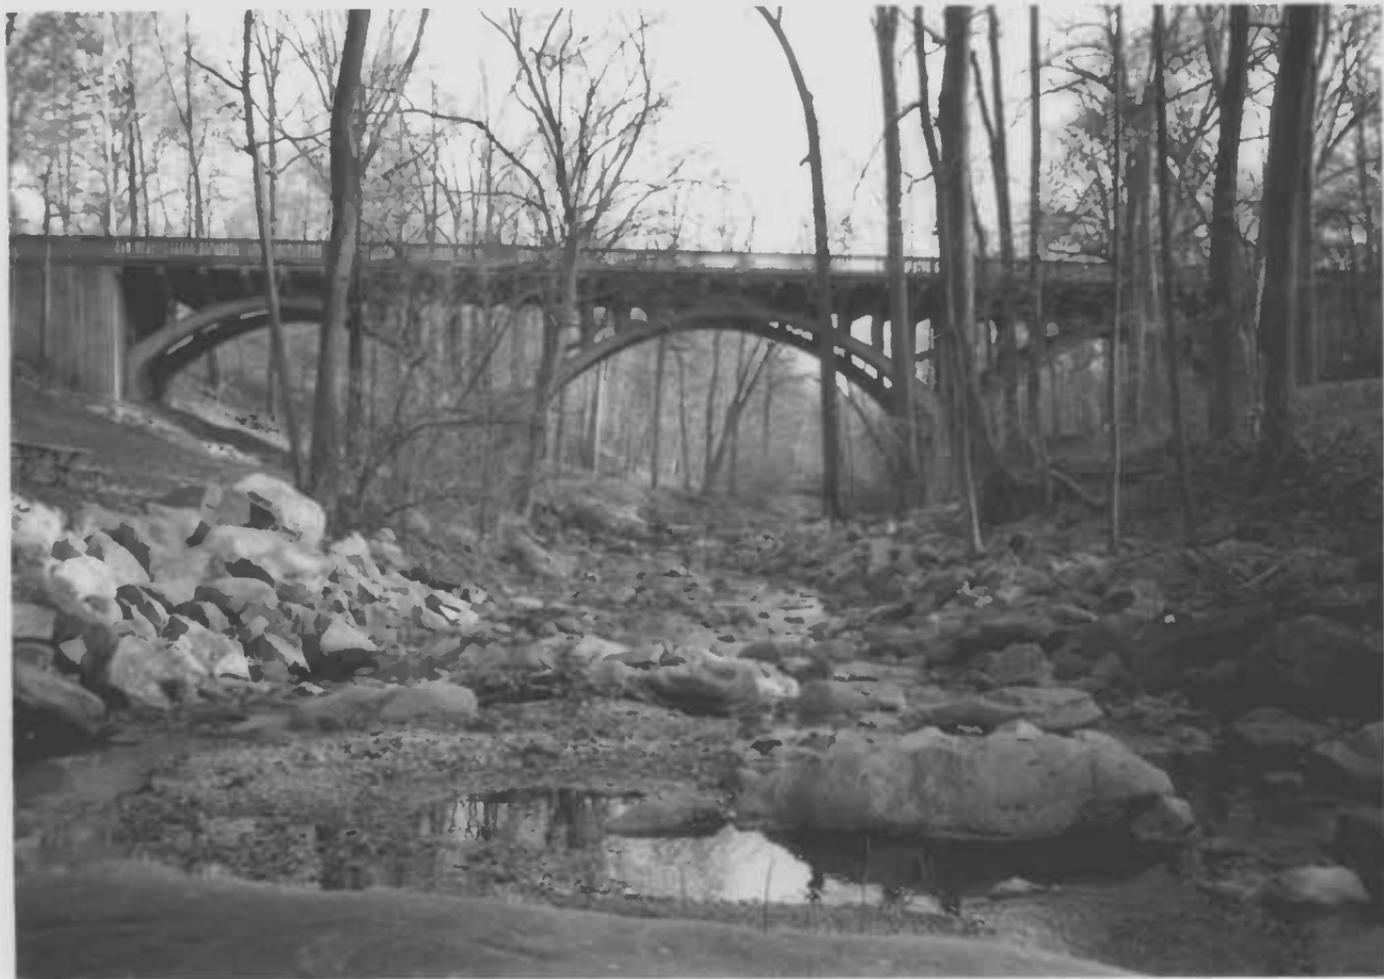
1. M:37-7
2. MD 195 over Sligo Creek
3. Montgomery Co., MD
4. Wallace, Montgomery & Assoc.
5. 12/97
6. MD SHPD
7. Elevation looking downstream
8. 4 of 7

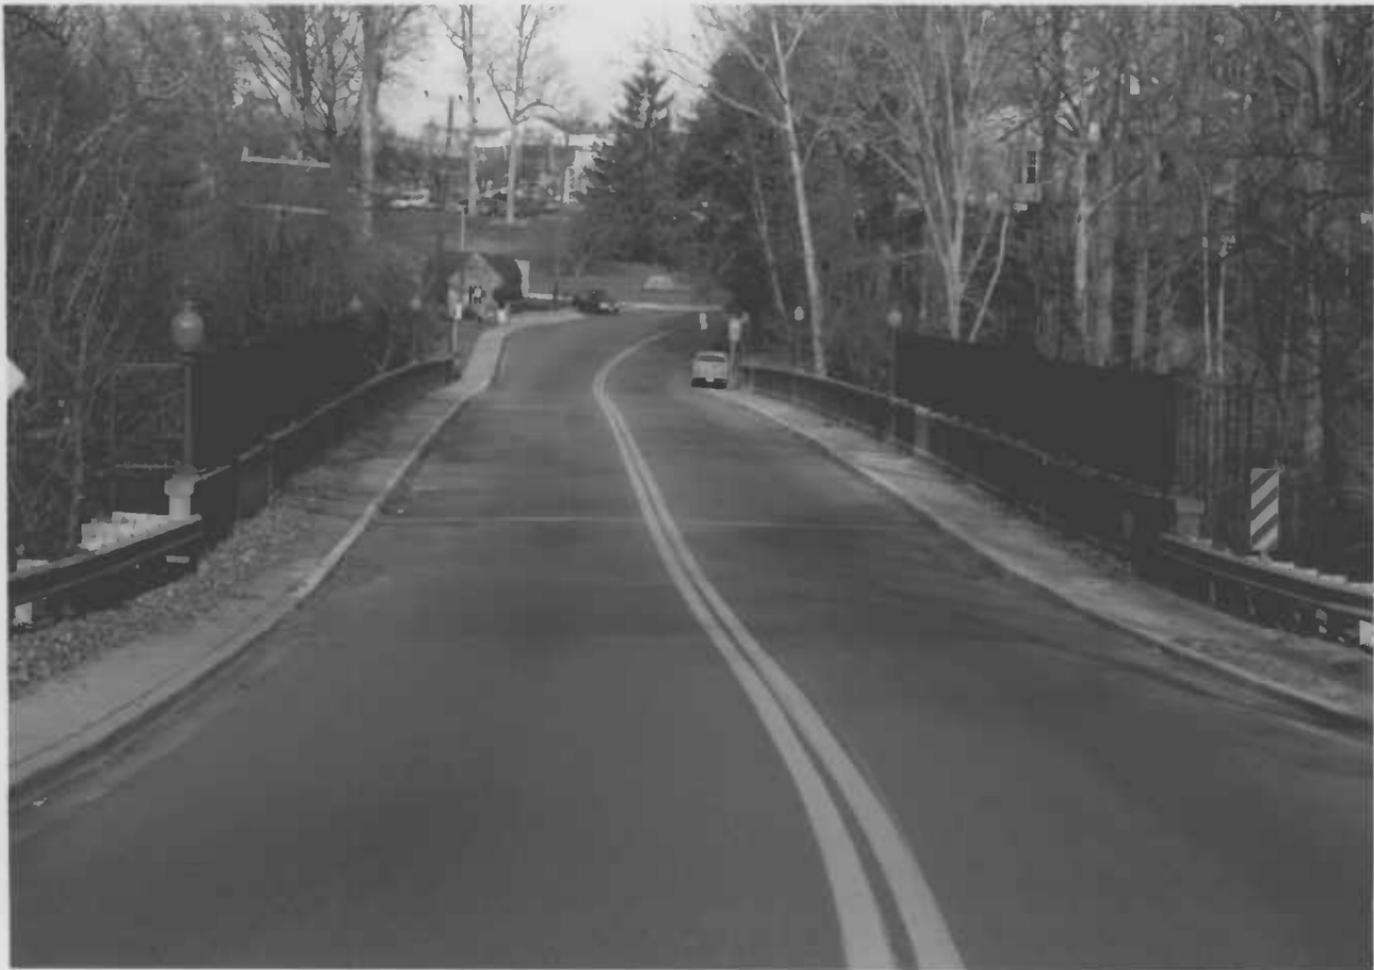
1. M: 37-7
2. MD 195 over Sligo Creet
3. Montgomery Co., MD
4. Wallace, Montgomery & Assoc.
5. 12/97
6. MD SHPO
7. Looking East
8. 6 of 7

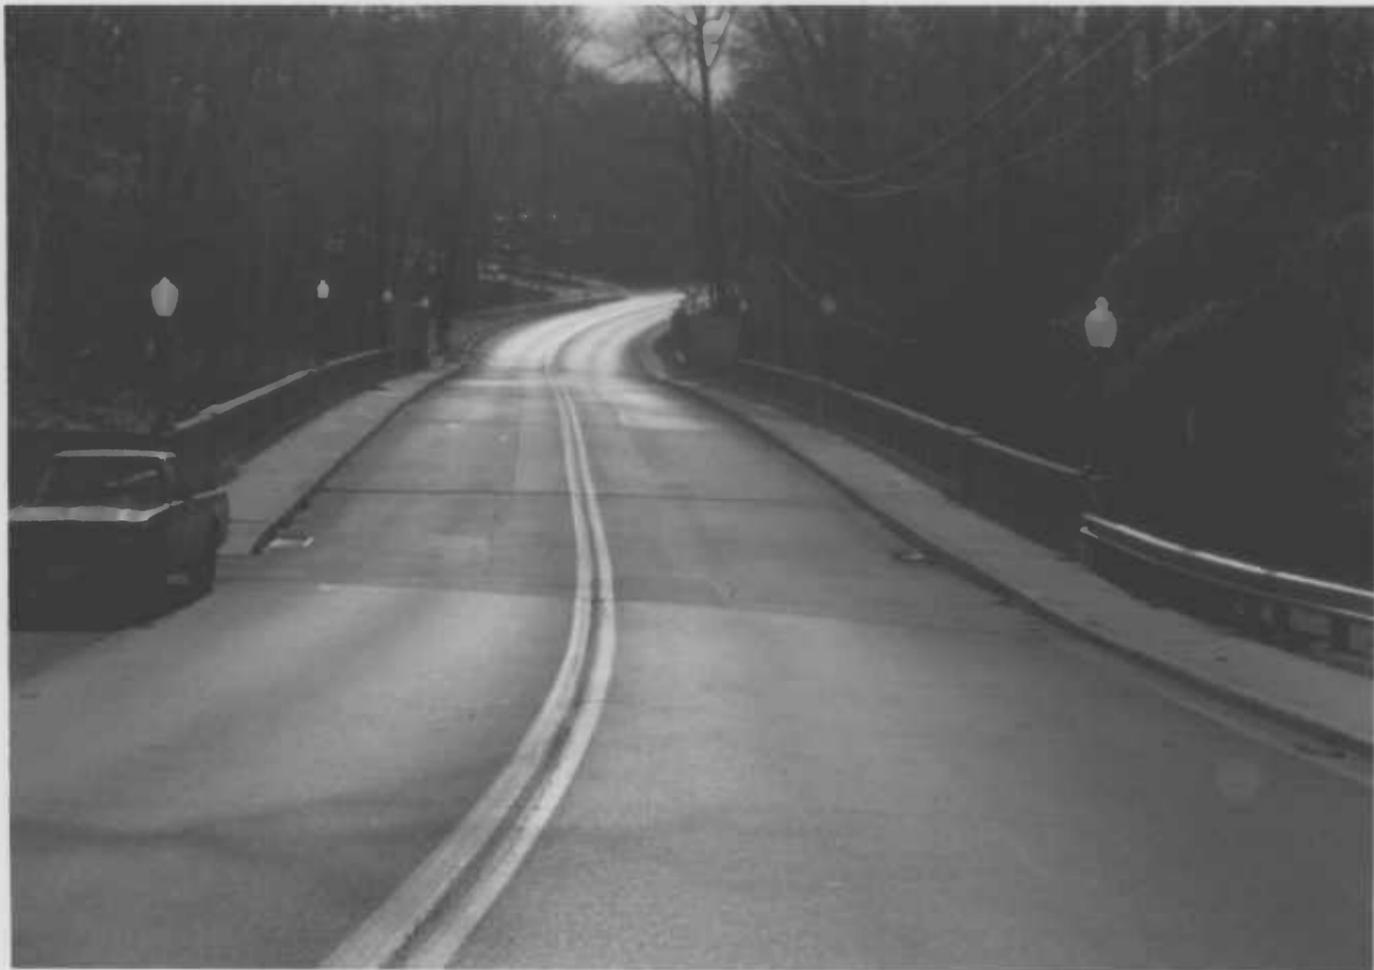
1. M:37-7
2. MD 195 over Sligo Creek
3. Montgomery Co., MD
4. Wallace, Montgomery & Assoc.,
5. 12/97
6. MD SHPO
7. Looking West
8. 7 of 7
