PG LAU-1-7
817-819 Main Street
Laurel, Maryland

Maryland Historical Trust State Historic Sites Inventory Form

and/or common Laurel Factory House

"LAUREL FACTORY HOUSE," 817-819 MAIN STREET

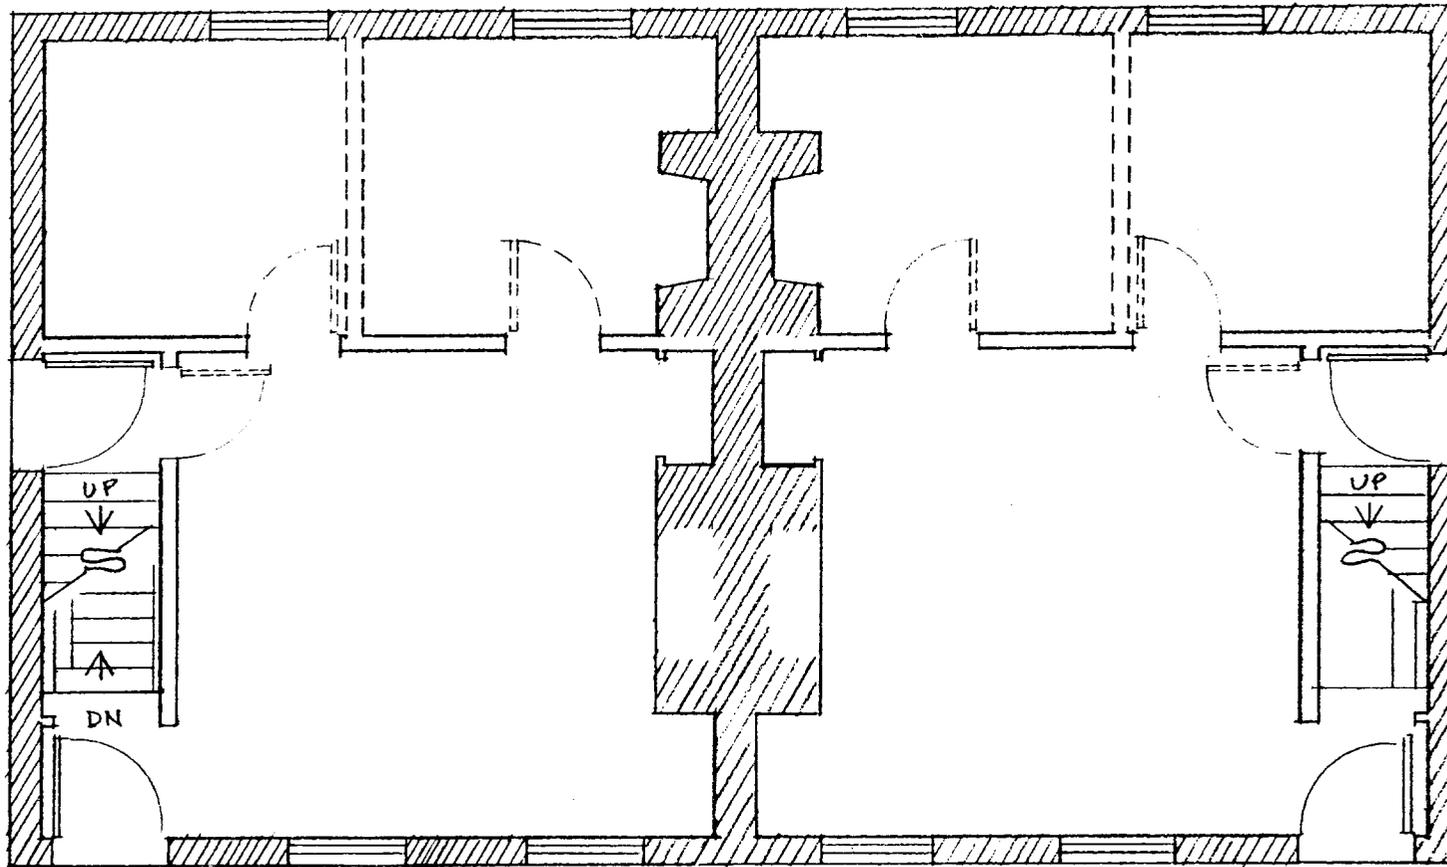
FIRST FLOOR PLAN

The interior was originally organized into four equal three-room units, one on each of the main floors of each half of the double house. Each of these units comprises a large room with a fireplace, spanning the breadth of the house on the south, with the northern space partitioned into two smaller rooms, one heated and the other unheated. The entrance opens into the south (front) room, which measures approximately 15' by 13'-8"; the heated rear room measures 9'-4" by 8'-2", and the unheated room is practically square, 8'-4" by 8'-2". The first-floor apartments are entered through doorways in the outer bays of the south facade; the gable-end entrances appear primarily to have served the second-floor units, opening into a small vestibule from which the stair rises to the upper story. The segregation was not complete, however; an interior door opens from the vestibule to the first-floor front room in each unit. The basement comprises four equal-sized rooms, each with its own exterior entry and a large cooking fireplace; these rooms did not communicate, but apparently provided a separate kitchen for each of the four apartments above. A steep, narrow stair from each of the first-floor south rooms provided interior access to the corresponding north basement room; access to the south basement rooms was by means of an exterior stair leading from the gable-end entrances to the basement door. This inference is based on graphic and physical evidence: Sanborn fire insurance maps indicate a stair in this location at the west end, and the former areaway at the east end is oriented correspondingly. This suggests that the north basement rooms were used by the occupants of the first-floor units, and the south basement rooms were assigned to the second-floor apartments. The attic space is partitioned into four rooms (two per half); these spaces are not as clearly segregated as the basement, as the attic is reached by means of a stair from the second floor front room, and the northern attic room is entered through the southern room. The basement floor is partially paved with brick; the stone exterior walls are whitewashed, and the brick partitions are plastered (the partition between the north and south basement rooms in the western half has been removed). The upper levels, including the attic, are framed with 3" by 4" studs, 1'-9" on center, and finished in plaster on circular-sawn lath which is secured with machine cut nails. The roof framing consists of 2-3/4" by 5" vertical-sawn common rafters

The units retain clear evidence of their original plans, as described; in all but the second floor eastern unit, however, the partition separating the two smaller northern rooms has been removed. Fireplace mantels in the western half of the building have been removed or severely damaged; however, the eastern section retains its original Greek Revival-style fireplace mantels in the front room on both floors, composed of pilasters supporting a plain frieze and a shelf above a bed mold comprising Grecian ovolo and cove profiles (the fireplace opening has been blocked). The mantel in the rear room is simpler, with a flat surround and Grecian ovolo/fillet bed mold. The space north of the chimney breast in each heated room was originally finished as a closet, fitted with shelves and closed with a batten door. Other interior decorative detailing throughout the building includes batten doors, plain baseboards, and narrow plain door and window frames with a bead at the jamb edge. The sole exception to this pattern is the casing of the door from the main room to the stair in the first floor eastern unit, which is trimmed with broad symmetrical architrave molding and corner blocks typical of the Greek Revival style.

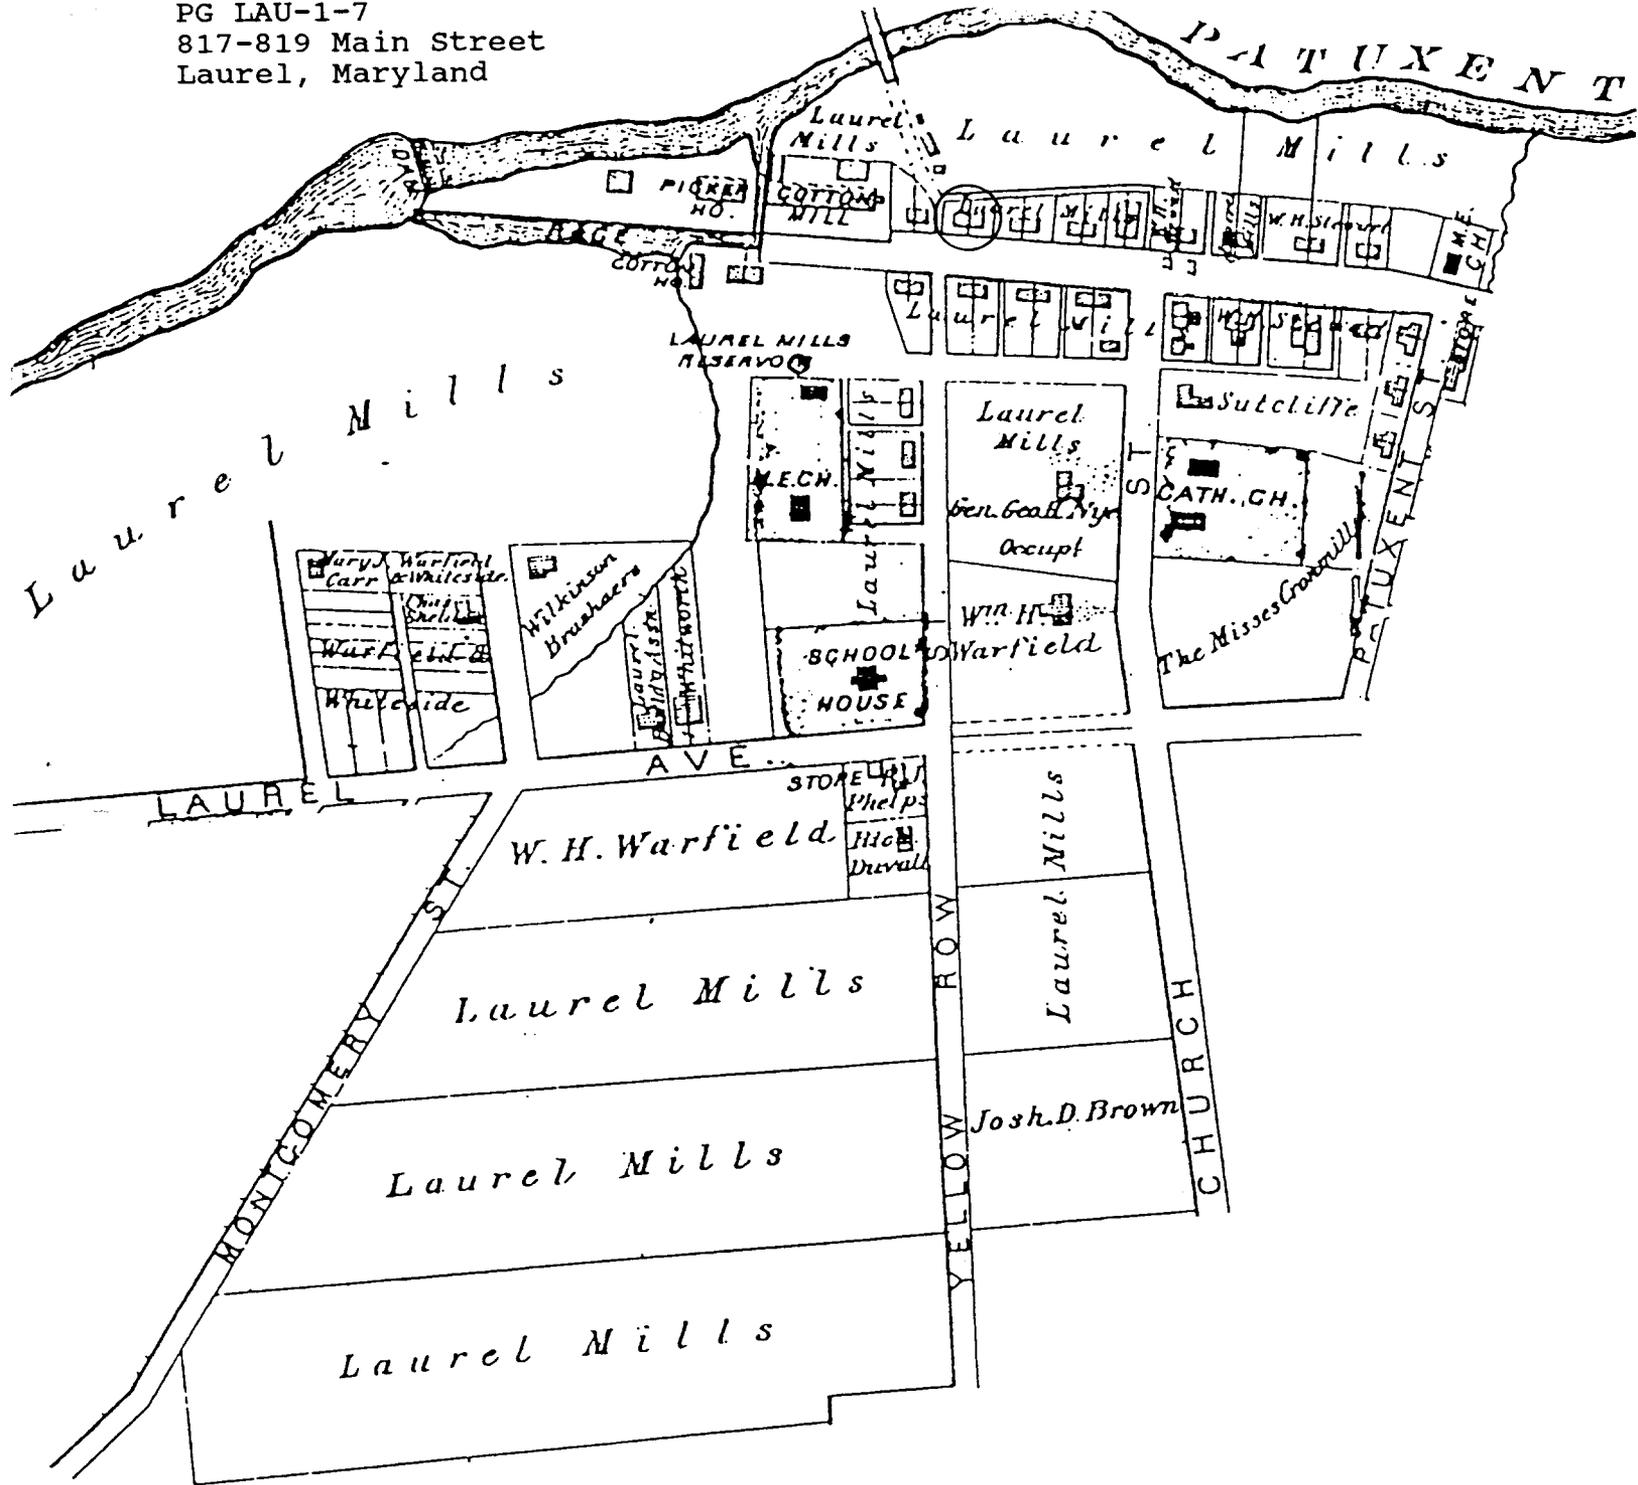
The G. M. Hopkins atlas of 1878 shows extensive landholdings of the Laurel Mills in the western section of Laurel. Waterworks including a dam, millrace, and reservoir served the complex. The cotton mill was shown as a large rectangular structure located to the east of the tail race, with a smaller picker house to the west, and a cotton warehouse on the south side of the millrace, opposite the picker house. In addition, a total of 16 double houses, mostly west of Church Street, are indicated as under company ownership. An approximately equal number of similar houses were shown in the blocks to the east, under different ownership; these were likely part of Capron's original development, but passed into other hands in subsequent year, perhaps in one of a series of corporate reorganizations which began as early as the 1840s. The 1878 atlas also shows that Laurel Mills owned several large undeveloped parcels fronting on Yellow Row (present Ninth Street) southwest of Laurel Avenue, and another on the south bank of the Patuxent River northwest of the mill complex; these parcels probably were part of Horace Capron's original acquisition.

Detail of 1878 atlas showing Laurel Mills properties;
 817-819 Main Street circled

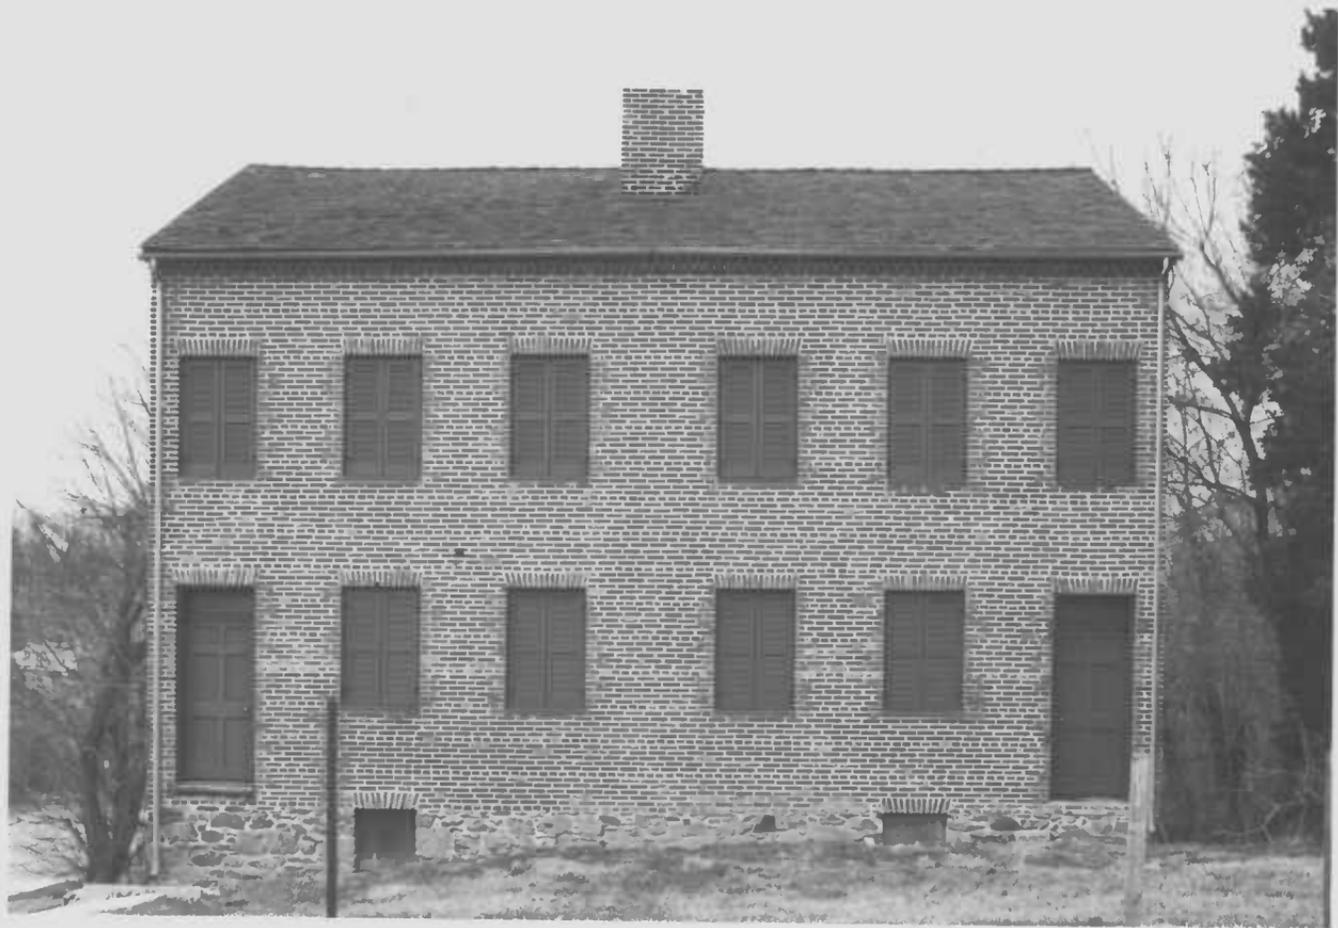
1 OF 9

The building is constructed of brick laid in five-course common bond, above a basement of uncoursed rubble, and stands 2-½ stories high; the composition of the six-bay-wide south facade is symmetrical, with each of the two sections of the double house presenting a mirror image of the other.

The double house at 817-819 Main Street in Laurel, Maryland, is one of a group of houses constructed in the mid-nineteenth century to accommodate workers at the Patuxent Manufacturing Company (later Laurel Company) textile mill. The building is located at the northeast corner of Main and Ninth (formerly Yellow Row) streets. It is constructed of brick laid in five-course common bond, above a basement of uncoursed rubble, and stands 2-½ stories high; the topography of the lot falls away sharply to the north and west, so that the stone basement is fully exposed on those sides. The six-bay-wide principal facade faces south, toward Main Street. The facade composition is symmetrical, with each of the two sections of the double house presenting a mirror image of the other. On the ground floor, the two outer bays hold entrances, with four-light transoms above (recent) six-panel doors. The transom bar is detailed with a Greek Revival stepped molding below a backband with a Federal-style ogee/astragal profile. The remaining bays of the first floor, and the six bays of the upper story, hold six-over-six windows with bullnosed frames and plain wooden sills. Splayed brick lintels appear above all openings. Louvered shutters are fitted to all sash. The facade is capped with a two-course brick cornice. The gable roof is covered with wood shingles; a large central chimney exits from each slope. The basement is lighted by two windows on the south elevation; the eastern window is located in a well. A photograph taken about 1970 shows a two-bay-wide hip-roofed porch sheltering the west entrance and its adjacent window, and the outline of a similar porch which had been removed from the east entrance.

SOUTH FACADE

A recent campaign of stabilization and limited restoration involved the replacement of window sash with six-over-six, true divided light units similar in configuration to the original sash, replacement of all exterior doors with stock colonial six-panel doors on the ground floor and new batten doors in the basement, replacement of deteriorated window sills, and installation of a new wood shingle roof. In addition, a fire protection system was installed. Current plans call for thorough rehabilitation of the building to serve as museum and office space.

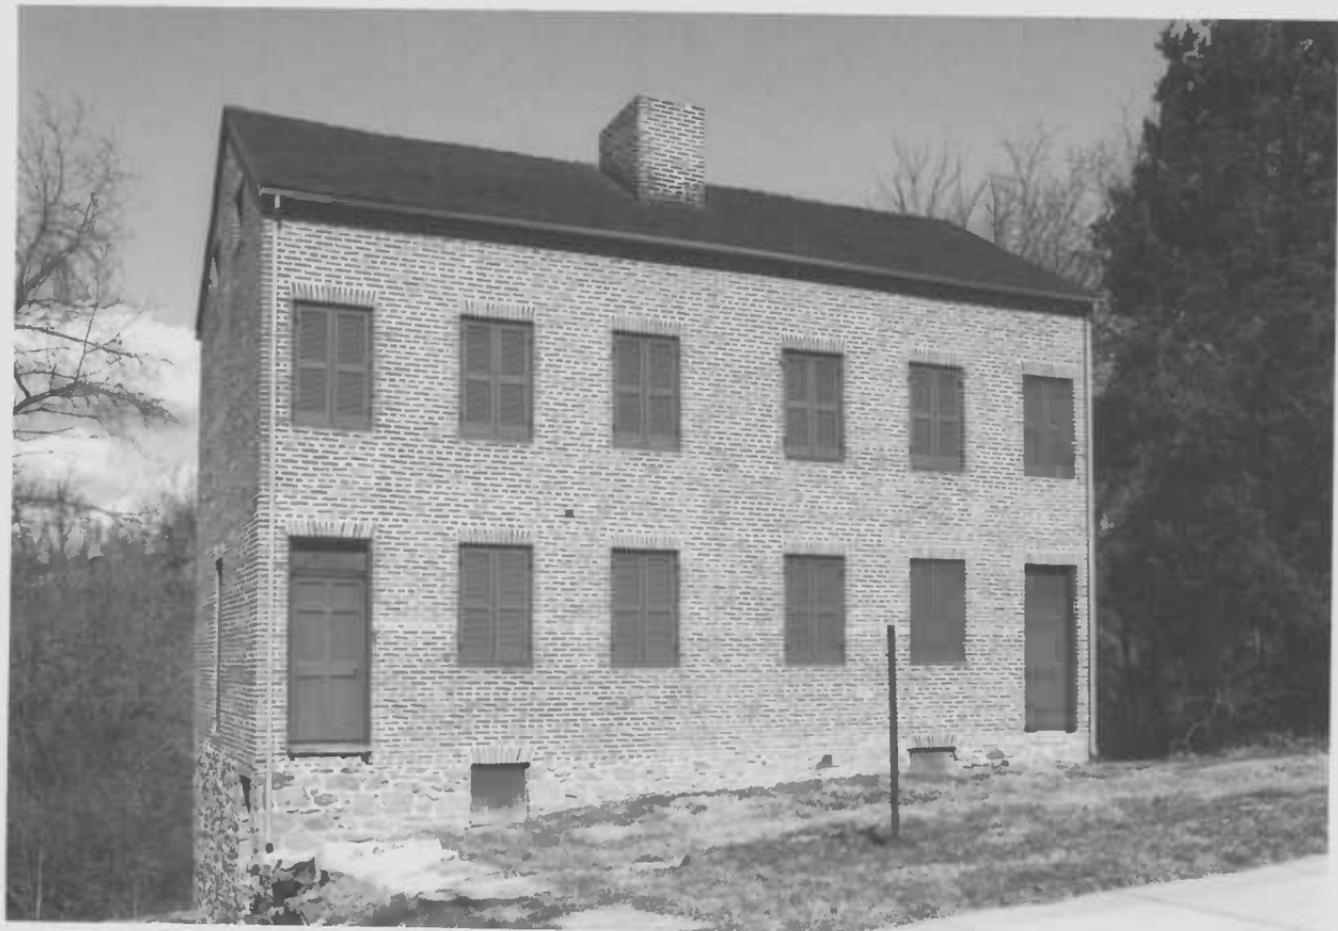
2 OF 9

The west gable end has a basement entrance near its south corner; a stone and brick retaining wall extends to the south. A transomed entrance is approximately centered at ground-floor level; the topography indicates that this entrance was undoubtedly originally served by a porch and flight of steps. Two small casements in the gable peak light the attic.

VIEW FROM SOUTHWEST

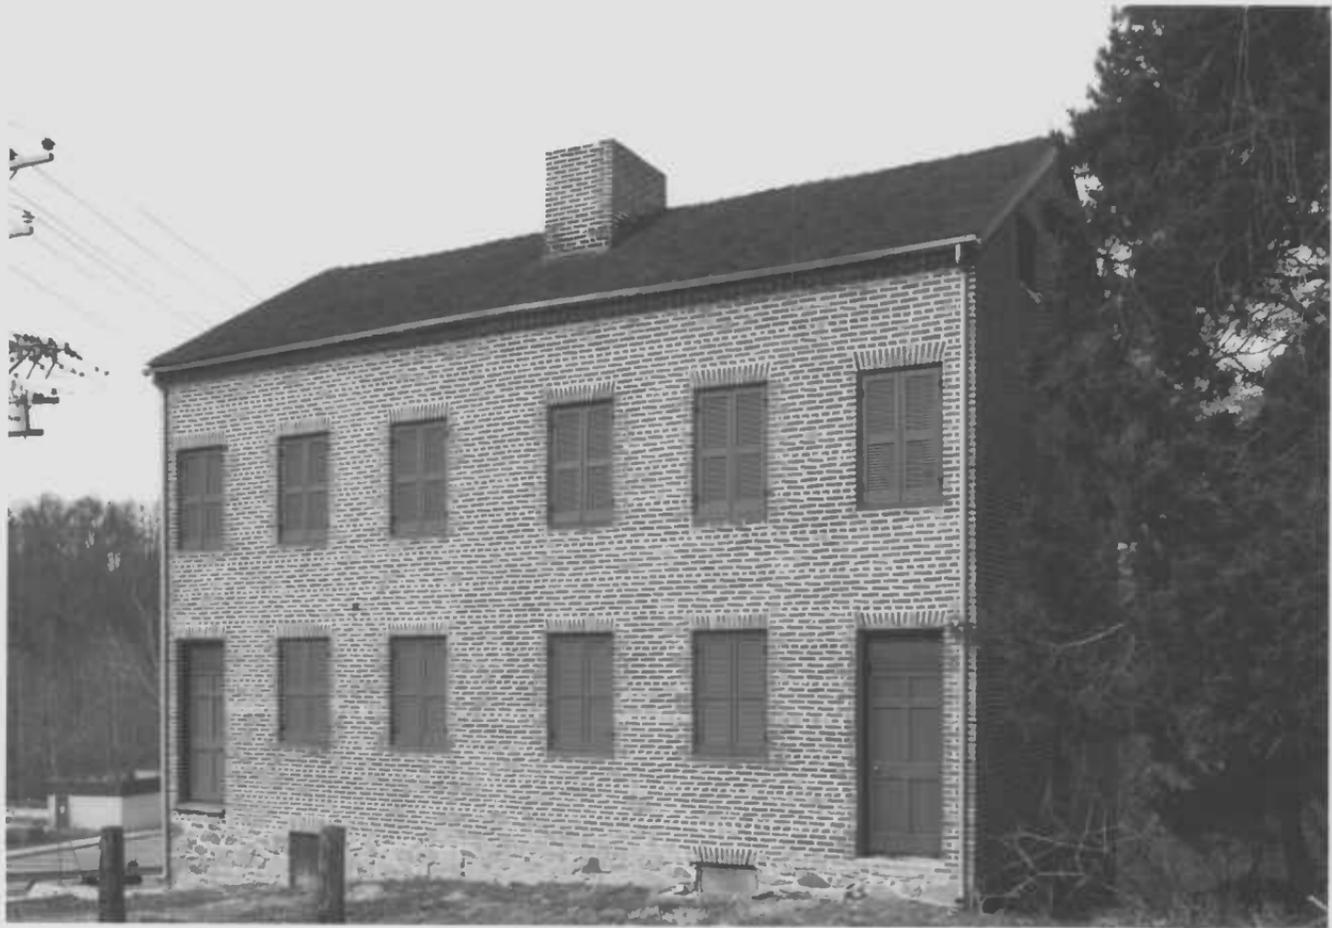
3 OF 9

The east gable end is fenestrated similarly. At this end, the higher ground level necessitated an excavated areaway for access to the basement entrance, which was located near the south corner;

this entrance has been blocked, creating a basement window, but evidence of its original configuration is clearly visible on the interior. The areaway also has been infilled, but the outline of its retaining walls appear on the ground surface. There is an approximately-central entrance a short distance above ground level, and two casements in the gable peak.

VIEW FROM SOUTHEAST

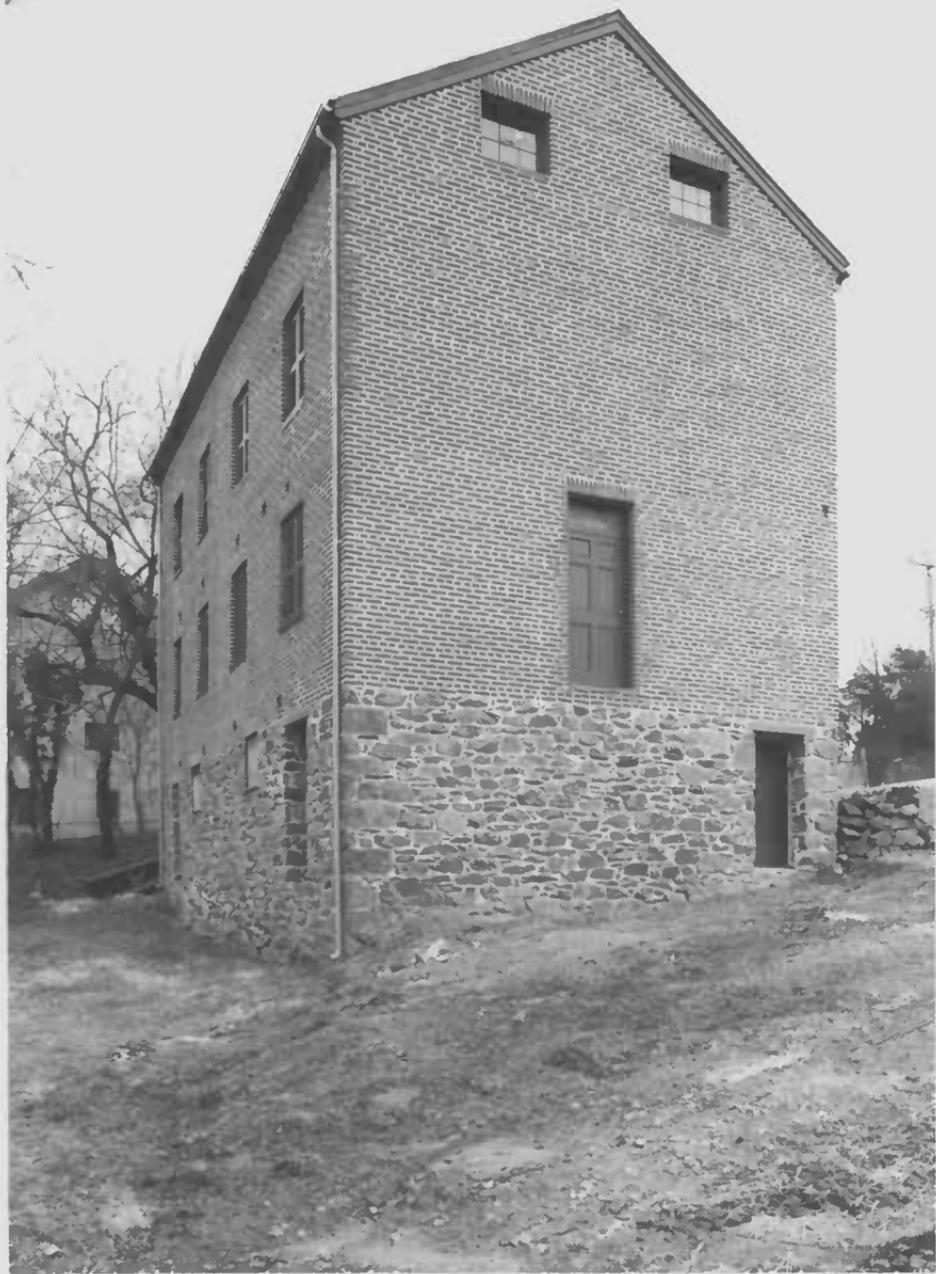
4 OF 9

The rear elevation is four bays wide. As noted above, the basement level is fully exposed, and comprises an entrance in each of the outer bays, with casement windows in the inner bays. The ground- and second-floor openings hold six-over-six sash. Four cast-iron stars (the decorative ends of structural stabilizing rods) appear at the first- and second-floor levels. Details of the window openings and brickwork are identical to the south facade.

VIEW FROM NORTHWEST

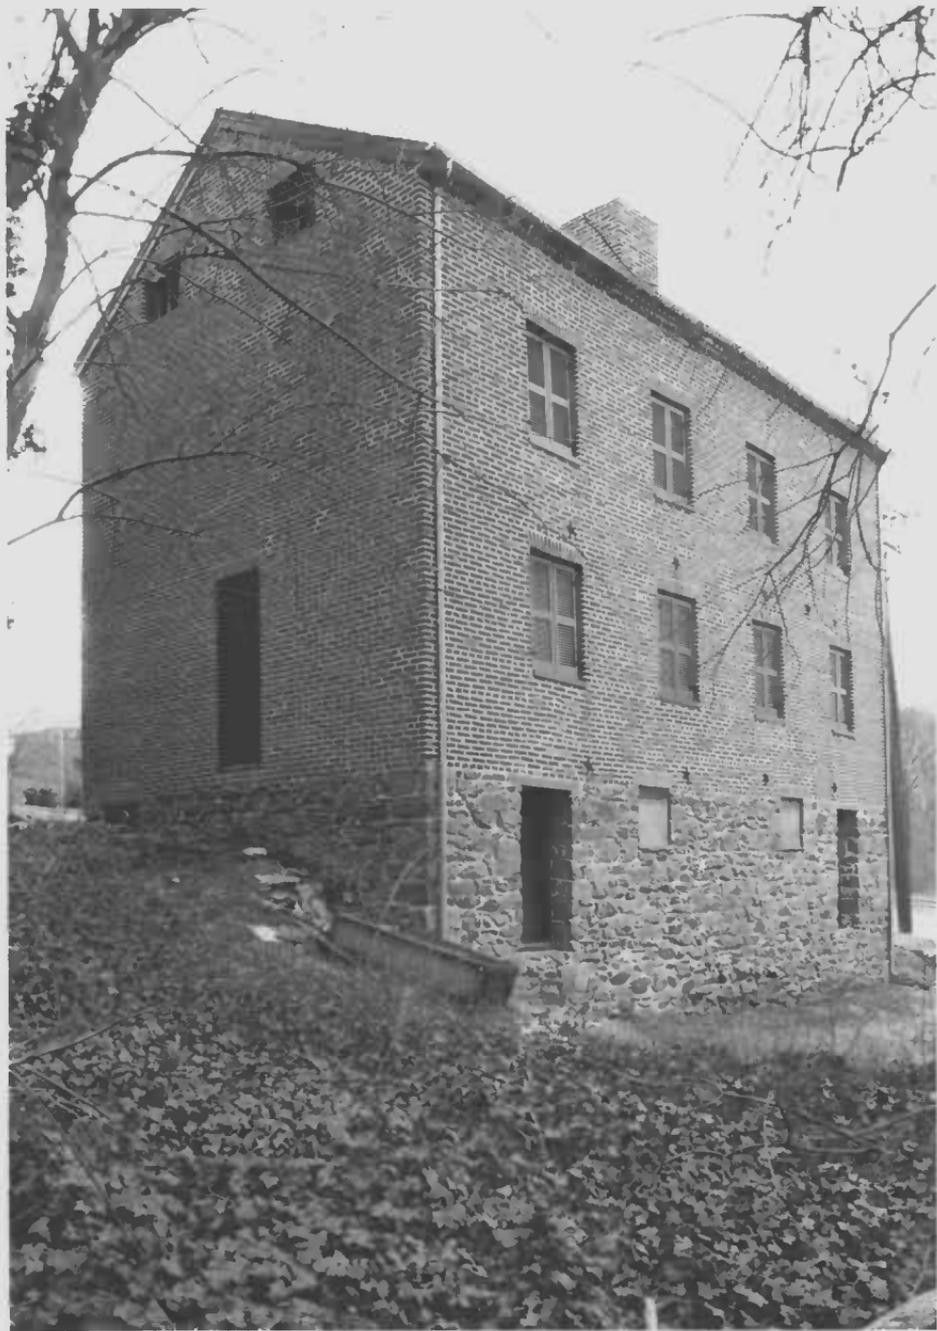
5 of 9

VIEW FROM NORTHEAST

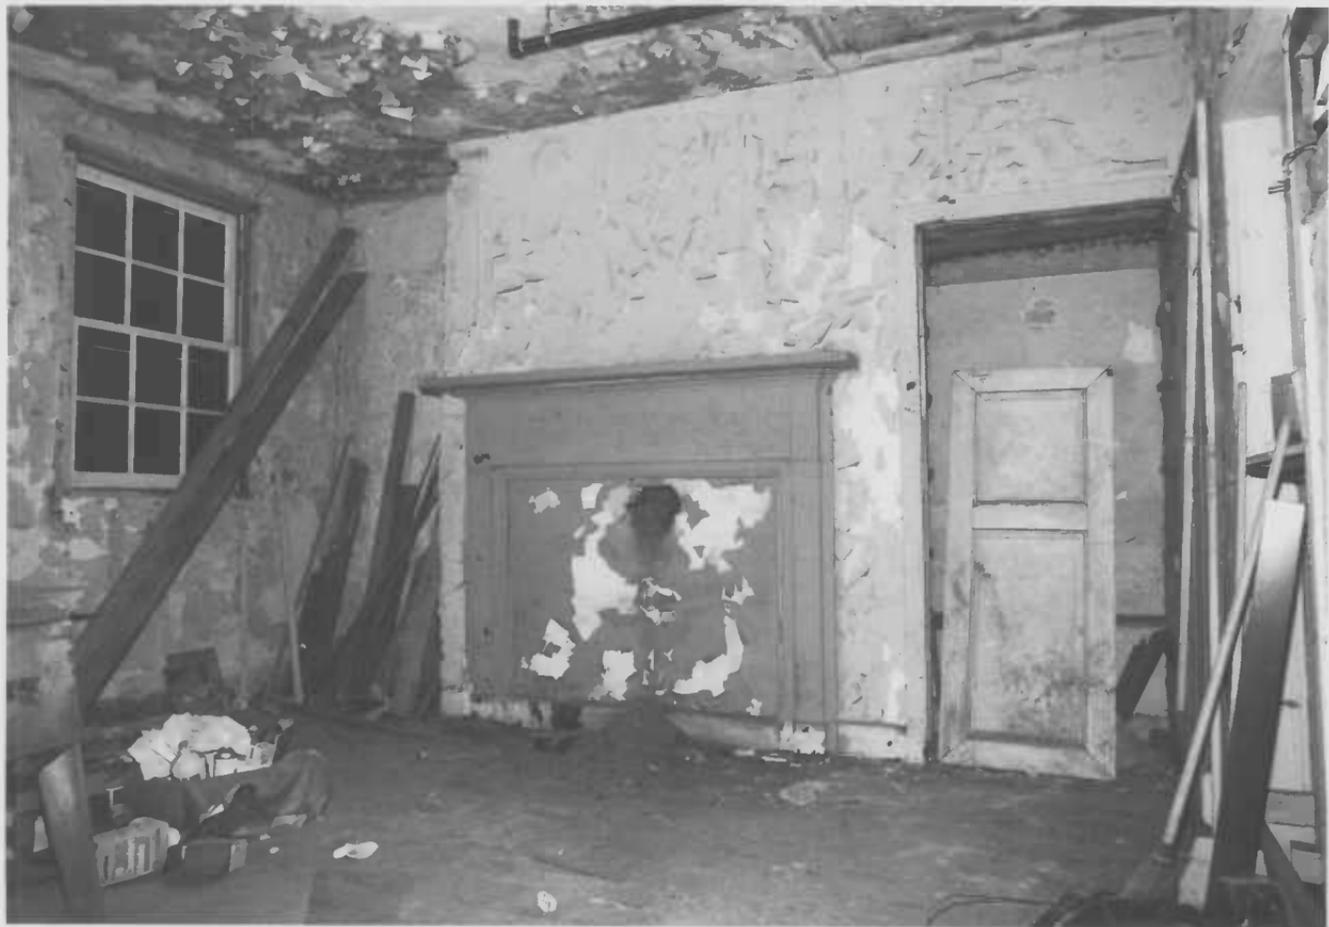
6 OF 9

The interior has undergone relatively little alteration. The most significant change is the removal of the partitions which separated the two rear rooms in all but the second floor eastern unit; where these partitions have been removed, clear evidence of their former location remains in the plaster walls and ceiling. Bathroom plumbing has been inserted into the second floor rear rooms, with pipe stacks running through the former closet area north of the fireplaces. In the late 19th or early 20th century, fittings for stove flues were inserted in the chimney stacks, and most of the first- and second-floor fireplaces were blocked.

FIRST FLOOR FRONT ROOM, EAST UNIT (#817)

CAMERA FACING SOUTHWEST

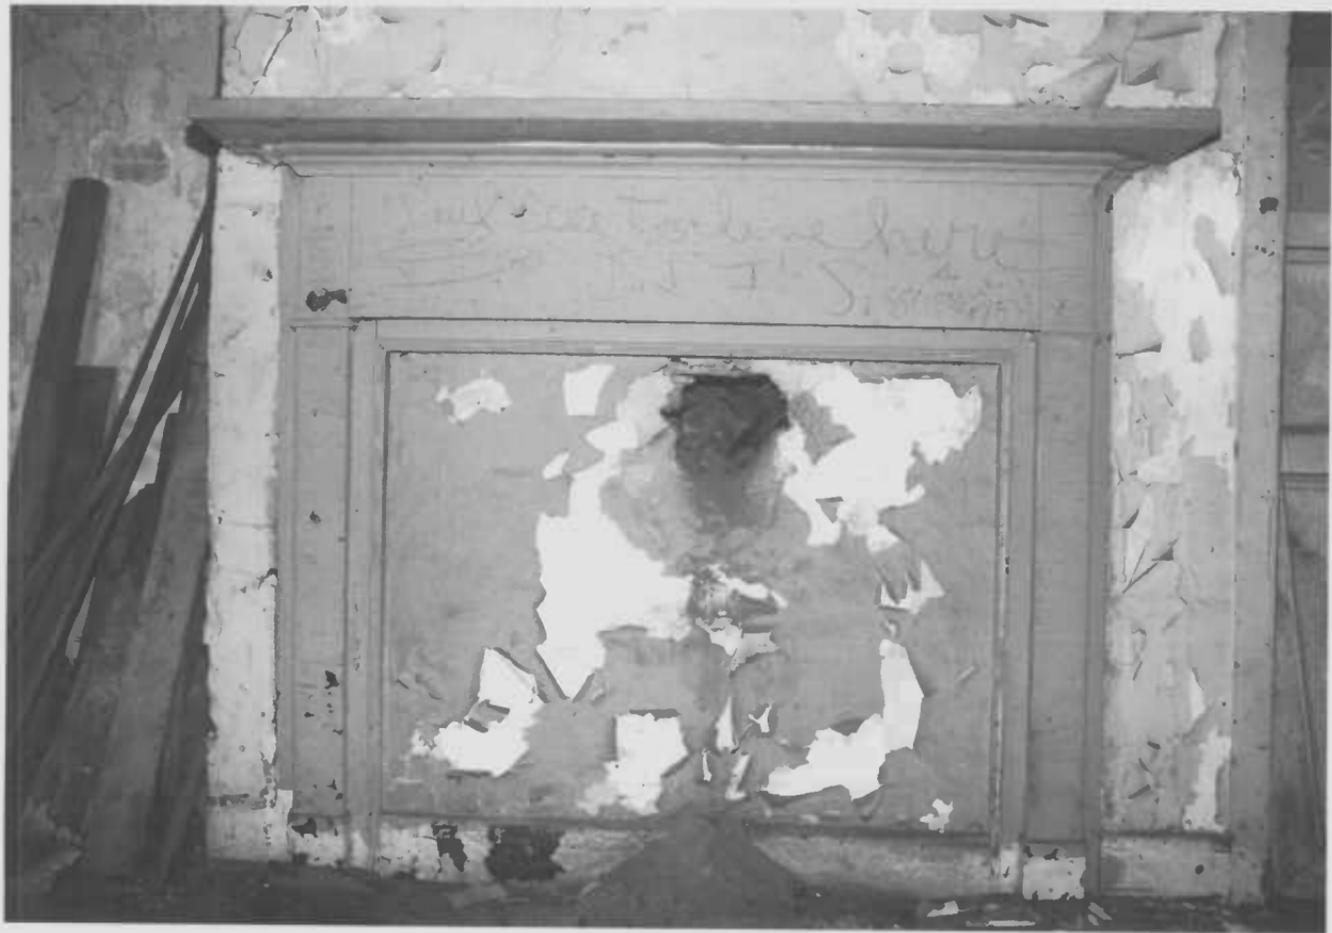
7 OF 9

MANTEL, FIRST FLOOR FRONT ROOM, EAST UNIT

(#817)

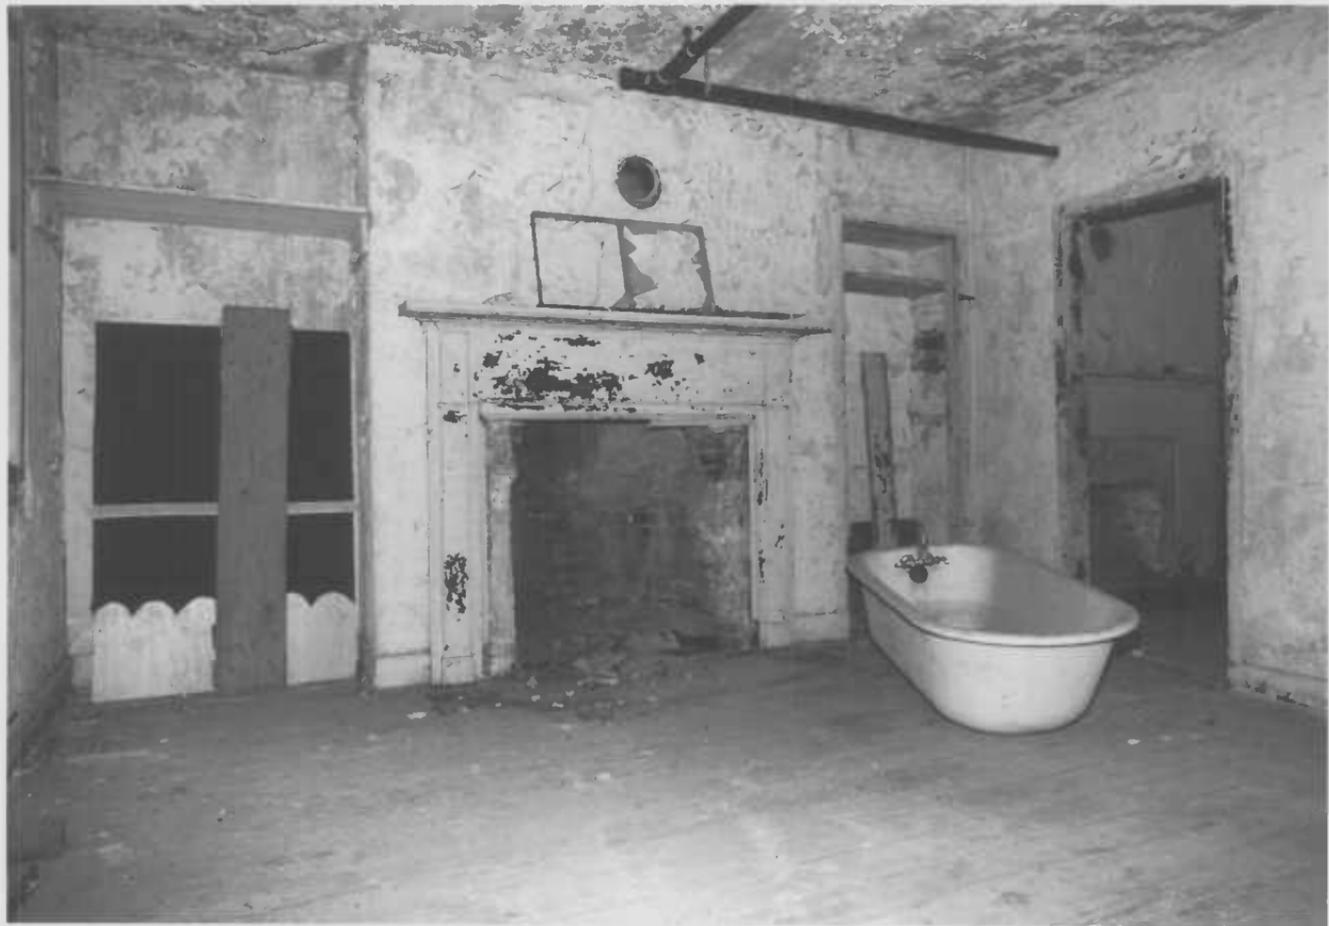
8 OF 9

SECOND FLOOR FRONT ROOM, EAST UNIT (E817)

CAMERA FACING NORTHWEST

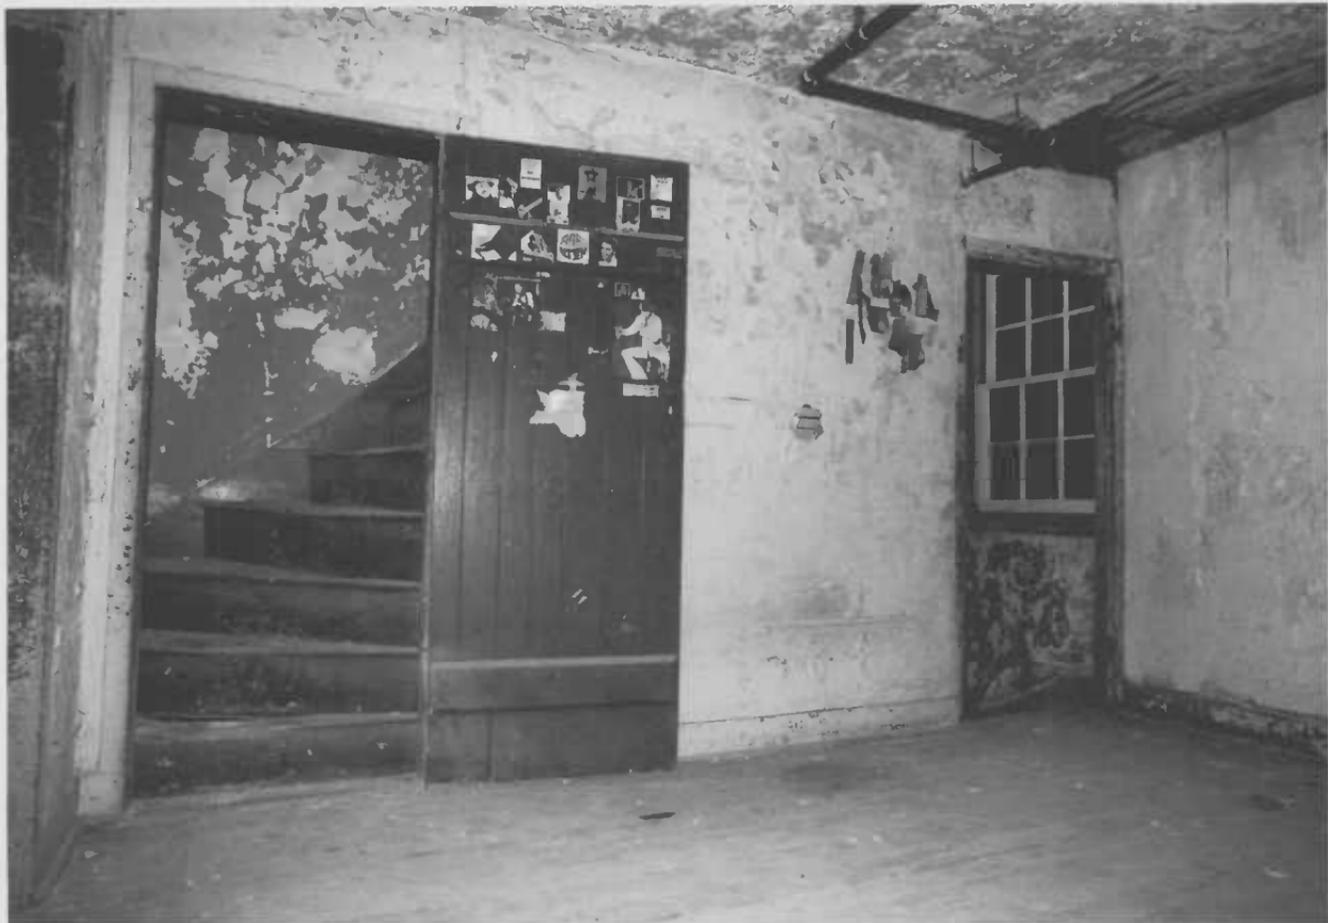
9 OF 9

SECOND FLOOR FRONT ROOM, EAST UNIT (#817)

CAMERA FACING EAST

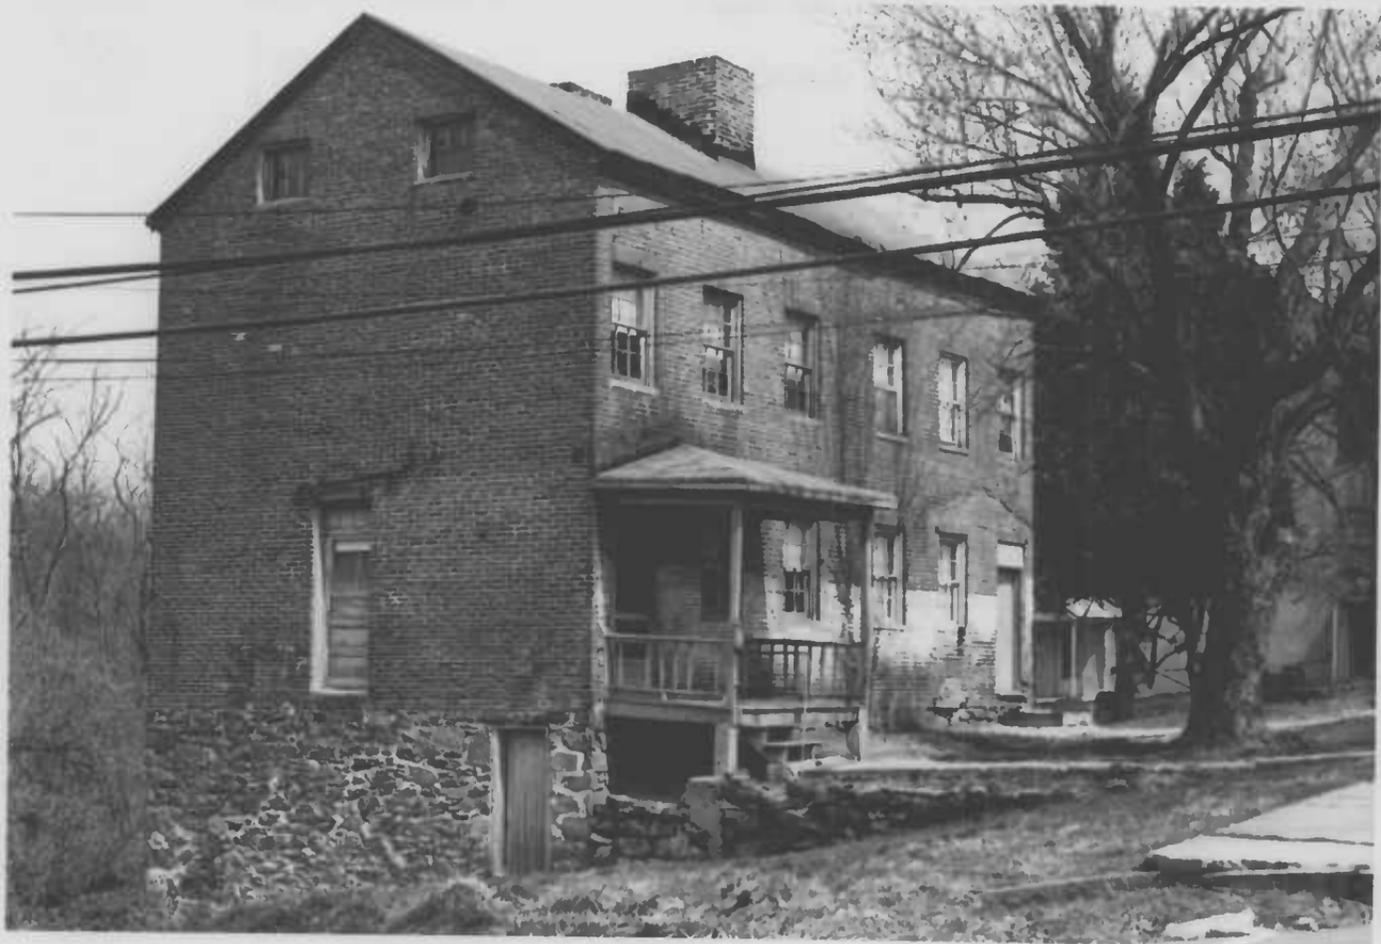
P.G. - Laurel - 1 - 7

FACADE SW
