Property Name: Building 10 Greenhouse Range 2 Survey Number: PG:61-18

RANGE 2, BELTSVILLE AGRICULTURAL RESEARCH CENTER

NATIONAL REGISTER OF HISTORIC PLACES  
REGISTRATION FORM

historic name Range 2, Beltsville Agricultural Research Center  
other names/site number Building 010

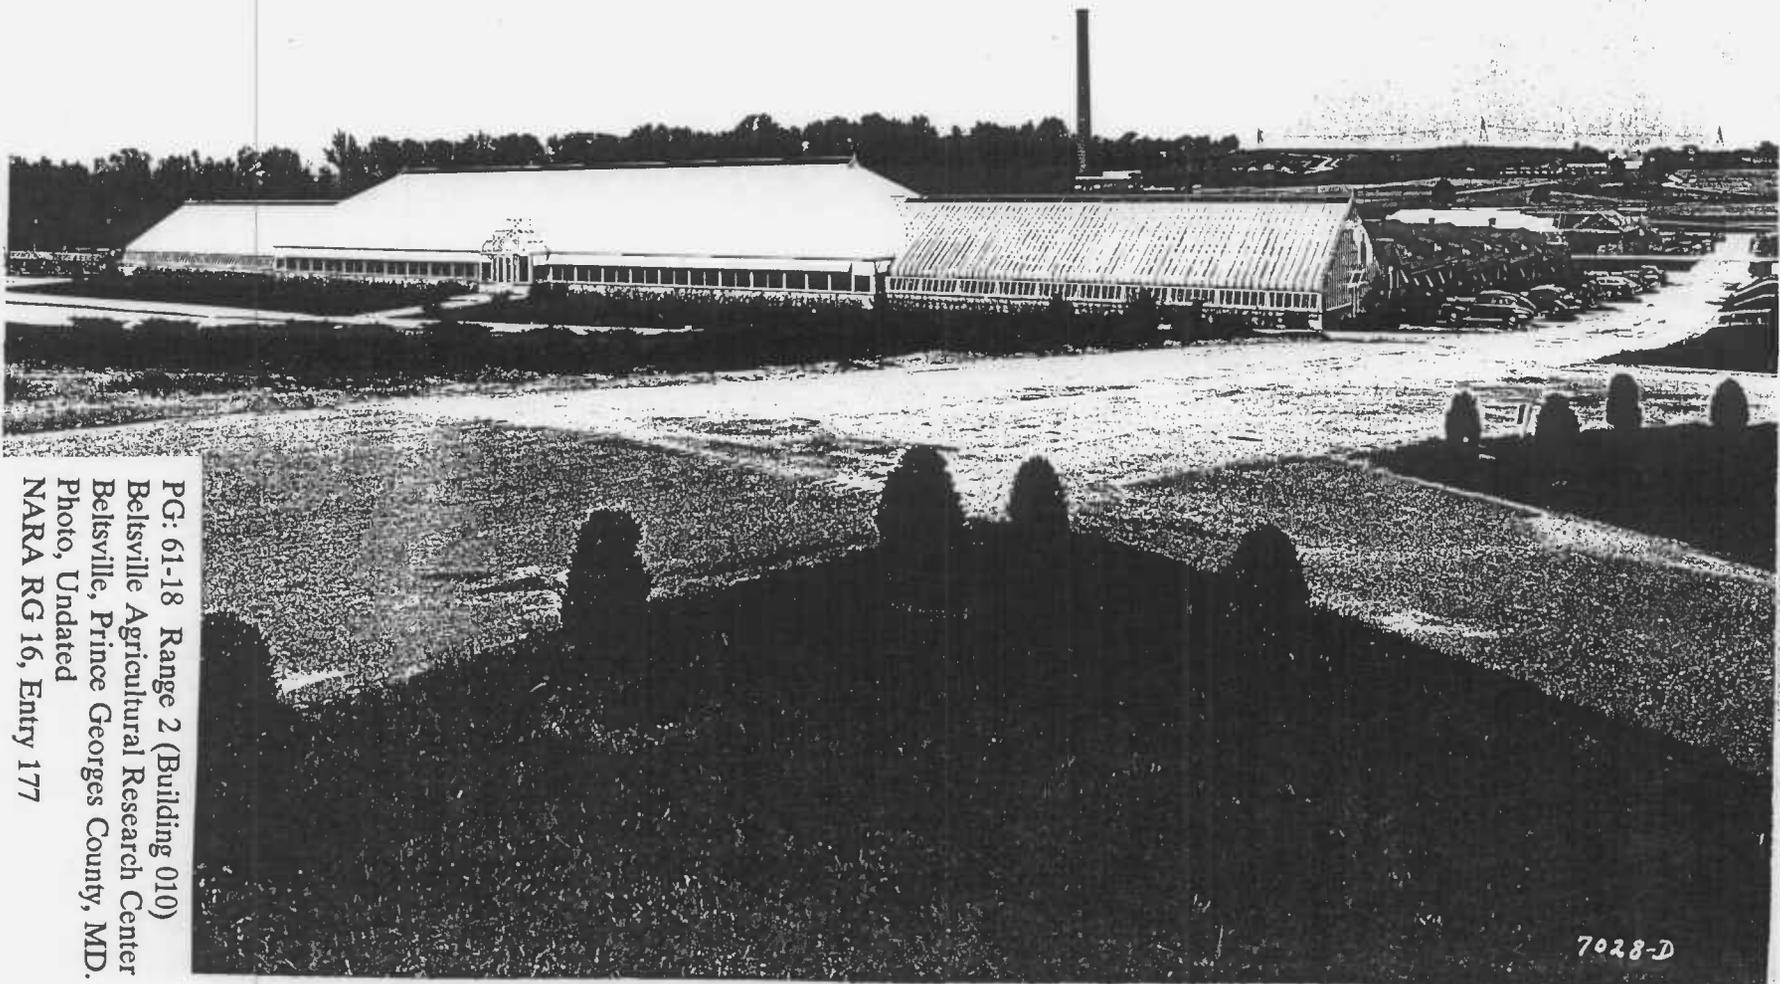
7028-D

PG: 61-18 Range 2 (Building 010)  
Beltsville Agricultural Research Center  
Beltsville, Prince Georges County, MD.  
Photo, Undated  
NARA RG 16, Entry 177

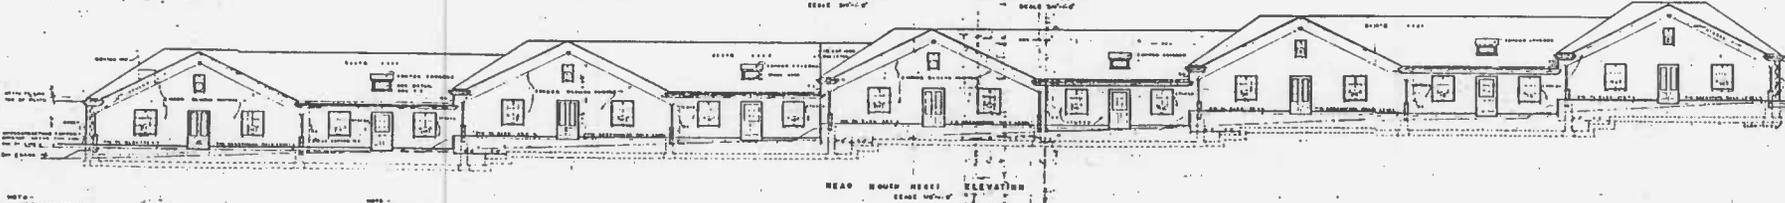
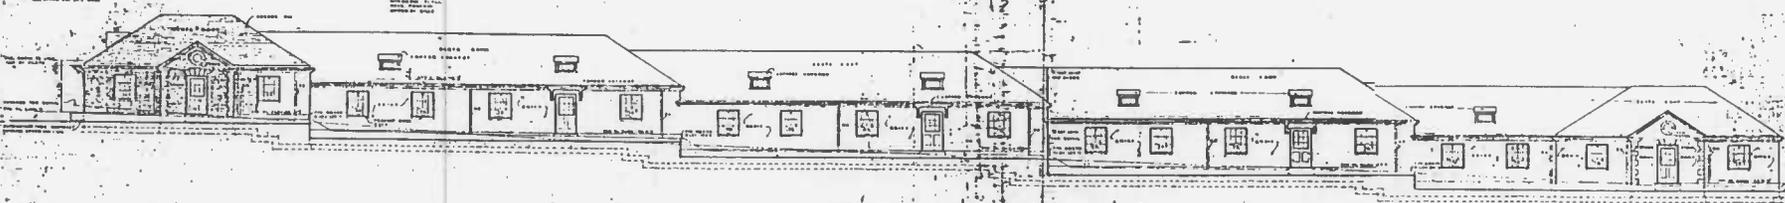
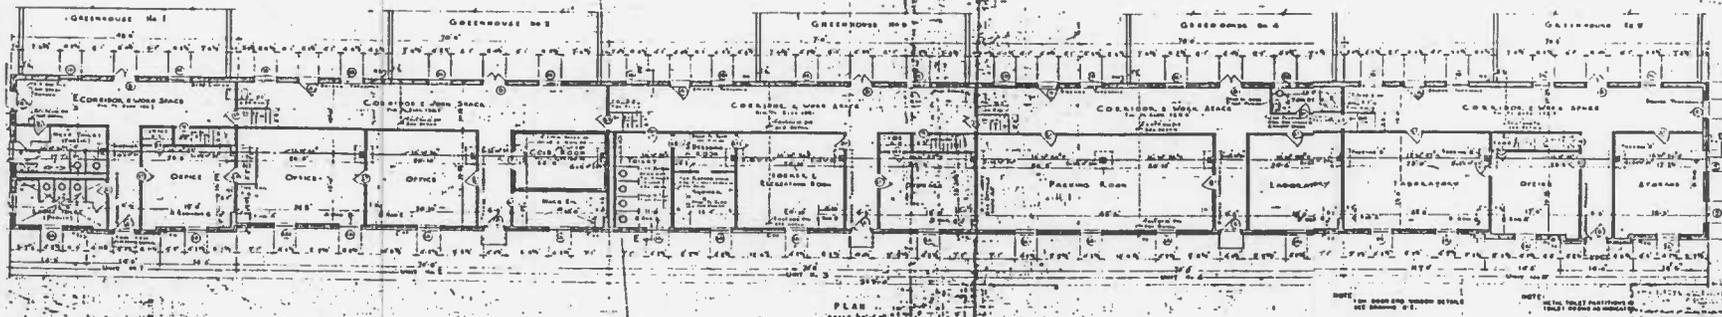
Plan (1938) Range 2 (Building 010)  
Beltsville Agricultural Research Center  
Beltsville, Prince Georges County, MD.

The Range 2 headhouse is 323 feet long and 30 feet wide. The building is separated into five stepped sections, each of which originally led to a separate greenhouse.

All five of the sections feature steel casement-style windows consisting of twelve panes, the central four of which pivot from the top. Doors throughout the building are half-glass with two vertical panels below and nine panes above.

The center three sections of the headhouse are largely identical. Each consists of five bays, with three windows to the east side, then a door, and a single window to the west. Downspouts located between the second and third windows and after the west window subdivide the stepped units into equal sections. This central portion of the building has a gabled roof with

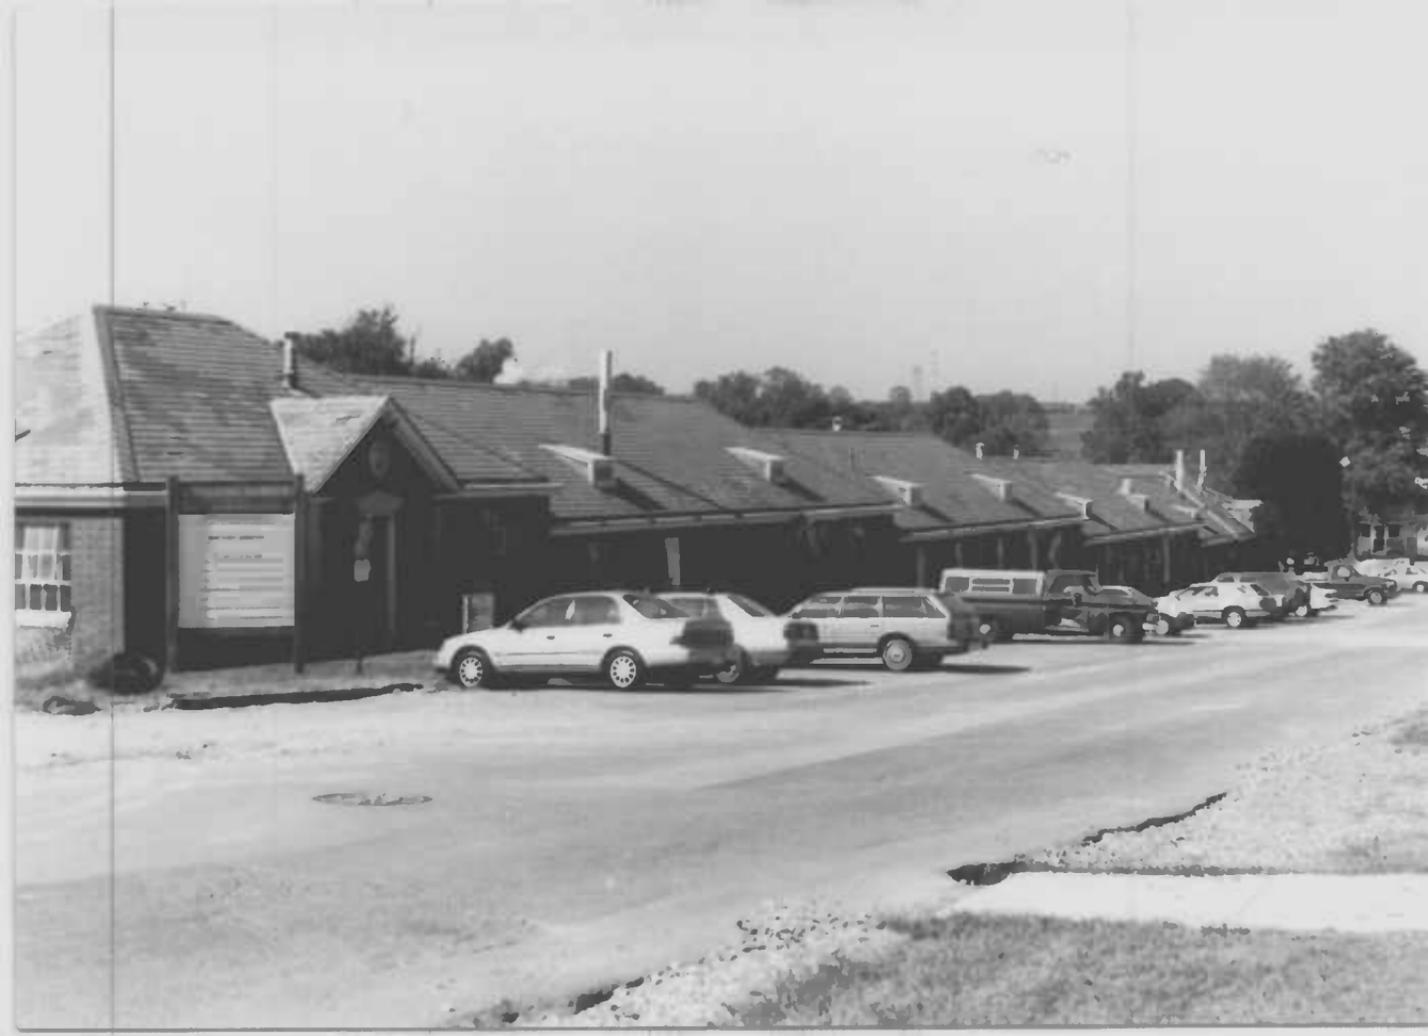
1/2

Front (Northeast) Facade

The front of the building faces northeast onto Range 2 Drive. Because of its sloped site, and to avoid shading the greenhouses, the headhouse is stepped to follow the contours of the topography.

The one-and-one-half story Georgian Revival building is of concrete block construction with brick veneer walls and concrete foundations. All downspouts and gutters are copper, and the roof throughout is of slate. Decorative detailing is limestone, with the exception of windowsills and interior door lintels, which are of cast stone.
