**INDIVIDUAL PROPERTY/DISTRICT  
MARYLAND HISTORICAL TRUST  
INTERNAL NR-ELIGIBILITY REVIEW FORM**

Property/District Name: Beltsville Agricultural Research Center Survey Number: PG :62-14

PG:62-14  
Beltsville Agricultural Research Center  
National Register-eligible Historic District  
Beltsville and Laurel Quadrangles

Beltsville Agricultural Research Center (BARC)  
Beltsville, Prince George's County, Maryland

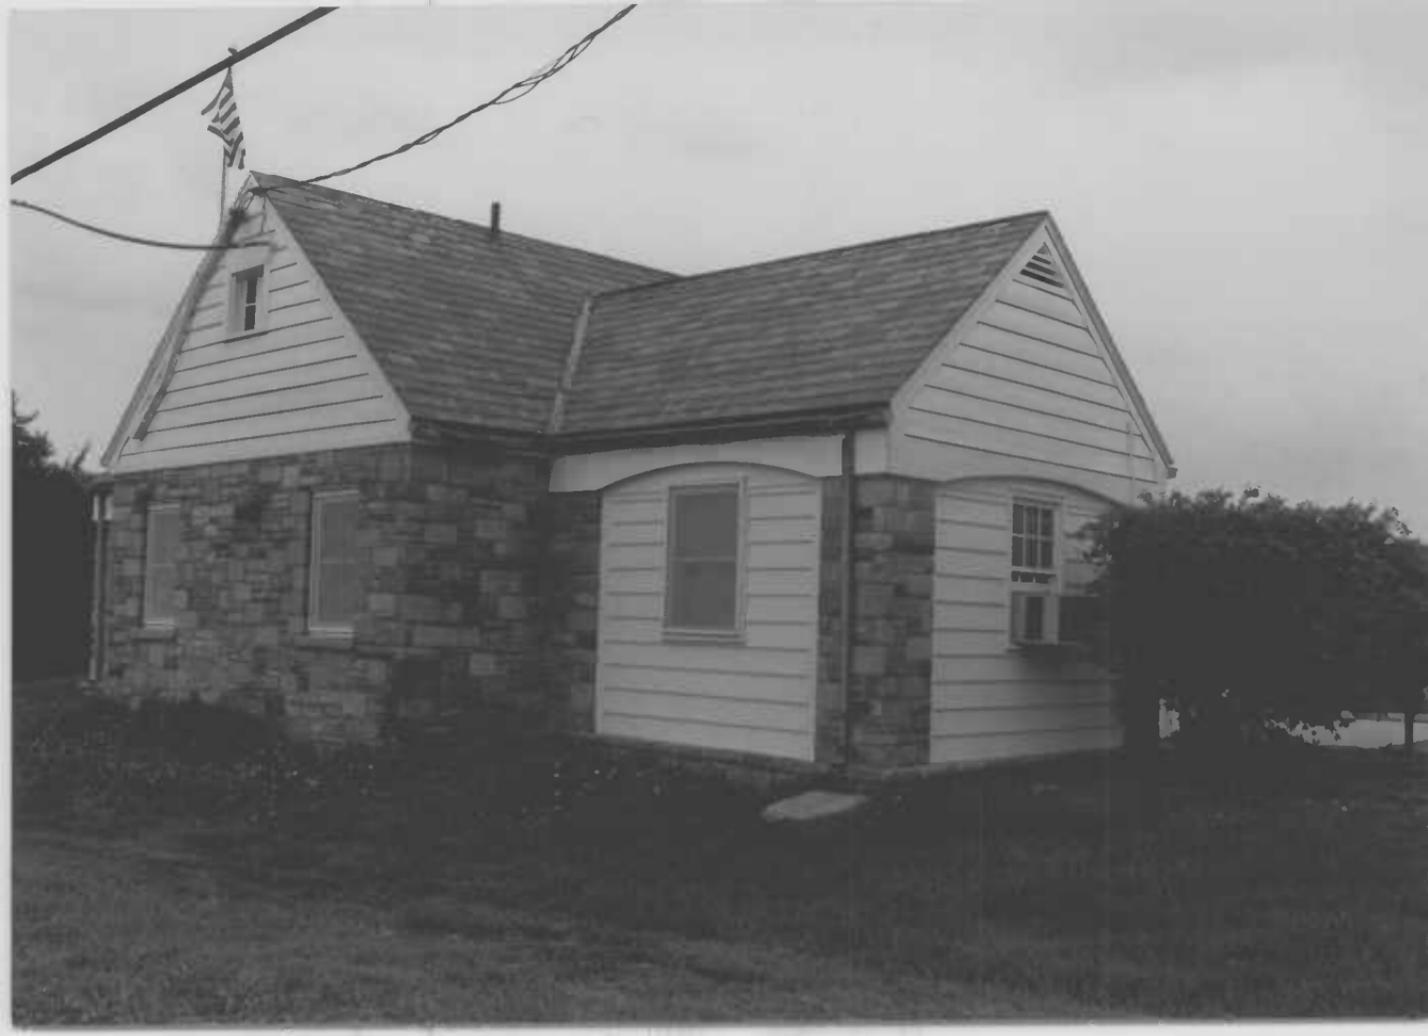
8 6 of 35

The first building is Building 156. It is located on the south side of Powder Mill Road, near its intersection with Edmonston Road. The building is identified as a guard's office on the map located on the BARC property, but it appears to be currently unoccupied. Plans for the building indicate that it was constructed in 1941 as a comfort station. In 1957, the building was used by Park Police and was later occupied by the BARC security force until the unit relocated to Building 186. The building is a 1-story, 5-bay, cross-gable structure. The building has projecting center gable-bays on the front and rear elevation. The structure has a cross-gable roof with slate shingles. It is of fieldstone and frame construction on a raised stone foundation. The windows are double-hung wood sash.

2 BHK Bldg 15.6 - grand office

7 SE corner

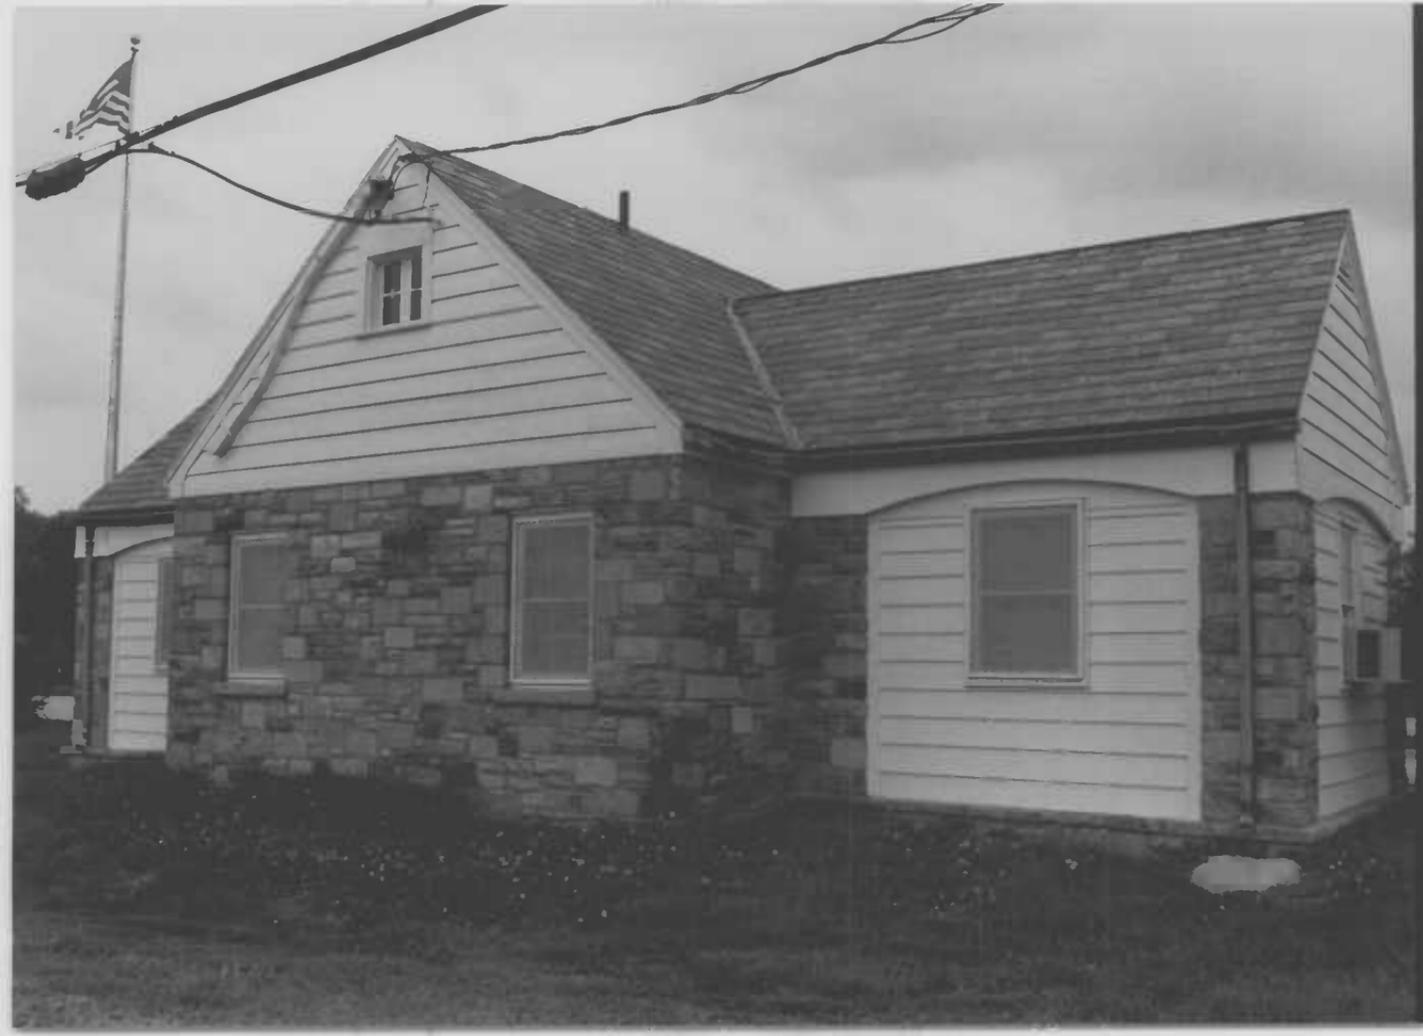
8. 5 of 35

The south, or rear elevation has a projecting gable-end stone center bay flanked by two frame side-gable wings. There are two 6/6 double-hung windows in the gable-end, and a 1/1 double-hung window in each of the flanking wings.

7. S elevation

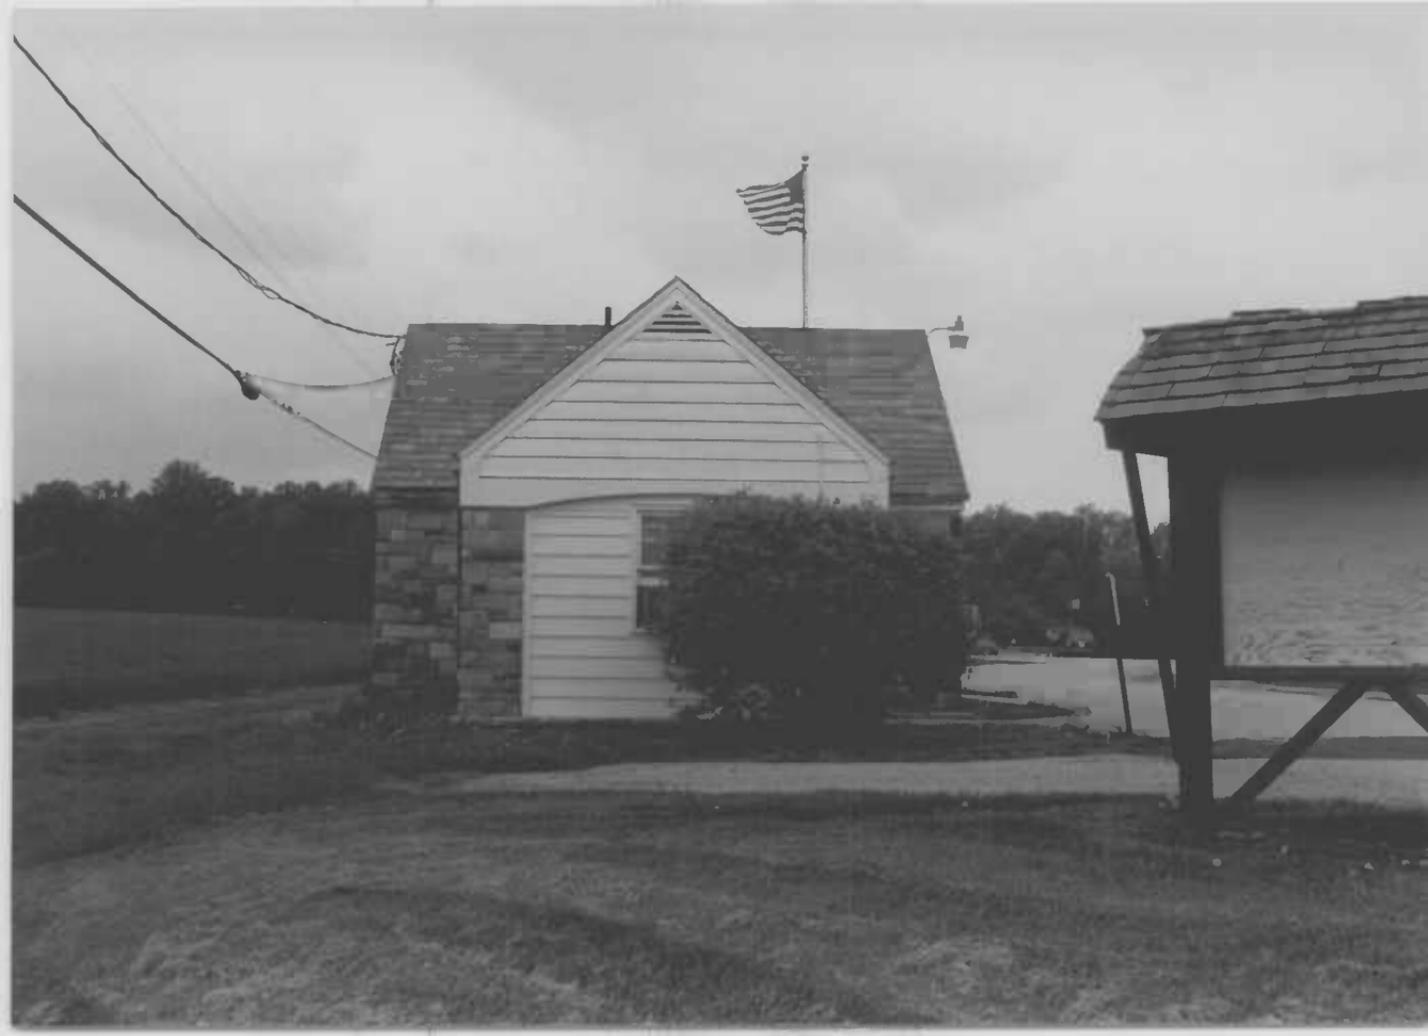
- 1 116 - 62 - 114
- 2 BARC King 156 - guard office
- 3 Prince Georges Co. MD
- 4 Susan Taylor
- 5 5/98
- 6 MD SHPO
- 7 E. locations
- 8 7 of 35

The east elevation has a raised stone foundation. The gable-end of the side wing projects from the center block. There is a 6/6 double-hung window centered on the gable-end, and a 4/4 double-hung window on the main block.

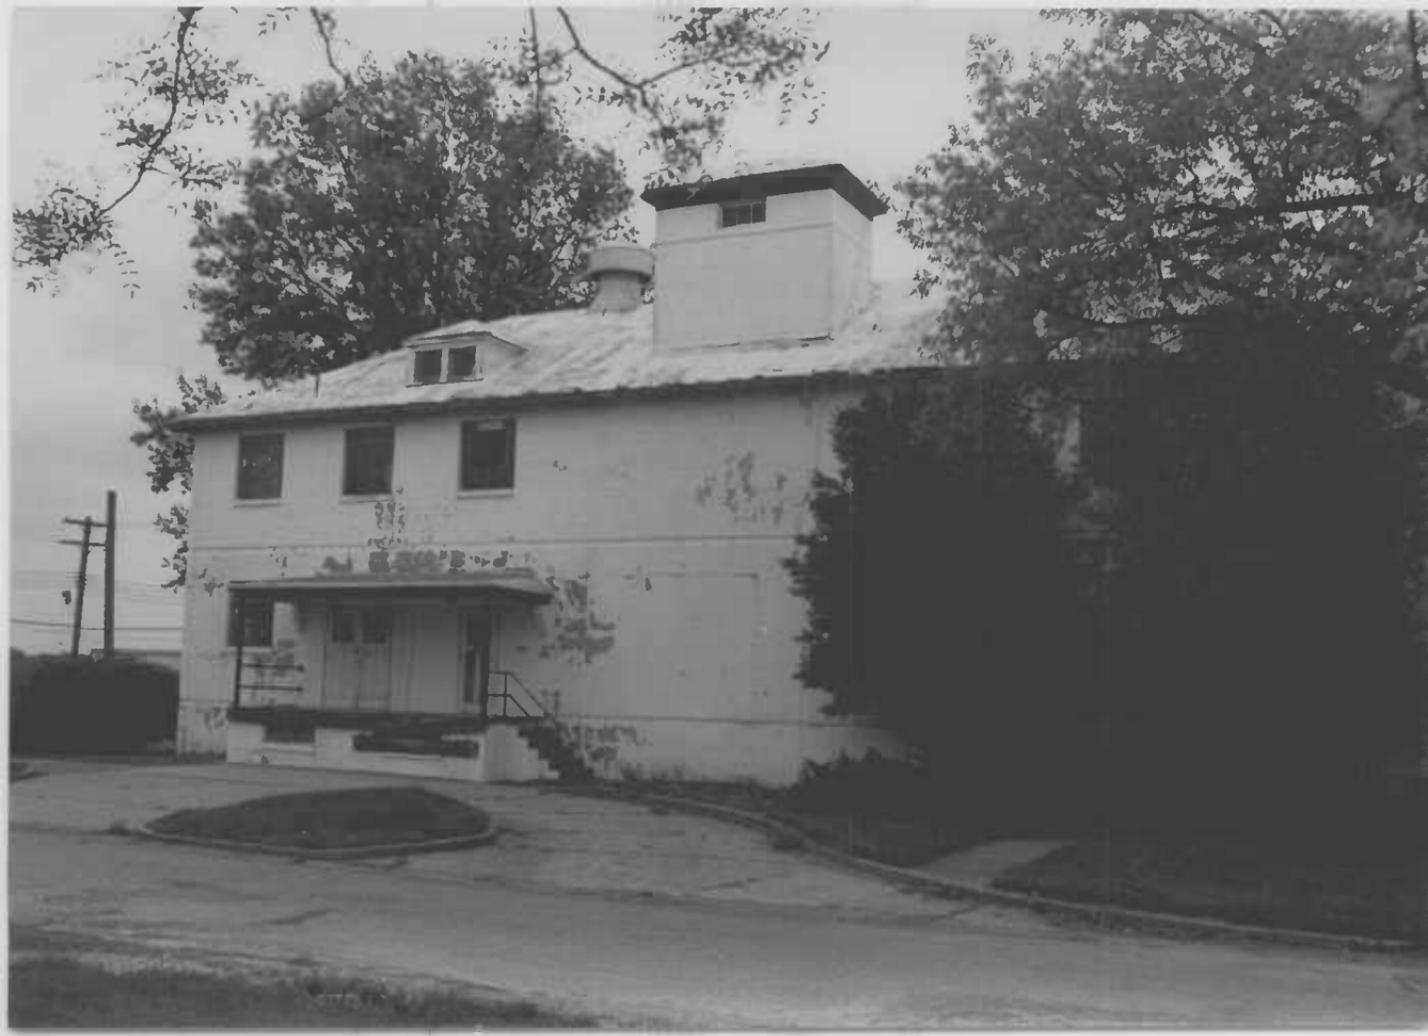
- 1 PG 62-7d
- 2 Park Bldg. 157. USDA Dairy
- 3 Prince George's Co MD
- 4 Susan Taylor
- 5 5/98
- 6 MD SHIP
- 7 West elevation
- 8 9 of 35

There is a rectangular tower on the east side of the building, with a hipped roof. Building 157 is located next to cultivated fields on the west. There are dairy barns and research facilities to the south of the building. USDA housing is on the other side of South Dairy Road, to the east. A semicircular drive leads from South Dairy Road to the loading dock on the east side of the building.

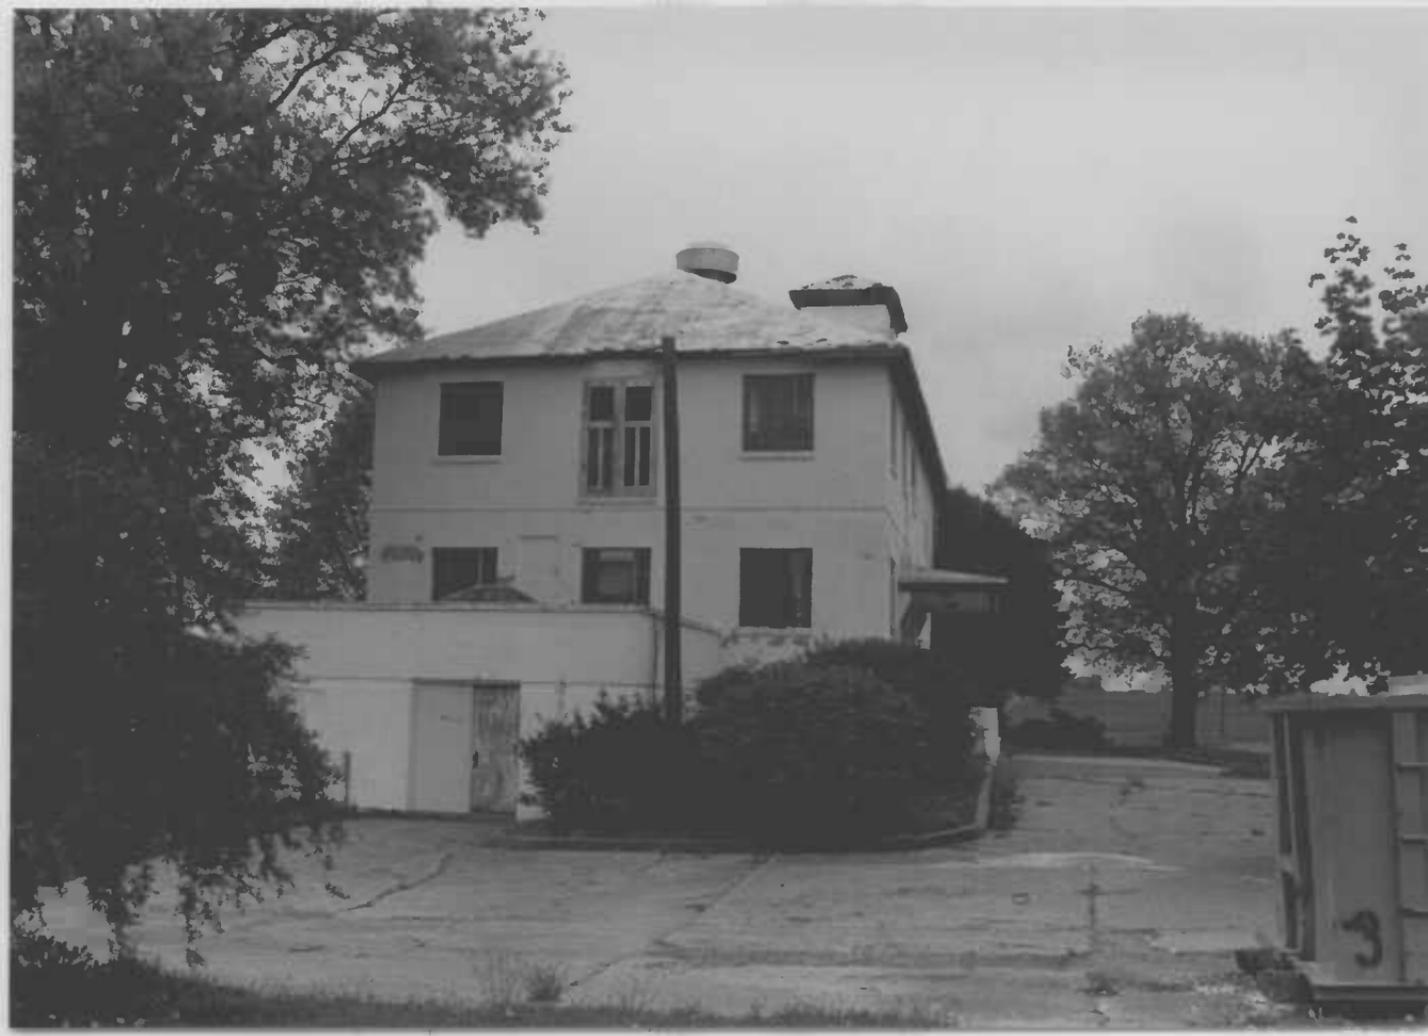
8 11 of 35

The south elevation has a 1-story concrete block garage/storage addition. There are three 16-light windows on the first story. The second story has two 16-light windows flanking central double doors. The west elevation has four 8-light windows on the basement level. There are eight 16-light windows on the first floor. The second floor has seven 16-light windows, and a fire-escape door, reached by a set of metal steps.

7 S elevation

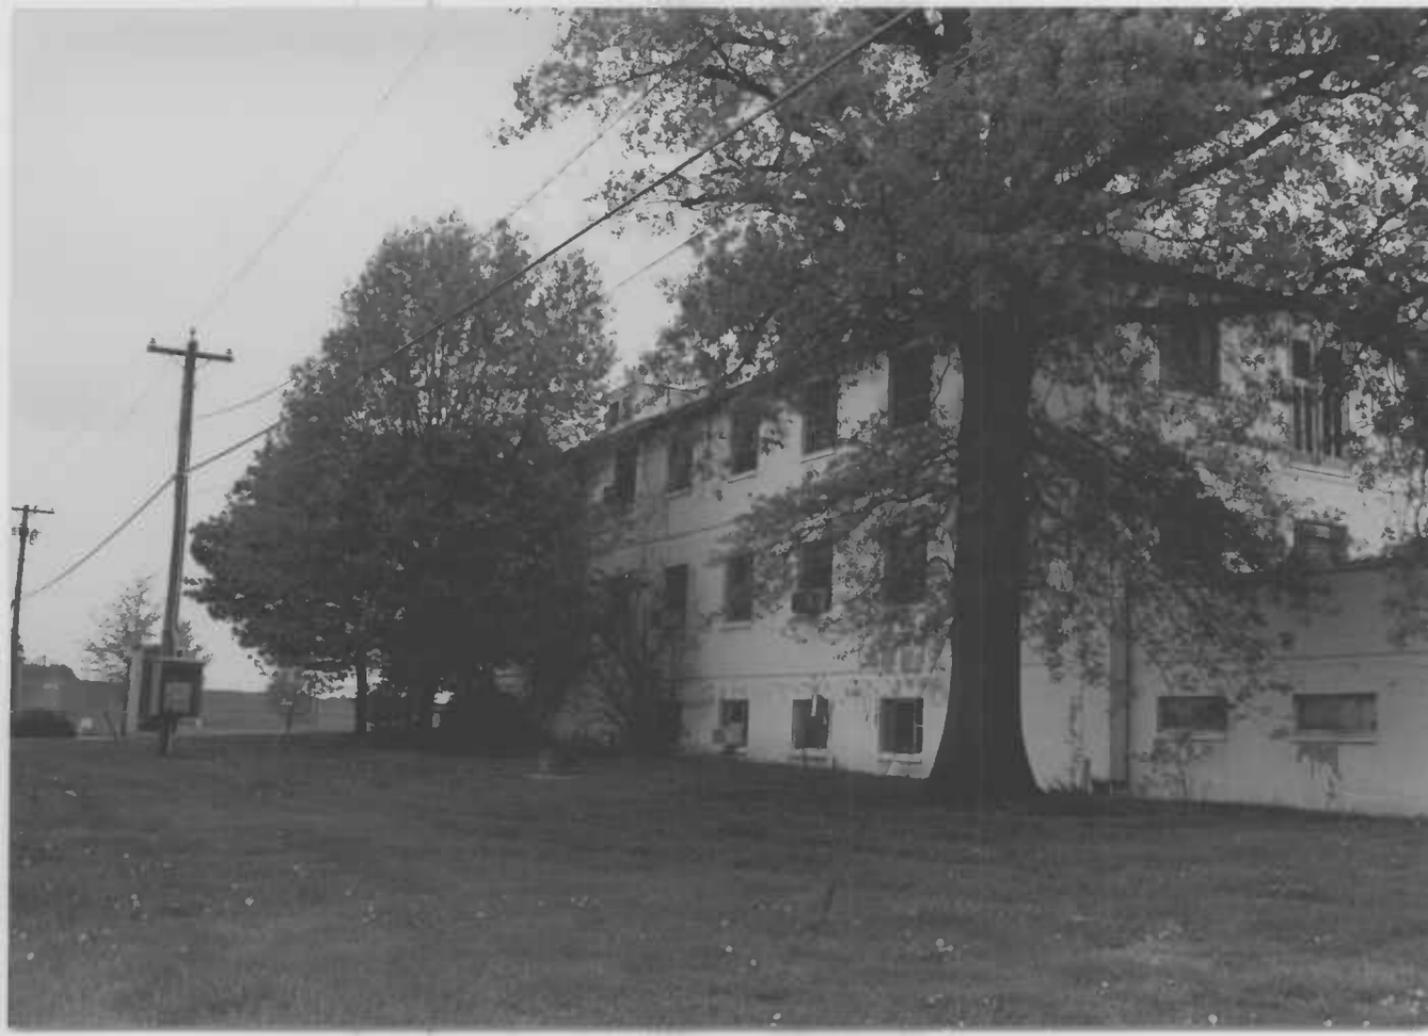
8 13 of 35

The east, or front elevation faces onto South Dairy Road. It is 4-bays wide. The basement level has two fixed-light windows in the loading dock foundation. There is a 16-light window in the first bay, a loading dock with a concrete foundation and hipped roof. The loading dock has double-doors and a single door in the second and third bays. The fourth bay contains the main entrance, and a set of double-doors reached by a set of concrete steps. There are four 16-light windows on the second story. There are two hipped-roof dormers, each with two 6-light windows.

7 E elevation

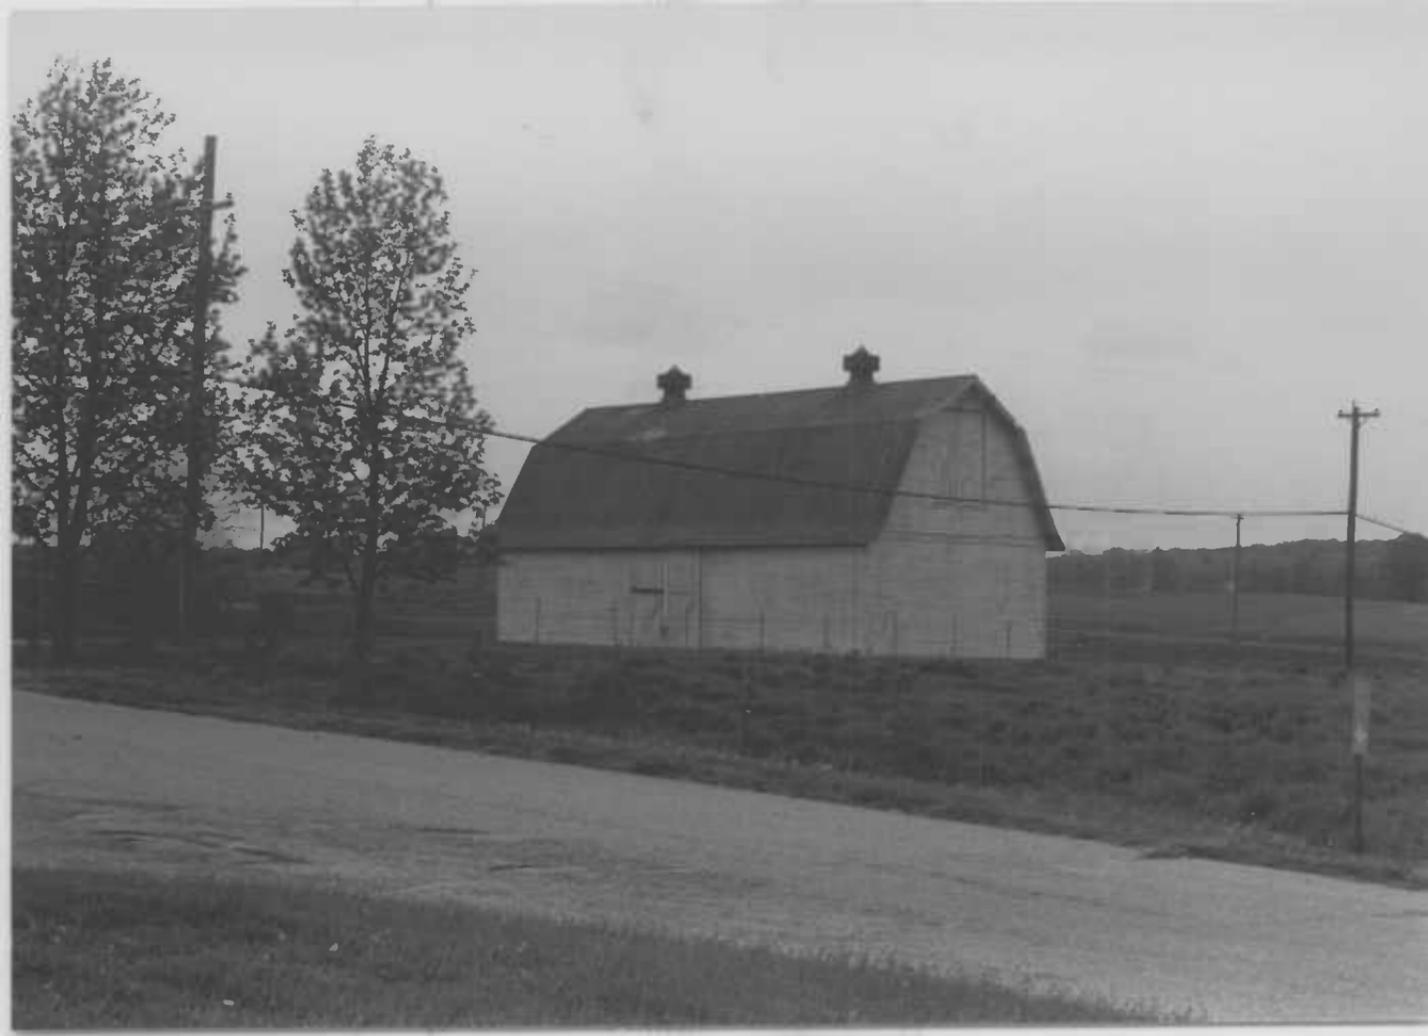
8 26 of 35

Building 188, a gambrel-roof barn, is located to the northeast of the farmhouse. It is of wood-frame construction with weatherboard siding. The gambrel roof has two metal vents and is covered in diamond-pattern shingles. The barn has double braced doors in the hayloft on the south end, and double-braced doors on the west and east elevations. According to drawings, the barn was built in 1933 as a hay barn.

7 Gambel Roof Barn, Su Center

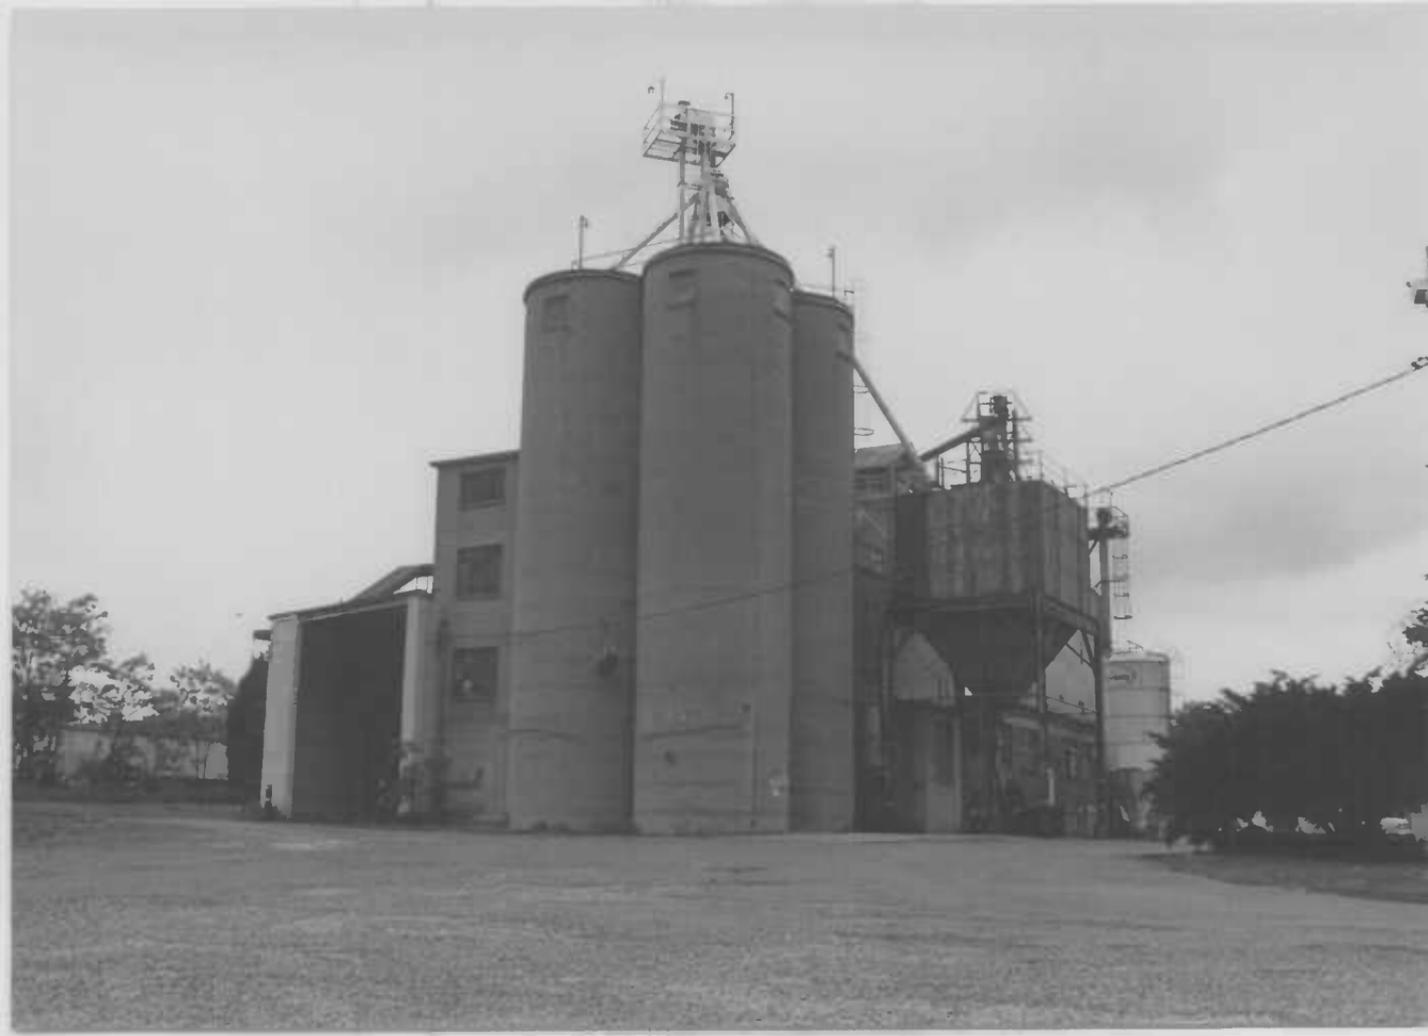
8 29 OF 35

different elevator which would discharge into the ground feed storage bins. Space was provided for four different types of mills, although the initial installation was to include the burr mill and the oat crusher only. A trolley hopper scale provided under the ground feed bins would weigh feeds to be mixed. From the hopper scale, the ground feed went to the second elevator and discharged into the feed mixer. Bagged grain elevated to the mixer would be dumped into a hopper at floor level on the second elevator. All mixed feed would be bagged directly from the feed mixer and hauled to the barns and stables as required.

7 1. Corn - grain elevator

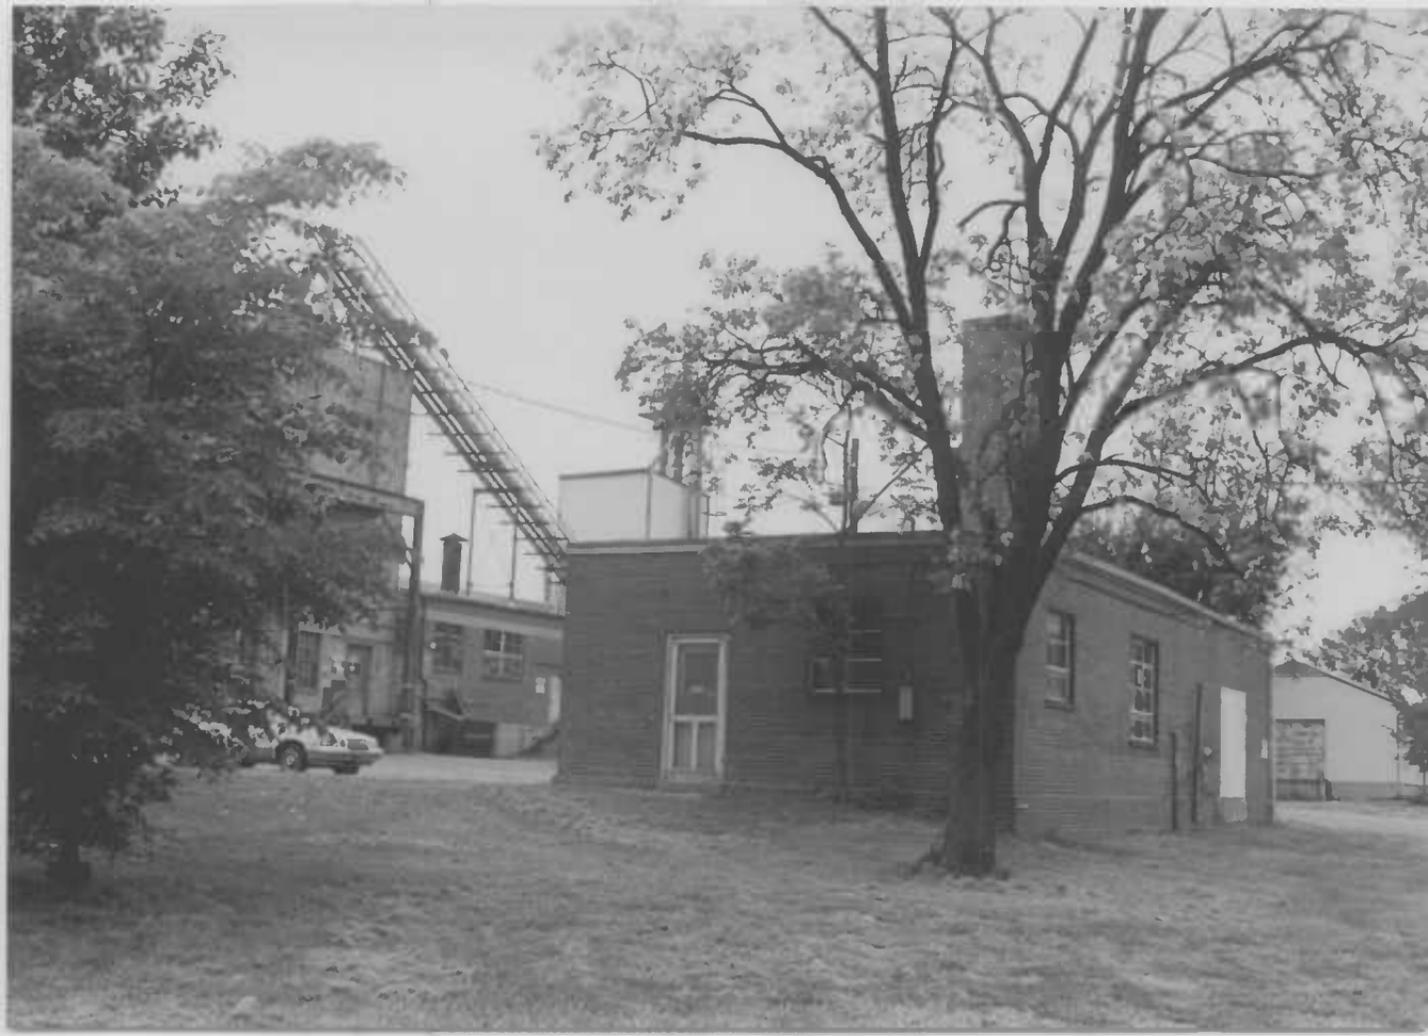
8 32 OF 35

A 1-story brick service building is located to the east of the main building. It has a flat roof and a large central brick chimney. It has 8-light metal frame windows and a door on the south elevation.

7 Service bldg

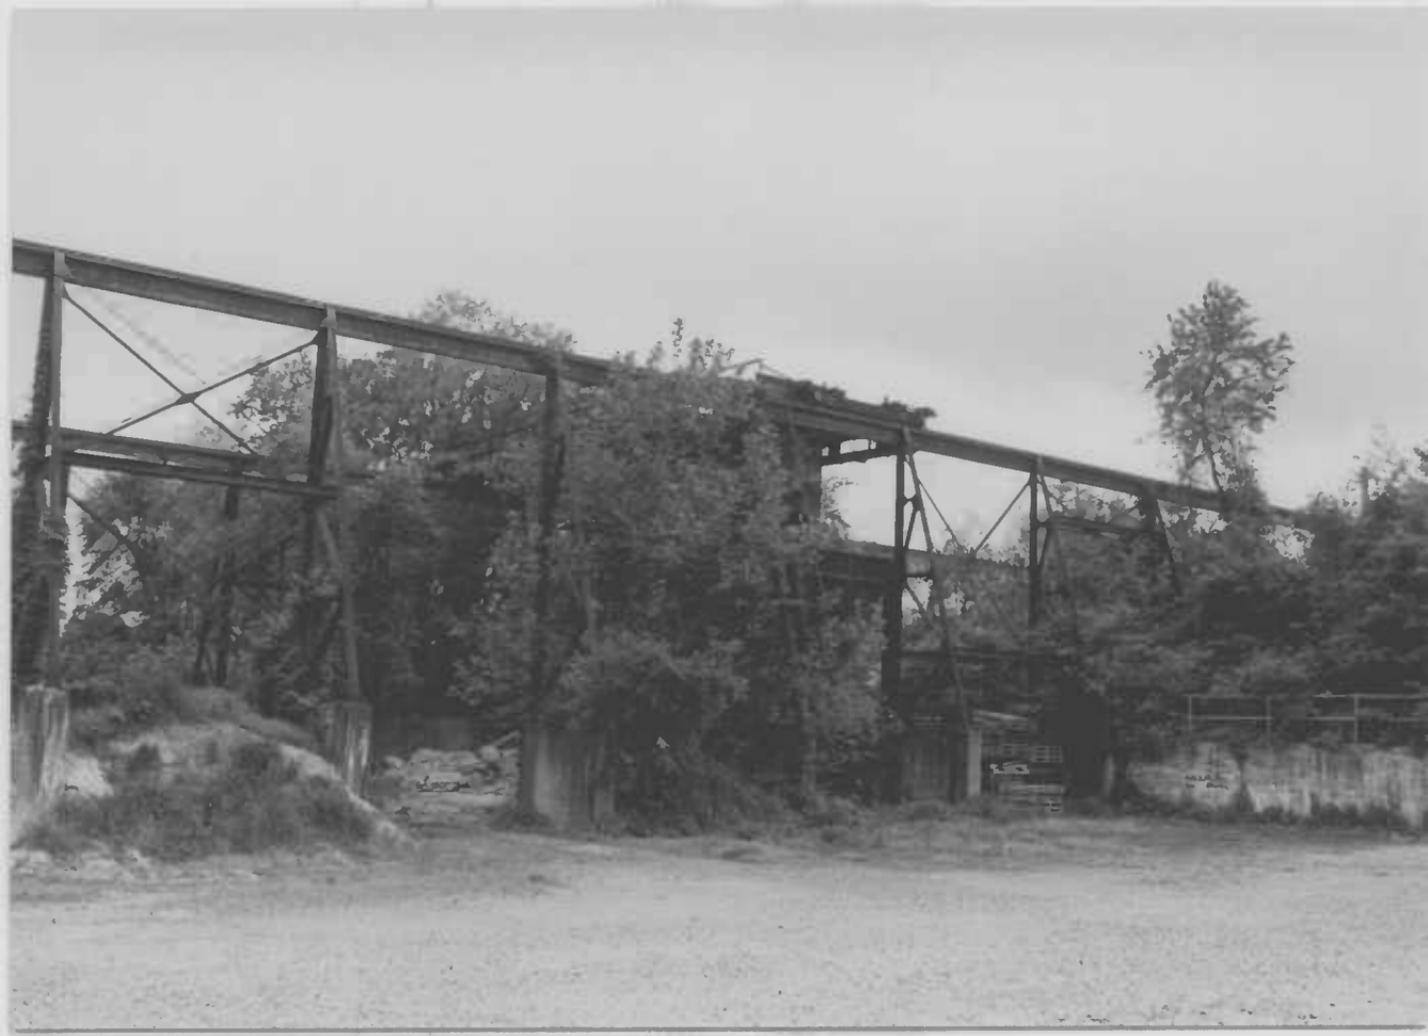
8 33 of 35

There is an elevated metal conveyor system on the south end of the complex, leading from the railroad. It is of rolled-metal girder construction on a concrete foundation.

7 Conveyer

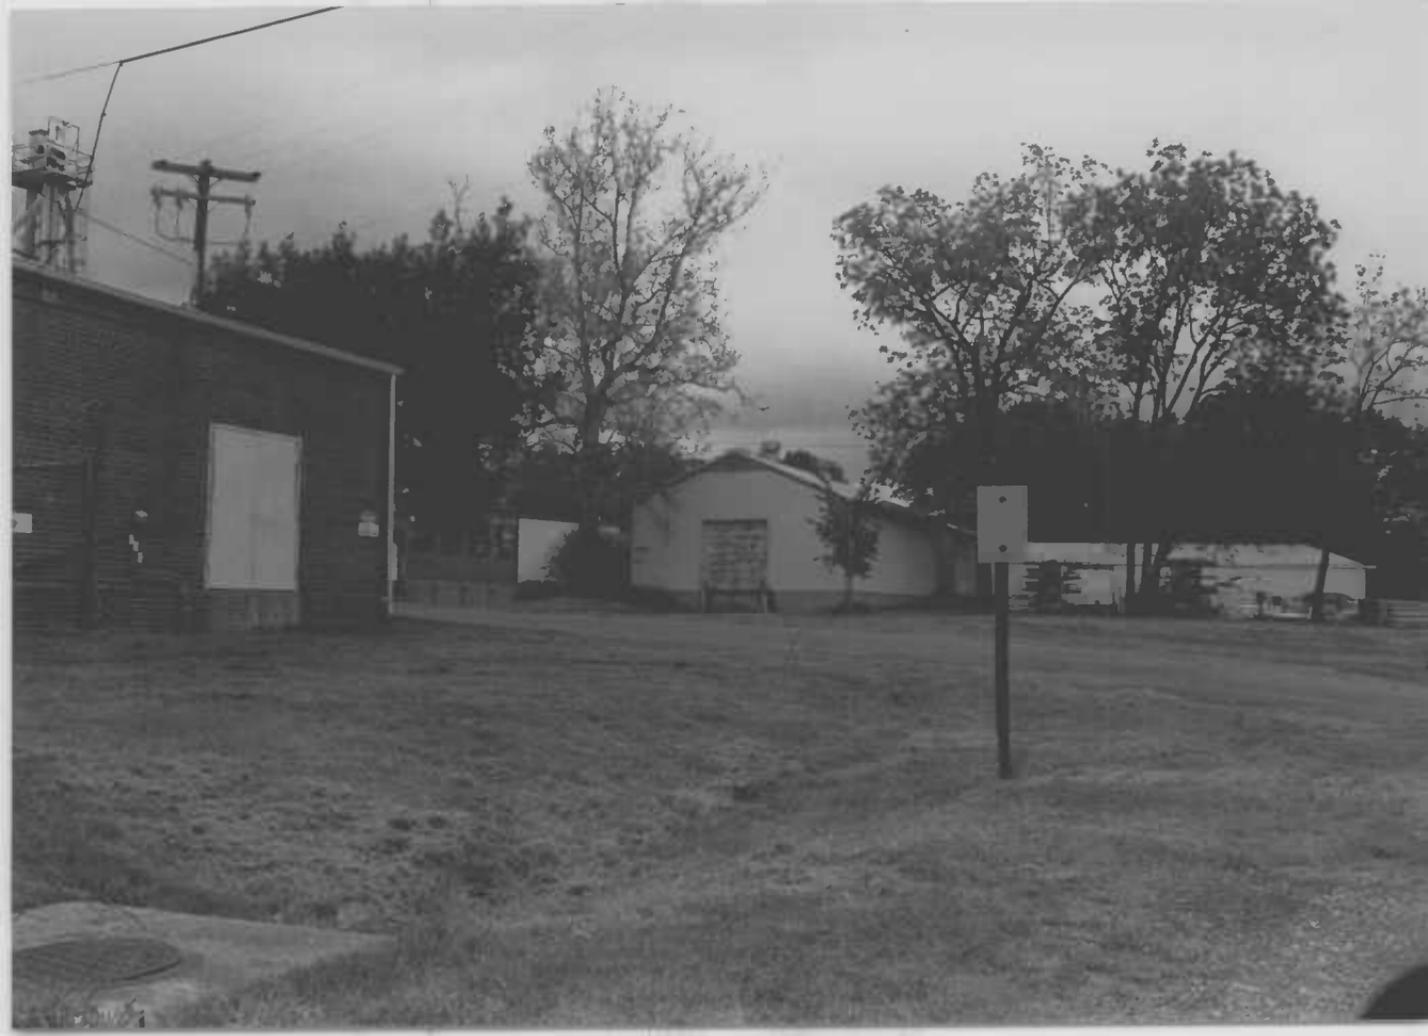
8 34 OF 35

A front-gable shed is located to the north of the service building. It has a concrete block foundation and is sheathed in corrugated metal. There is a garage door on the south elevation.

7 S. elevation, shed
