**CONTRIBUTING RESOURCE  
MARYLAND HISTORICAL TRUST  
INTERNAL NR-ELIGIBILITY REVIEW FORM**

Property Name: Buildings 193A,B and D Survey Number: P.G. #62-25

**The Expansible Farmhouses -- Buildings 193A, 193B, 193D -- P.G. #62-25  
Beltsville Agricultural Research Center**

**EXPANSIBLE FARMHOUSES (BUILDINGS 193A, B, & D) -- BELTSVILLE  
AGRICULTURAL RESEARCH CENTER**

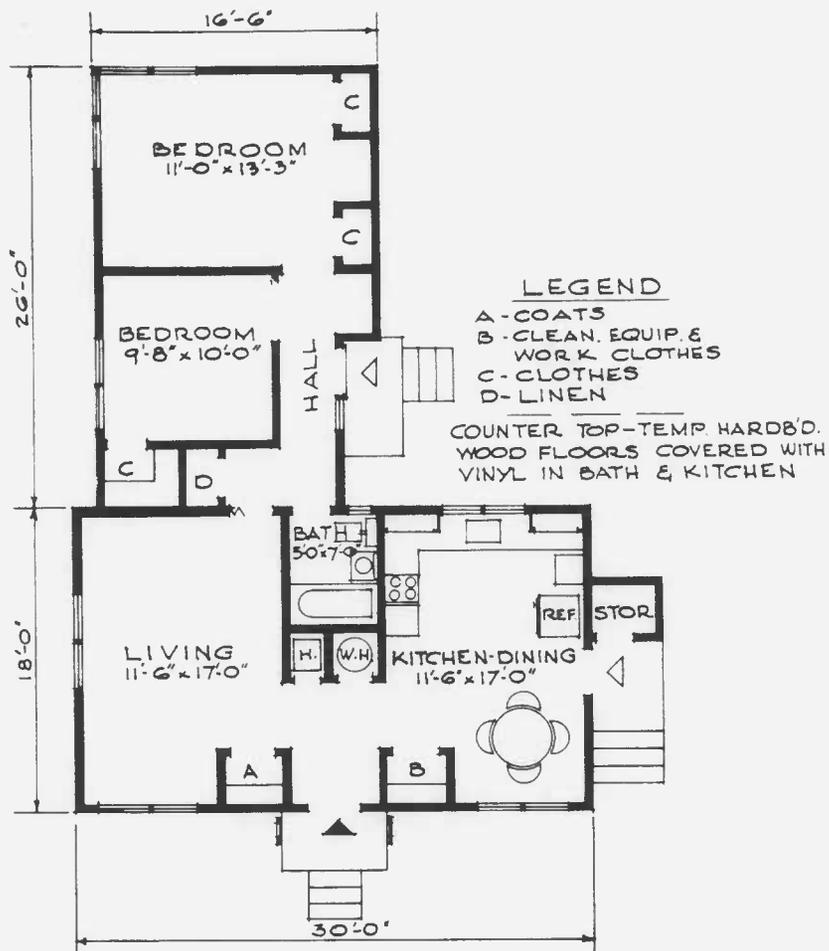
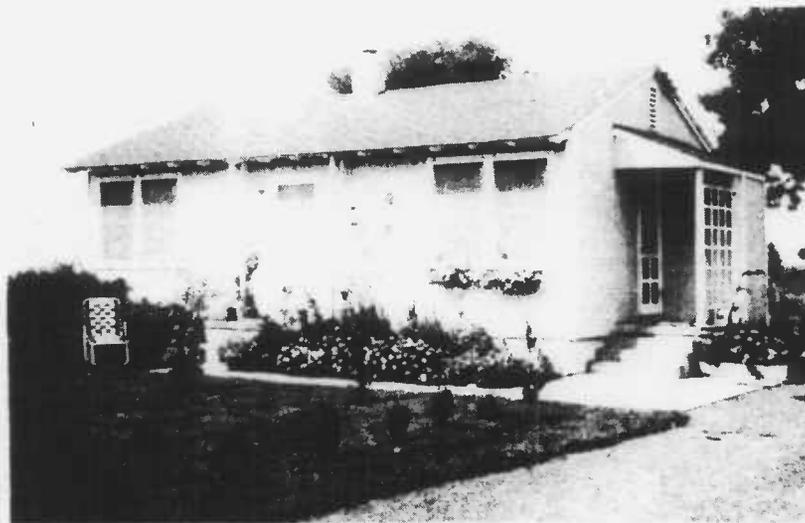
From *Some Effects of Construction...*, USDA (1961)  
 [Plan and Photo ca. 1961, Building 193A] 62  
 Expansible Farmhouses (Buildings 193A,B&D) P.G. #61-25  
 Beltsville Agricultural Research Center  
 Prince George's County, MD

Like Building 193B, both the "basic unit" and the bedroom addition to Building 193A were also completed in the summer of 1952. (Construction began in the summer of 1952.) Of the five expansible farmhouses, Building 193A was designed in the most conventional manner and with the fewest experimental features. The building is constructed on 12-inch-square brick piers on concrete footings set 2 feet below grade and extending 18 inches above grade. The foundations support a double wood floor over a crawl space which is covered with asbestos cement boards. The exterior walls of the building consist of diagonal sheathing covered with vertical tongue and groove siding which has been painted blue. Floors and windows are of wood construction. Windows are six-over-six double-hung. The roof is covered with asphalt shingles.

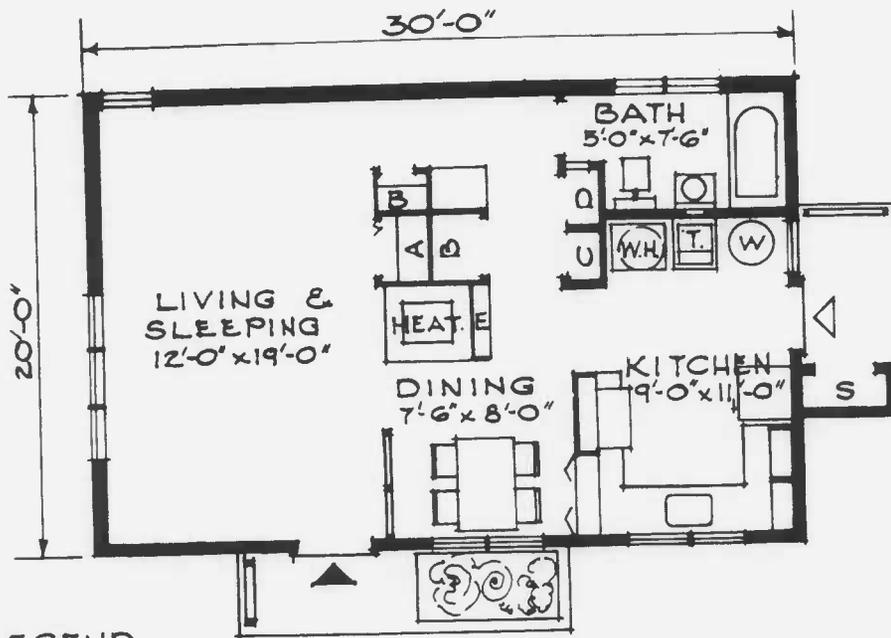
- A-COATS
- B-OTHER CLOTHES
- C-WORK CLOTHES & CLEAN. EQUIP.
- D-LINEN
- E-BOOKS

COUNTER TOP-LAMINATED PLASTIC  
 FLOOR COVERING ON CONC. SLAB  
 BATH-VINYL TILE  
 ALL OTHER-ASPHALT

From *Some Effects of Construction...*, USDA (1961)  
 [Plan and Photo ca. 1961, Building 193B] 62  
 Expansible Farmhouses (Buildings 193A,B&D) P.G. #61-25  
 Beltsville Agricultural Research Center  
 Prince George's County, MD

Completed in the summer of 1952, Building 193B was one of two buildings with identical plans built on the site. (The other, Building 193C, was demolished.) The building's foundations consist of a six-inch reinforced concrete beam laid on concrete posts set two feet below grade. It has a concrete slab-on-grade floor underlaid with roll roofing. The exterior walls of the building are composed of four-foot-by-eight-foot-wide vertical asbestos cement panels.<sup>5</sup> The roof is covered with asphalt shingles. Windows are frameless (the wood studs are used as jambs). They consist of both fixed glass and double-hung sash.

The front (east) facade of the building is an asymmetrical, three-bay-wide composition. It features a simple entry located roughly in the center of the building and two window groupings on the north end of the facade. These include a large (six-foot wide) window grouping consisting of two one-over-one windows each topped by individual fixed windows and, on the north end of the building, a pair of one-over-one double-hung windows. The south facade of the building consists of a slightly off-center nine-unit window consisting of three single-pane double-hung windows capped by single-pane fixed windows. Fenestration on the rear facade consists of two small single-pane windows on the east side and a single one-over-one window on the west side. The north facade of the building features a small ground-level porch with a shed roof. Alterations to the exterior of the building include the removal of a wood divider/grille that was located on the front facade. The divider, which ran perpendicular to the plan of the house articulated the entry area. Other alterations include changes to the windows. The hinged barn sash which swiveled open to provide ventilation has been replaced with one-over-one double-hung sash of the same dimensions.

The interior of Building 193B has a rectangular floor plan, with the southern end of the house occupied by a large, multipurpose room (the living room/bedroom). The rest of the house is arranged around a central utility/storage area, creating a circular circulation pattern. The kitchen is located in the northeast corner, the bathroom in the northwest corner. Along the western wall is a small hallway leading between the living room/bedroom and the bath, and along the eastern wall is a small alcove now used as a study area and hallway.

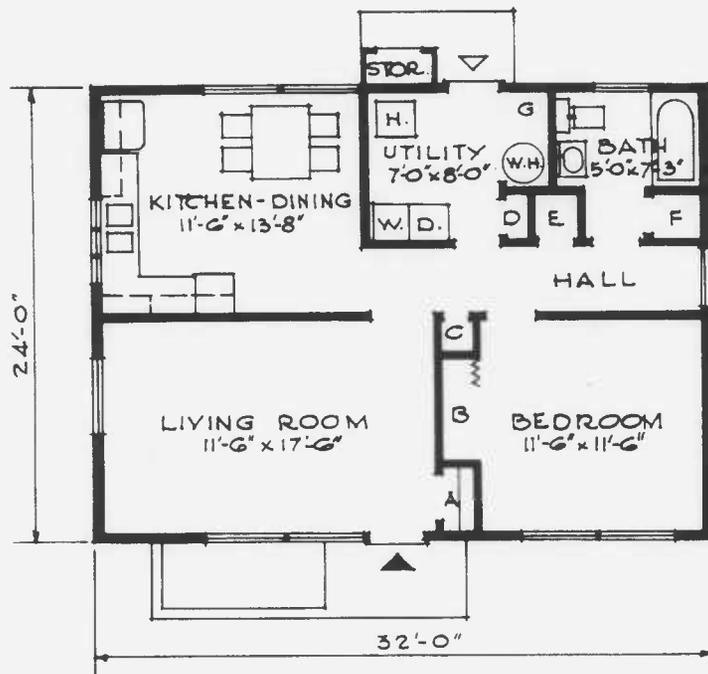
- A-COATS
- B-CLOTHES
- C-CLEAN. EQUIP. & SUPPLIES
- D-FOOD STORAGE
- E-MISC. STORAGE
- F-LINEN
- G-WORK CLOTHES

COUNTER TOP -LAM. PLASTIC  
VINYL TILE ON CONC. FL. SLAB

From *Some Effects of Construction...*, USDA (1961)  
 [Plan and Photo ca. 1961, Building 193D] 62-  
 Expansible Farmhouses (Buildings 193A,B&D) P.G. #61-25  
 Beltsville Agricultural Research Center  
 Prince George's County, MD

The most recent of the expansible farmhouses, Building 193D, was completed in the fall of 1954 and first occupied in November 1955. The foundations of the building are of six-inch thick reinforced concrete set ten inches below grade. The floor is a concrete slab laid over twelve beds of alternating gravel and earth (one-half of the slab was underlaid with a vapor barrier). The exterior walls of the building are of 1 1/4 inch corrugated aluminum.<sup>6</sup> Some windows in the building are fixed sash and others are horizontal sliding aluminum sash.

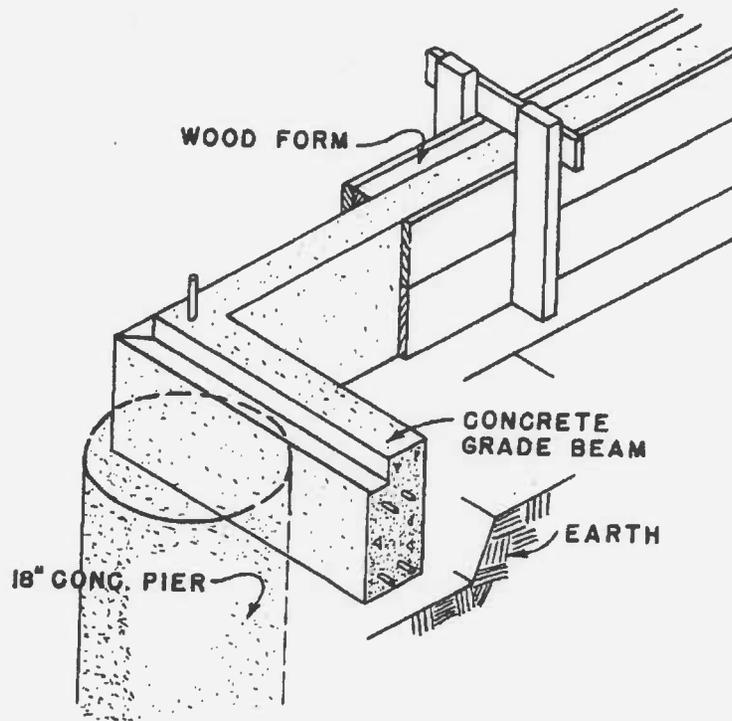
FIGURE 3--Concrete grade beam, House A.

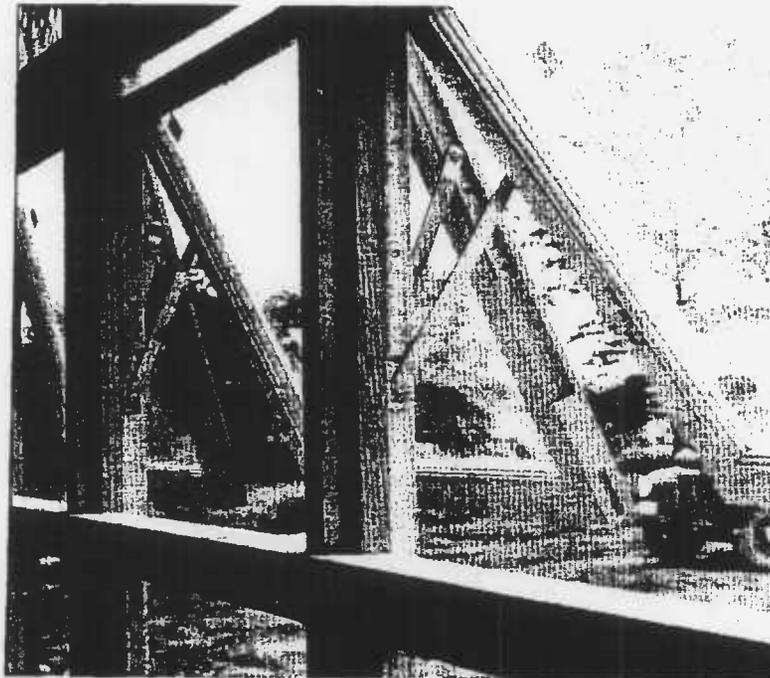
FIGURE 4--Frameless window jambs, House A.

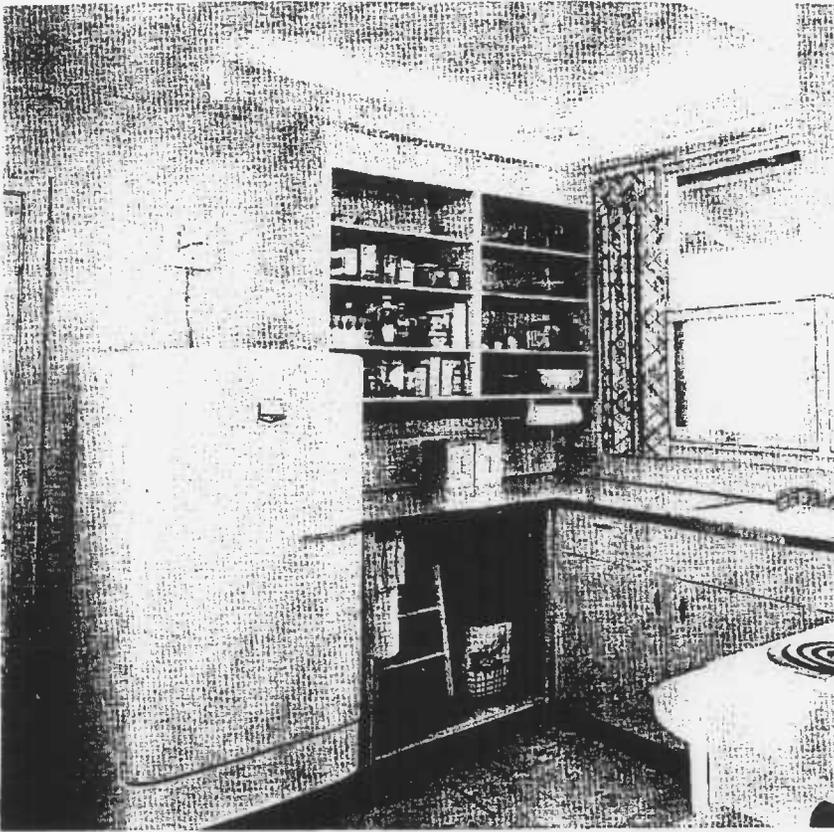
FIGURE 5.--Doorless wall cabinets,  
Houses A, B, and C.

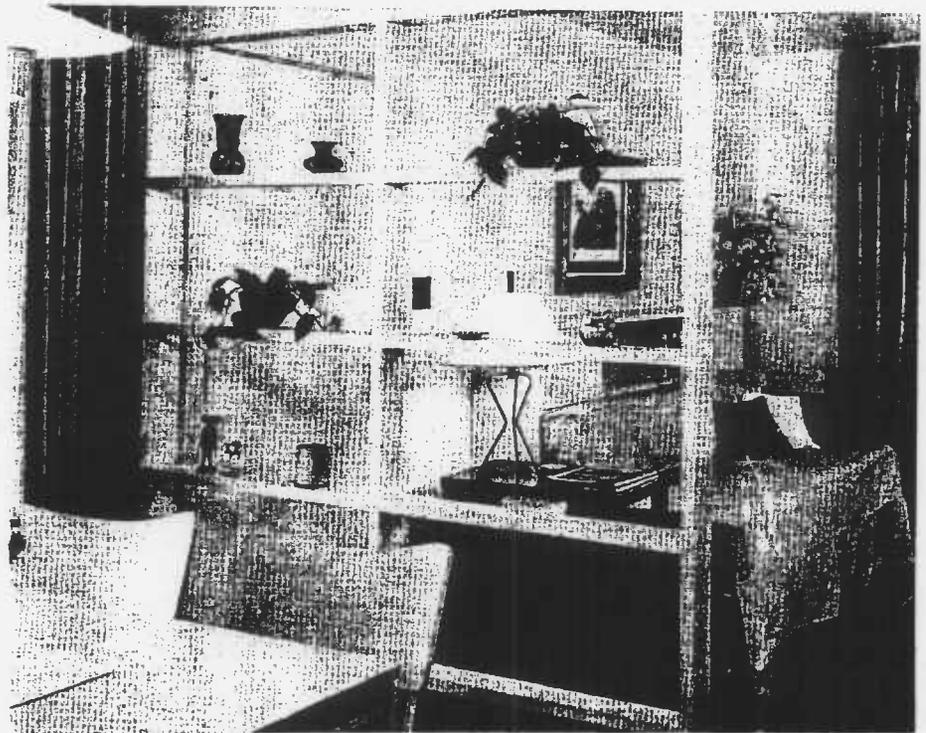
FIGURE 6.--Wood grille,  
Houses A and B.

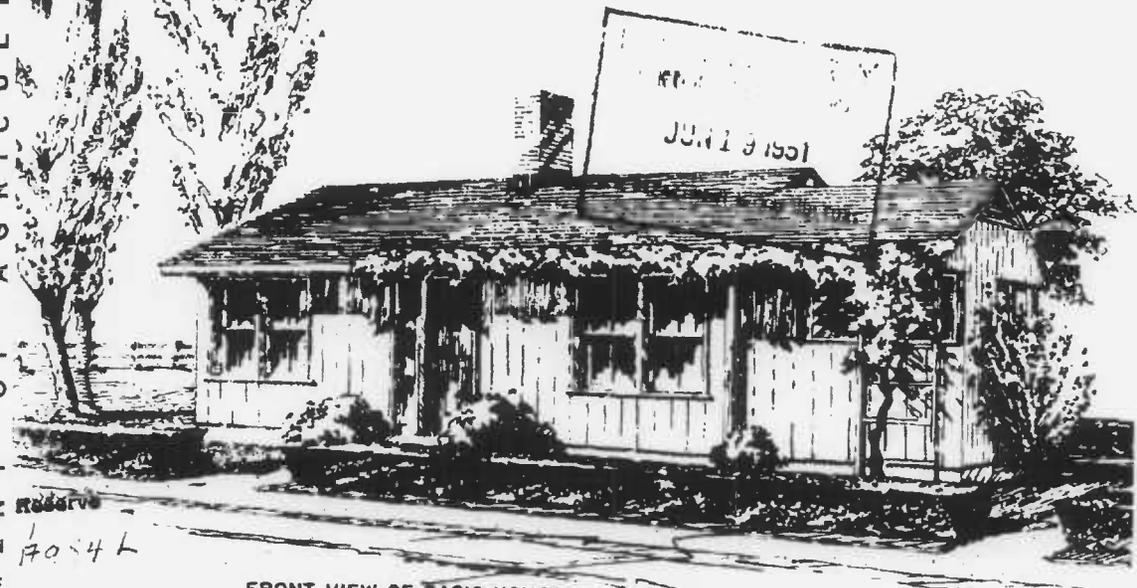
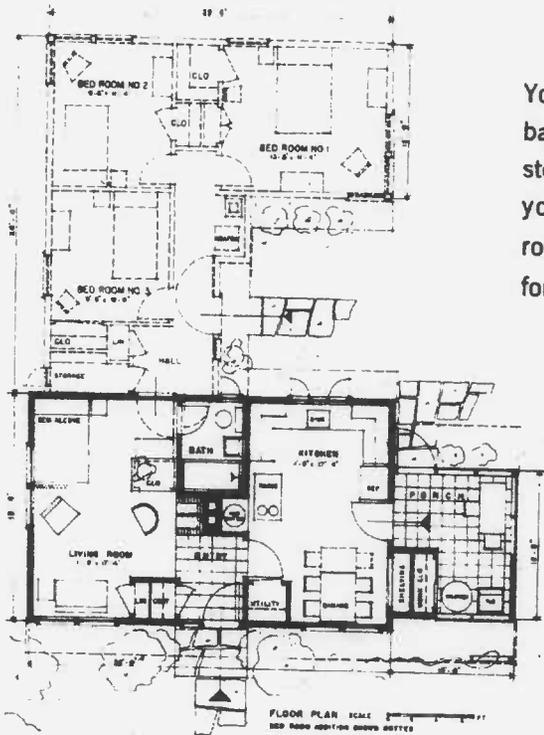
FRONT VIEW OF BASIC HOUSE

You may build this house in stages. The basic plan provides sleeping and clothes storage space in the living room. Later you may add one, two, or three bedrooms. The basic plan is well adapted for use as a farm labor house.

PLAN NO. 7079  
HOUSE AS SHOWN . . . . . 7 SHEETS  
PLAN NO. 7079R  
HOUSE REVERSED . . . . . 7 SHEETS  
SQUARE FOOT AREA:  
BASIC HOUSE . . . . . 660  
COMPLETED HOUSE . . . . . 1230

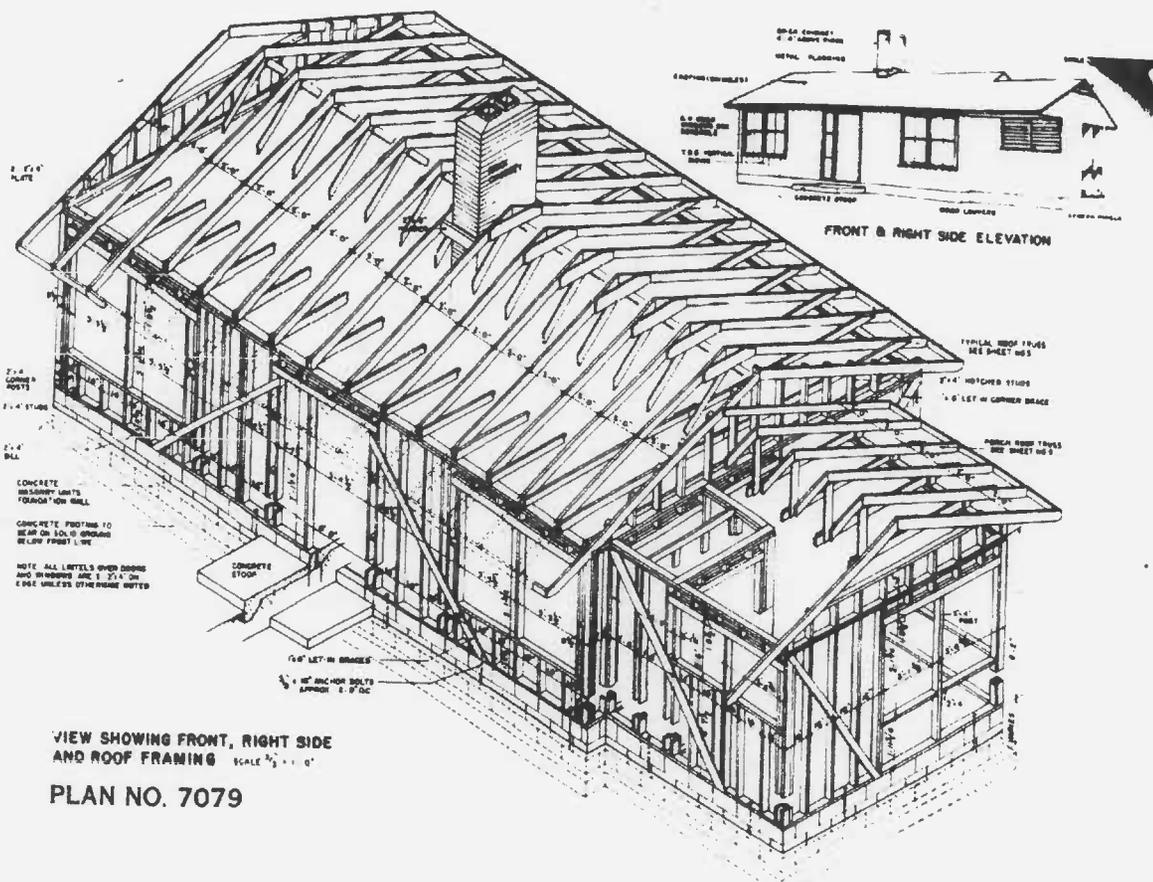
VIEW SHOWING FRONT, RIGHT SIDE AND ROOF FRAMING SCALE 3/8" = 1' 0"  
 PLAN NO. 7079

On this page are shown two examples of these drawings reduced in size, and on the back page, two more examples of the larger details of construction.

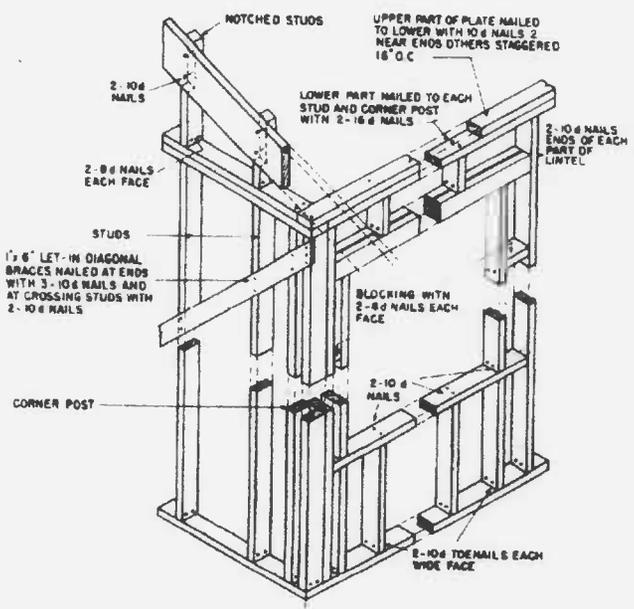
TYPICAL NAILING DIAGRAM

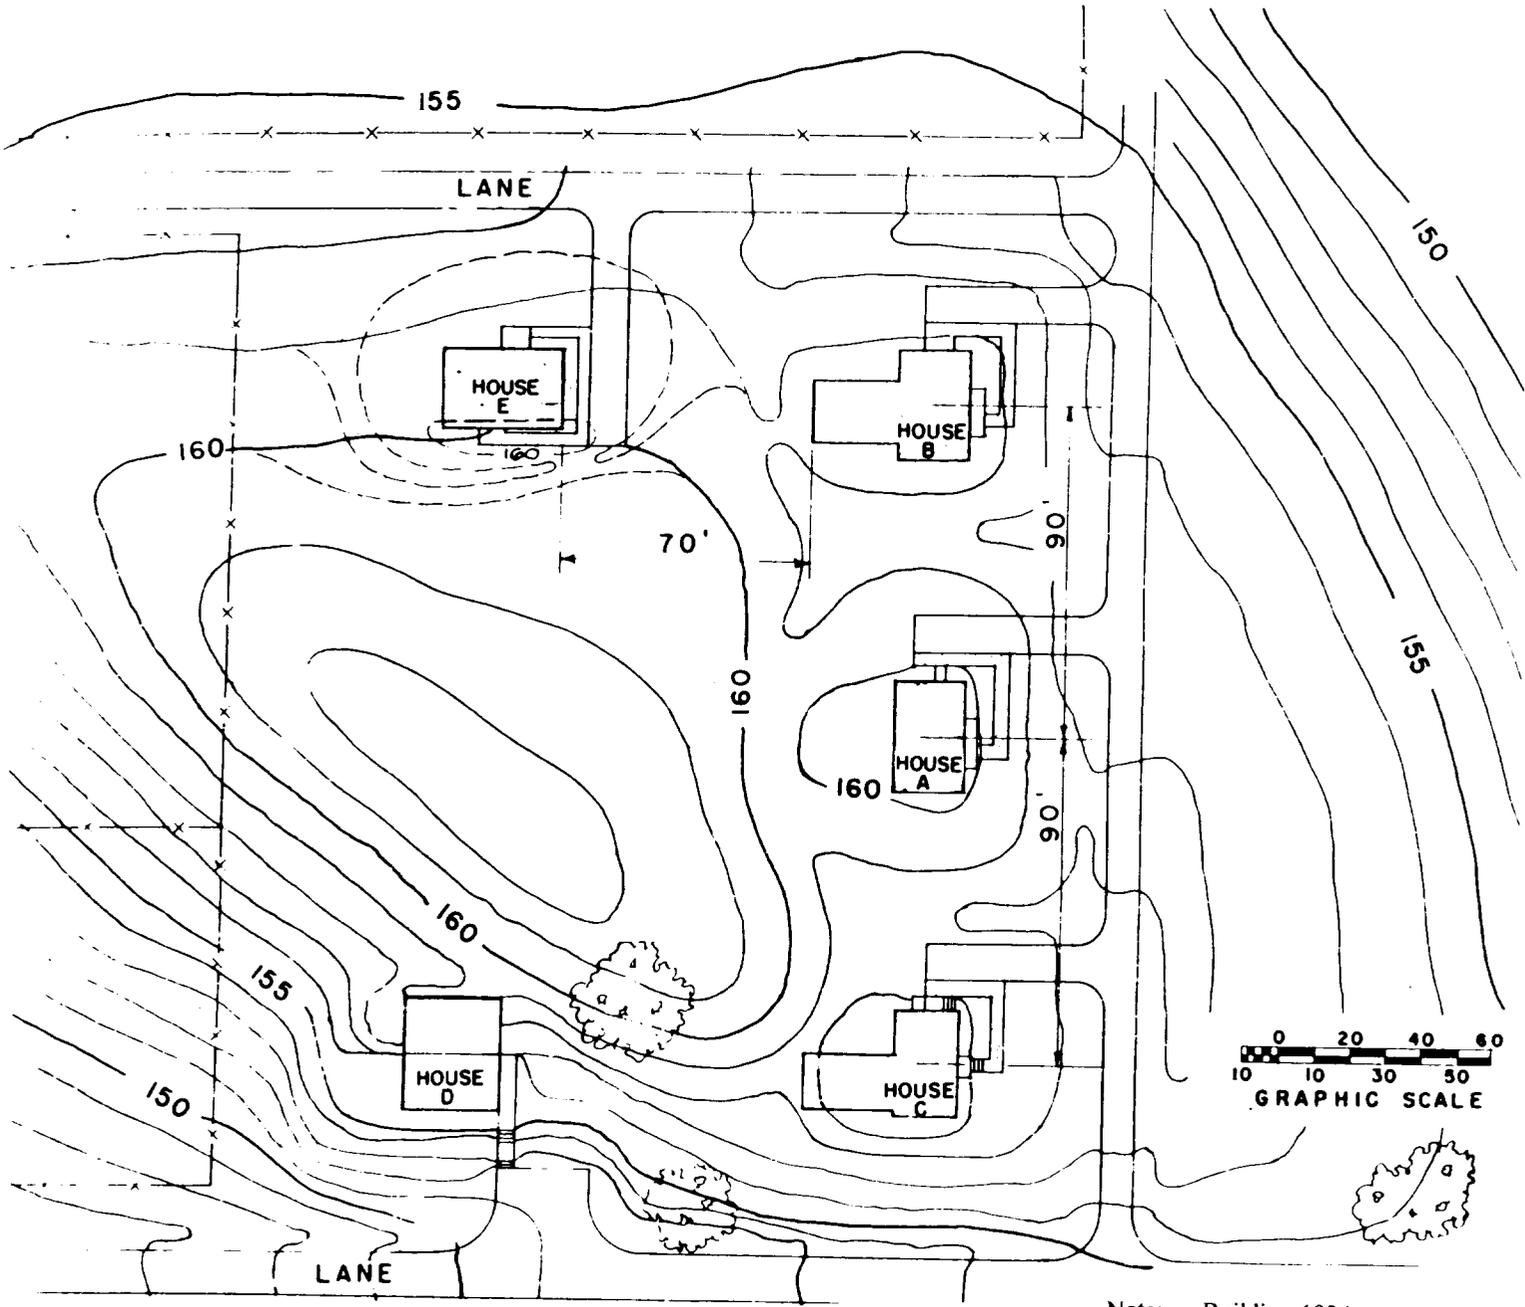
Note: Building 193A appears on plan as House C  
 Building 193B appears on plan as House A  
 Building 193D appears on plan as House E

From *Some Effects of Construction...*, USDA (1961)  
 [Site Plan]  
 Expansible Farmhouses (Buildings 193A, B&D) P.G. #61-25  
 Beltsville Agricultural Research Center  
 Prince George's County, MD
