**CONTRIBUTING RESOURCE
MARYLAND HISTORICAL TRUST
INTERNAL NR-ELIGIBILITY REVIEW FORM**

Property Name: Muller House Bldg 191 Survey Number: P.G. #⁶²~~6~~-26

The Muller House -- Building 191

Beltsville Agricultural Research Center -- Beltsville, MD

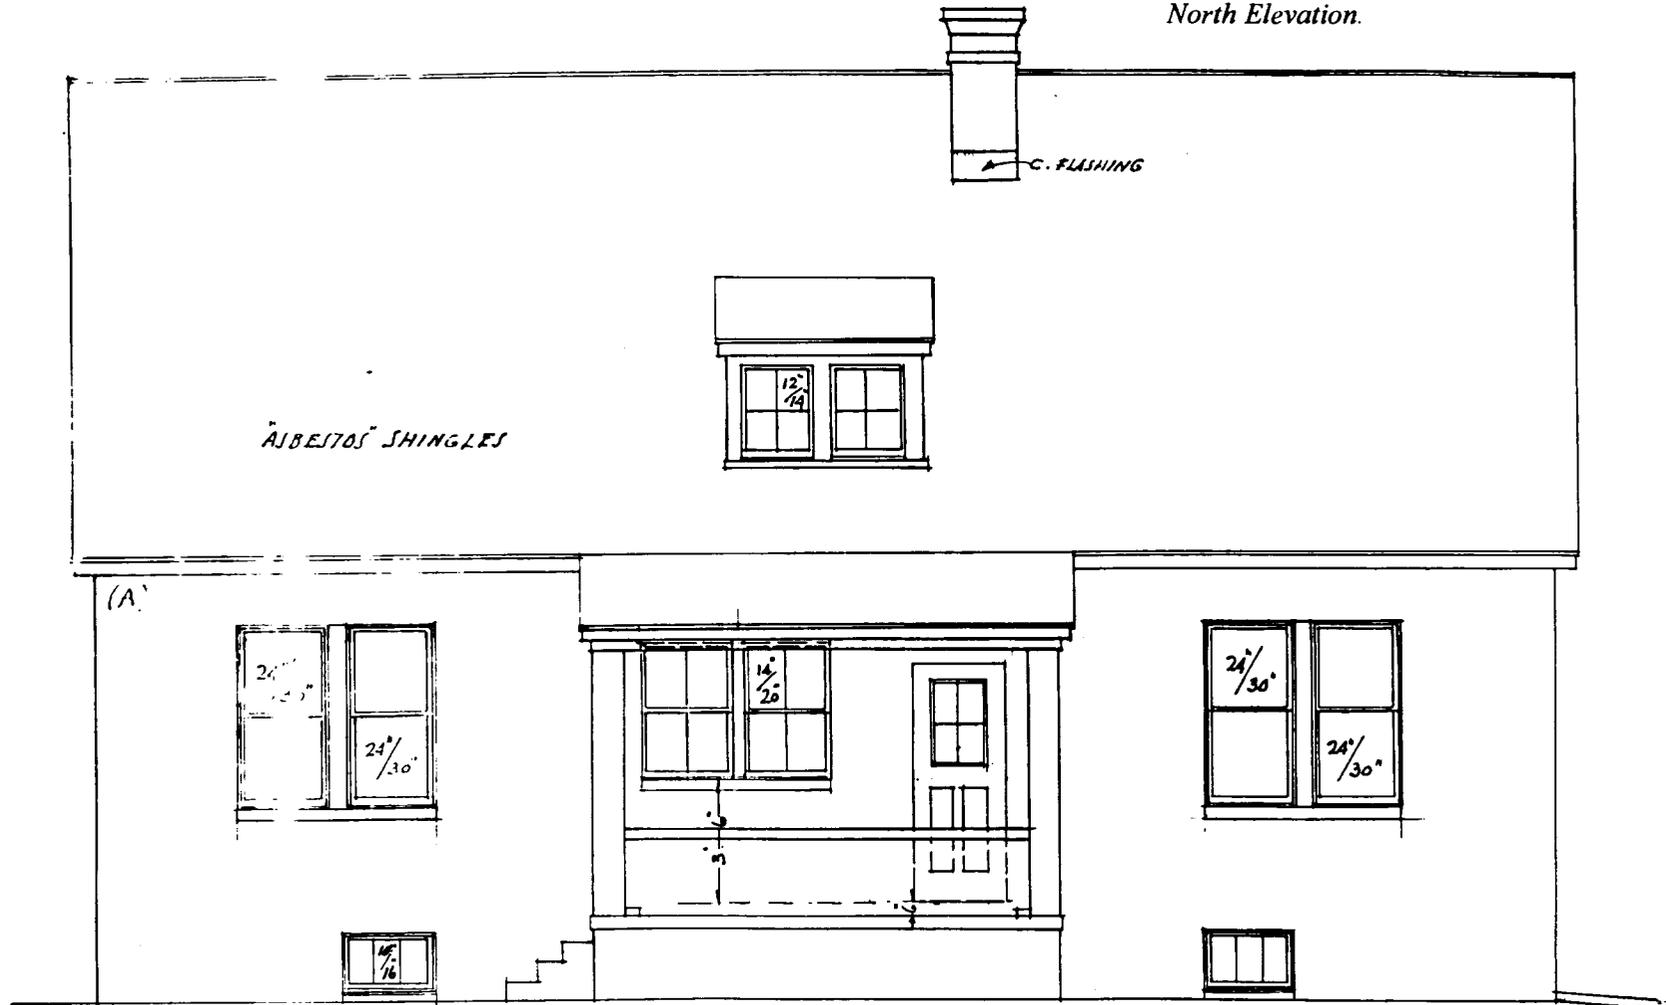
NORTH ELEVATION

PG: 62-26 The Muller House (Build: 191)
Beltsville Agricultural Research Center,
Beltsville, Prince George's County, MD
Remodeling of the Muller House, 1936, revised 1939
North Elevation.

The north elevation is very similar in its composition to the principal facade. It features a central, projecting shed-roofed porch. Framed of the same brick as the main block of the building, the porch was not screened originally. It has a side entrance, accessed from the driveway by a concrete path; the main porch front features a row of tall casement windows; it is possible that these casement windows were installed later, when the porch was enclosed. On the roof there is a projecting shed-roof dormer with a paired window, and an interior chimney close to the ridge of the roof.

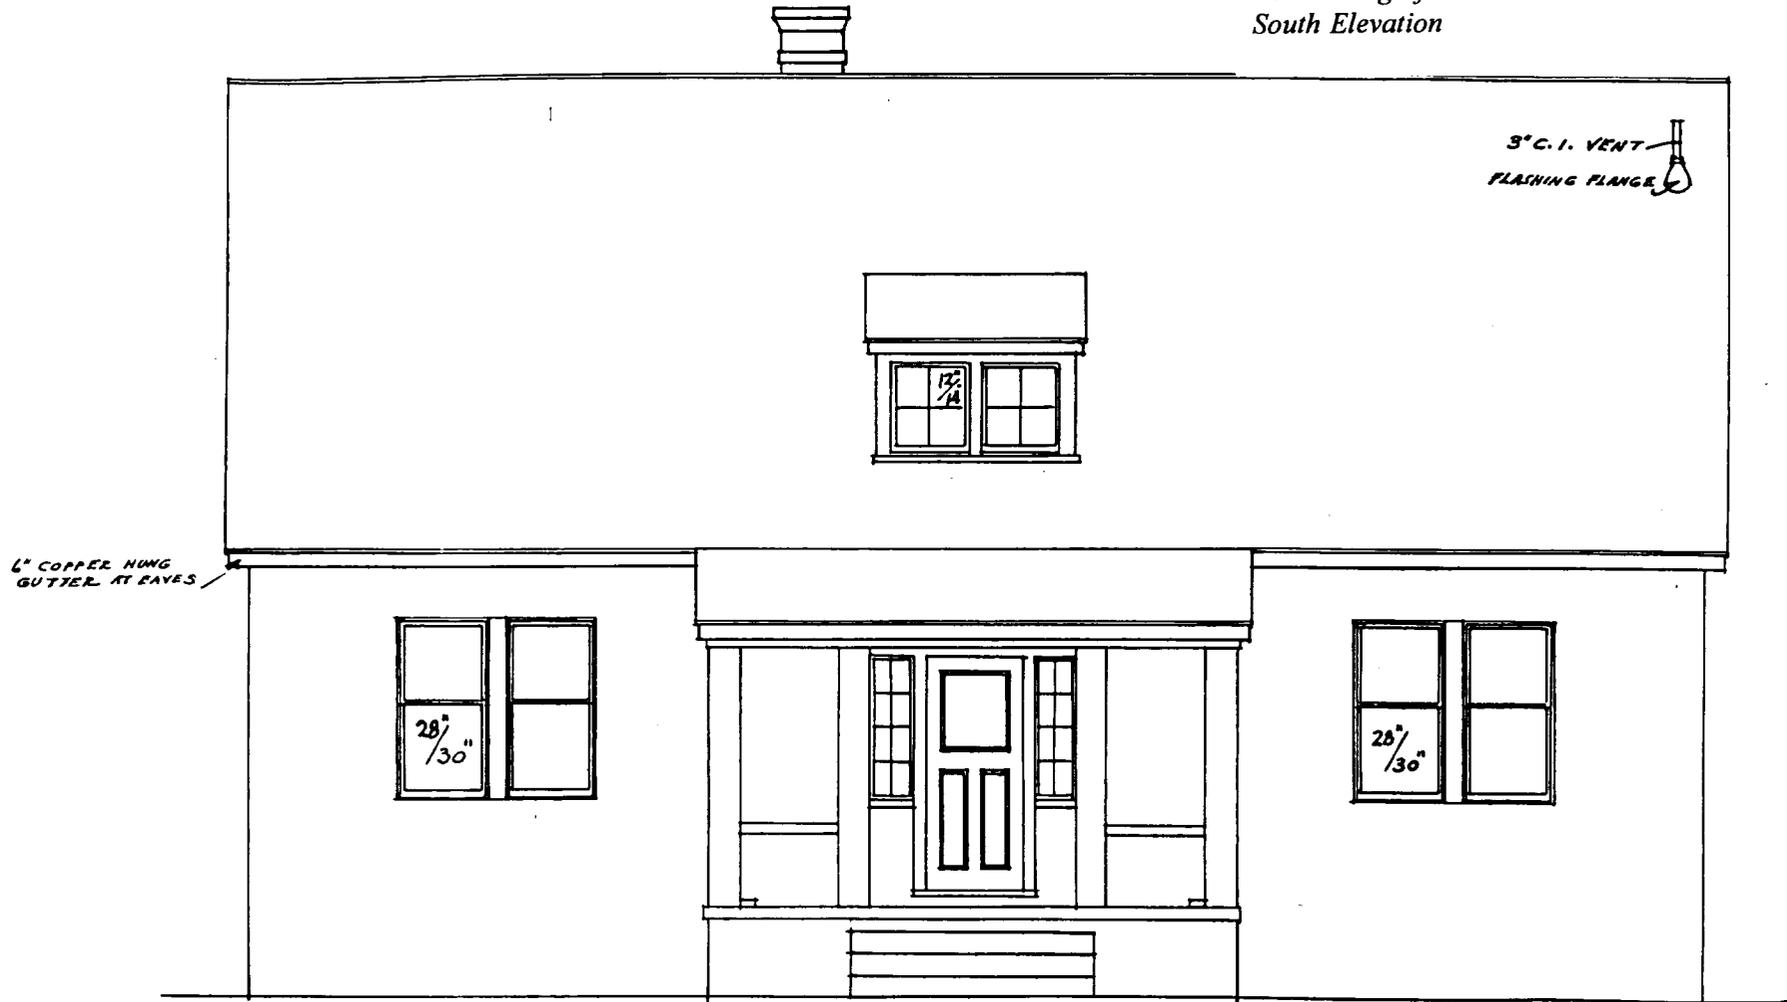
*SOUTH ELEVATION
(FRONT)*

PG: 62-26 The Muller House (Built 1911)
Beltsville Agricultural Research Center
Beltsville, Prince George's County, MD
Remodeling of the Muller House, 1936, revised 1939
South Elevation

The principal (or south) facade is three bays across, with a projecting, shed-roof porch enclosing the entrance door in the center bay. In an early BARC photograph dated circa 1939, the porch has not yet been screened in.¹ The entrance door visible in the 1939 photograph, a wooden door with sidelights, is still extant today. In the photograph, the porch's shed roof was covered in the same composition shingles as the main roof; these shed-roof shingles have since been replaced. On either side of the porch are paired one-over-one windows. These windows, like all those of the building, have brick flat-arch, vertical-joint lintels and slipsills of brick headers.

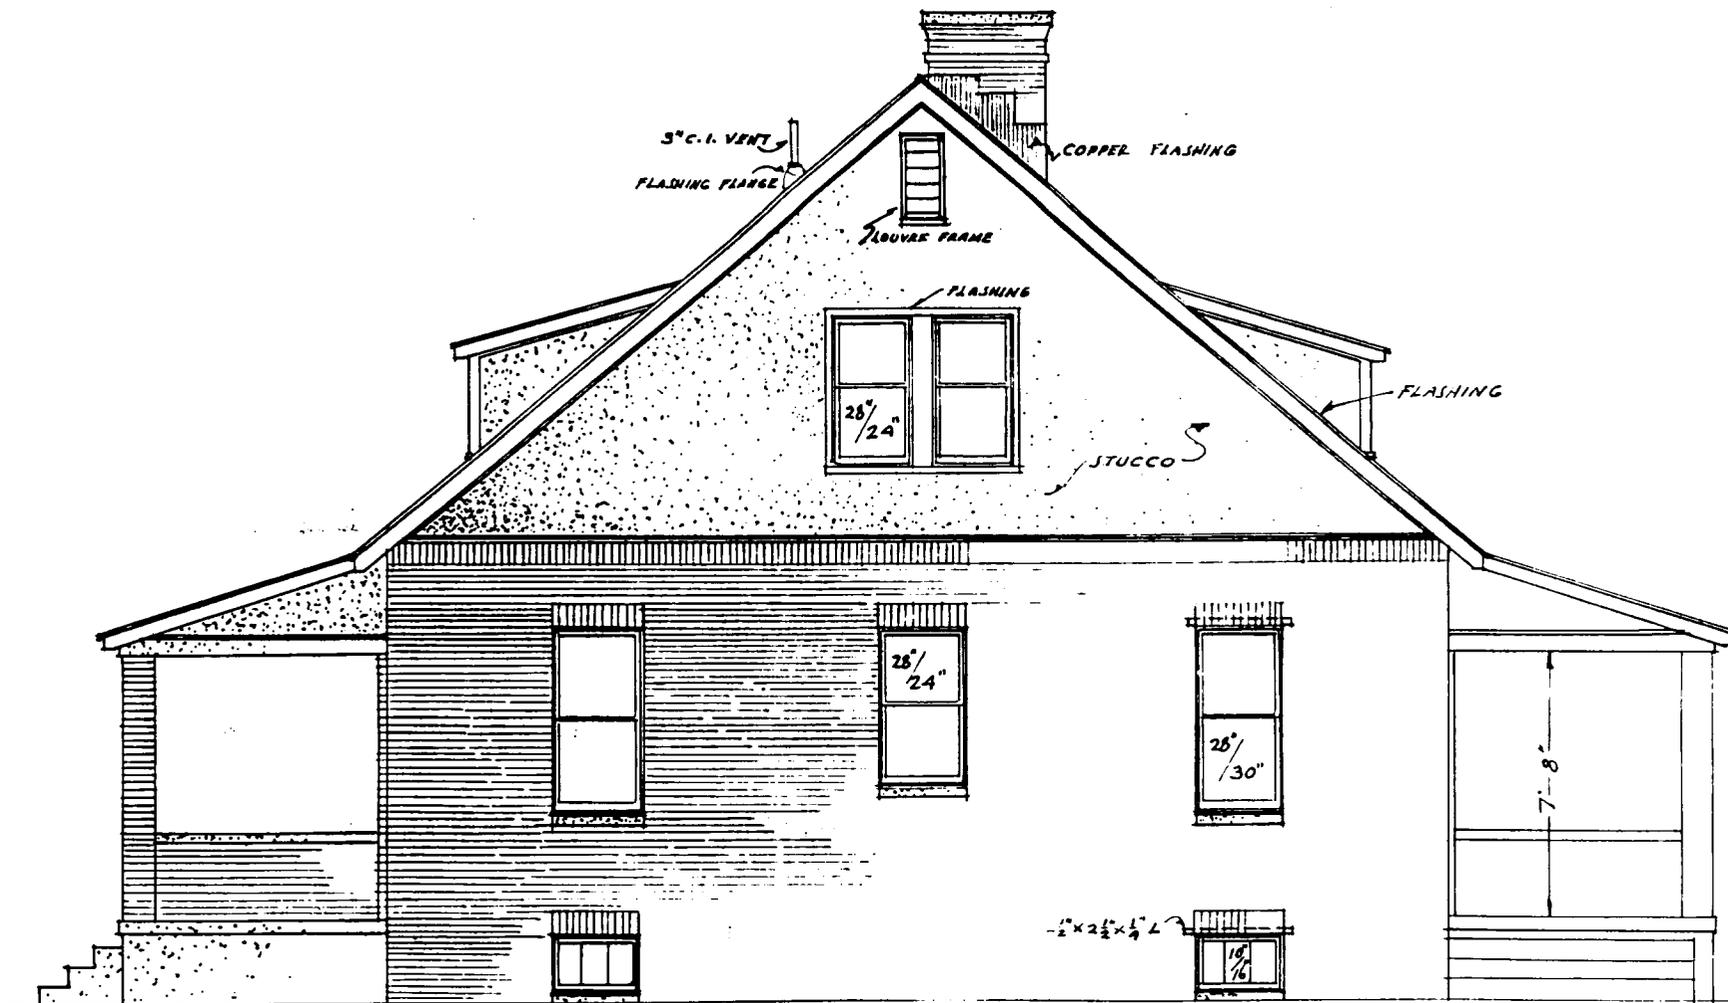
EAST ELEVATION

PG: 62-26 The Muller House (Building 191)
 Beltsville Agricultural Research Center
 Beltsville, Prince George's County, MD
Remodeling of the Muller House, 1936, revised 1939
 East Elevation

The side gables, forming the east and west facades, each feature a paired one-over-one window with simple wooden sash in the second story. Above this window, in the very apex of each gable, is a vertical vent. The gable areas are finished in stucco, which was applied as part of the renovations to the building in 1936. A course of vertical-joint bricks demarcates the line between the two stories. On the east elevation, three single one-over-one double-hung windows, with the center window

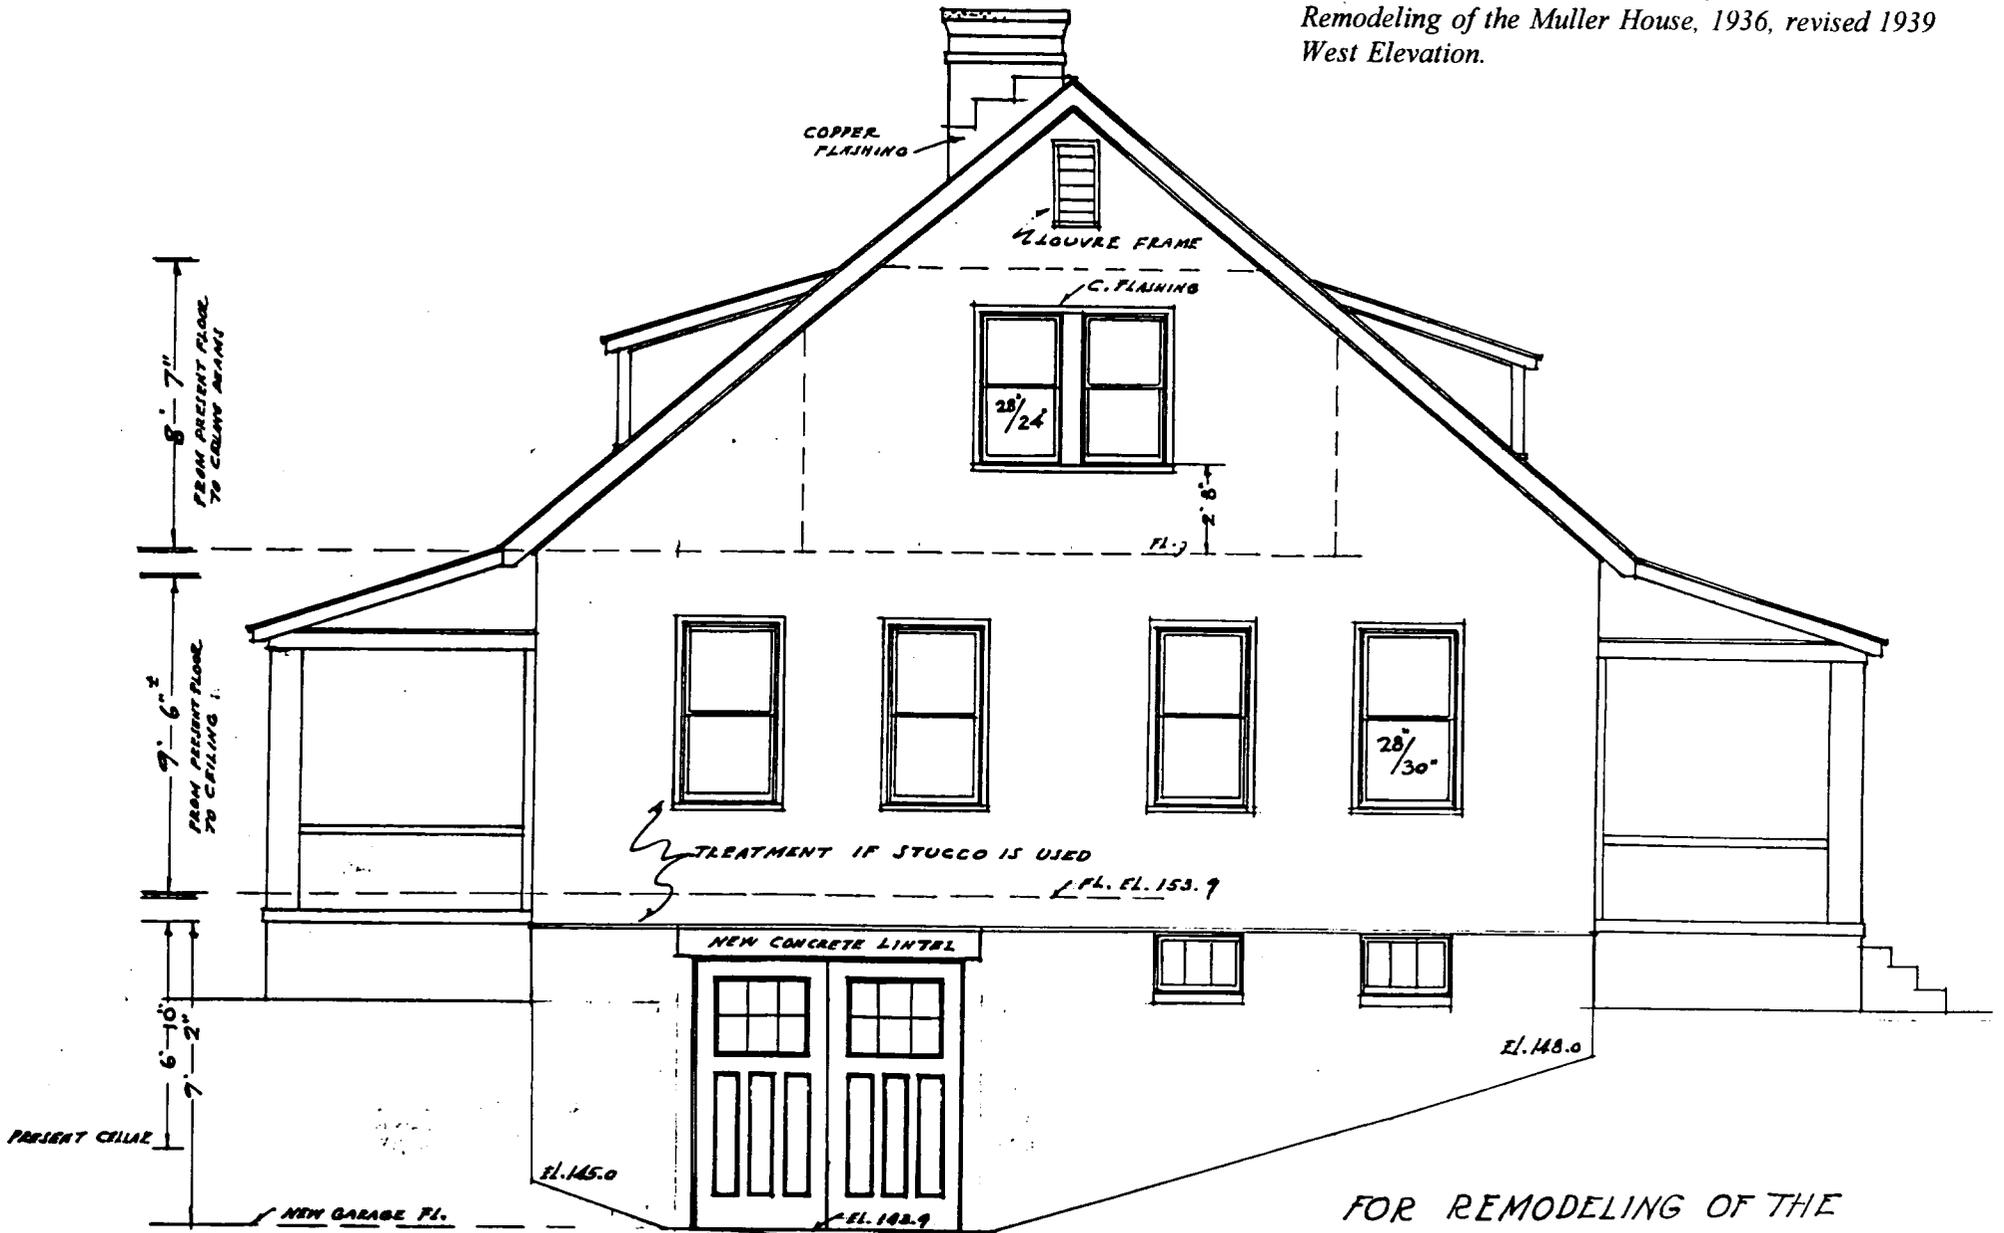
WEST ELEVATION

PG: 62-26 The Muller House (Building '01)
 Beltsville Agricultural Research Center
 Beltsville, Prince George's County, MD
Remodeling of the Muller House, 1936, revised 1939
 West Elevation.

slightly smaller than the two end windows, punctuate the first story. The west elevation features four single one-over-one double-hung windows on the first story level. During the 1938-39 renovations, the west elevation was changed fairly dramatically. The original cellar level was lowered to accommodate a garage in the basement underneath the dining room. The ground was excavated to expose the entire foundational level on this elevation. A pair of large wood paneled doors, each with six lights, provided access to the garage. At some later date, these wooden doors were replaced with a metal automatic garage door, which is still in place today. This basement level also contains two small cellar casement windows.

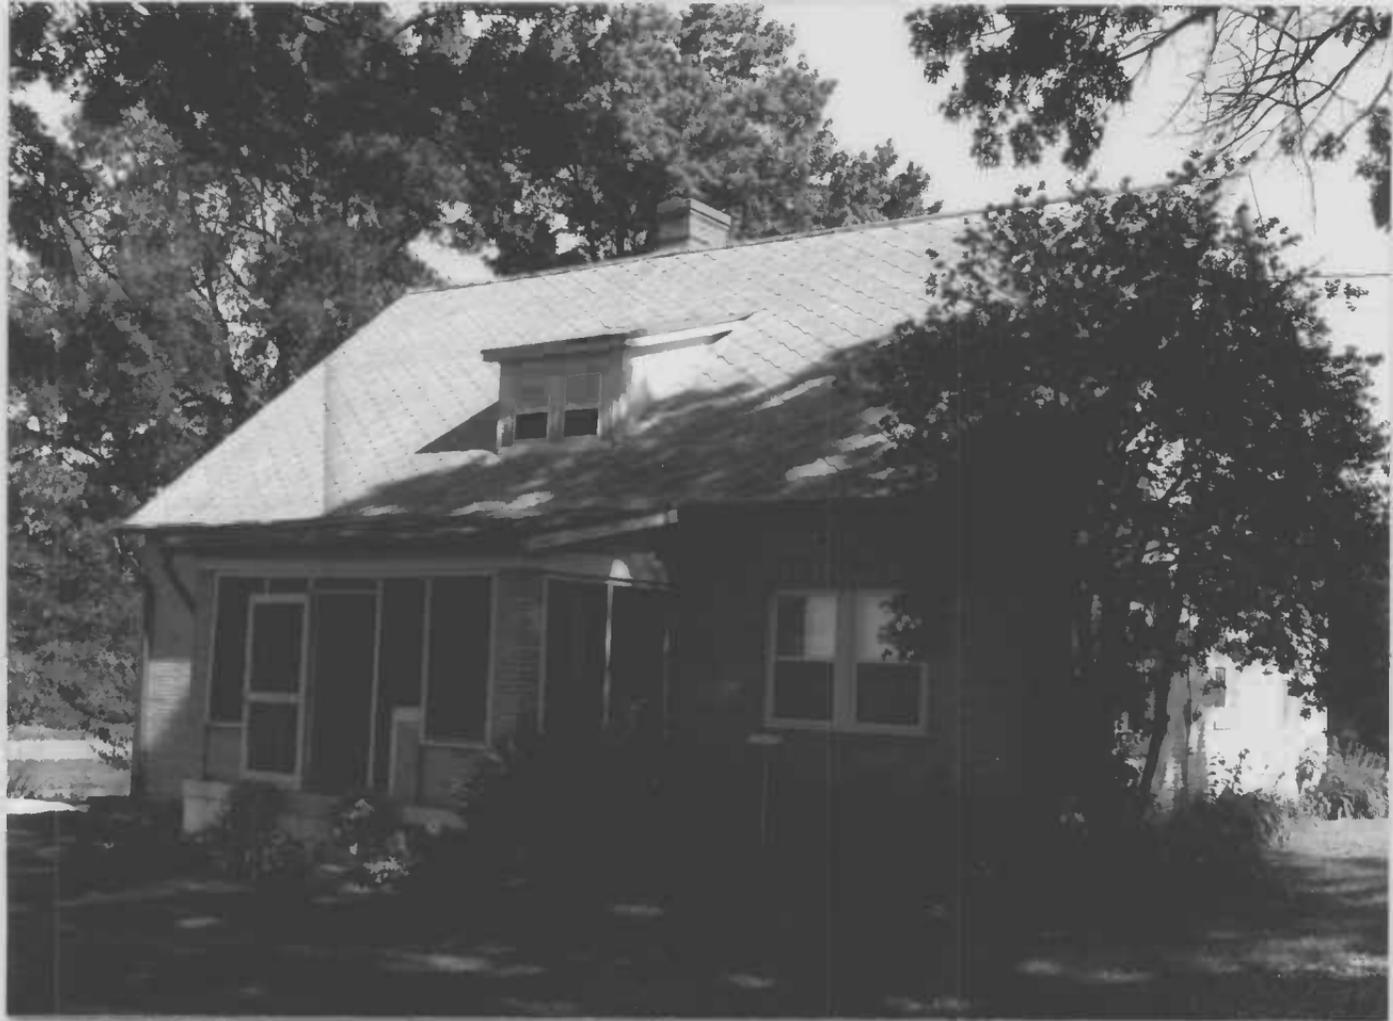
SOUTH FACADE, LOOKING NORTHWEST

Building 191 is a two-story yellow brick residence, with a steeply pitched (45 degree) side-gable roof that encloses the entire upper story. The roof is covered in diamond-shaped asbestos composition shingles, the same as those used on some of the barns and other structures of BARC erected during the 1930s. These shingles were placed on the building during the renovations that the U.S. Department of Agriculture undertook in 1936, after acquiring the building.

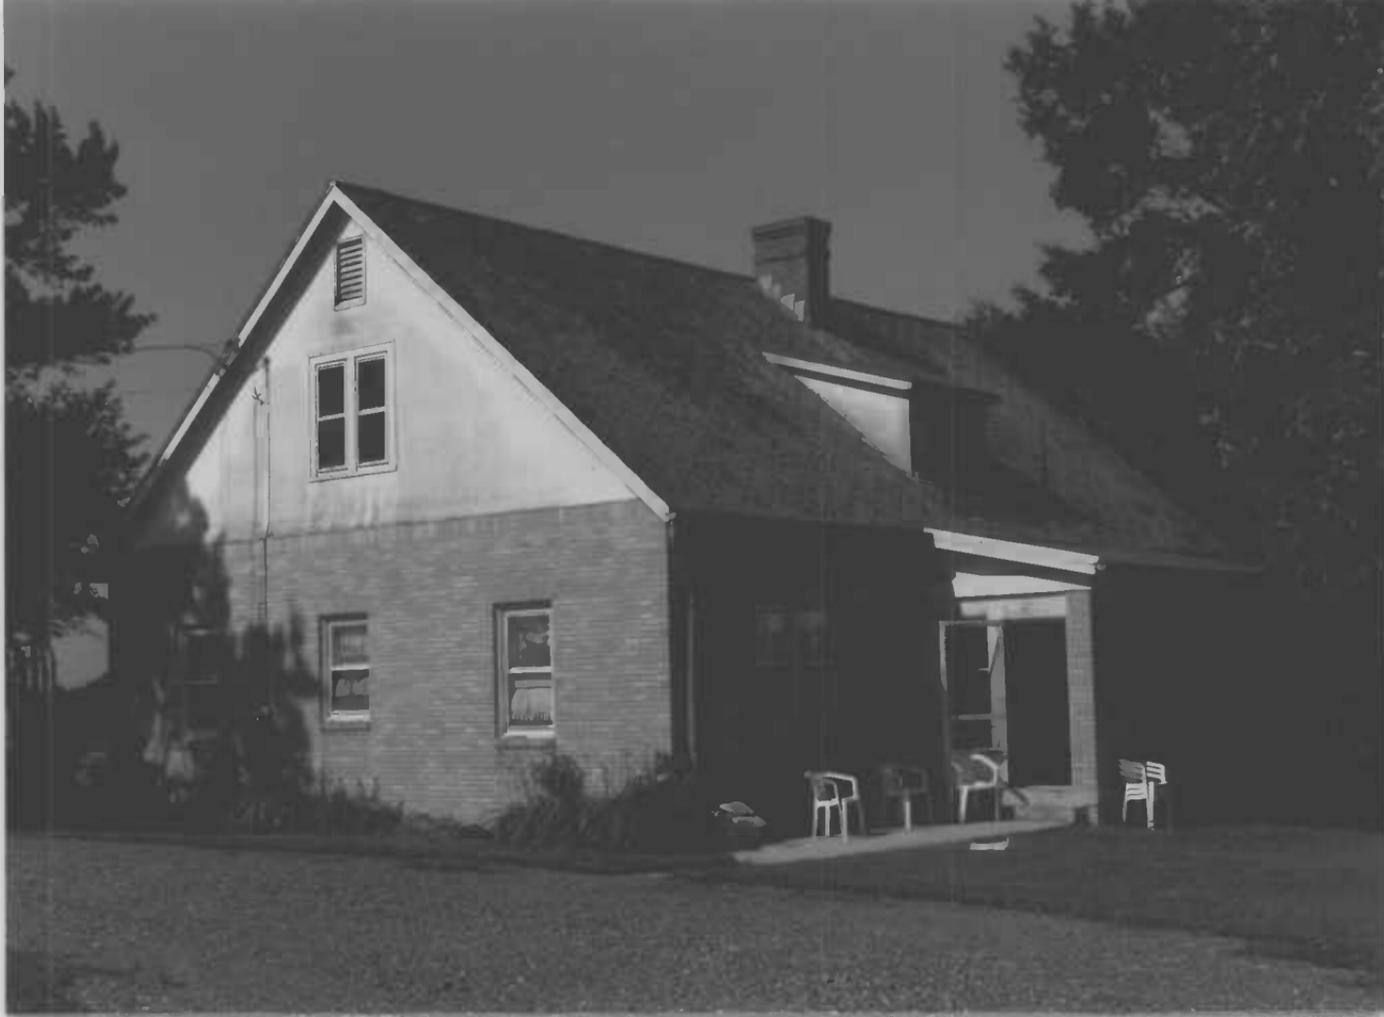
EAST + NORTH FACADES, LOOKING SOUTHWEST
