**CONTRIBUTING RESOURCE
MARYLAND HISTORICAL TRUST
INTERNAL NR-ELIGIBILITY REVIEW FORM**

Property Name: Hense House Bldg 542 Survey Number: P.G. #64-11

The Hense House -- Building 542

**Maryland Historical Trust
State Historic Sites Inventory Form
Maryland Inventory of Historic Properties**

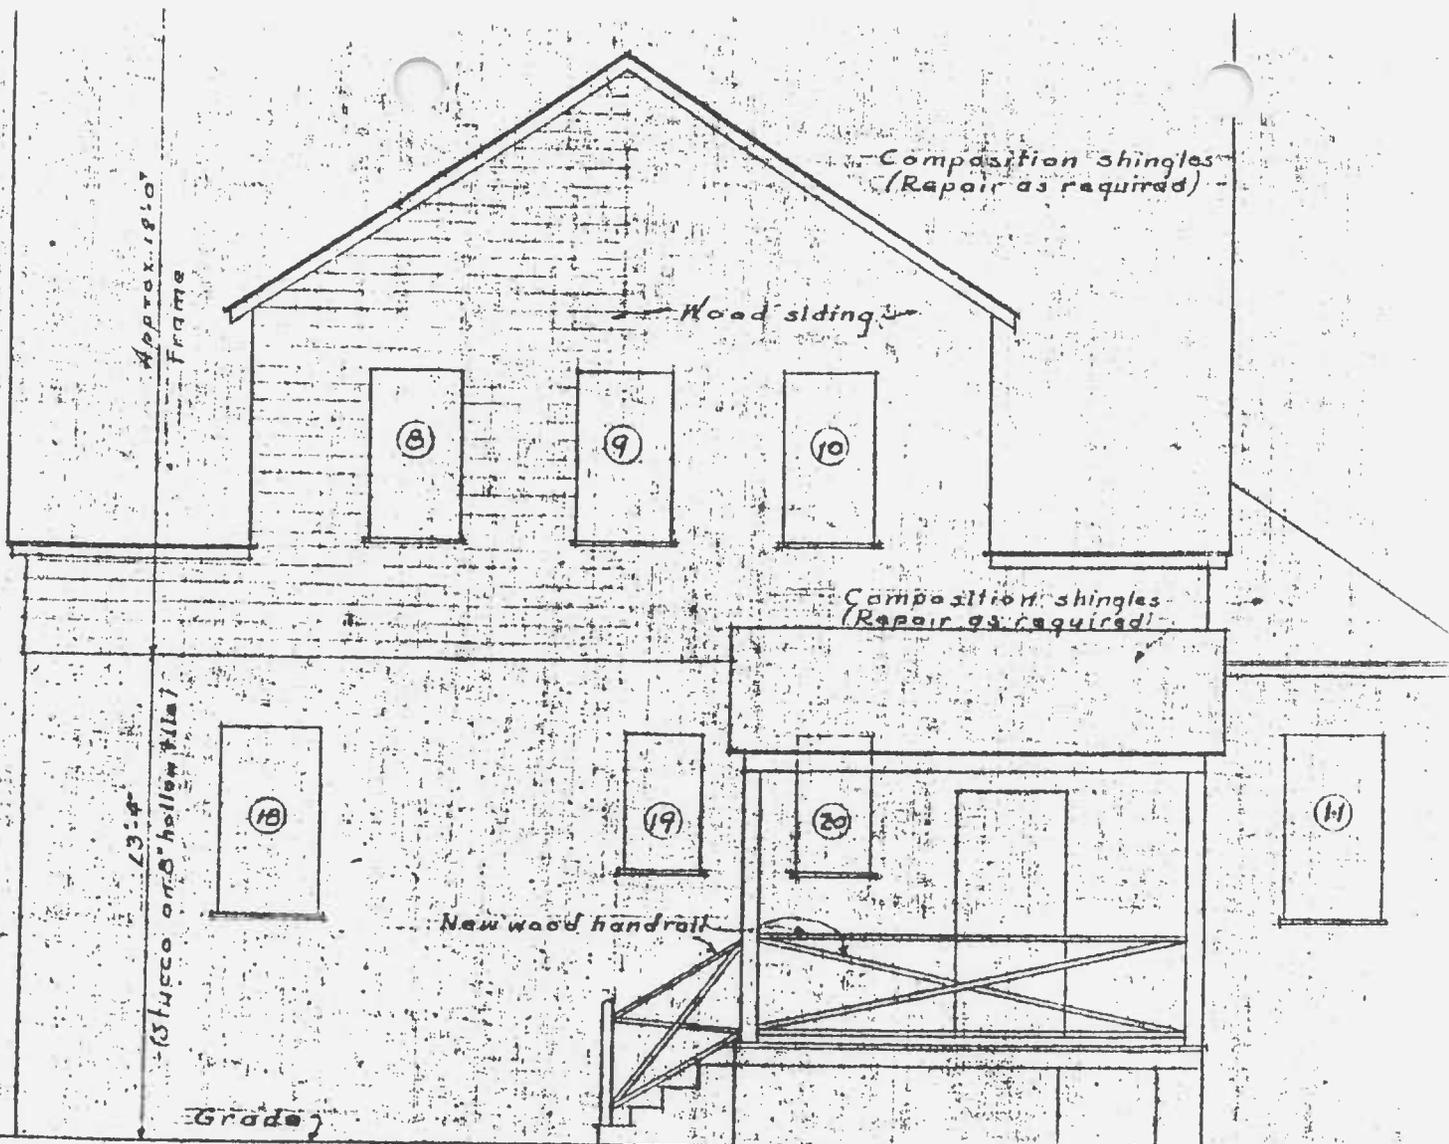
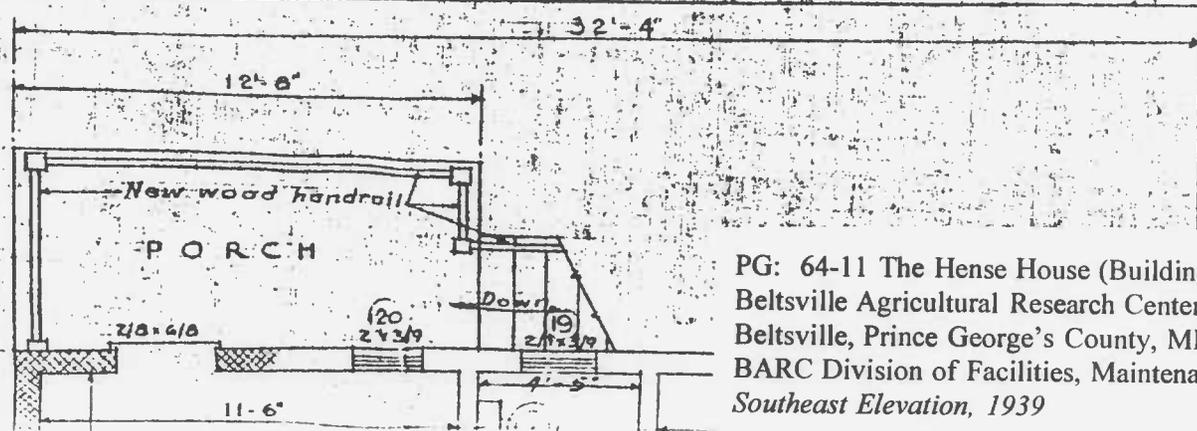
SOUTHEAST ELEVATION
 Scale $\frac{1}{4}'' = 1'-0''$

PG: 64-11 The Hense House (Building 542)
 Beltsville Agricultural Research Center
 Beltsville, Prince George's County, MD
 BARC Division of Facilities, Maintenance and Operations
 Southeast Elevation, 1939

¹One drawing exists for the building, showing the first- and second-floor plans and the southeast exterior elevation. The drawing is located at BARC, Division of Facilities, Maintenance and Operations Division, Building 426.

The Bureau of Agricultural Engineering's Division of Plans and Service prepared a drawing in 1939 for the Hense House alterations, to prepare the house as a employee residence. The changes were not substantive; they involved primarily the replacement of doors and of handrails, missing risers, and treads on the stairs. A sink was proposed for installation in the kitchen, and a lavatory and toilet for a first-floor bathroom adjacent to the kitchen, but it does not appear from on-site inspection that these items were ever installed. The plans showed the first- and second-floor layouts, as well as the elevation of the southeast facade of the house. This was the only exterior elevation given for the project, indicating most probably the new primacy given to this side of the house. The southeast elevation was originally the rear of the house, but probably became the principal entrance, as it is today. The drawing identified the various building materials of this house, particularly the composition of the lower exterior: stucco on eight-inch hollow tile. The roof, of composition shingle, was shown as potentially needing repair.

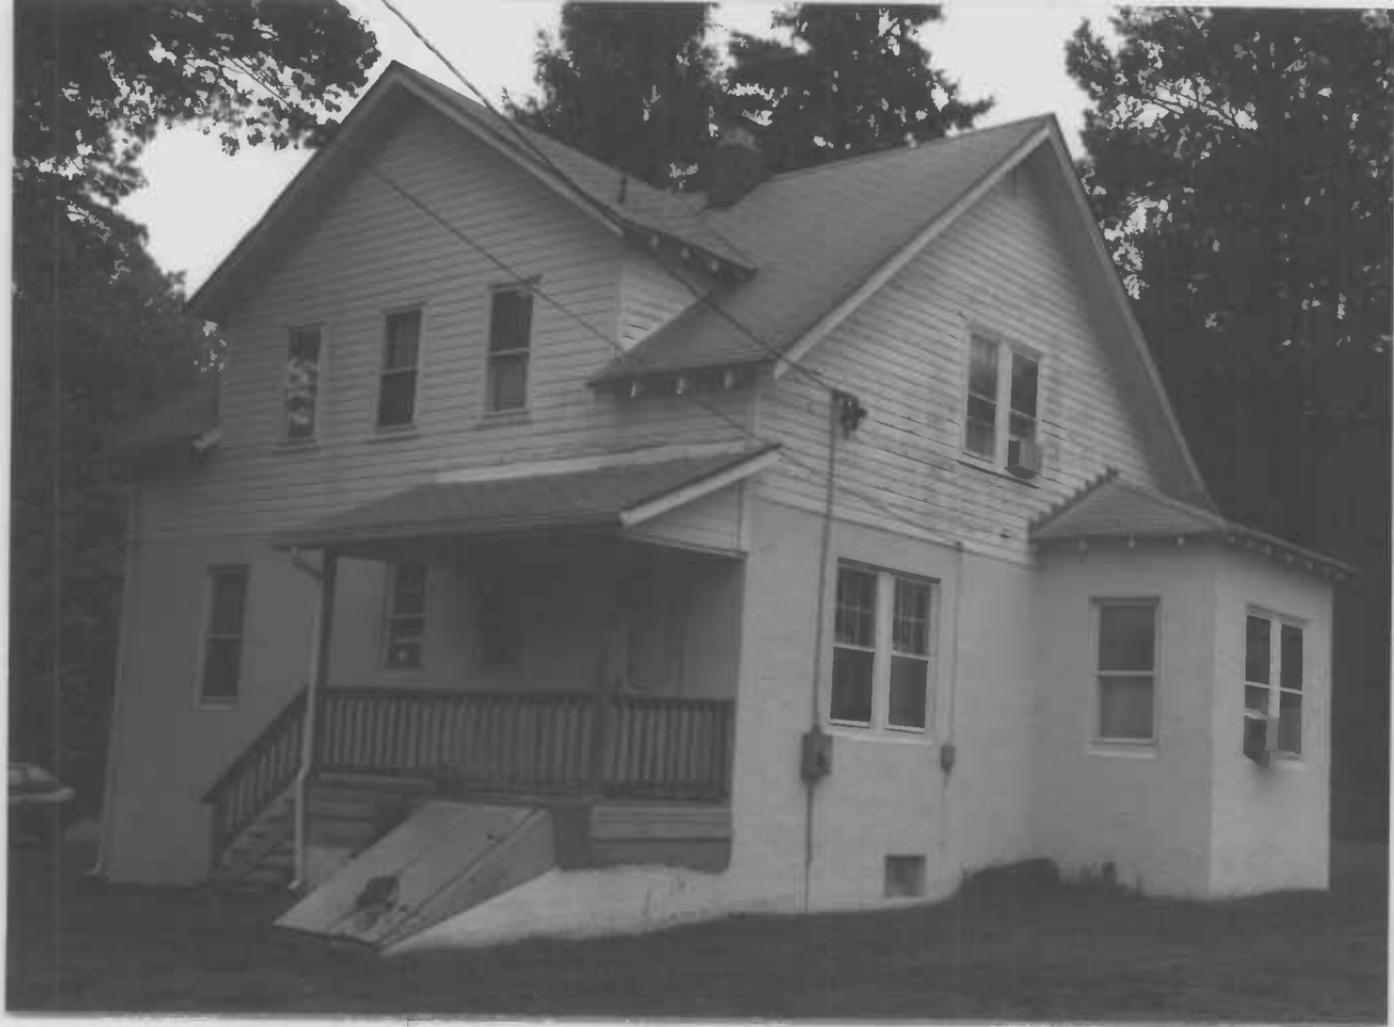
PG: 64-11

SOUTHEAST + NORTHEAST FACADES, LOOKING WEST

On the southeast facade, the house is entered via a small raised wooden porch; this shed-roof porch has recently been rebuilt using pressurized wood. The first story along the southeast facade contains three windows, two of them smaller in size than the other -- which is similar to others in the house. The second story is an oversized dormer which contains three windows, more widely spaced apart than those of the northwest facade dormer.

Projecting on the northeast side of the house is a small, one-story alcove room, located off of the dining room and flush with the northwest facade. This projection has a shed roof, supported as the large dormers are by simple wooden brackets. It is lit on all sides, with one window on either side and a paired window on the front or northeast facade. Adjacent to the stuccoed projecting bay is another set of paired windows. In the gabled second story, which is covered in clapboard siding, there also is a paired window.

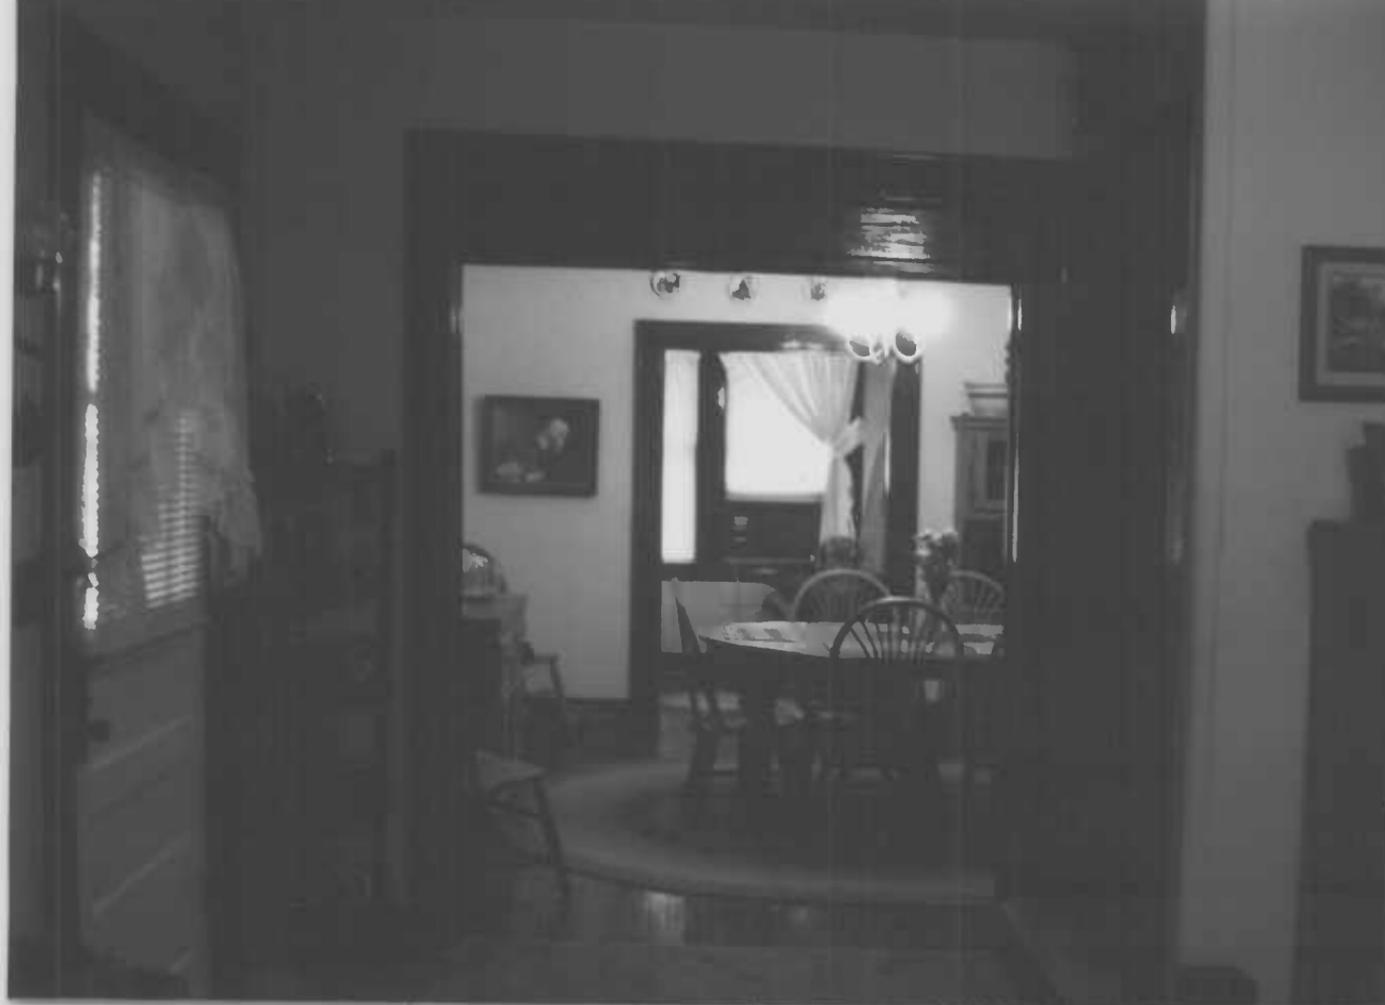
PG: 64-11
HENSE HOUSE (BUILDING 542)
BELTSVILLE AGRICULTURAL RESEARCH CENTER
PRINCE GEORGE'S COUNTY, MD

INTERIOR, VIEW OF ENTRY HALL + DINING ROOM.
LOOKING NORTHEAST

On the interior, in plan, the entry door opens onto a large parlor to the right or southwest; the dining room is to the left or northeast, and the stairway to the second floor is directly ahead. These rooms are characterized by large windows and Craftsman-style molding -- wide and flat planed boards -- surrounding the windows and door frames. Off of the dining room is a small alcove with windows on three sides. Connected to the dining room is the kitchen, which contains the backdoor leading to the secondary porch. The kitchen and study at the rear (southeast) end of the house are connected by a narrow pantry/laundry area; according to the 1939 plan, this room was intended to contain a bathroom, though it does not appear to have been installed. This area also contains the entrance to the basement.

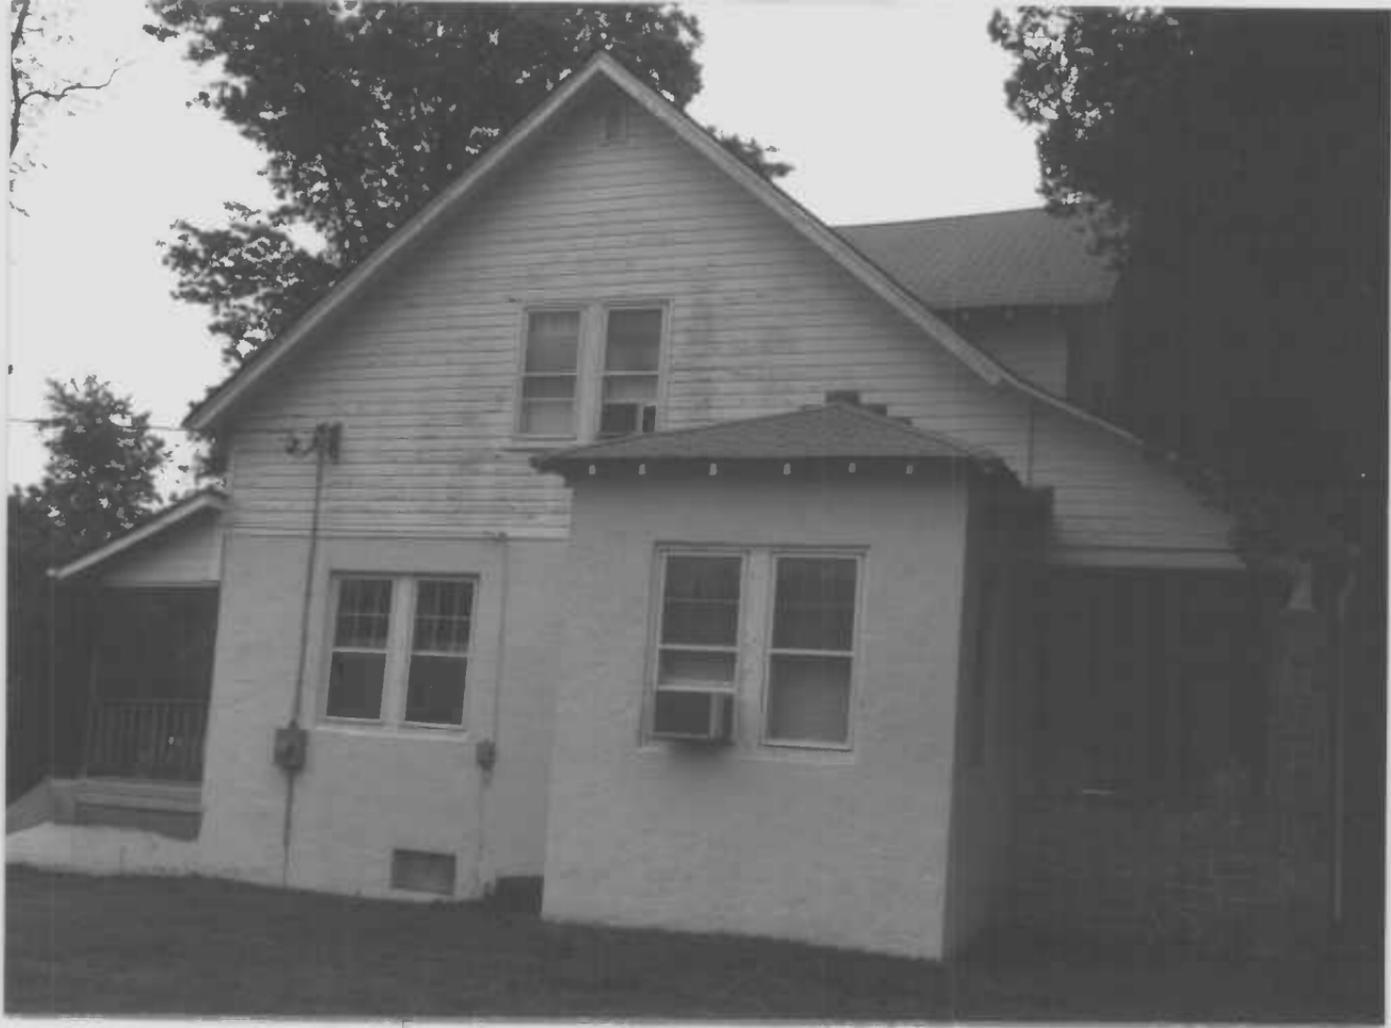
PG: 64-11

NORTHEAST FACADE, LOOKING SOUTHWEST

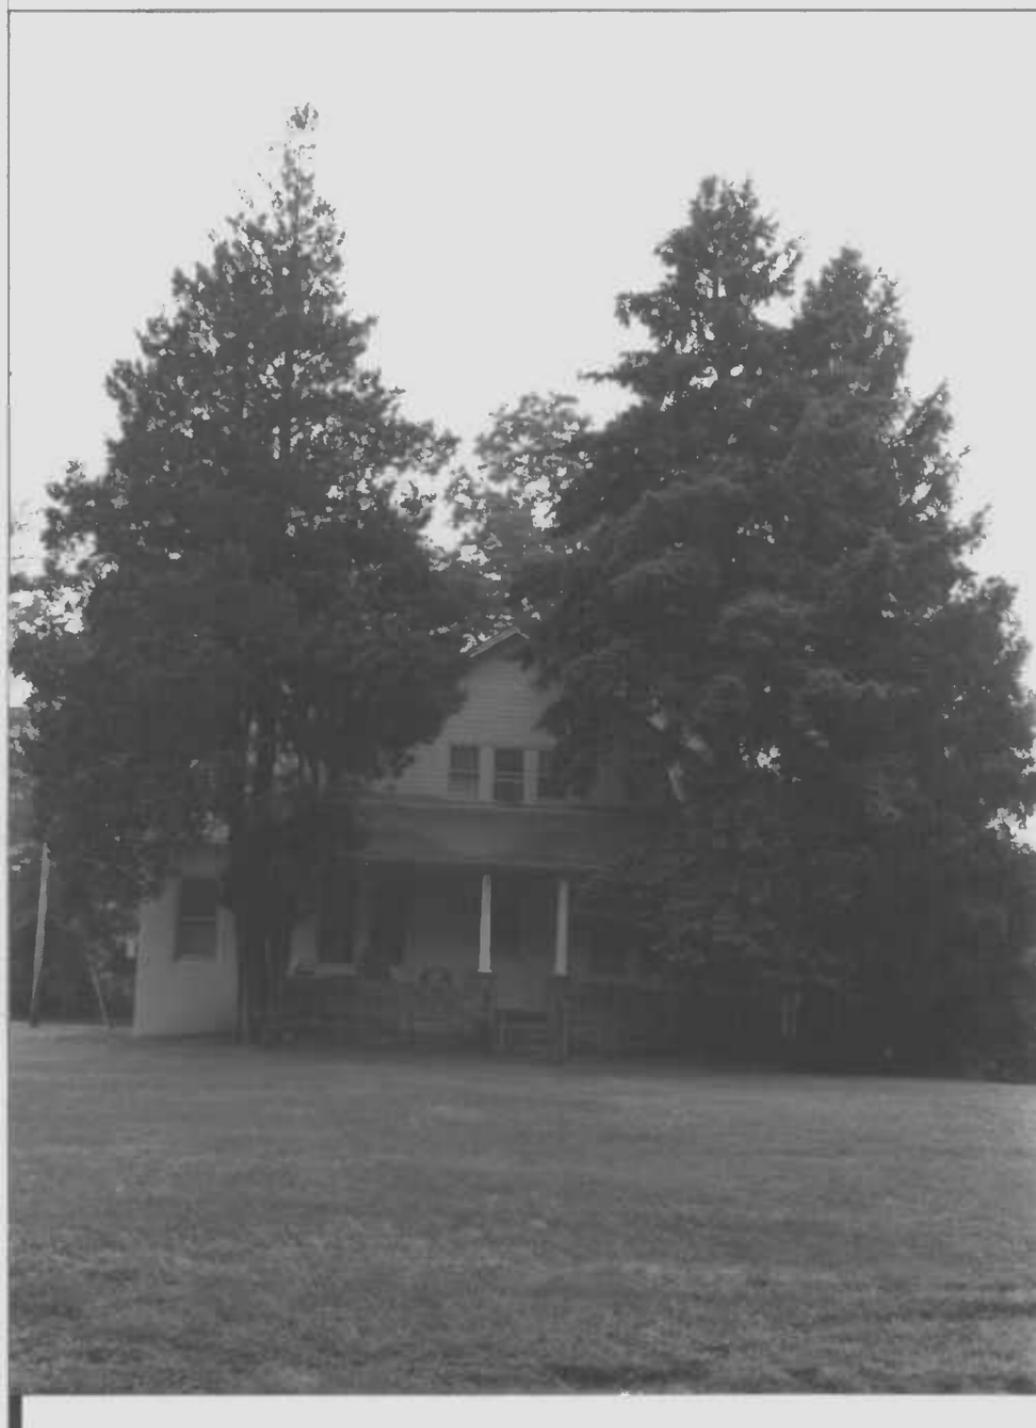
PG: 64-11

NORTHWEST FACADE, LOOKING SOUTH EAST

The northwest facade, originally the principal facade, is dominated by a one-story, shed-roof porch, which runs the length of the facade. This entrance, framed by two overgrown cedar trees that have surpassed the roof line of the house, no longer serves as the principal entrance to the house. The central door is flanked on either side by a pair of large, six-over-one, double-hung windows. These windows are original and are found almost without exception throughout the house. The lower section of this facade is stuccoed. There is also a window on this facade, on the single-story extension on the northeast, which is flush with this facade. The second story is an oversized dormer, which is covered in clapboard siding. It contains a grouping of three windows. The main porch was originally wooden, with a central stair. Openings for the joists are still visible in the main body of the house, and traces of the stair pattern are evident by the front door. The porch consists today of a poured concrete slab, upon which is built a stone wall with light-colored, gum-like mortar. Flanking the current concrete steps are two narrow square posts, situated atop the stone wall, that support the shed roof. At the corners, short square posts rest atop raised stone columns.
