Maryland Historical Trust State Historic Sites Inventory Form

historic Wilson Farmand/or common N/A

Survey No. PG 72-44

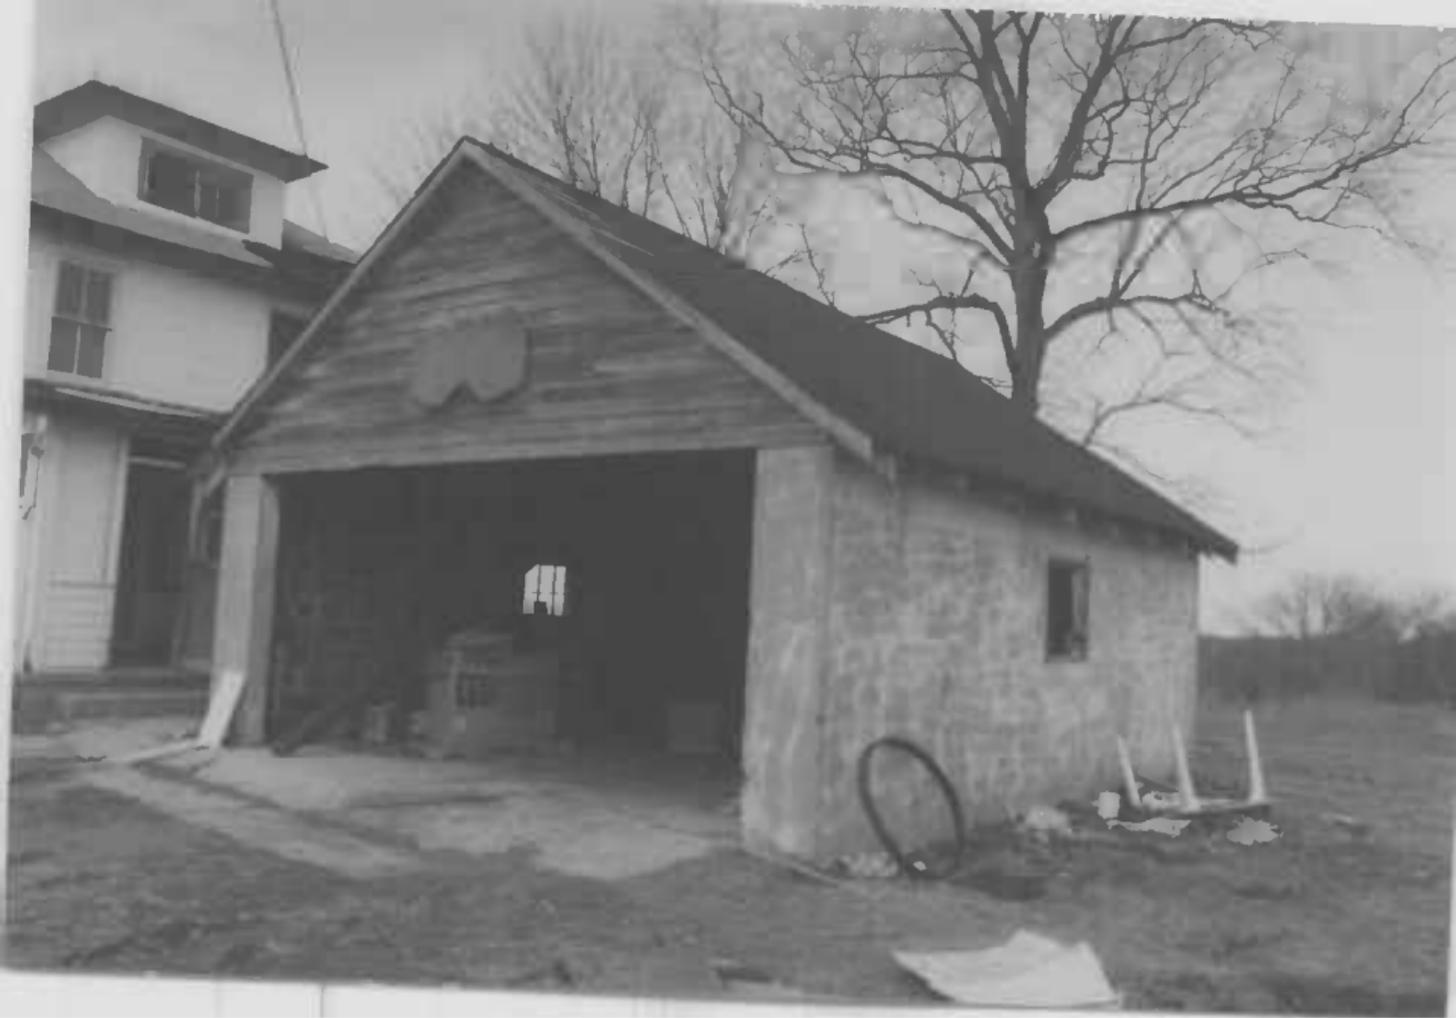
3 of 14

Building 4, erected ca. 1950, closely resembles Building 2. The building is a two-bay, concrete block garage constructed on a concrete slab (Figure 5). The garage is located directly behind Building 3 and faces south. On the exterior, the concrete walls are sheathed in a smooth coat concrete stucco. The gable peaks are clad with wood clapboards. A single window opening is located on each side elevation. A fixed four-light wood sash remains on the west elevation; no sash remains in the east elevation opening.

The building is in fair condition. The stucco exterior walls are cracking and the roof and clapboards are deteriorating.

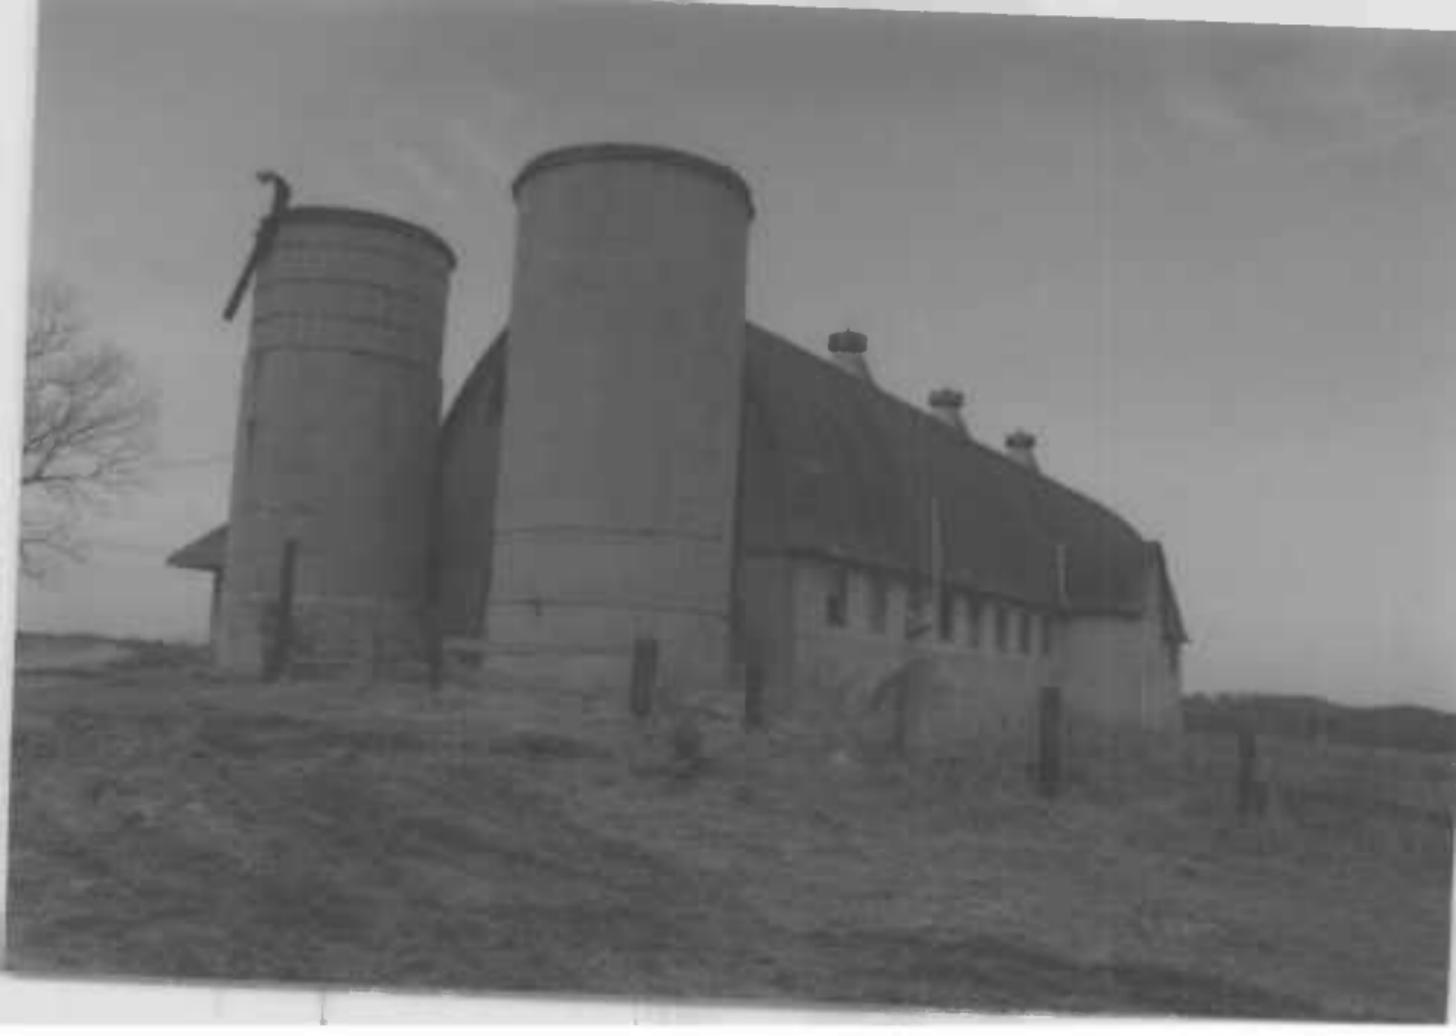
4 of 14

The Dairy Barn, constructed ca. 1950, is the largest building in the Wilson Farm complex. It consists of two sections: the main barn and the creamery. The main barn is a rectangular, two and one-half story building that terminates in a gambrel roof (Figure 6). The creamery is a smaller, one-story building projecting from the south end of the barn's west elevation (Figure 7).

The main barn is oriented on a north-south axis. The walls of the barn are concrete block; the ends of the building are clad in standing seam metal siding. The roof is sheathed in composition roll roofing; four ventilators are located along the roof ridge. The two primary entrances to the barn are located on the north and south ends of the building. A wood sliding door is located at each opening. Windows on the barn are metal sash. Lintels are concrete and sills are red brick. The interior floor of the main barn is poured concrete. Feeding troughs extend along the walls.

Two small, two-story projections are located on the east and west elevations of the main barn. These gambrel roof projections link the first and second floors of the barn. They were used as a means for hay from the second floor of the barn to be delivered to the first floor feeding areas.

The creamery on the barn's west elevation occupies a rectangular footprint and terminates in a side gable roof. This three-bay by one-bay structure faces south and, like the main barn, is constructed of concrete block. A single door is located along the structure's south and east elevations. A broad overhanging eave on the south and east elevations shelters the doorways and forms a breezeway to the main barn. The roof of the creamery is sheathed in asphalt shingles. A single metal ventilator is centered on the roof ridge. Glazed tiles cover the interior walls of this structure. The building is in fair condition.

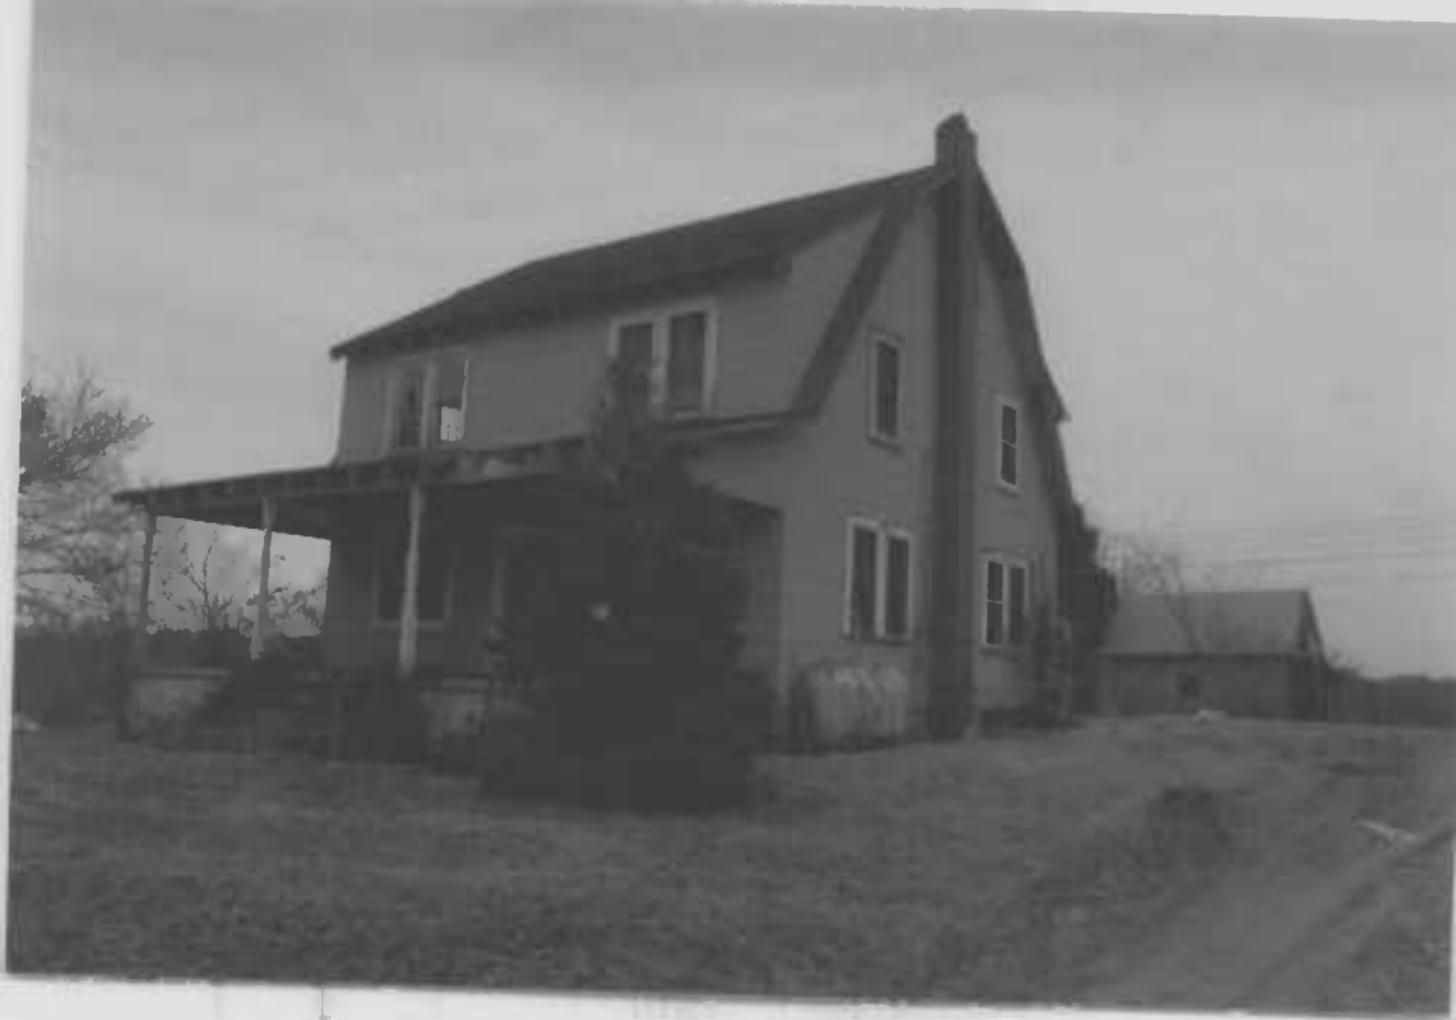
1 of 14

Building 1, constructed ca. 1930, is a two-story wood frame house terminating in a side gambrel roof (Figure 3). The three-bay by two-bay building is constructed on a concrete block foundation and faces west. The exterior walls of the building are clad with synthetic shingles. The roof is sheathed in asphalt shingles. An exterior brick chimney is centered on the building's south elevation. Windows in the building are six-over-one light double-hung wood sash.

The front elevation is characterized by a full-width shed dormer and an open porch. The front three-bay porch extends the full-width of the west elevation. It terminates in a shed roof and is supported by simple turned wood posts. The primary entrance is centered along the front facade. A single rear entrance is sheltered by a similar two-bay shed roof porch. The building is in fair condition.

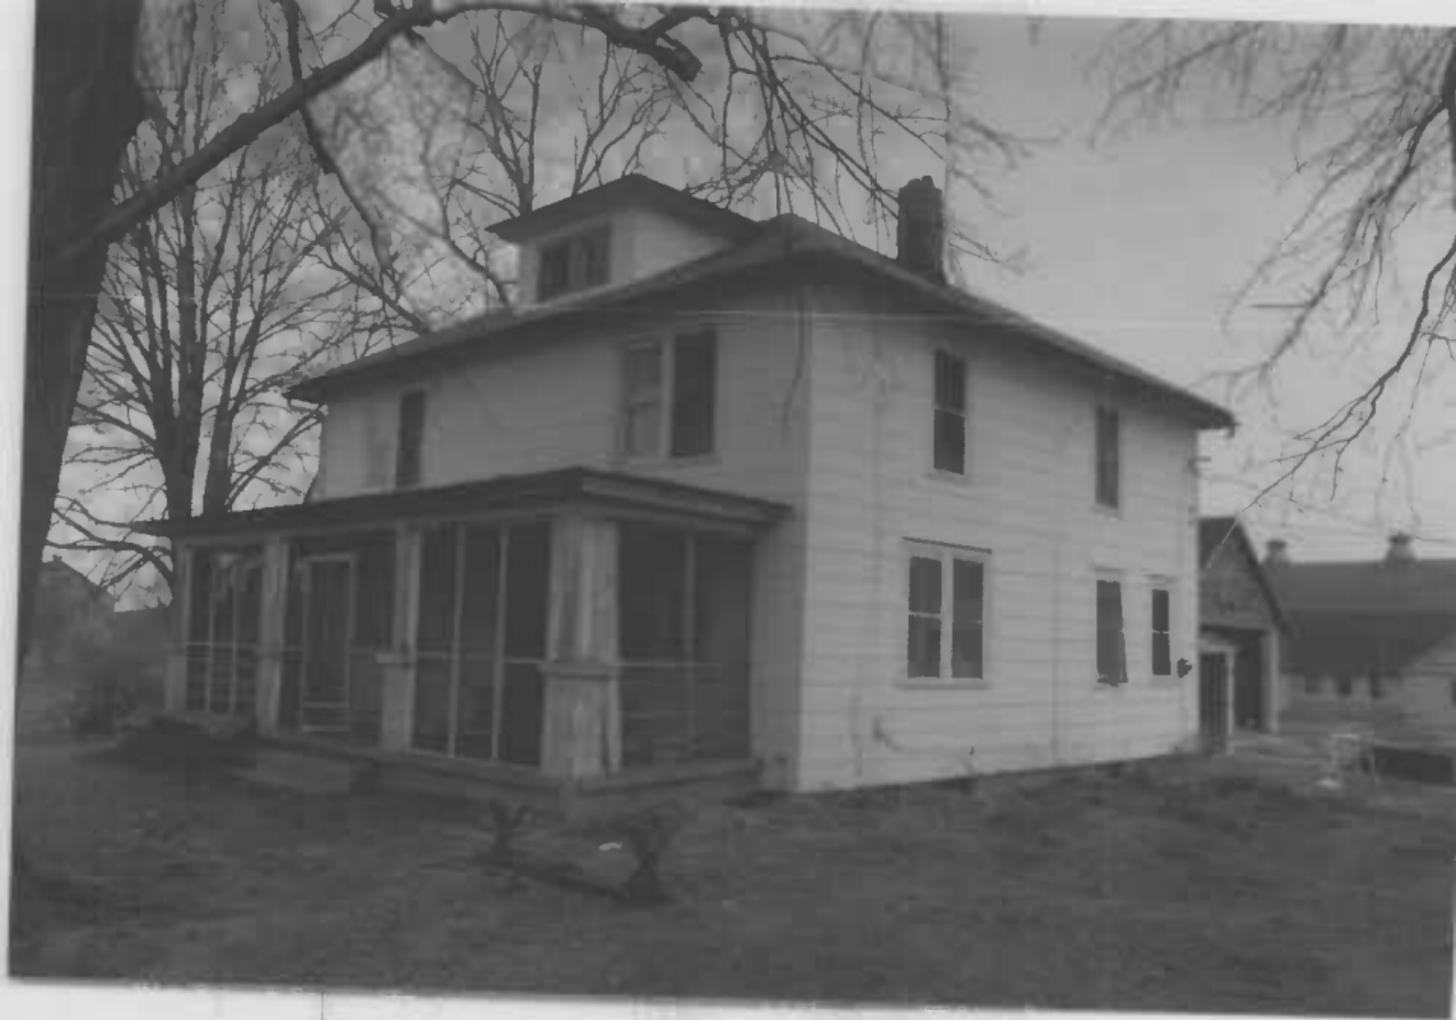
2 of 14

Building 3 is a Colonial Revival style, three-bay, two and one-half story dwelling constructed ca. 1930 (Figure 4). The wood frame building adopts a "four-square" form, defined by its square plan, symmetrical facade, and low-pitched hip roof. The dwelling stands on a poured concrete foundation and is oriented to the west. Synthetic shingles cover the original wood clapboard siding on the building's exterior walls.

The building terminates in a low-pitched hip roof sheathed in asphalt shingles. The building incorporates two interior brick chimneys. A low hipped dormer is located on both the front and rear elevations. Paired four-light casements are located in each dormer.

A one-story, three-bay porch extends the full width of the front elevation. The porch terminates in an asphalt-clad hipped roof supported by square wood posts on concrete piers. The porch, originally open, is enclosed with screens. The primary entrance is centered on the front facade. The two-over-two light windows throughout the building are original to the structure and are aligned symmetrically.

An enclosed one-story porch is centered on the rear elevation. The porch terminates in a shed roof. A four-light wood panelled door provides entry into the rear of the dwelling. The building is in fair condition.

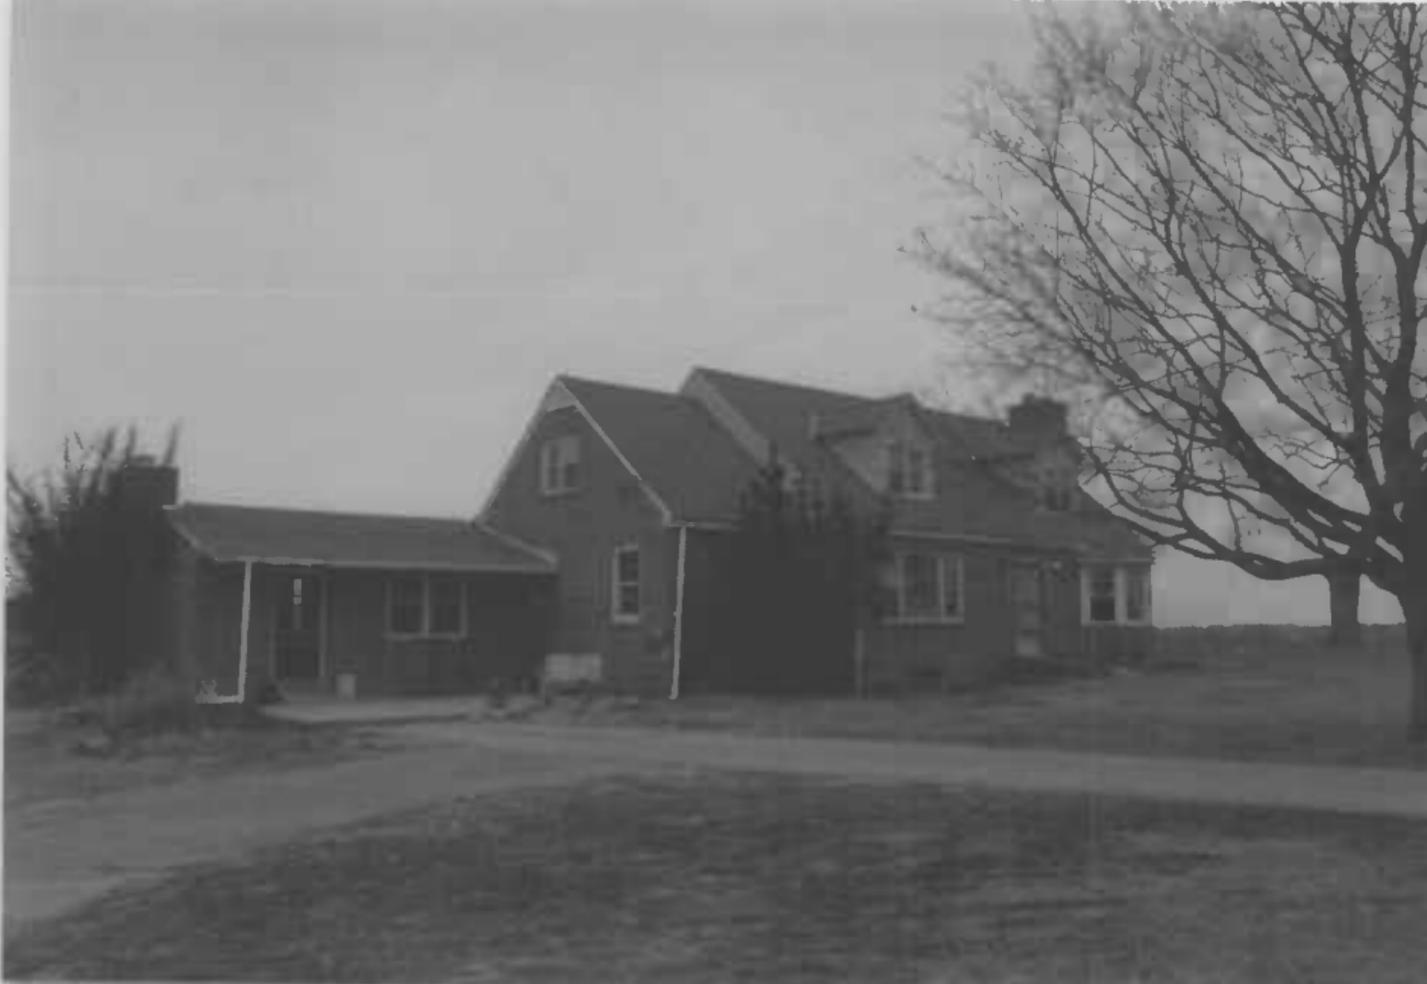
8 of 14

Building 9 is a one-story, wood frame house constructed in two phases, ca. 1930 and ca. 1950 (Figure 11). The earlier part of the house occupies a rectangular plan and is oriented on an east-west axis with a front gable roof. A single door entry is located on both the east and west elevations. Both doors are original to the dwelling. The door on the east elevation is a four-light panelled wood door; the door on the west elevation is a six-light panelled wood door. The windows in this earlier section are six-over-six light, double-hung wood sash. A poured concrete interior chimney is located at the west end of the dwelling.

The second part of the house is rectangular in plan, faces east, and terminates in a side gable roof. The rear elevation is flush with the west elevation of the earlier section. A single wood door with a diamond pane is located on the east elevation. Windows in this section of the building are six-over-one light, double-hung wood sash. An interior brick chimney is located at the south end of this section.

Synthetic shingles cover the original wood clapboards on the exterior walls of the dwelling. The roof of the earlier section is sheathed in corrugated metal; the roof of the later section is sheathed in standing seam metal. The dwelling is in fair condition.

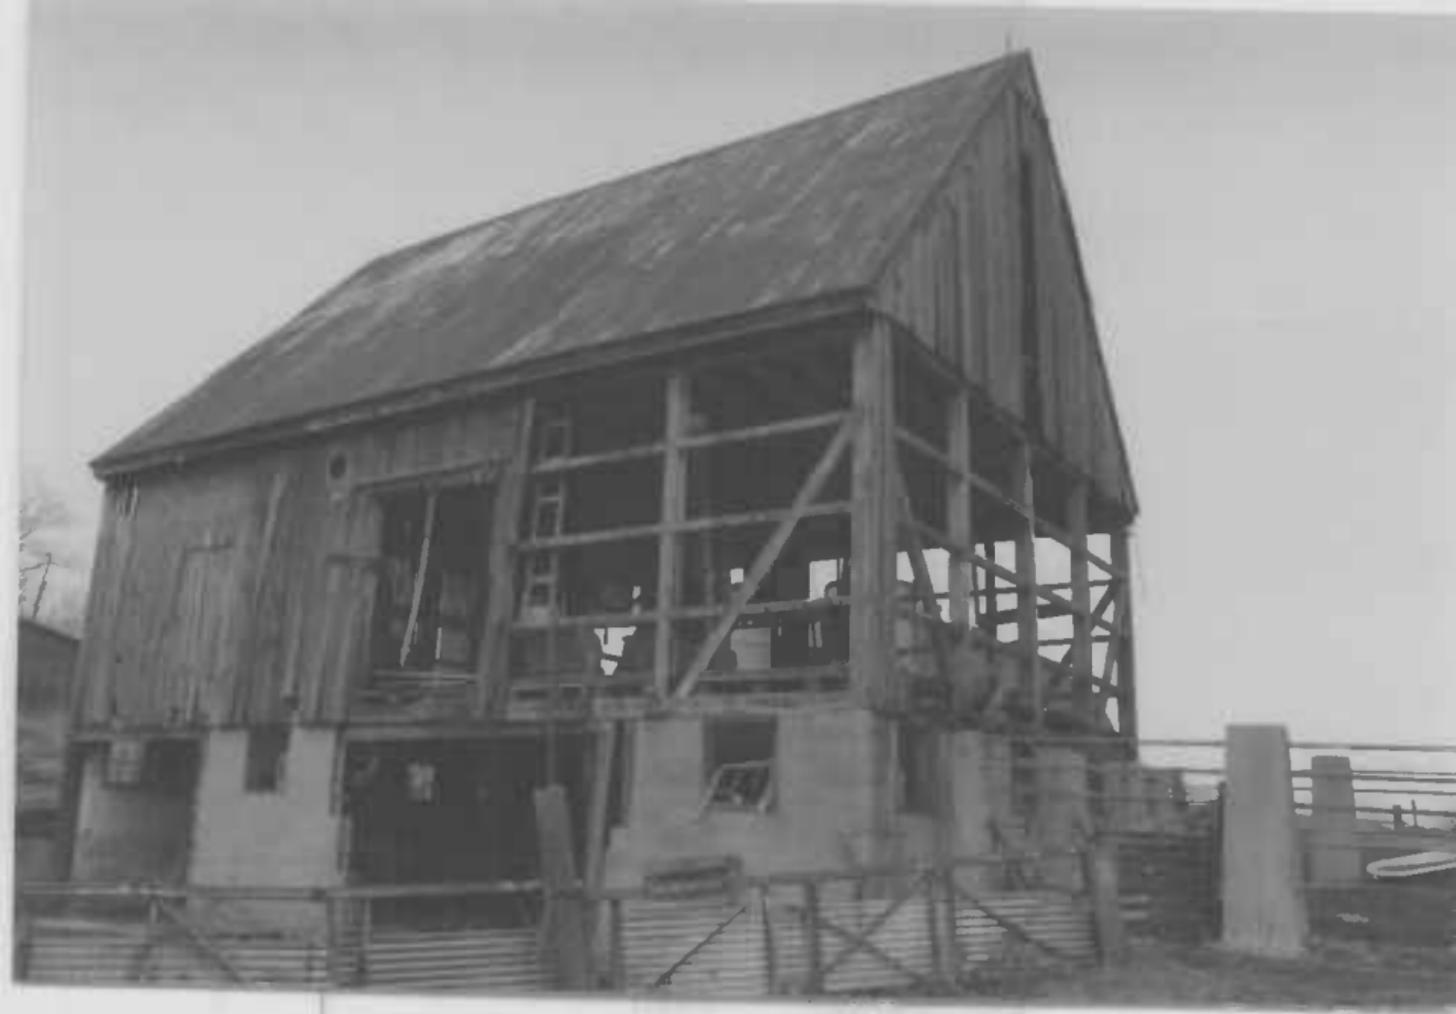
11 of 14

Building 12 is a one-story, wood frame barn constructed ca. 1930 (Figure 14). The building faces east. The barn occupies a rectangular plan and terminates in a gable-on-hip roof. The barn is clad with vertical wood siding and the roof is sheathed in corrugated metal. The barn sits on a concrete block foundation. Two wide openings with sliding wood doors are located on the east elevation. A smaller single wood door is centered between these wider openings. Secondary entrances are located on the north elevation; no doors remain.

The barn is in poor condition. The corrugated metal roofing is corroded and much of the wood siding is missing.

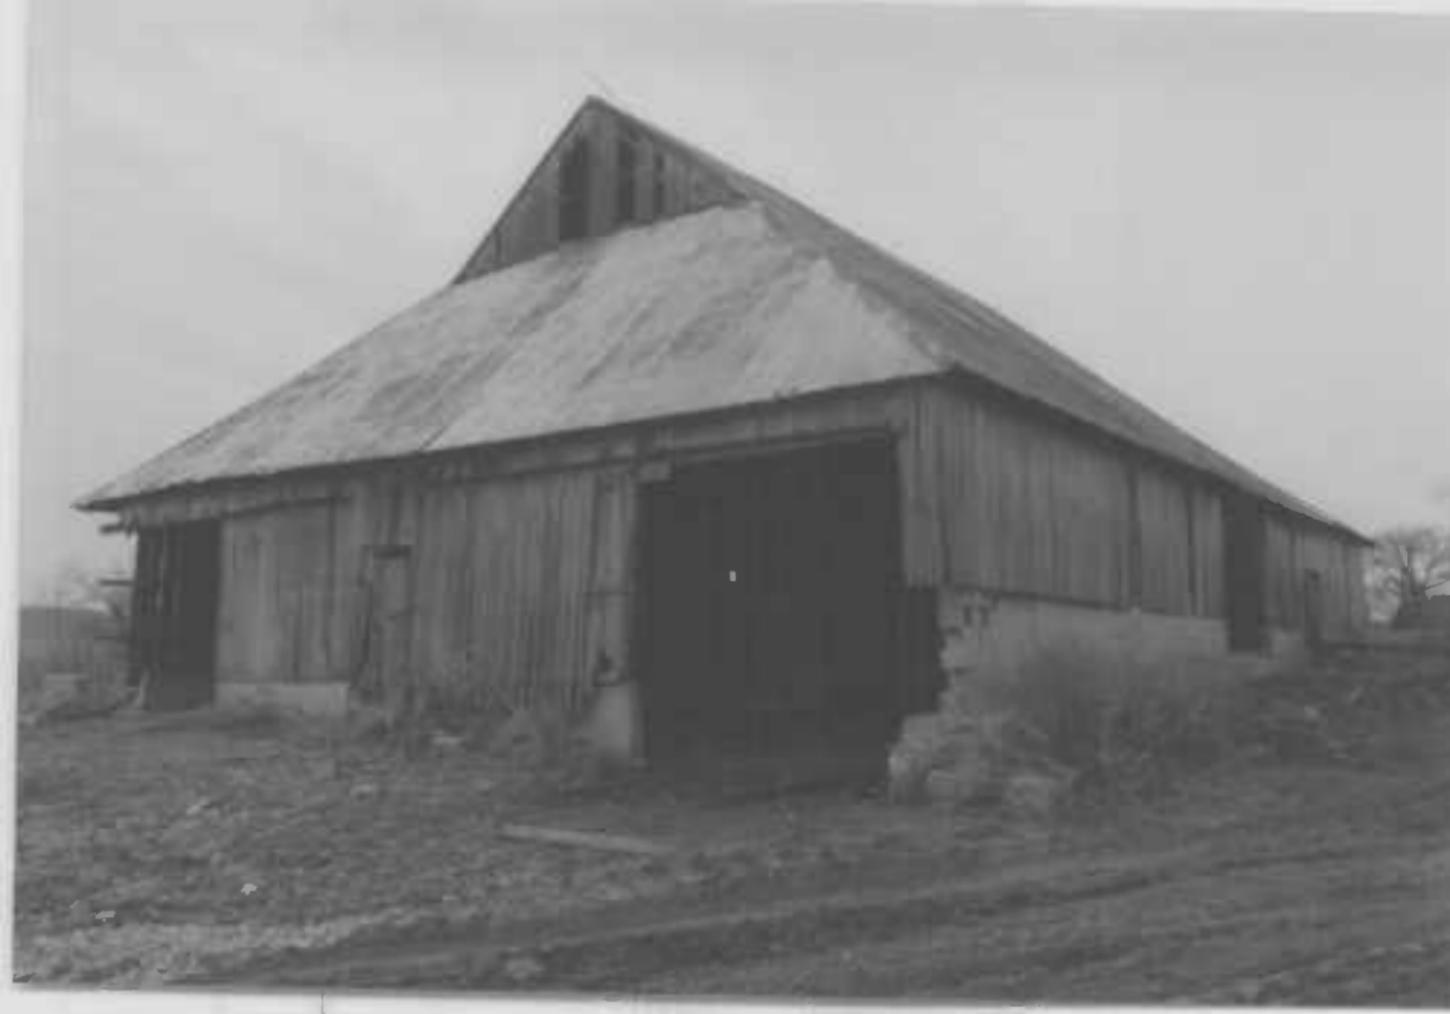
12 of 14

Building 13 is a one-story, wood frame shed constructed ca. 1930 (Figure 15). The building is rectangular in plan and faces south. It is constructed on a concrete block foundation and terminates in a front gable roof. The walls of the shed are clad with horizontal wood siding. The building is in poor condition. Most of the wood siding is missing and the wood frame is deteriorating. The deteriorated condition of the structure made it difficult to identify the original locations and number of openings.
