Maryland Historical Trust

Maryland Inventory of Historic Properties number: PG. 76A-23
Name: SP 398/WHEELER HULL ED. at FARMASY RUN

MARYLAND INVENTORY OF HISTORIC BRIDGES
HISTORIC BRIDGE INVENTORY
MARYLAND STATE HIGHWAY ADMINISTRATION/
MARYLAND HISTORICAL TRUST

SHA Bridge No. P398 Bridge name Wheeler Hill Road over Barnaby Run

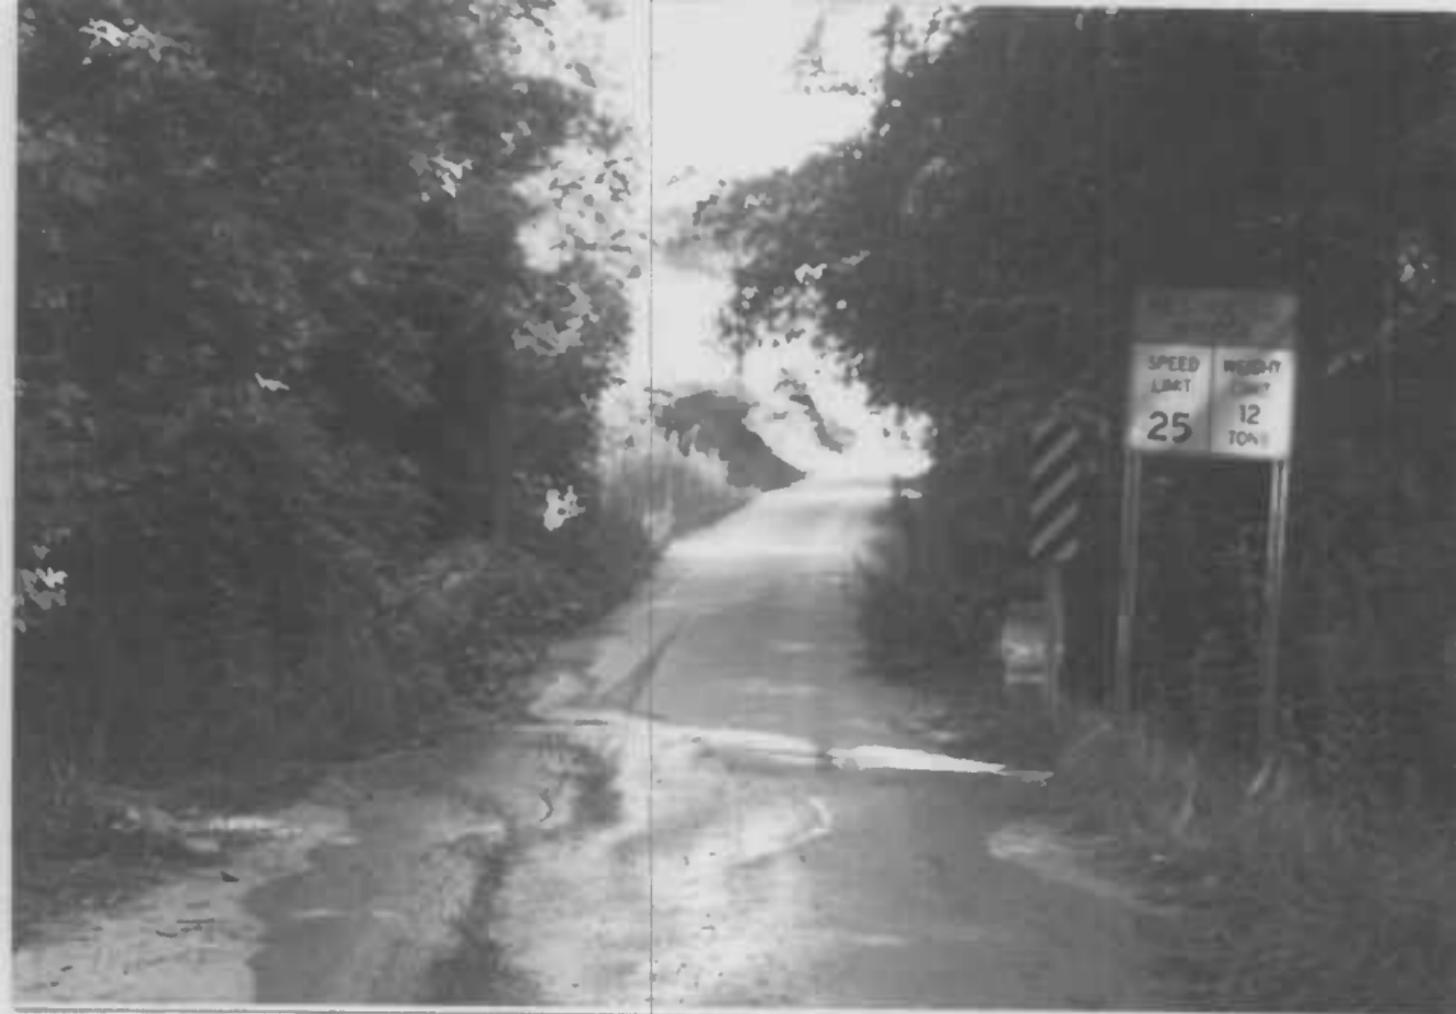
- 1 PG:76A-23
- 2 (P398) Wheeler Hill Rd. over Barnaby Creek
- 3 Prince George's County, MD.
- 4 Tim Tamburino
- 5 8/11/95
- 6 MD SHPO
- 7 South Approach, View Looking North
- 8 1 of 5

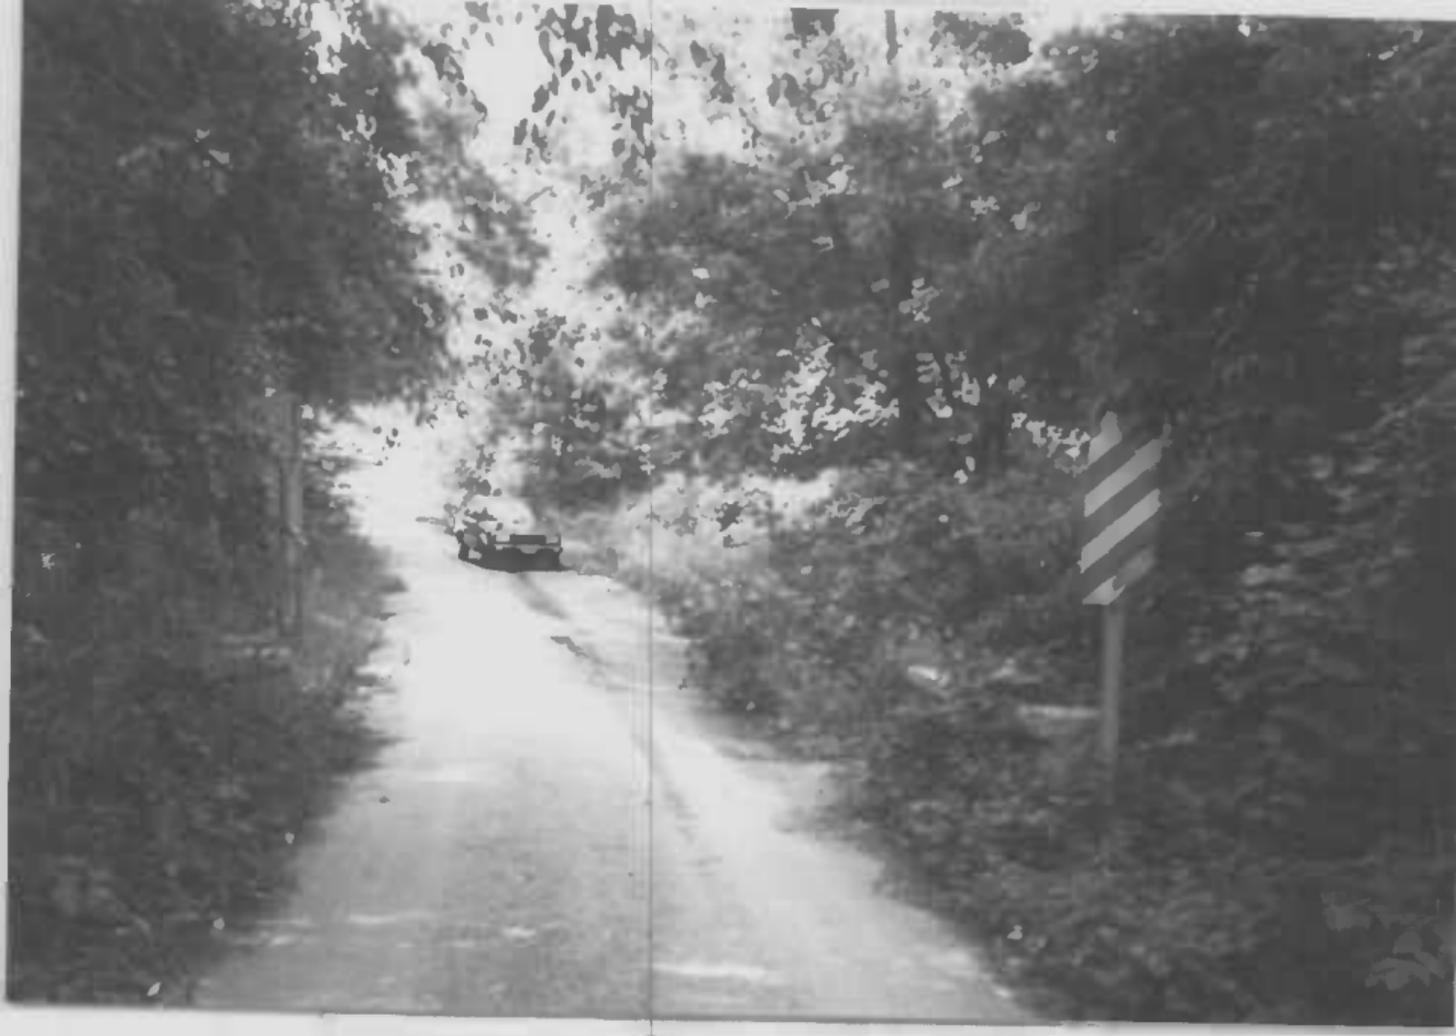
- 1 PGI: 76A-23
- 2 (P398) Wheeler Hill Rd. over Barnaby Creek
- 3 Prince George's County, MD.
- 4 Tim Tamburri
- 5 8/11/95
- 6 MD SHPO
- 7 North Approach, View Looking South
- 8 2 of 5

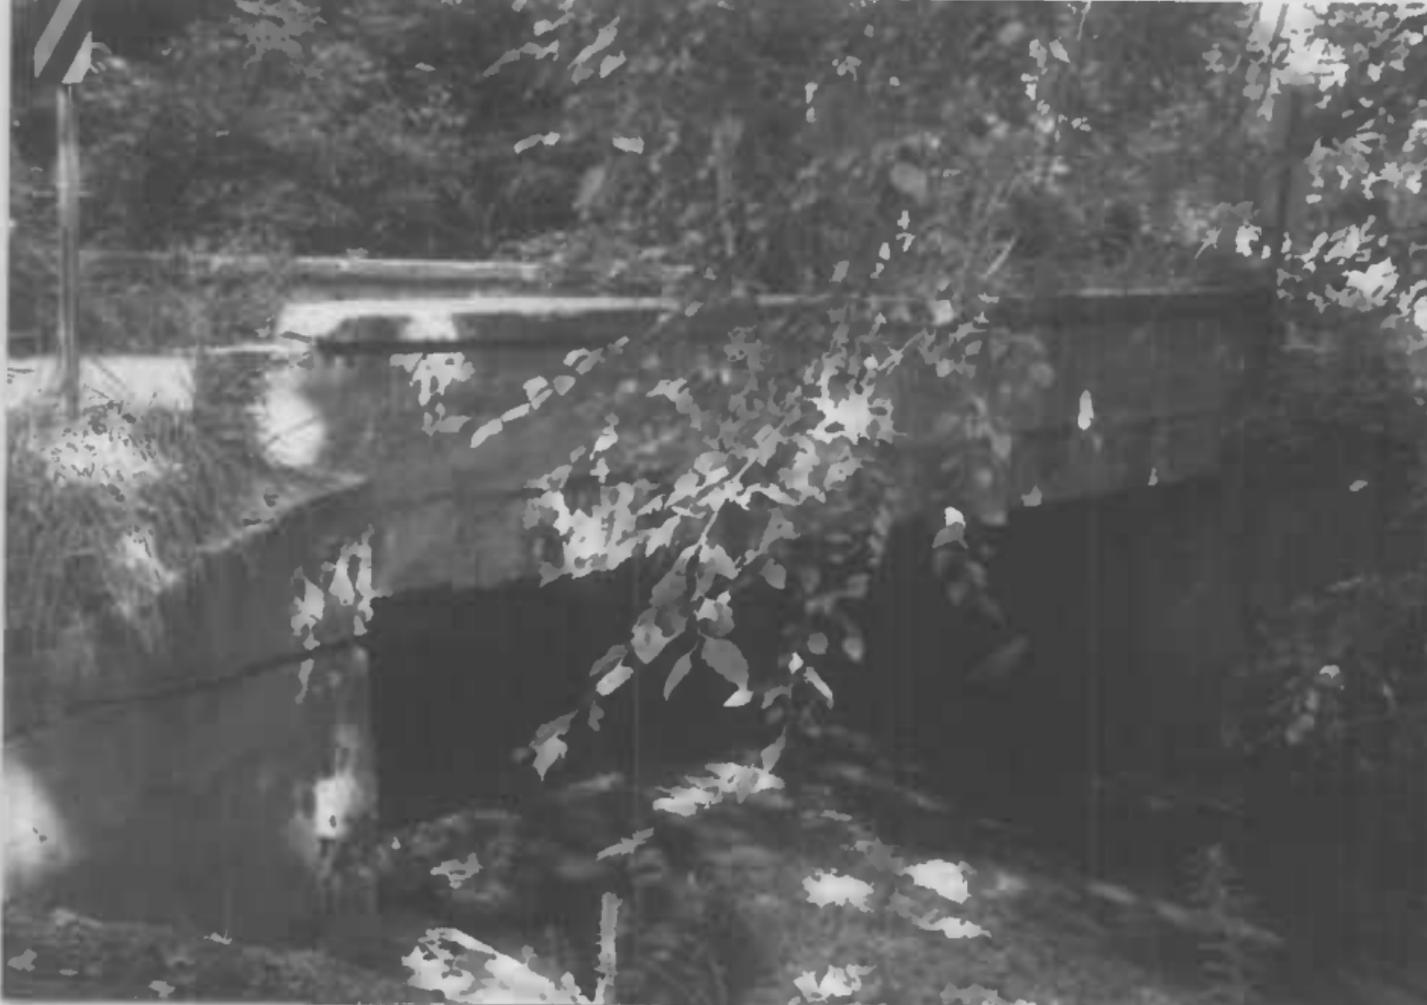
- 1 PG: 764-23
- 2 (P398) Wheeler Hill Rd. over Barnaby Creek
- 3 Prince George's County, MD
- 4 Tim Tamburino
- 5 8/11/95
- 6 MD SHPO
- 7 East Elevation, View looking N.W.
- 8 3 of 5

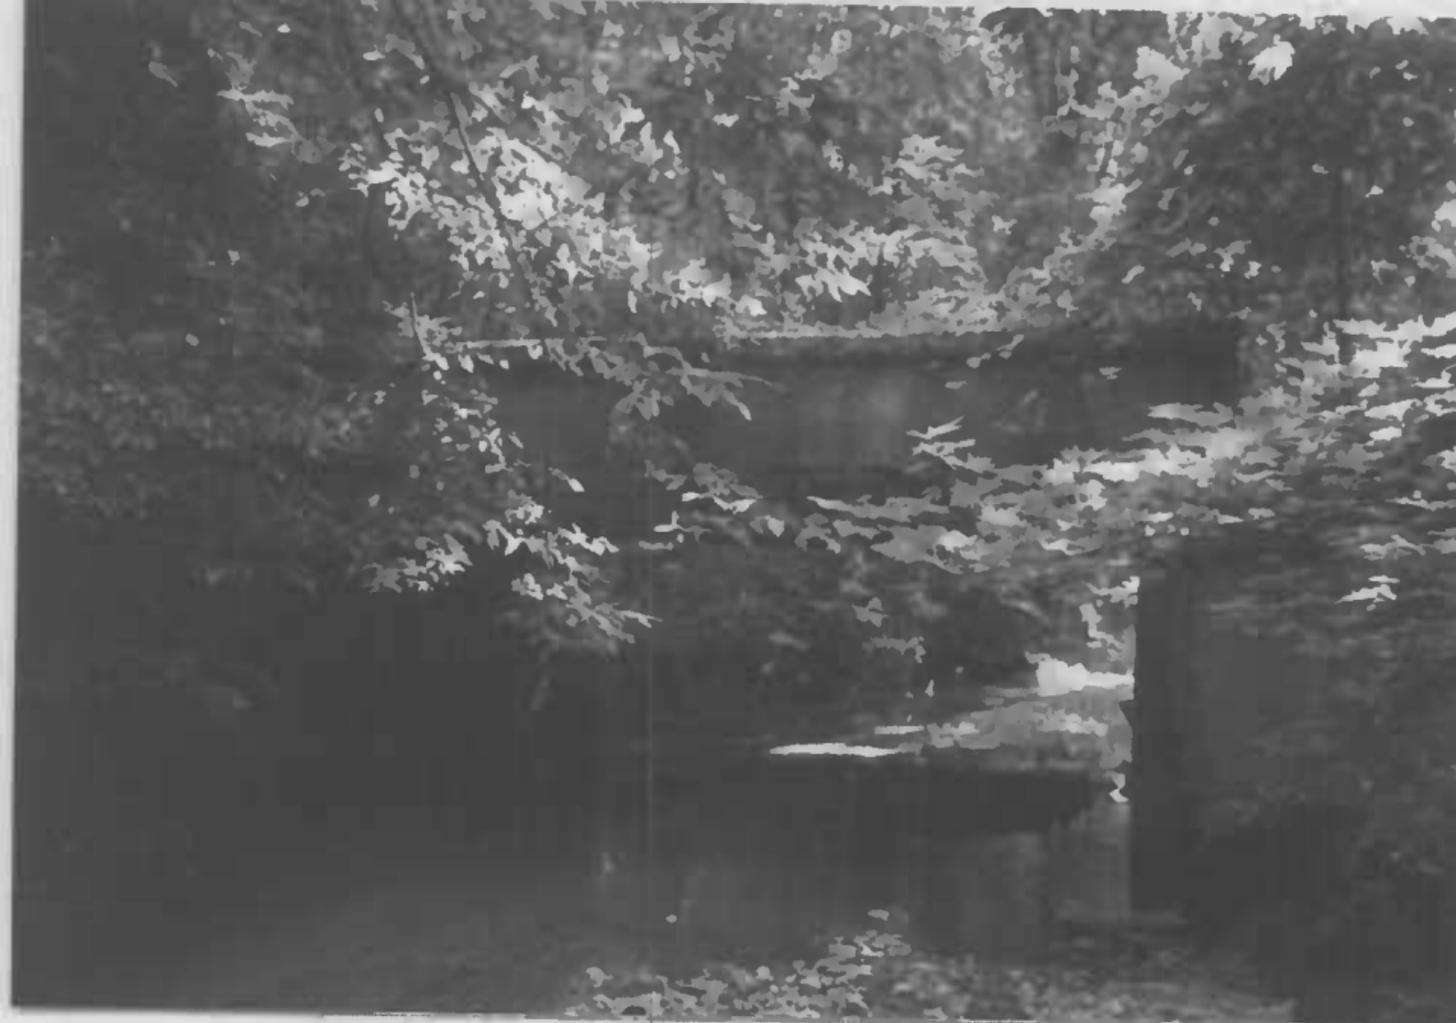
- 1 PG: 76A-23
- 2 (P 398) Wheeler Rd. over Barnaby Creek
- 3 Prince George's County, MD
- 4 Tim Tamburrino
- 5 8/11/95
- 6 MD SHPO
- 7 West Elevation, View Looking East
- 8 4 of 5

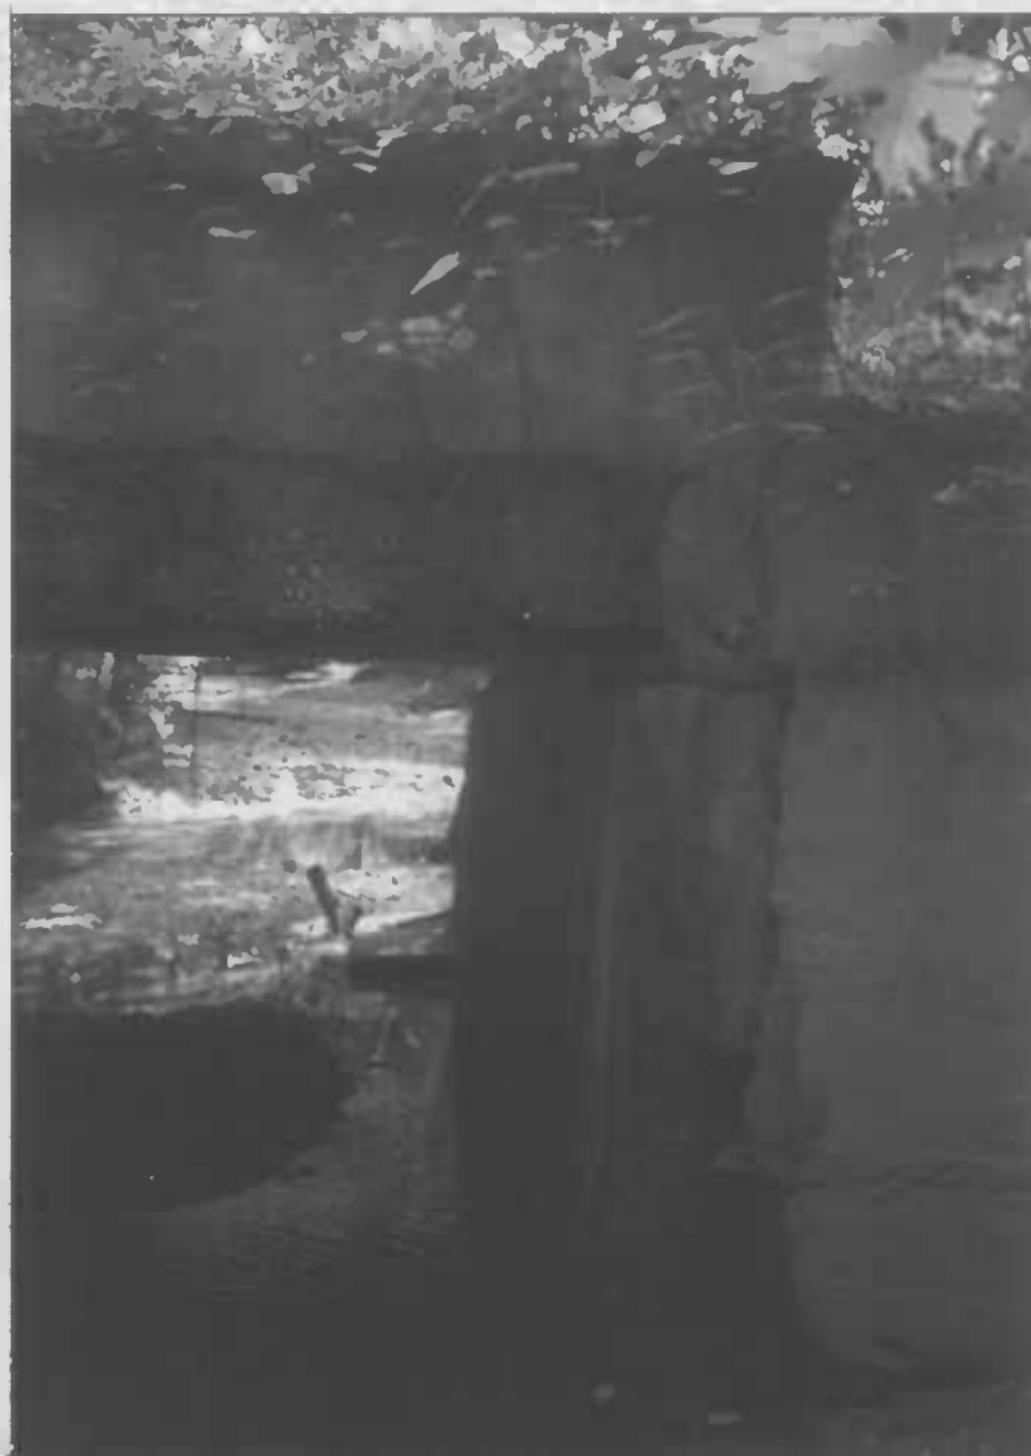
The bridge inspection from 1991 indicates the structure to be in fair condition. The deck concrete has spalling with exposed deteriorating reinforcing steel near the outer edges along the underside. Settlement at the southeast wingwall has caused approximately 4" of movement in this wall. All the wingwalls have open vertical cracks at the abutment corners. Stream flow against the north abutment has eroded up to 9" out of the face of the wall along much of its length. No significant change has occurred in the condition of this structure since the 1989 inspection. It was recommended in the inspection report that the bridge be replaced due to the deck geometry and limited load carrying capacity

- 1 PG:76A-23
- 2 (P398) Wheeler Hill Rd. over Barnaby Creek
- 3 Prince George's County, MD.
- 4 Tim Tamburino
- 5 8/11/95
- 6 MD SHPO
- 7 West Elevation, Detail of Slab + Wingwall
View Looking East
- 8 5 of 5
