PRINCE GEORGE'S COUNTY
HISTORIC SITE SUMMARY SHEET

Survey #: P.G. #86A-27 Building Date: ca. 1745-1930's

Building Name: Croom Historic Survey

Maryland Historical Trust State Historic Sites Inventory Form

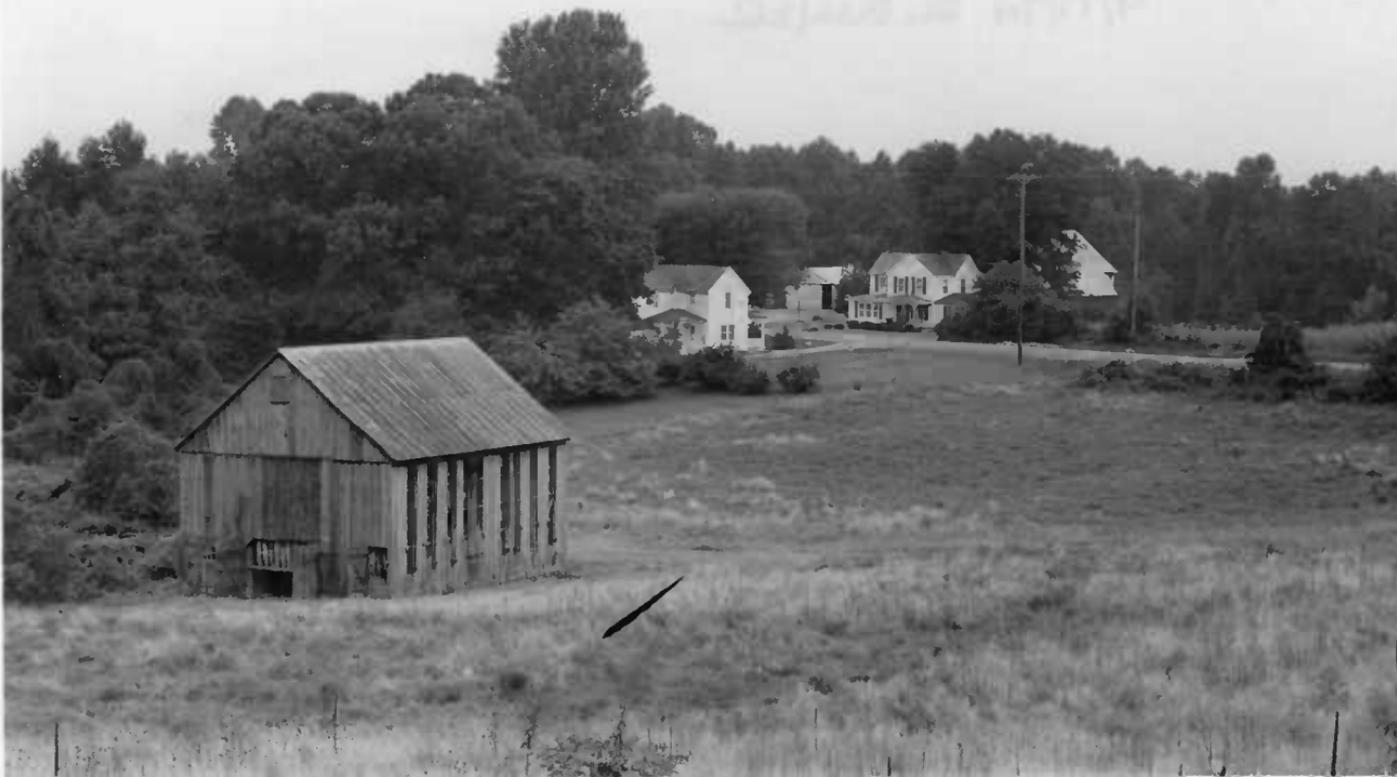
NAME FARMHOUSES AT CROOM PG. 86A-27

FACADE LOOKING SW FROM CHURCH

PHOTO TAKEN 9/17/74 M. DWYER

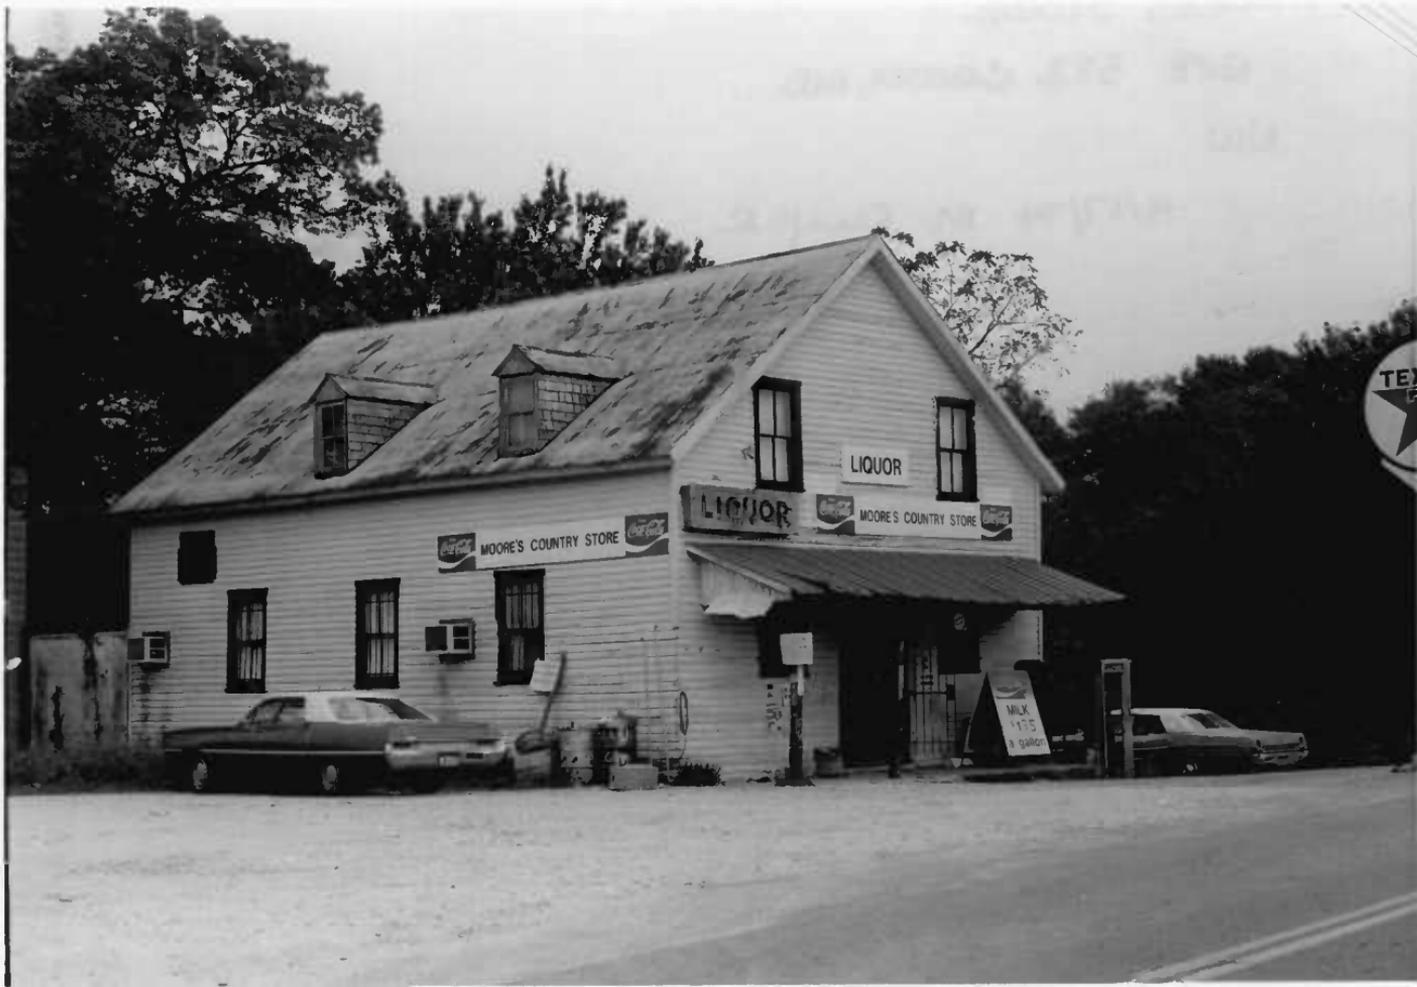
THE STORES OF THE
COUNTRY

MOORE'S COUNTRY STORE

40. (C) Moore's Store, (early 20th century), 10104 Croom Road, map 128, parcel 7.

A three-by-two bay, two story frame building with entrance through the west gable end. The structure is German sided and rest on a cement block base. The gable roof is covered with corrugated metal. There are two north and two south facing gable dormers. The first floor interior is one large room used as a convenience store. The building was built as a hall for St. Thomas Church, in the early 20th century and was sold to Harry Moore in the early 1940's. Moore extended it one bay to the east and opened a store
