S-193  
Old Chamberlin House  
Near Kingston  
Private

c. 1800-1815 with  
c. 1880 addition.

# Maryland Historical Trust State Historic Sites Inventory Form

and/or common Old Chamberlin House

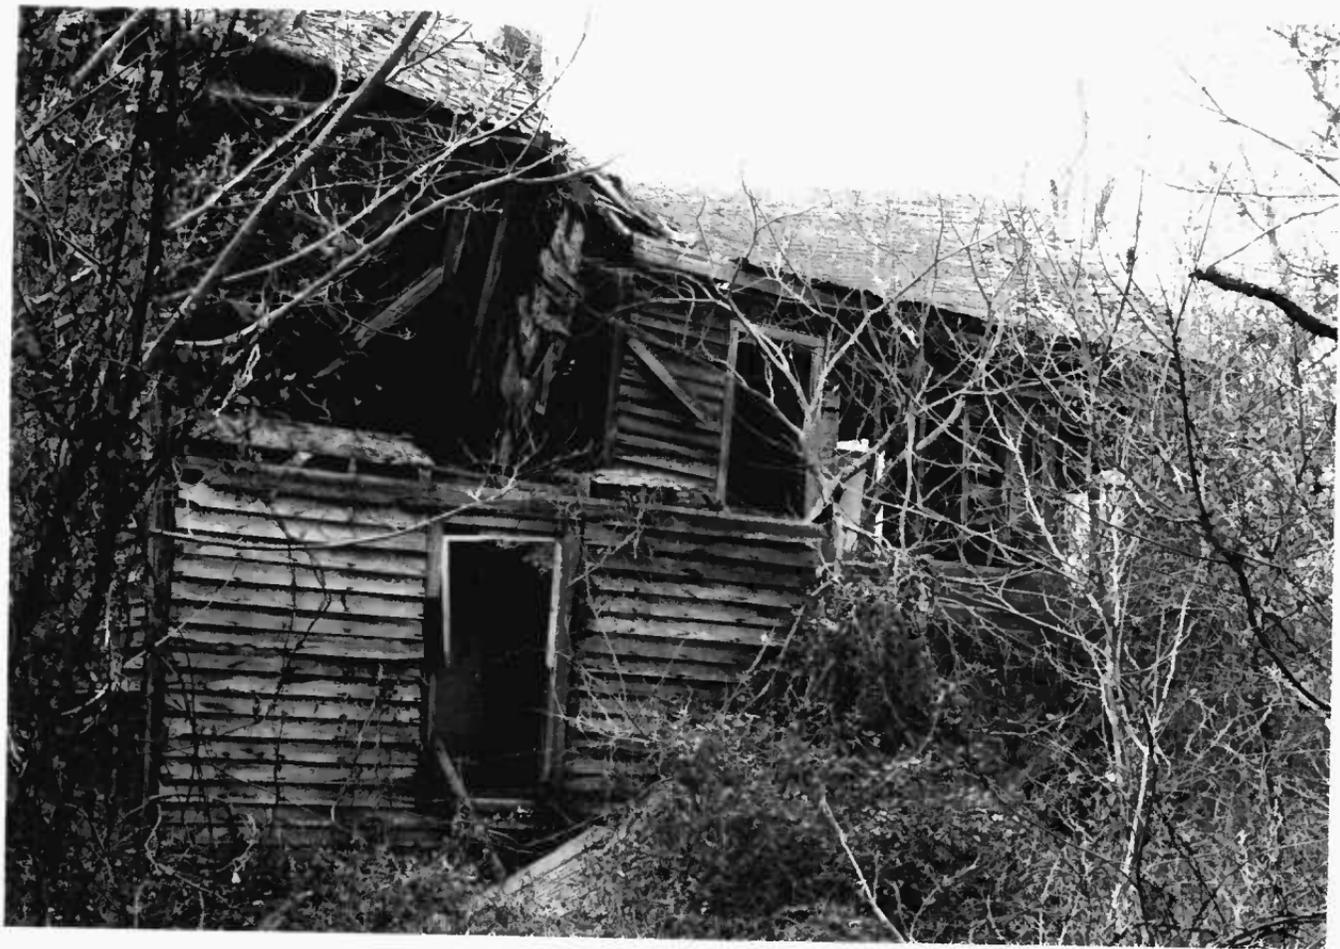
S-193

The Old Chamberlin house is a composite frame structure that stands on the north bank of the Annemsee~~x~~ River just west of MD. Route 413, near Kingston, Somerset County, Maryland. The front section is a c. 1880-1900 cross-gabled farmhouse, which has a c. 1800-1815 two-story three-bay mortise and tenon frame <sup>rear wing</sup> in an advanced state of deterioration.

The front portion is a typical late 19th-century cross-gabled house with a center entrance and flanking windows. The cross-gable is pierced by a pointed window, and a pair of brick chimneys rise from the center of the house. Both gable ends have a single window on each floor. The interior is badly deteriorated, but some late 19th-century finish materials survive around door and window openings.

Old Chamberlin House  
Near Kingston, Somerset County  
Norht Elevation  
3/84 Paul Touar  
Neg./ Maryland Historic Trust
