S-247
Fred Henss Farm
Kingston vicinity
Private

Maryland Historical Trust State Historic Sites Inventory Form

Survey No. S-247

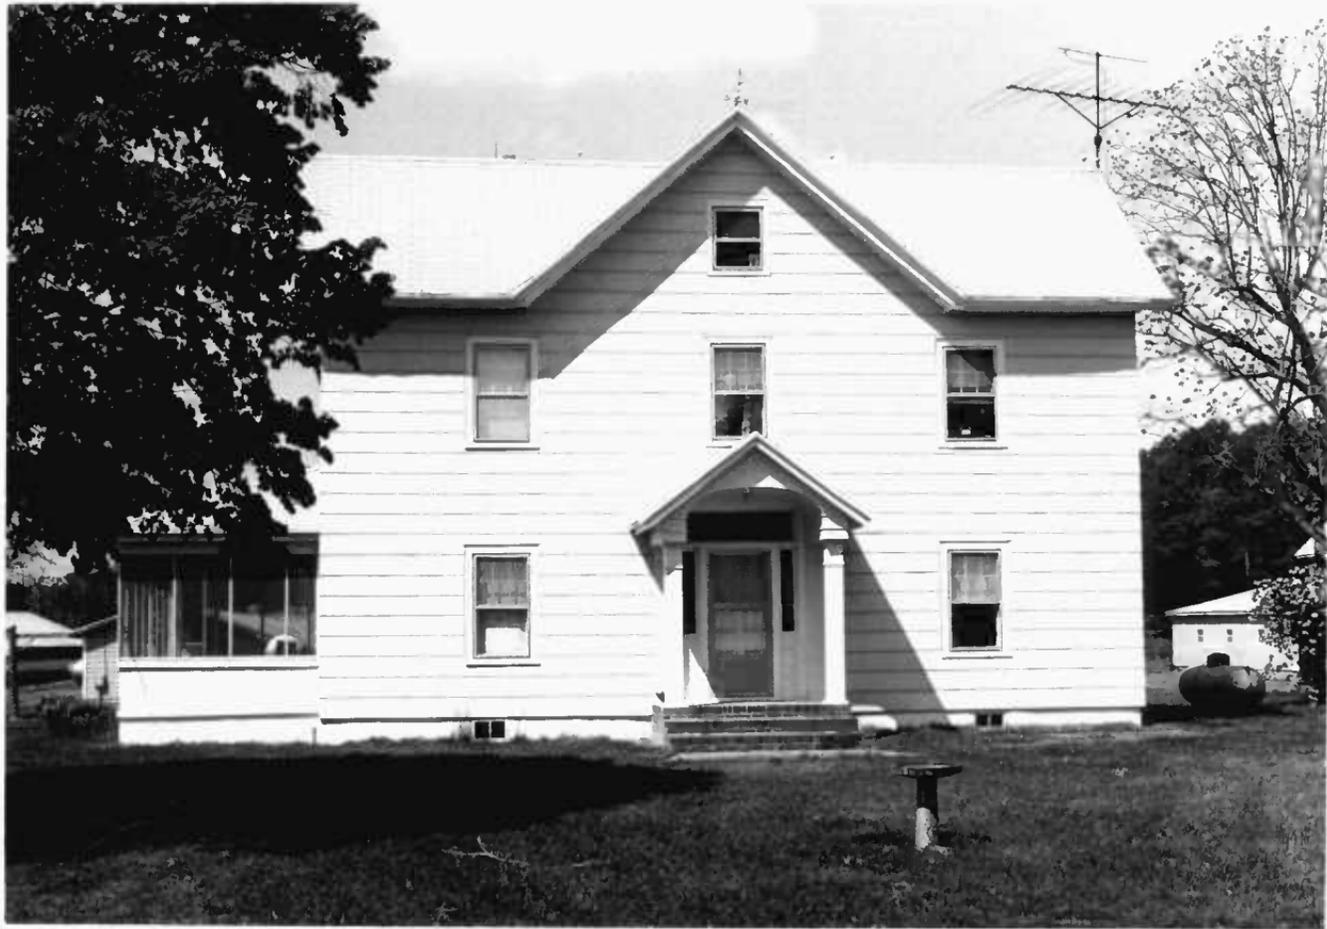
East Elevation

The east (main) elevation is symmetrically arranged with a center door and flanking 6/1 sash windows. The four-panel molded door is framed by colored three-light sidelights and a colored three-light transom. A gable front entrance stoop covers the center bay. The second floor is lighted by three 6/1 sash windows, while the cross gable is pierced by a single-pane sash window.

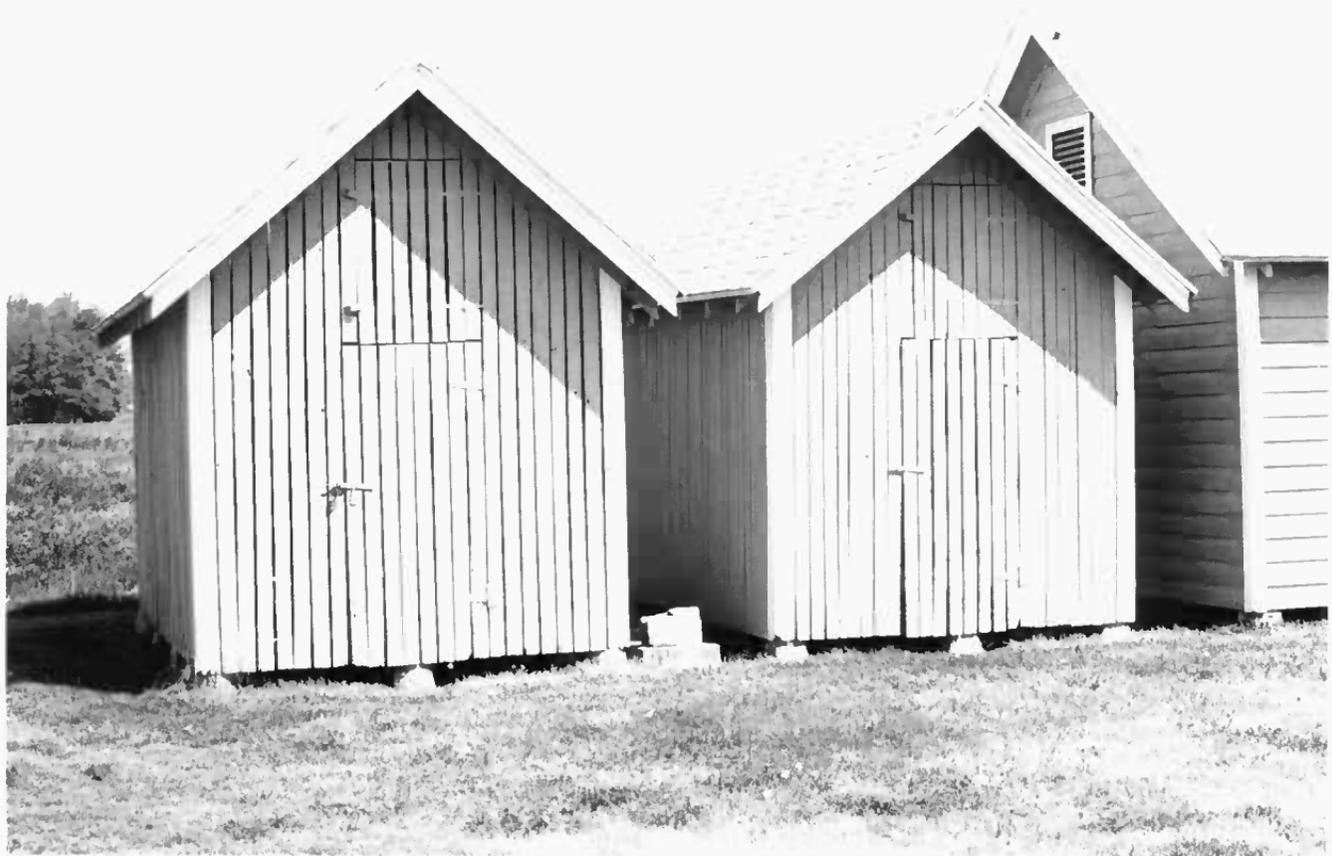
Corn Cribs

Next to the barn are a pair of frame corn cribs with vertical slat siding. Concrete piers support the two buildings, while simple gabled roofs cover them.

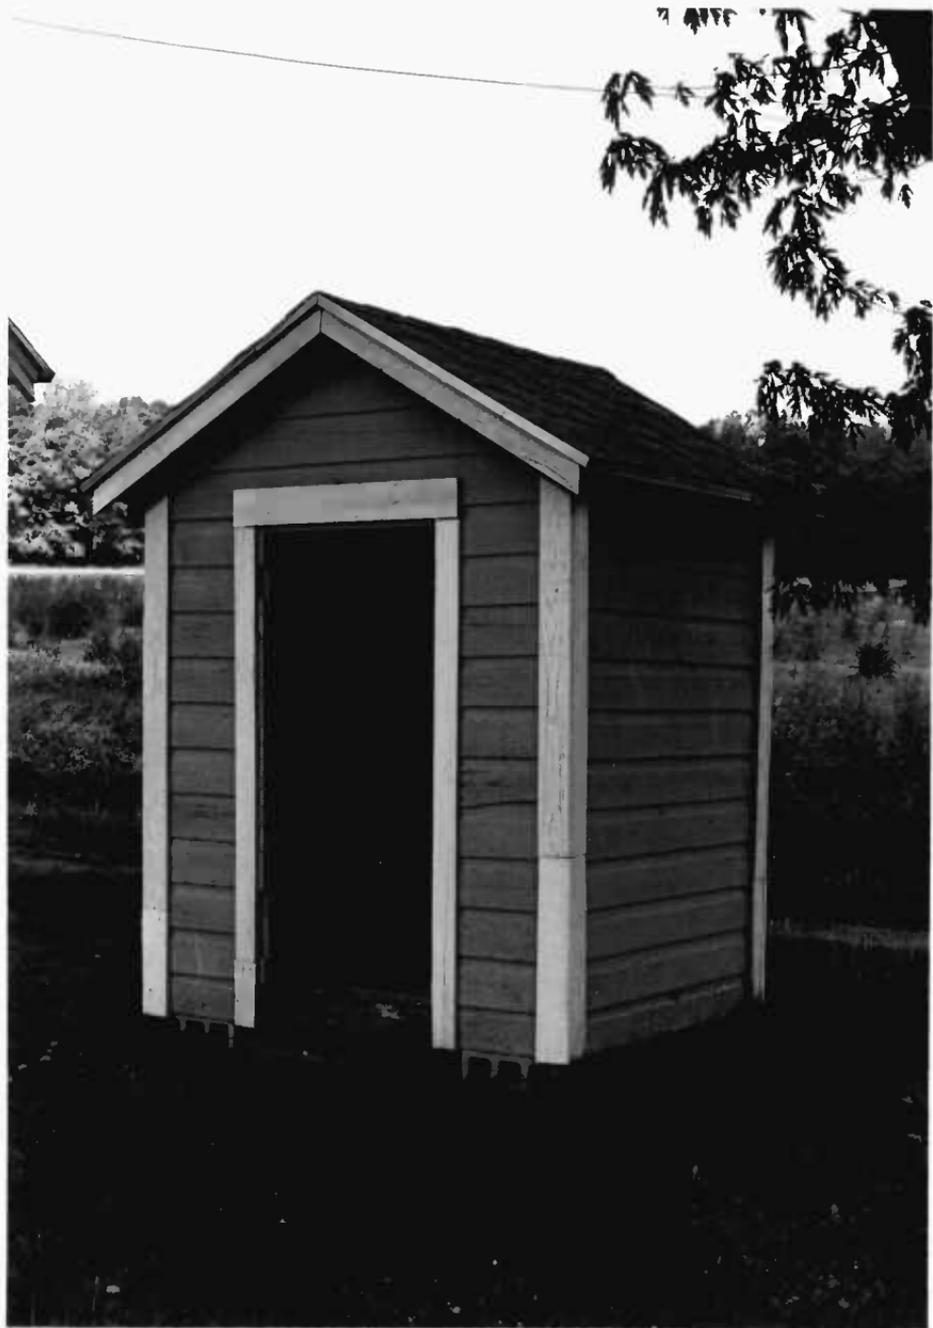
Privy

Another frame building with German siding stands next to the corn cribs. Finally a small one-bay by one-bay privy, which has been converted to a different use, completes the group of outbuildings. Like the barn, it is clad with German siding and covered by an asphalt shingle roof.
