S-253  
Dr. Thomas Costen House  
Rehobeth  
private

C. 1825-1840

# 7. Description

## Dr. Thomas Costen House

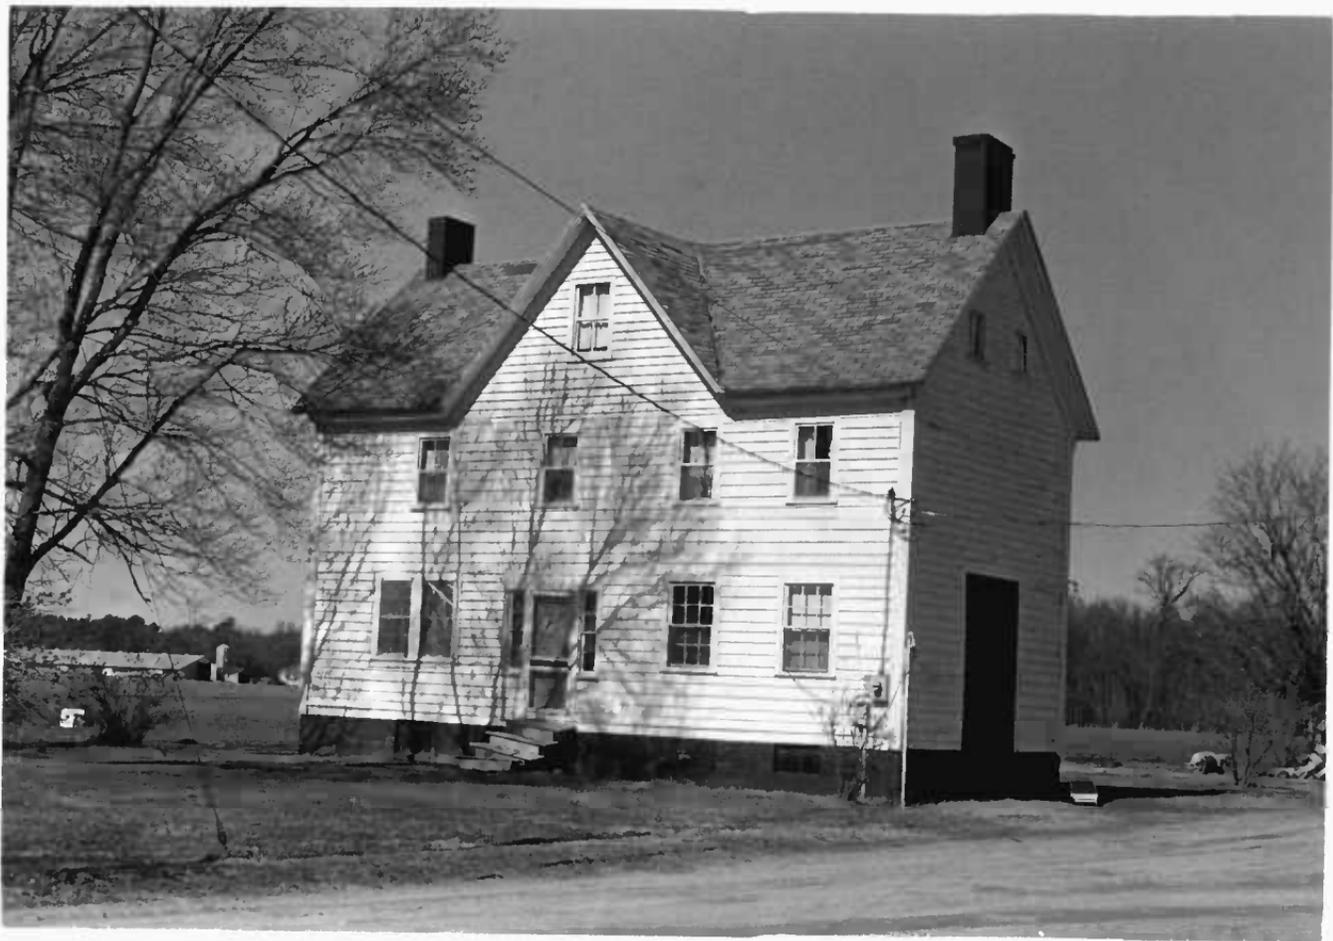
Dr. Thomas Costen House      S-253  
Near Rehobeth, Somerset County  
South Elevation  
4/85, Photographer, Paul Touart  
Neg./MD. Historical Trust

The asymmetrical south facade is divided into four bays with the entrance occupying the second bay from the west. A six-panel door is flanked by 2/2 sash sidelights. The two bays to the east are marked by two 6/6 sash windows, while the single bay to the west is filled with a modern paired 6/6 sash window. The second floor is lighted by four 2/2 sash windows, and the front gable is pierced by the same 2/2 sash light.

The gable ends have exposed brick firewalls that rise a full story in height. Four-pane attic windows flank the internal end brick stacks.

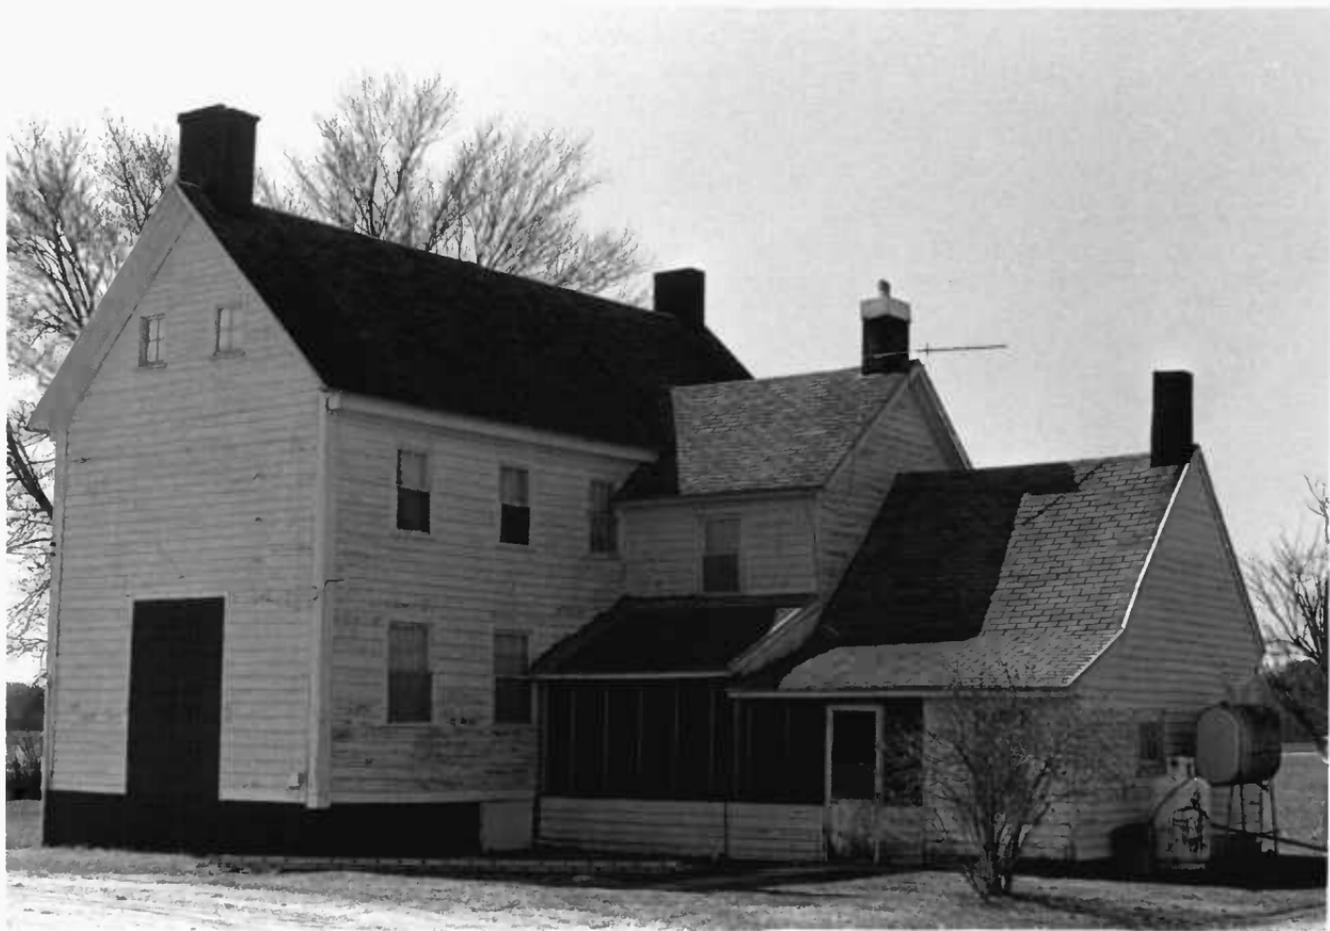
Dr. Thomas Costen House      S-253  
Near Rehobeth, Somerset County  
Northeast Elevation  
4/85, Photographer, Paul Touart  
Neg./MD. Historical Trust

Extending from the back of the house is a shorter two-story one-bay by one-room post-Civil War frame section with a medium pitched roof, exposed rafter feet and an internal end brick chimney. The kitchen, on the other hand, appears contemporary with the main house. The single-story one-room plan frame structure sits close to the ground and is covered by a steeply pitched asphalt shingle roof. The kitchen walls are covered with weatherboards. A screened-in porch is attached to the east side of both the kitchen and the dining room. An altered six-panel door and a 6/6 sash window mark the east kitchen wall.

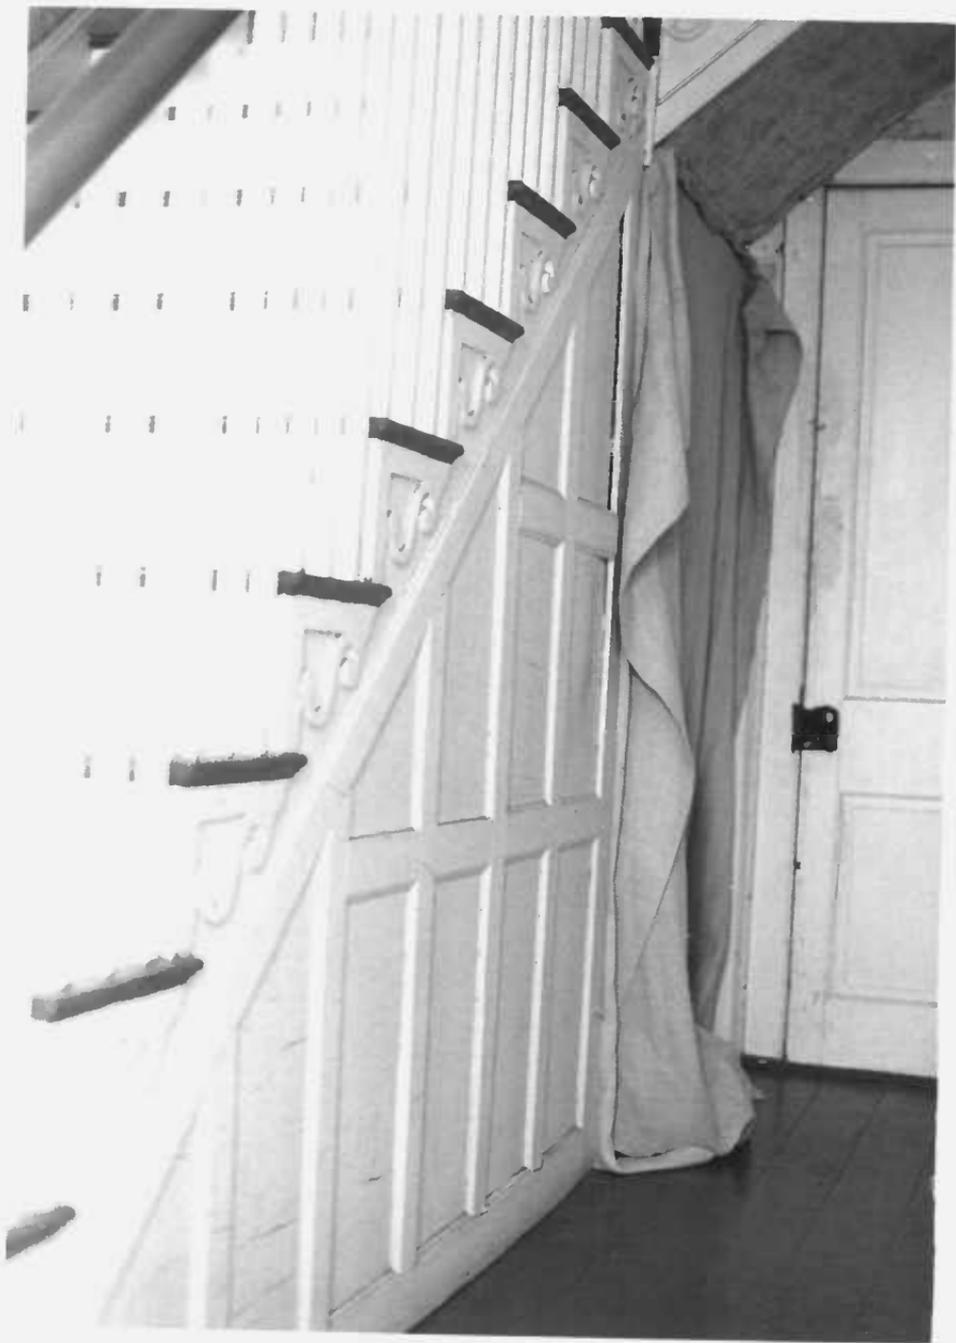
Dr. Thomas Costen House      S-253  
Near Rehobeth, Somerset County  
Stair paneling  
4/85, Photographer, Paul Touart  
Neg./MD. Historical Trust

A slender turned newel post with ball finial supports a circular-profile handrail. Three rectangular balusters rise from each step. The stringer is decorated by s-scrolled trim, while the space below the stringer is divided into a flush paneled grid. In addition to the stair, the hall is fitted with early 19th-century chair rail, door surrounds and six-panel doors.

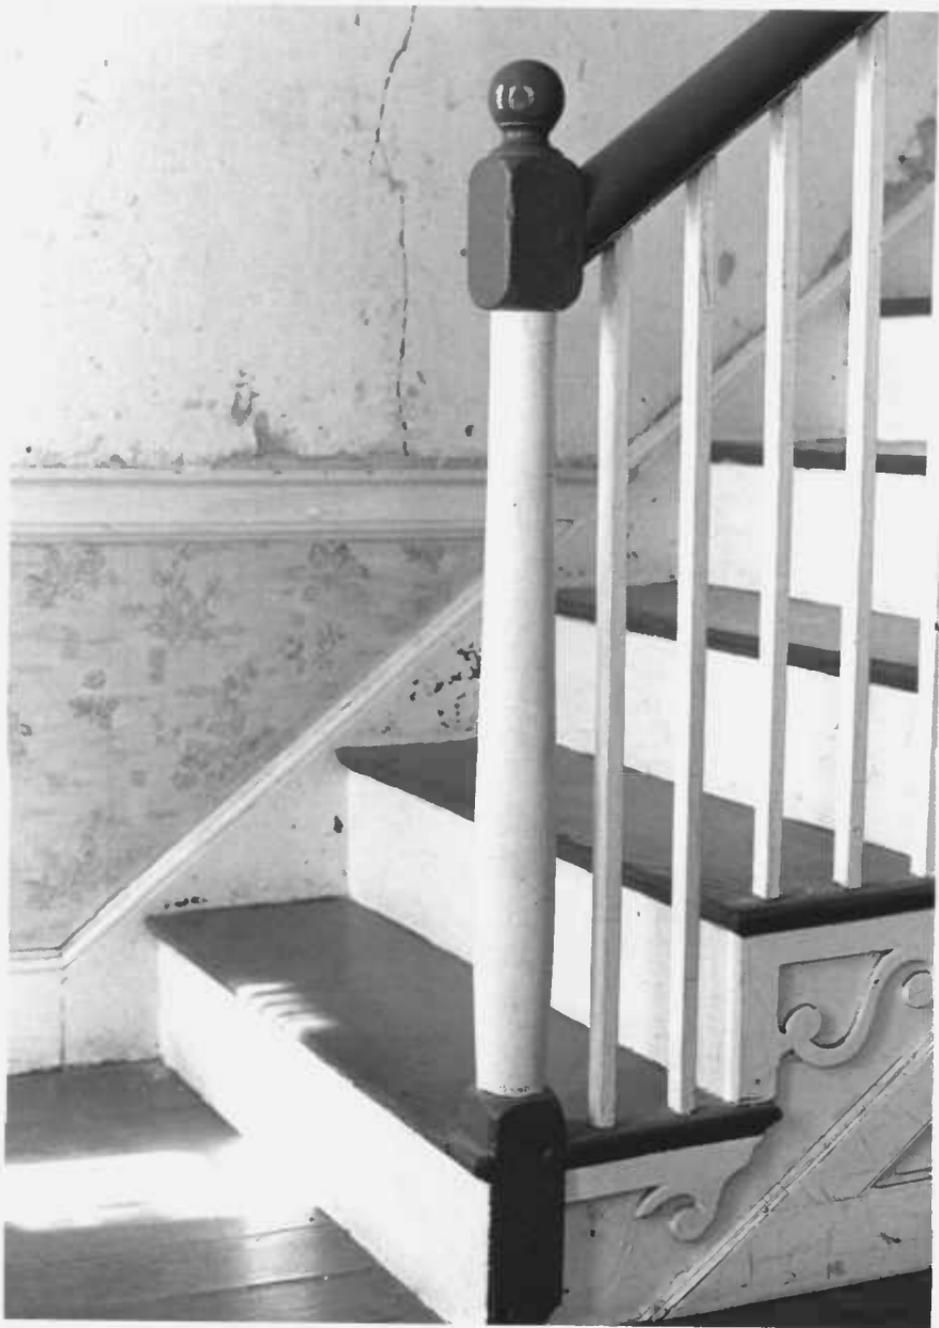
Dr. Thomas Costen House      S-253  
Near Rehobeth, Somerset County  
Stair  
4/85, Photographer, Paul Touart  
Neg./MD. Historical Trust

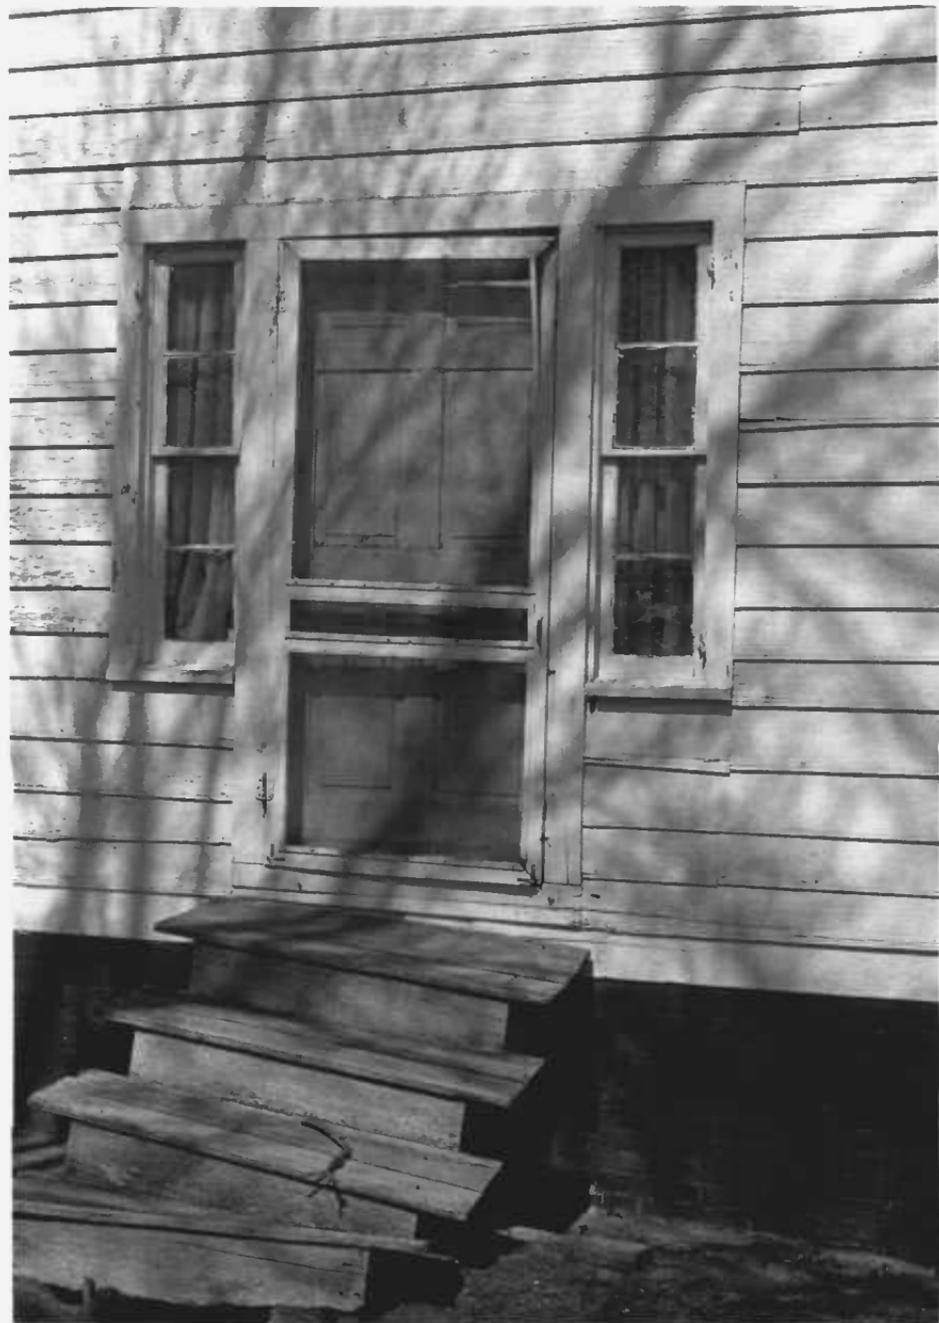
Dr. Thomas Costen House      S-253  
Near Rehobeth, Somerset County  
Front Entrance  
4/85, Photographer, Paul Touart  
Neg./MD. Historical Trust

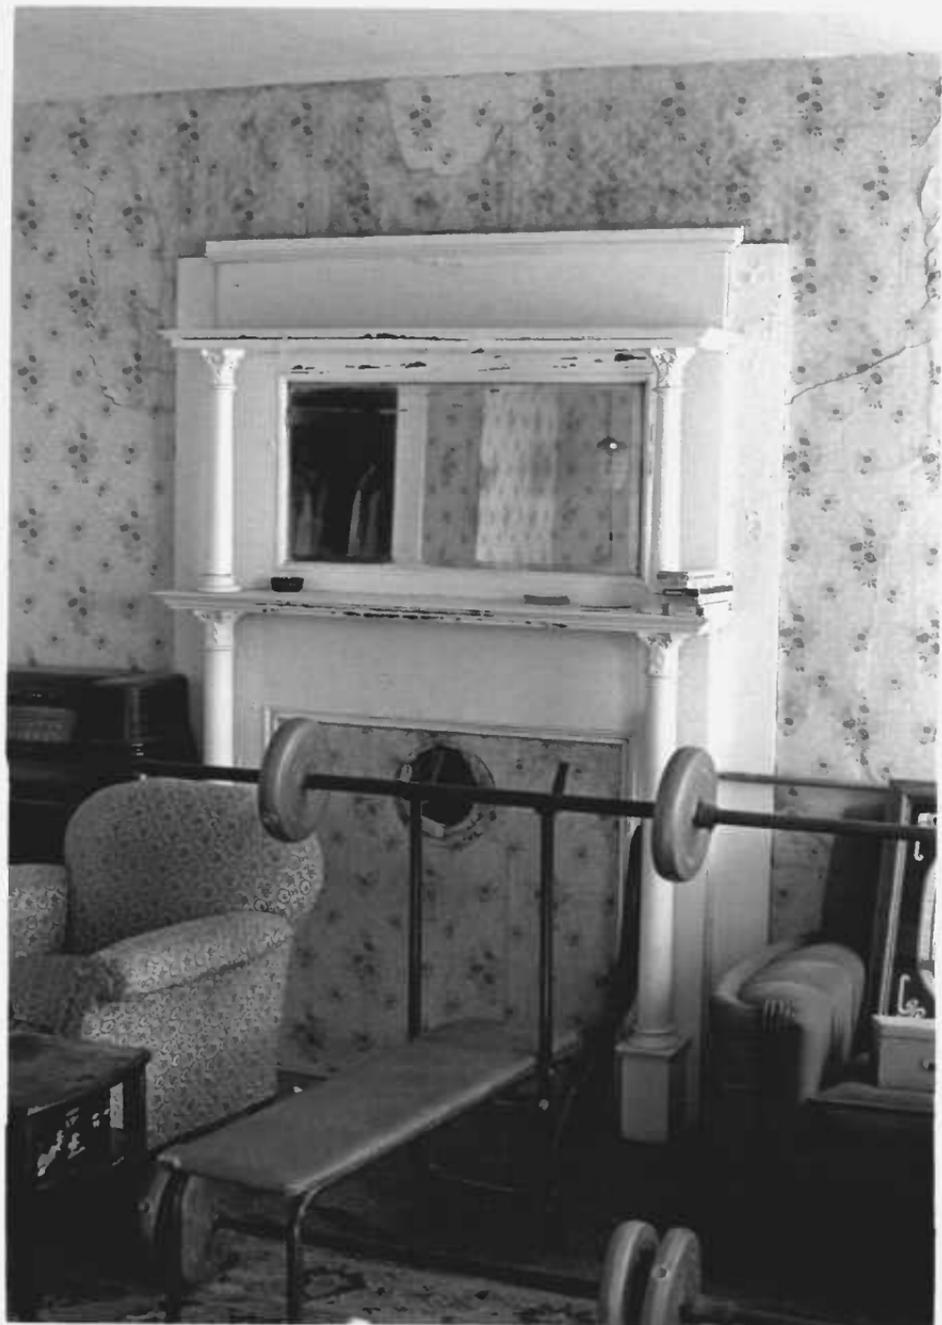
Dr. Thomas Costen House    S-253  
Near Rehobeth, Somerset County  
Parlor Mantel  
4/85, Photographer, Paul Touart  
Neg./MD. Historical Trust

The adjacent east room, or the parlor, retains the same chair rail as well as door and window surrounds. However, the Federal mantel has been replaced with a c.1900 detailed column colonial revival mantel with mirror overmantel.
