S-265  
Eastern Shore National Bank  
Marion  
public

# Maryland Historical Trust State Historic Sites Inventory Form

historic Eastern Shore National Bank

Survey No. S-265

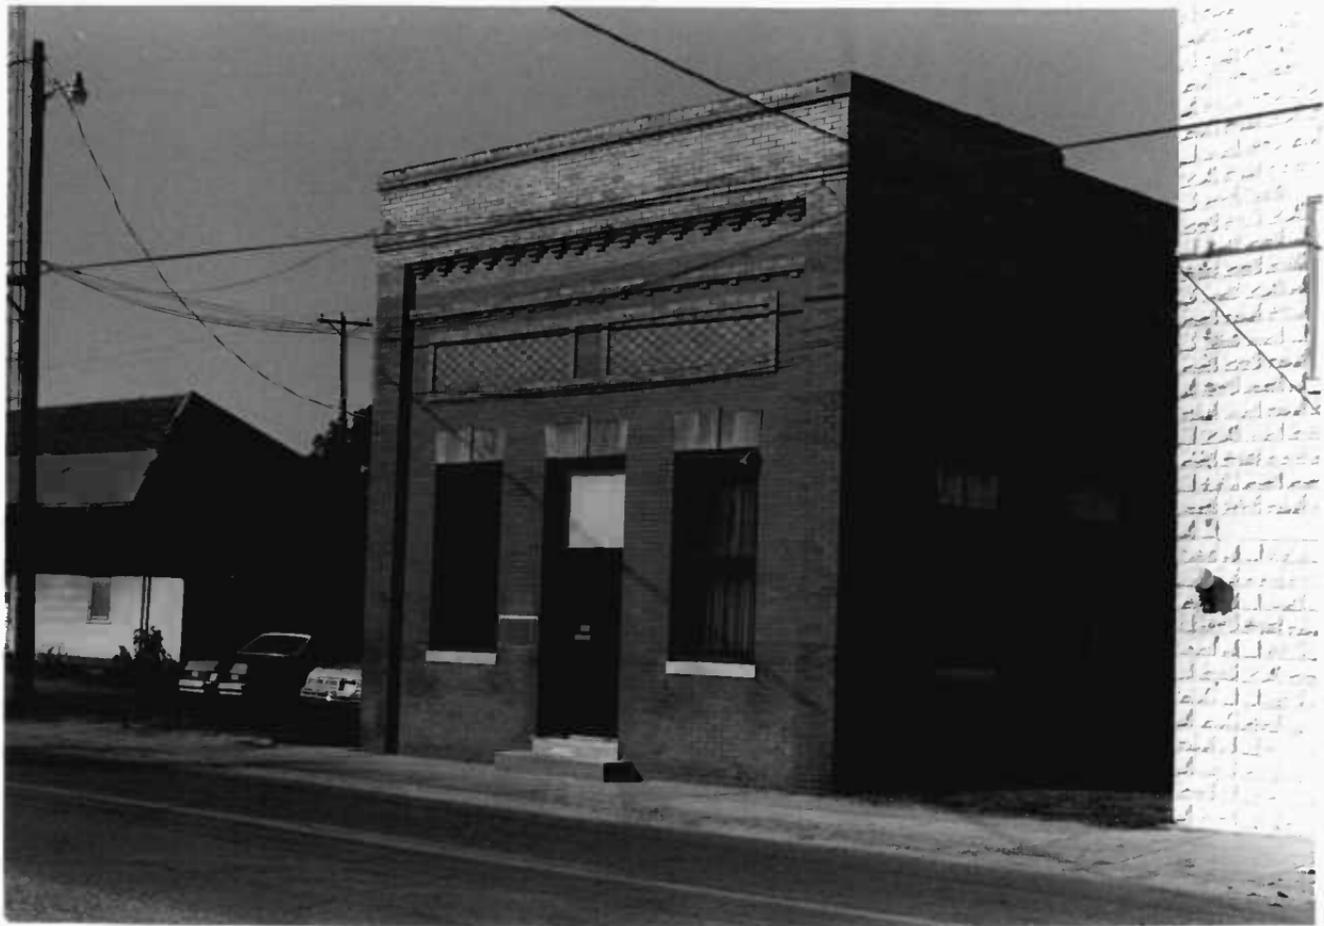
Eastern Shore National Bank      S-265  
Northeast Elevation  
Marion, Somerset County  
10/84, Paul Touart, Photographer  
Neg./MD Historical Trust

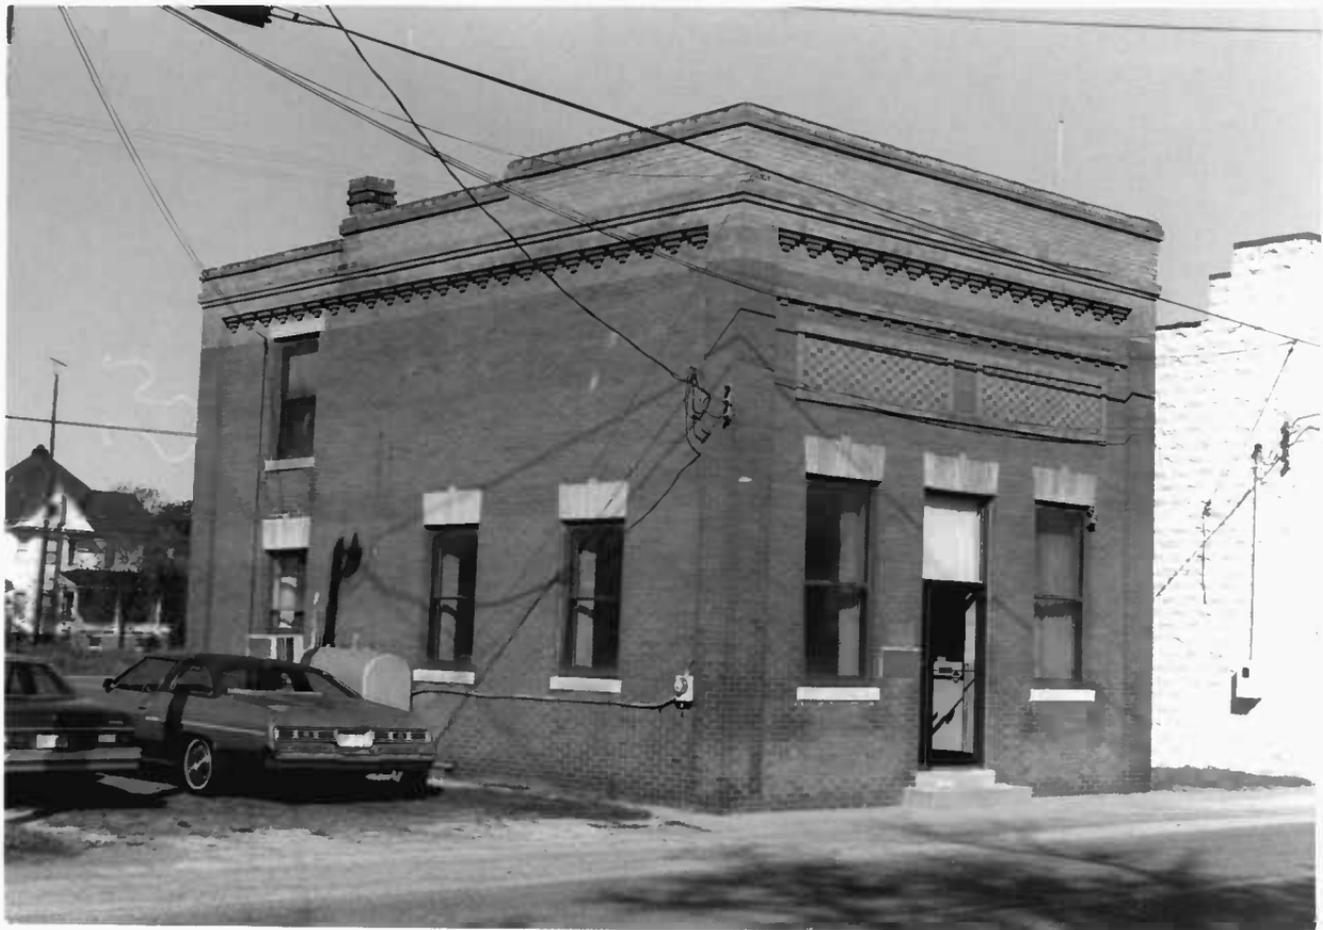
The main (southeast) facade is a symmetrical three-bay elevation with a center door and flanking single-pane sash windows. All three openings are topped by keystone masonry arches. The windows have limestone sills. Located between the first floor window arches and the cornice is a checkerboard brick pattern of light and dark brown bricks. A rectangular light colored brick border frames the decorative area.

Eastern Shore National Bank      S-265  
Southeast Elevation  
Marion, Somerset County  
10/84, Paul Touart, Photographer  
Neg./MD Historical Trust
