S-276
Old Whittington Farm
Marion vicinity
private

Maryland Historical Trust State Historic Sites Inventory Form

historic Old Whittington Farm

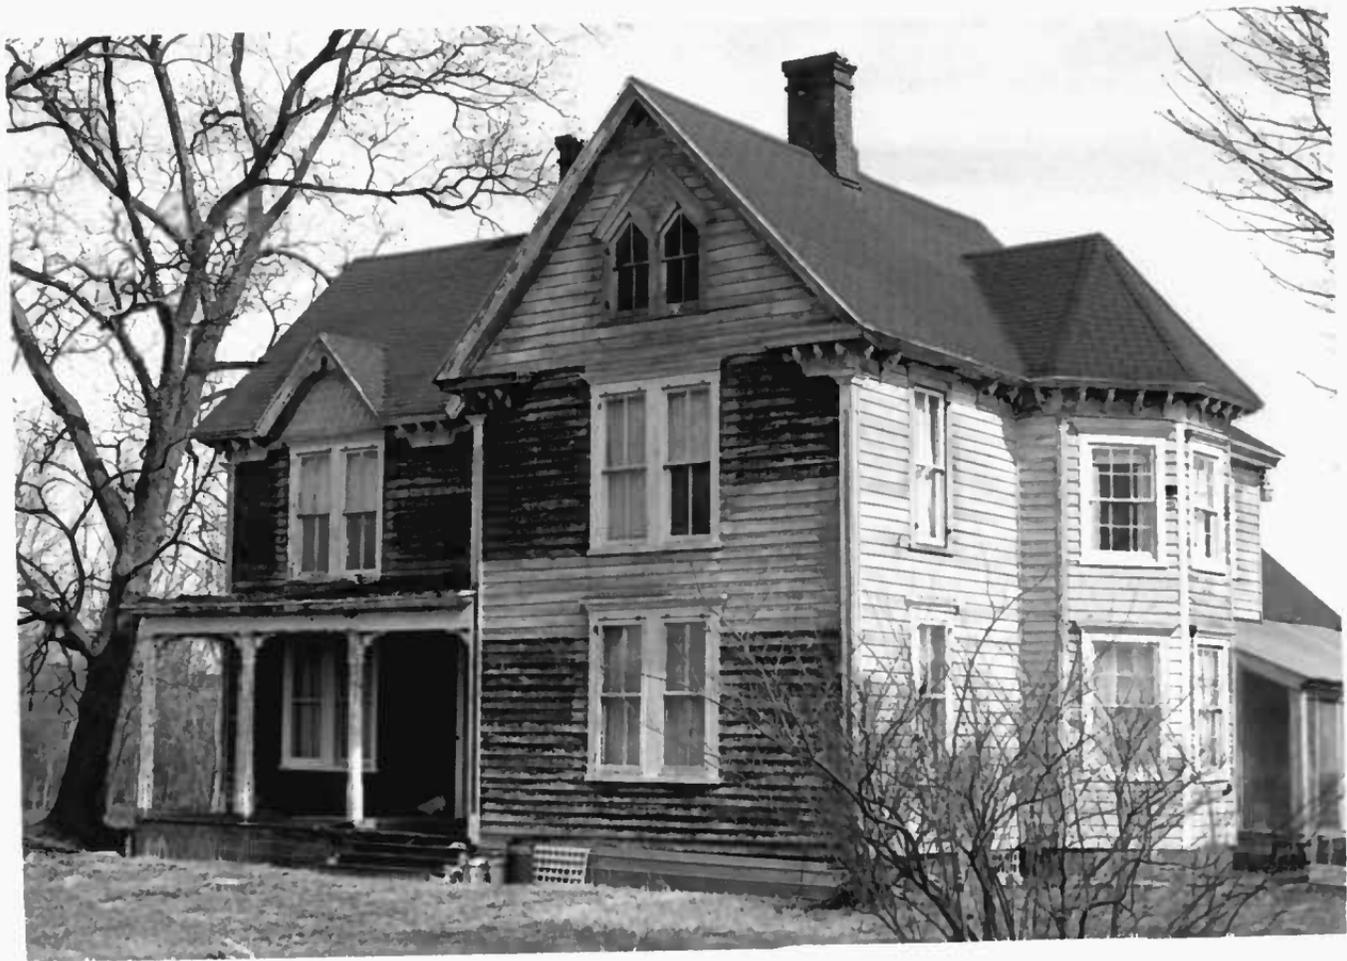
Old Whittington Farm S-276
Near St. Paul's Church, Somerset Co.
Southwest Elevation
4/85, Photographer, Paul Touart
Neg./MD. Historical Trust

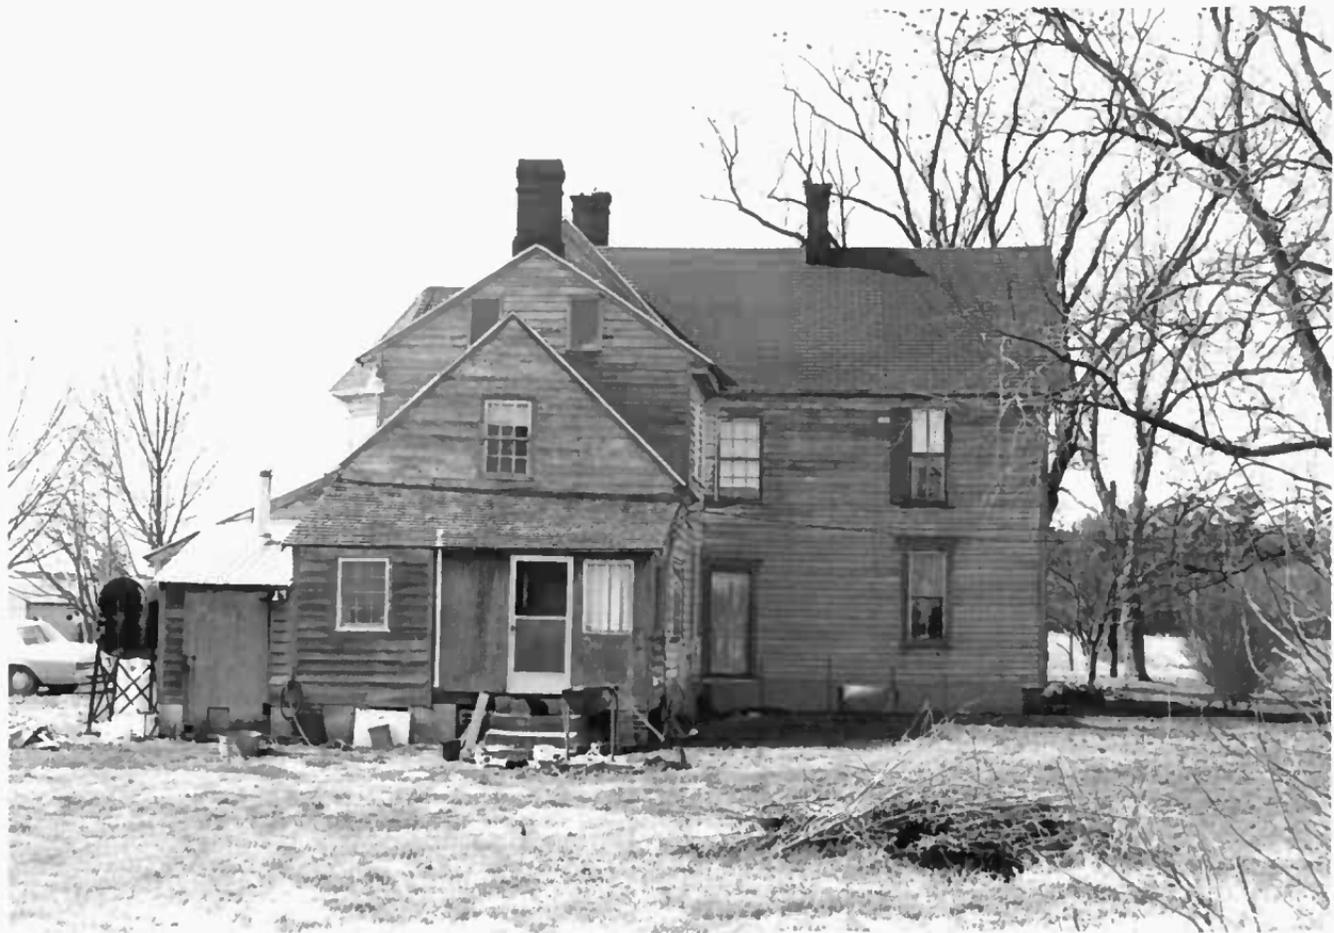
Old Whittington Farm S-276
Near St. Paul's Church, Somerset Co.
East Elevation
4/85, Photographer, Paul Touart
Neg./MD. Historical Trust

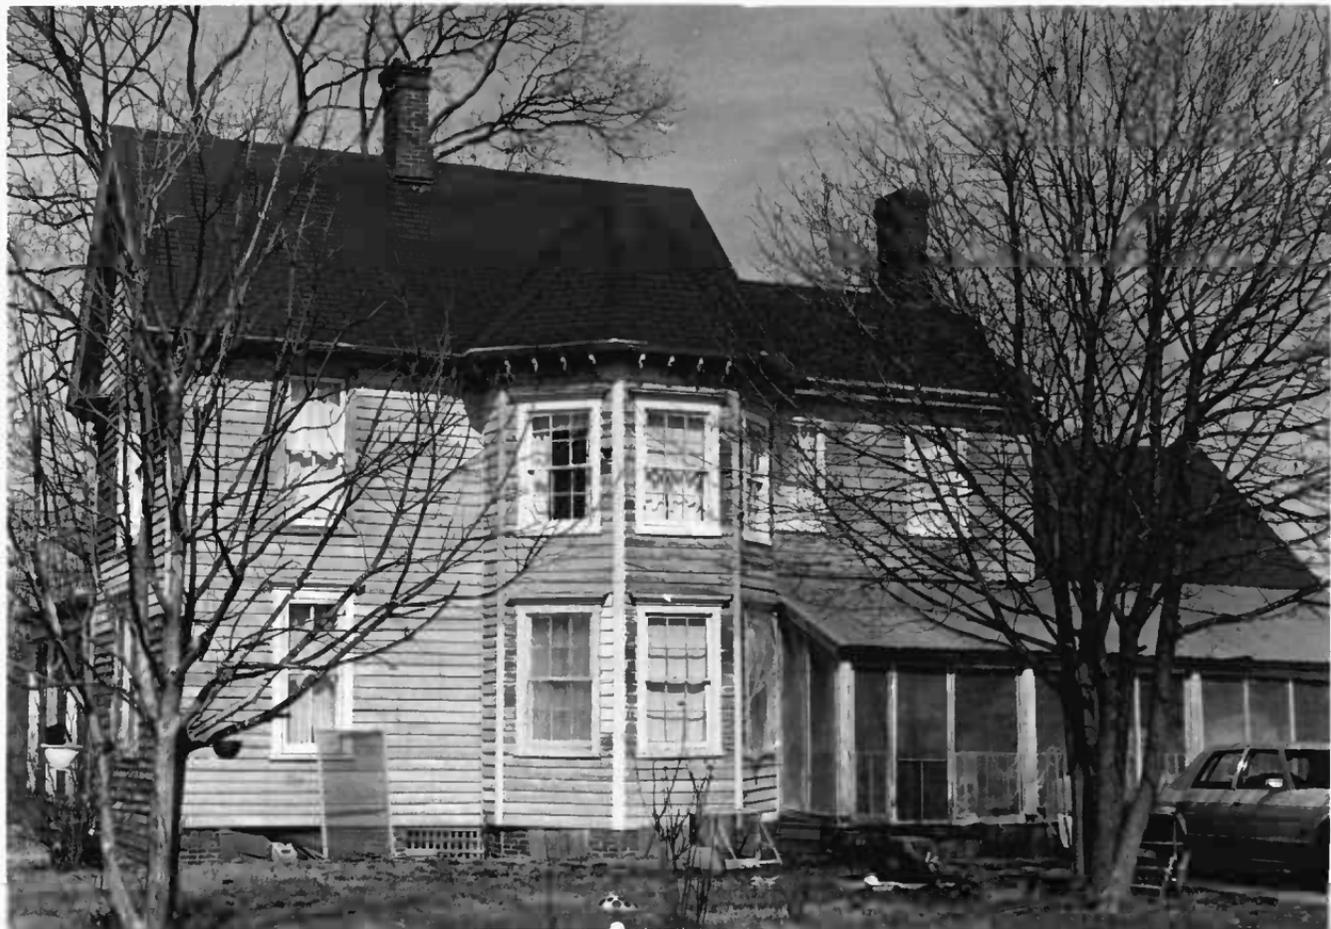
The south two-bay elevation of the front section is dominated by a two-story five-sided bay on the southeast corner. Three 6/6 sash windows pierce each floor of the bay, while 2/2 sash windows fill the west bays on each floor. Eave brackets continue around the south side of the house.

Old Whittington Farm S-276
Near St. Paul's Church, Somerset Co.
South Elevation
4/85, Photographer, Paul Touart
Neg./MD. Historical Trust

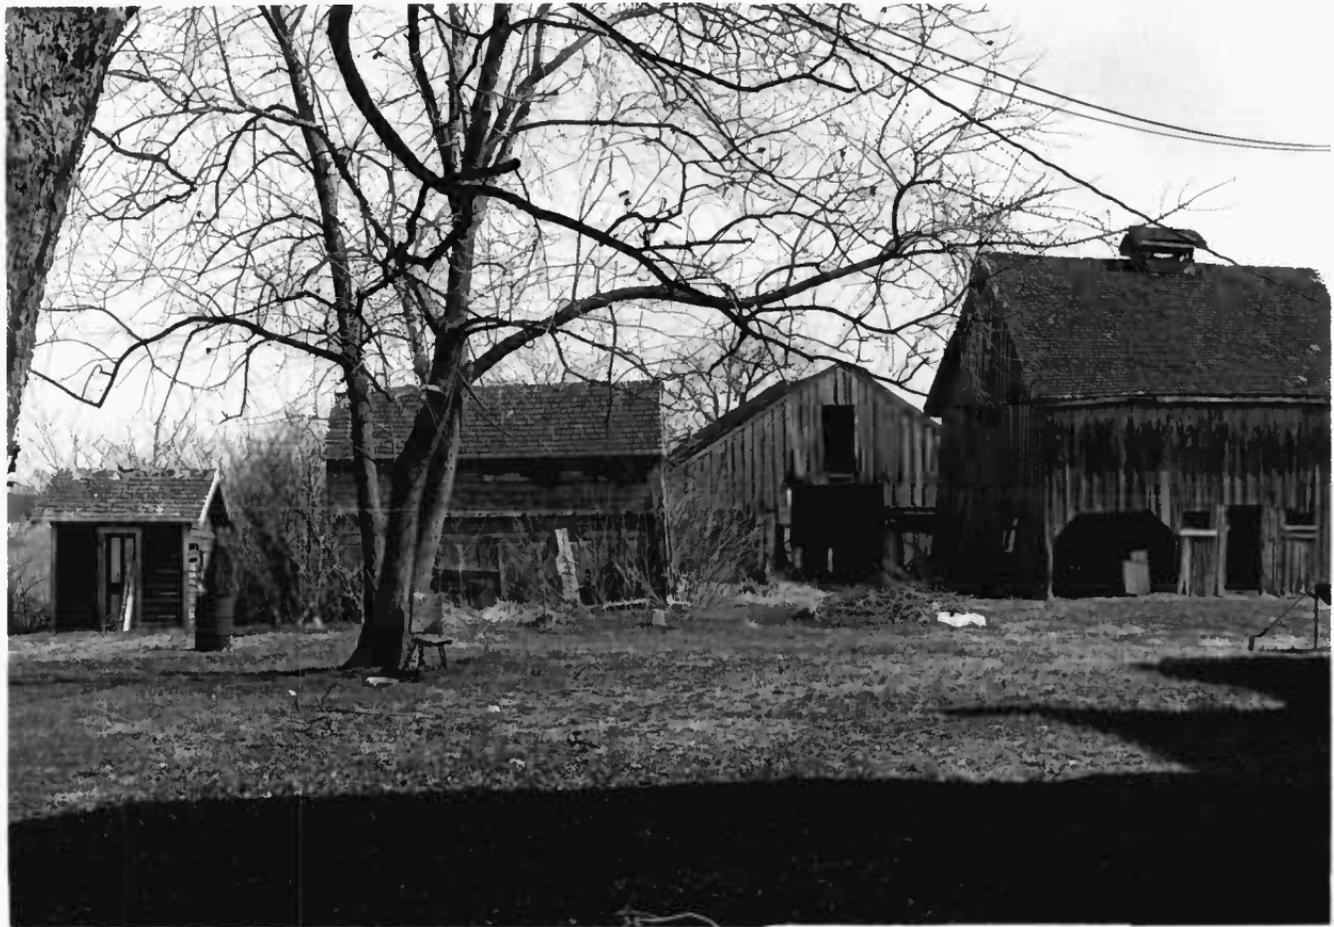
Located north and east of the house is a small group of farm buildings. The oldest of the four structures are a mortise and tenon frame granary and a mortise and tenon frame corn crib. The gable front barn is sheathed with board and batten siding and covered by a medium pitched corrugated tin roof. The barn has a center drive-through with aisles to each side. A floor was formerly located in the center passage but has been removed. The mortise and tenon frame structure has cut-nails.

Old Whittington Farm S-276
Near St. Paul's Church, Somerset Co
Farmyard from west
4/85, Photographer, Paul Touart
Neg./MD. Historical Trust

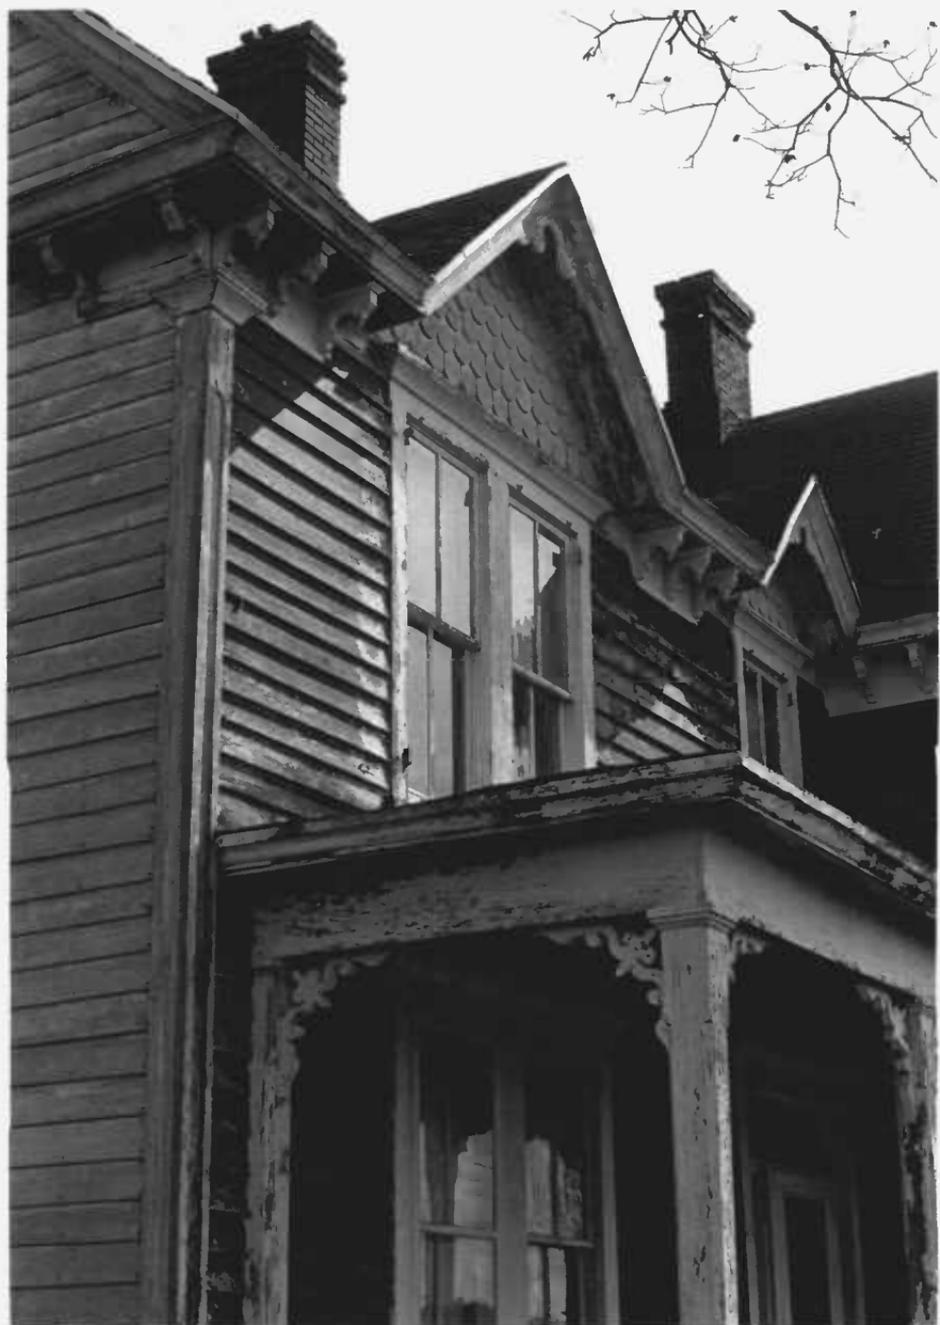
The second floor is lighted by a paired window over the first floor pair and a single 2/2 sash over the entrance bay. Both windows have a gable roof covering that interrupts the cornice. The gable fronts are covered with fishscale shingles. Brackets trim the eaves, and corner pilasters mark the principal corners of the house.

Old Whittington Farm S-276
Near St. Paul's Church, Somerset Co.
Eave Detail
4/85, Photographer, Paul Touart
Neg./MD. Historical Trust

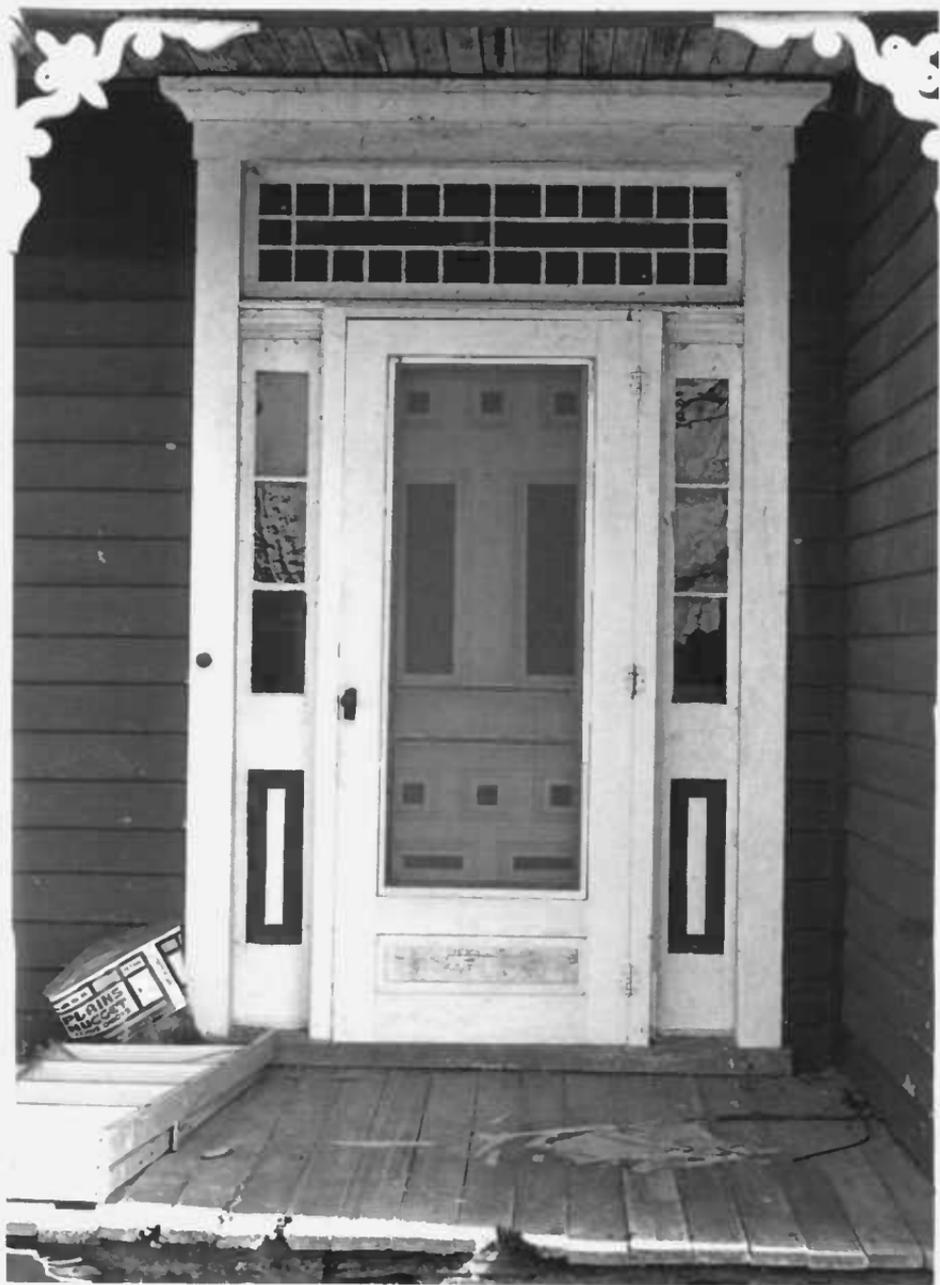
The west (main) elevation is an asymmetrical three-bay facade with a recessed entrance wall. The front twelve-panel door is framed by a colored-glass multi-pane transom and colored glass sidelights. Raised panels are found below each sidelight. The adjacent (north) bay is filled with a paired 2/2 sash window, and the first floor is covered by a hip roofed porch. Chamfered posts are embellished with corner brackets.

Old Whittington Farm S-276
Near St. Paul's Church, Somerset Co.
Entrance
4/85, Photographer, Paul Touart
Neg./MD. Historical Trust

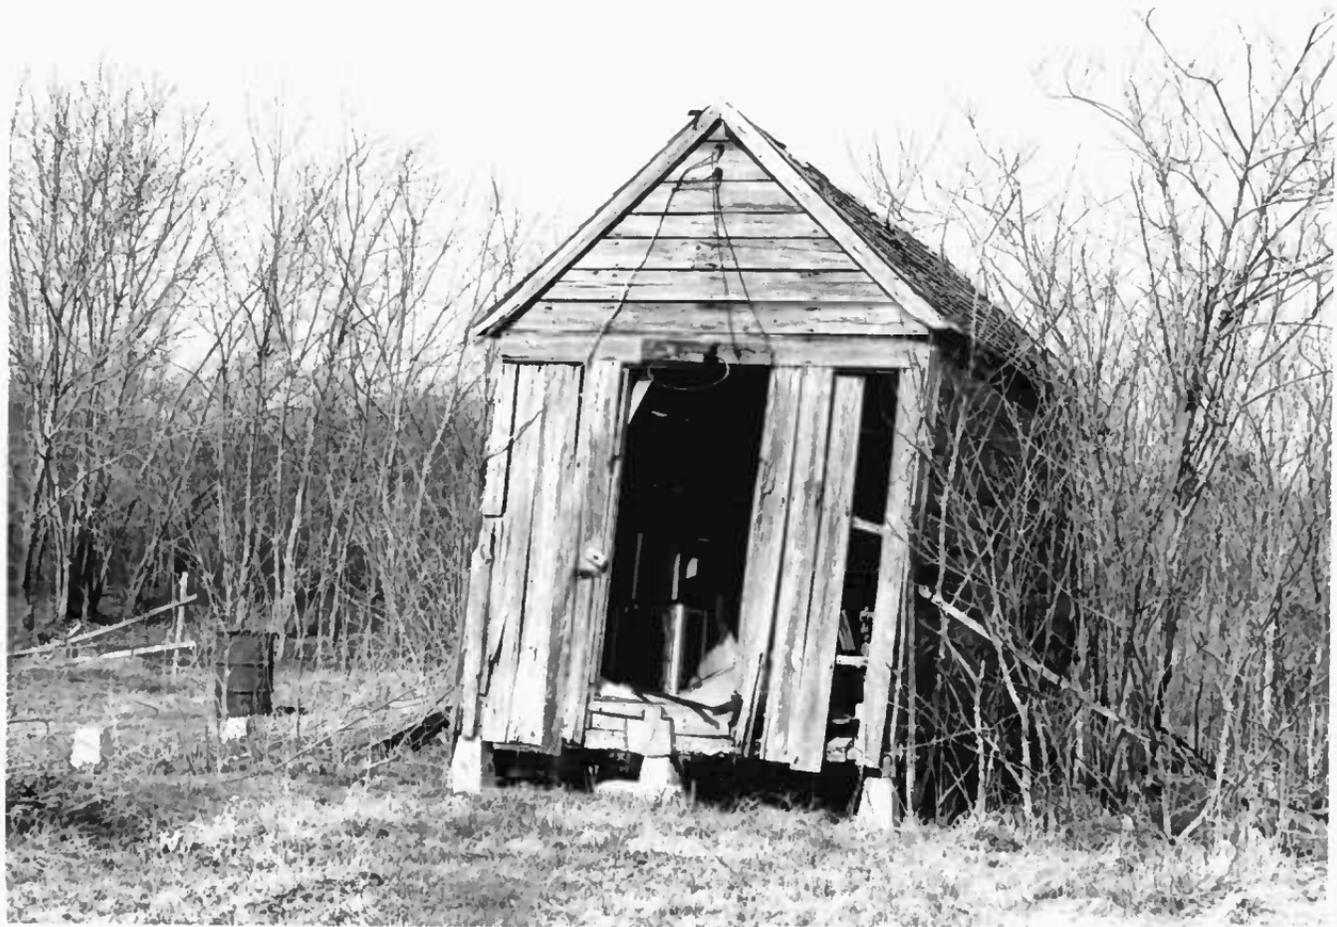
The corn crib is a single-pen mortise and tenon frame structure with some pit-sawn horizontal slats in place. The structure is covered by a steeply pitched wood shingle roof supported by a common rafter system. The pear joint is of mortise and tenon pinned construction.

Old Whittington Farm S-276
Near St. Paul's Church, Somerset Co.
Corn Crib
4/85, Photographer, Paul Touart
Neg./MD. Historical Trust
