S-298

Marine Bank of Crisfield
Crisfield
public

Survey No. S-298

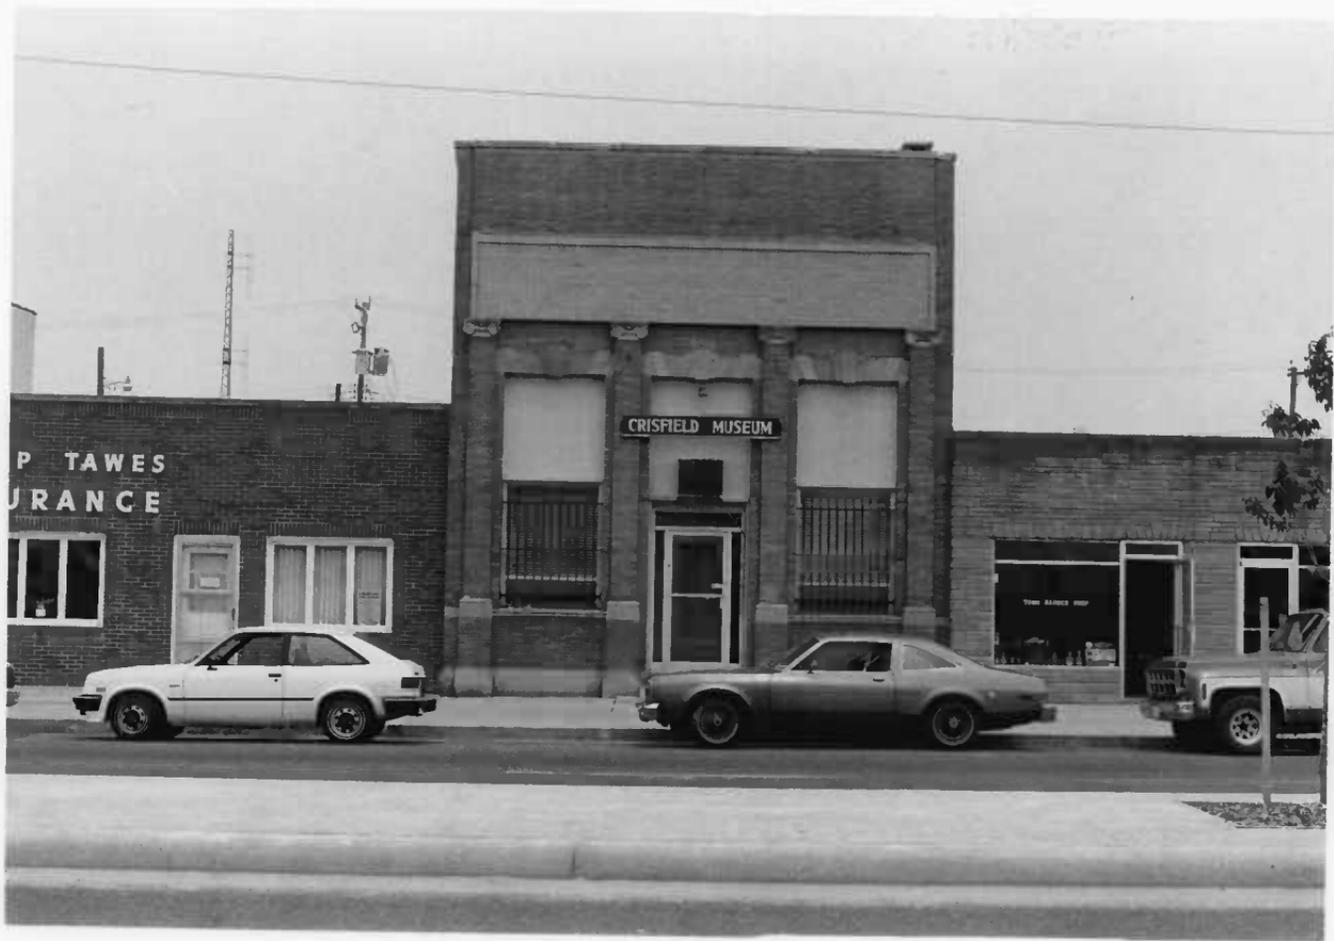
Southeast Elevation

The southeast (main) elevation is divided into three bays by four Ionic pilasters that rise from simply molded granite bases. The pilaster shafts are of brown brick while the capitals are of carved limestone. The pilasters support a rectangular beige-colored brick panel that stretches across the upper portion of the building. The parapet roof is capped by a course of limestone blocks. Located between each pair of pilasters is a large door or window opening with a finely tooled keystone arch. The center door and the flanking windows have been reduced in size. Curved iron grills protect the two window openings.

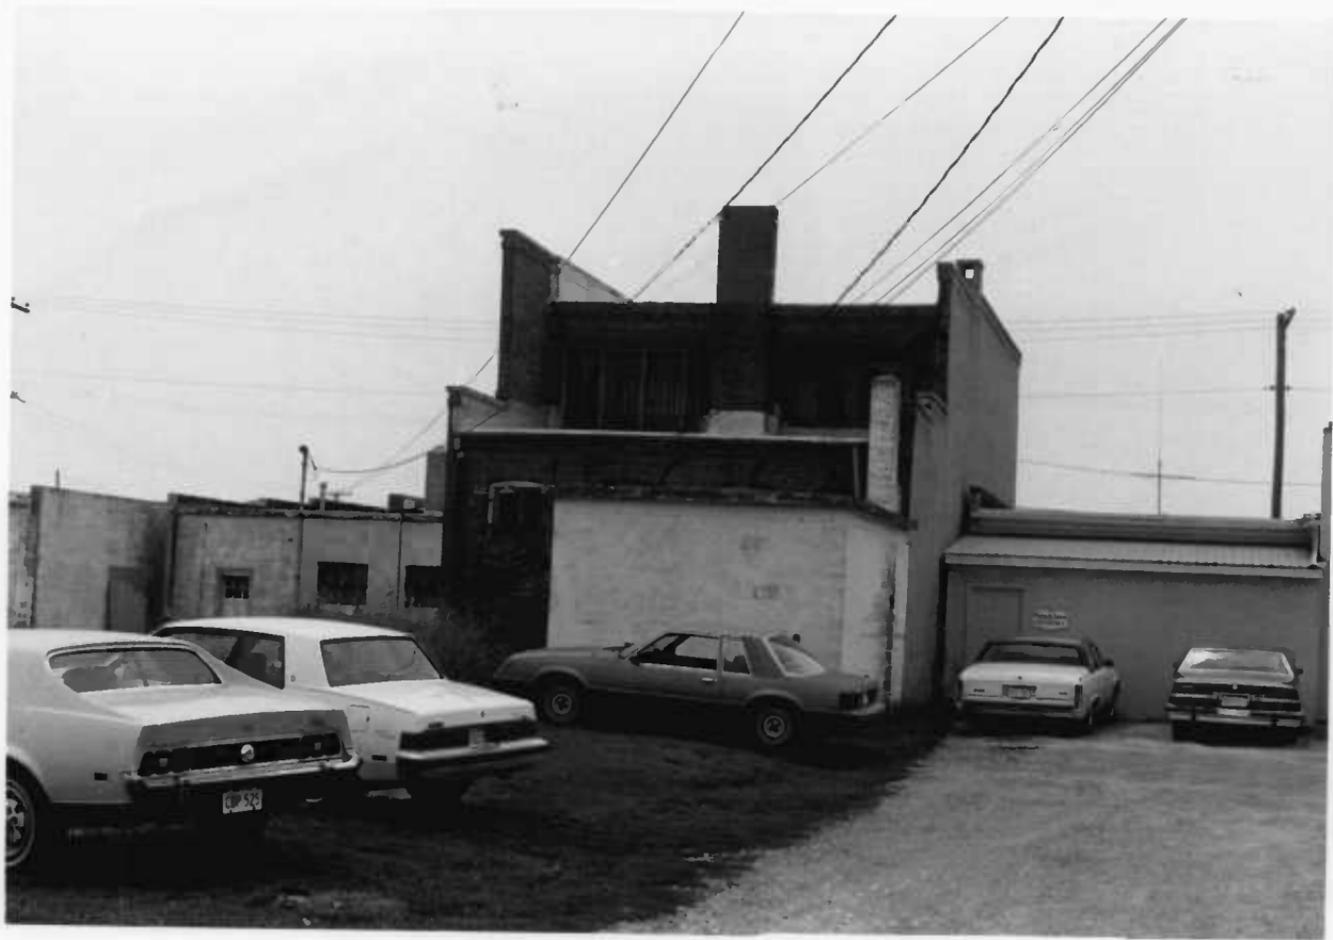
Marine Bank of Crisfield
Crisfield, Somerset County
Northwest Elevation

The northwest (rear) elevation of the old bank consists of a shorter single-story section that extends from the taller main block. Extending farther from the main block is a one-room concrete block addition. Large windows have been cut through the upper wall of the main block on either side of a brick chimney stack. The rear wall of the shorter section is marked by four segmental arched window openings, three of which are now covered by the concrete block addition. Iron bars remain on the northern-most window opening.
