S-302  
Old Customs House and Post Office  
Crisfield  
Public

c. 1900-1915

# Maryland Historical Trust State Historic Sites Inventory Form

historic Old Customs House and Post Office

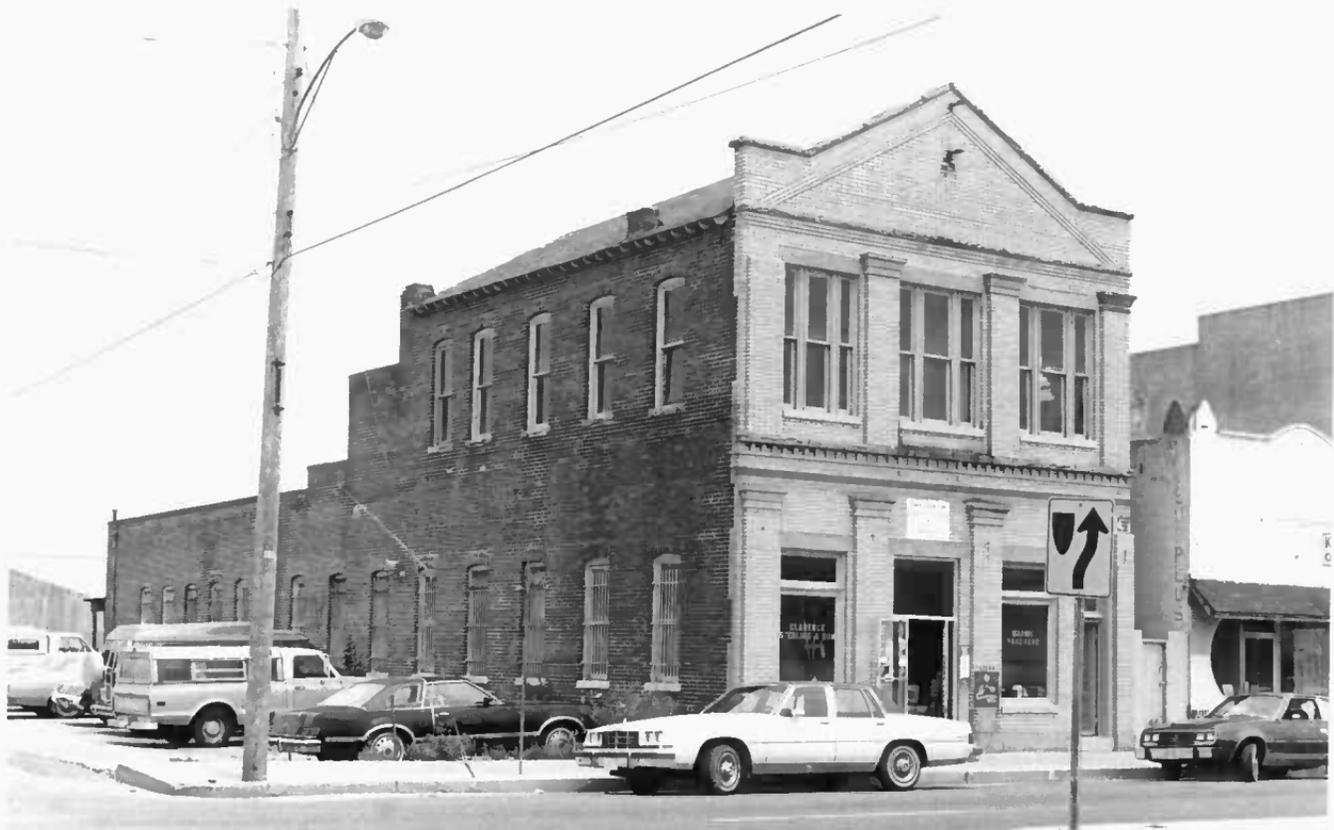
Old Customs House and Post Office    S-302  
Crisfield, Somerset County  
Southeast Elevation  
7/85    Photographer - Paul Touart  
Neg/Maryland Historical Trust

The southeast (main) elevation is a three-bay facade divided by four brick pilasters on each floor. A modern glass door occupies the center bay, while the two adjacent bays have large glass display windows. Painted on each window is "Clarence Sterling and Son." Also located in the north bay is a side door entrance that leads to the second floor. Each window and door opening is topped by a plain limestone flat arch. The first and second floors are divided by a rusticated stone string course with a decorative row of brick dentils below. Rising from the string course are four identical pilasters that divide the second floor windows. Tri-partite single-pane sash windows are topped by smooth limestone lintels. Stretching across the base of the gable roof is a corbelled brick cornice and another rusticated limestone string course. The gabled parapet roof is highlighted by corbelled brick that parallels the rusticated limestone parapet capping.

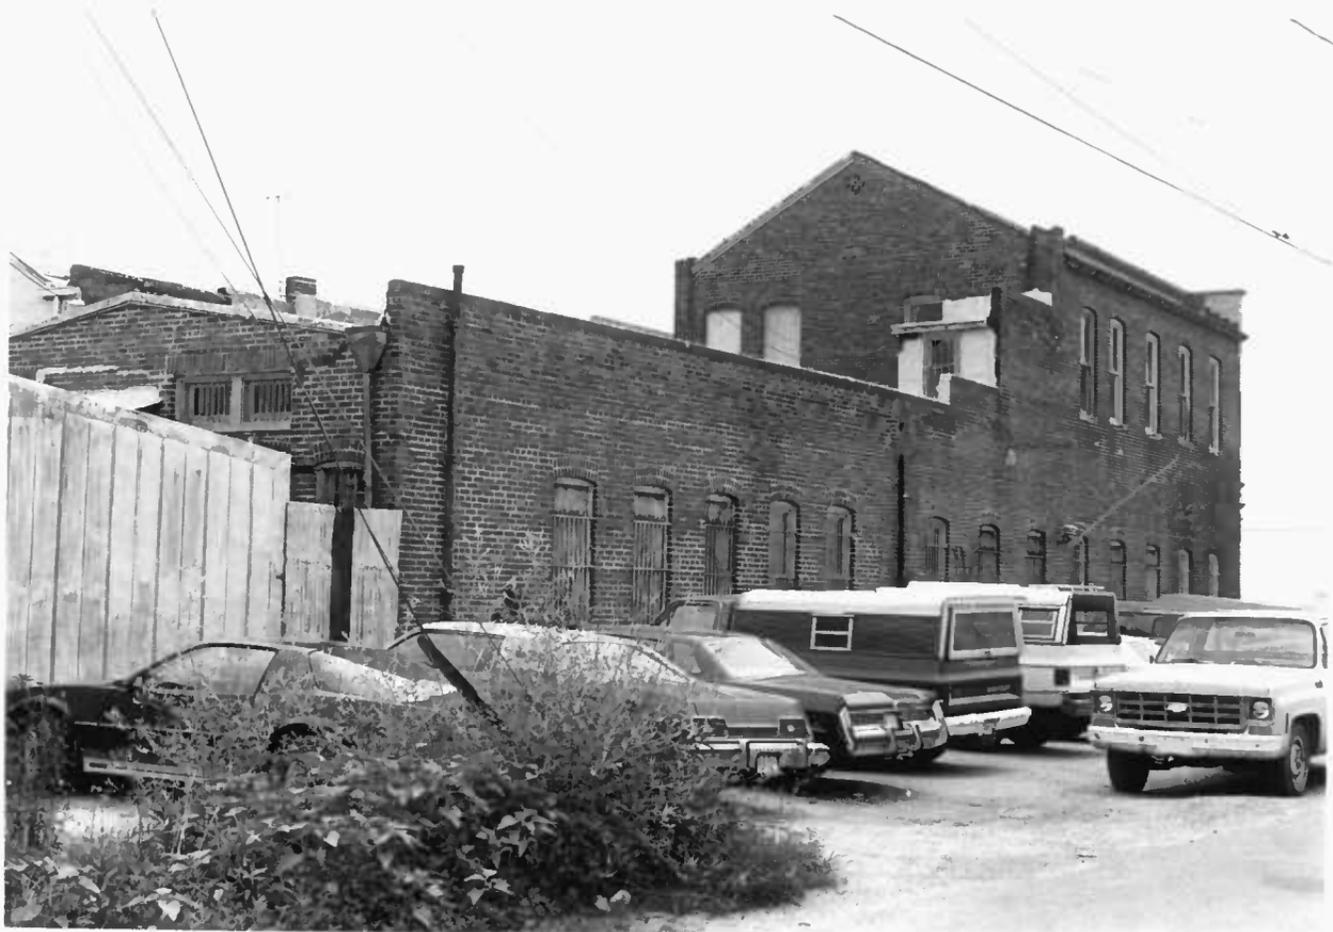
Old Customs House and Post Office    S-302  
Crisfield, Somerset County  
Southwest Elevation  
7/85    Photographer - Paul Touart  
Neg/Maryland Historical Trust

The southwest side of the main block is evenly divided into five bays marked by single pane sash windows with segmental brick arches. The sills are of rusticated stone and iron grills cover the first floor windows. Round butt rafter feet peak out below the slate roof, and a partially demolished brick stove stack rises from the southwest side and the southwest corner.
