S-307
United States Post Office
Crisfield
public

Maryland Historical Trust State Historic Sites Inventory Form

Survey No. S-307

and/or common Crisfield Post Office

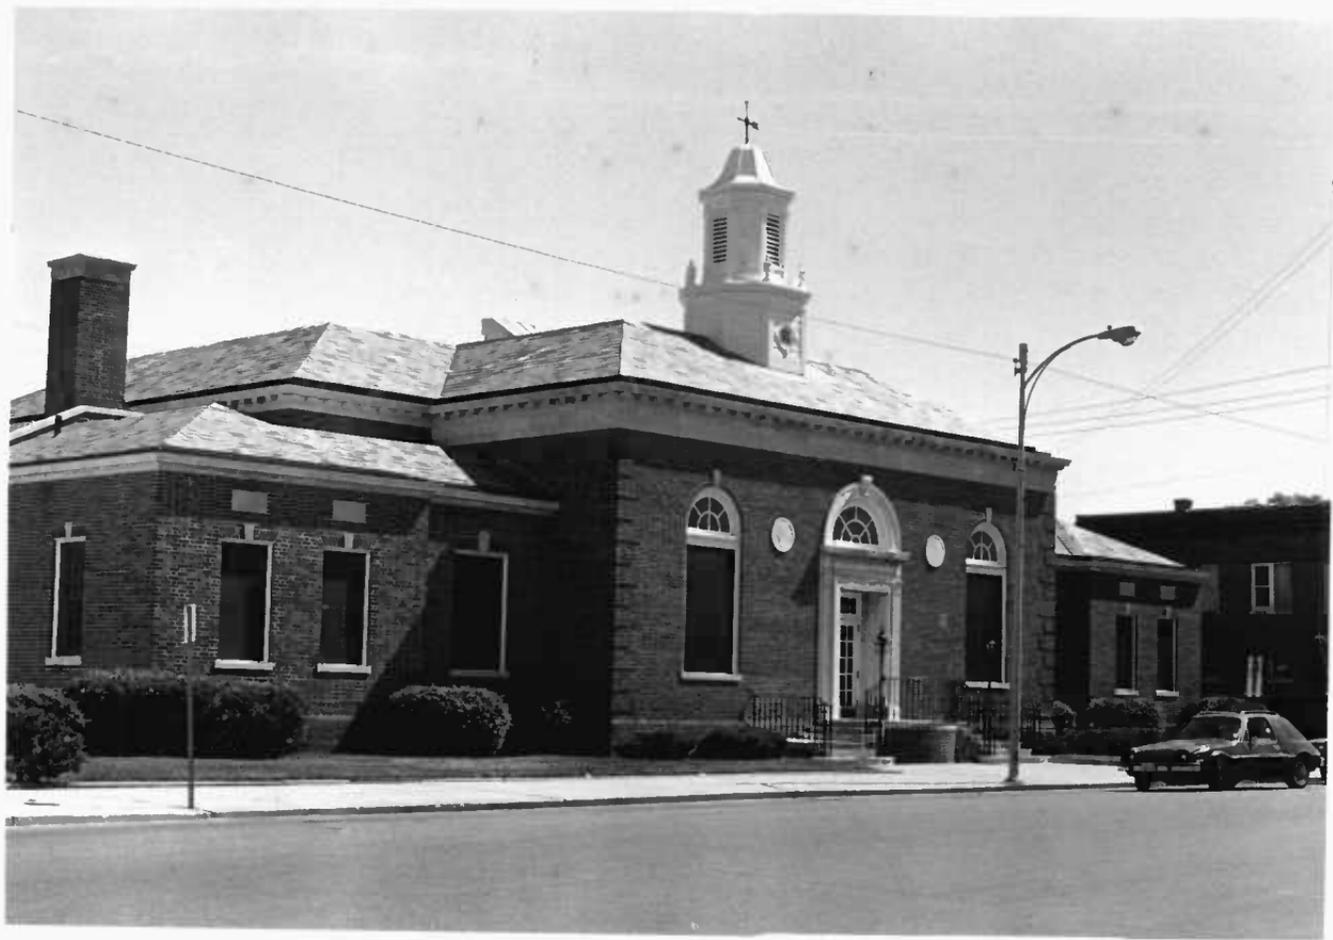
S-307

Crisfield Post Office
Crisfield, Somerset County
Southwest Elevation
7/85 Photographer - Paul Touart
Neg/Maryland Historical Trust

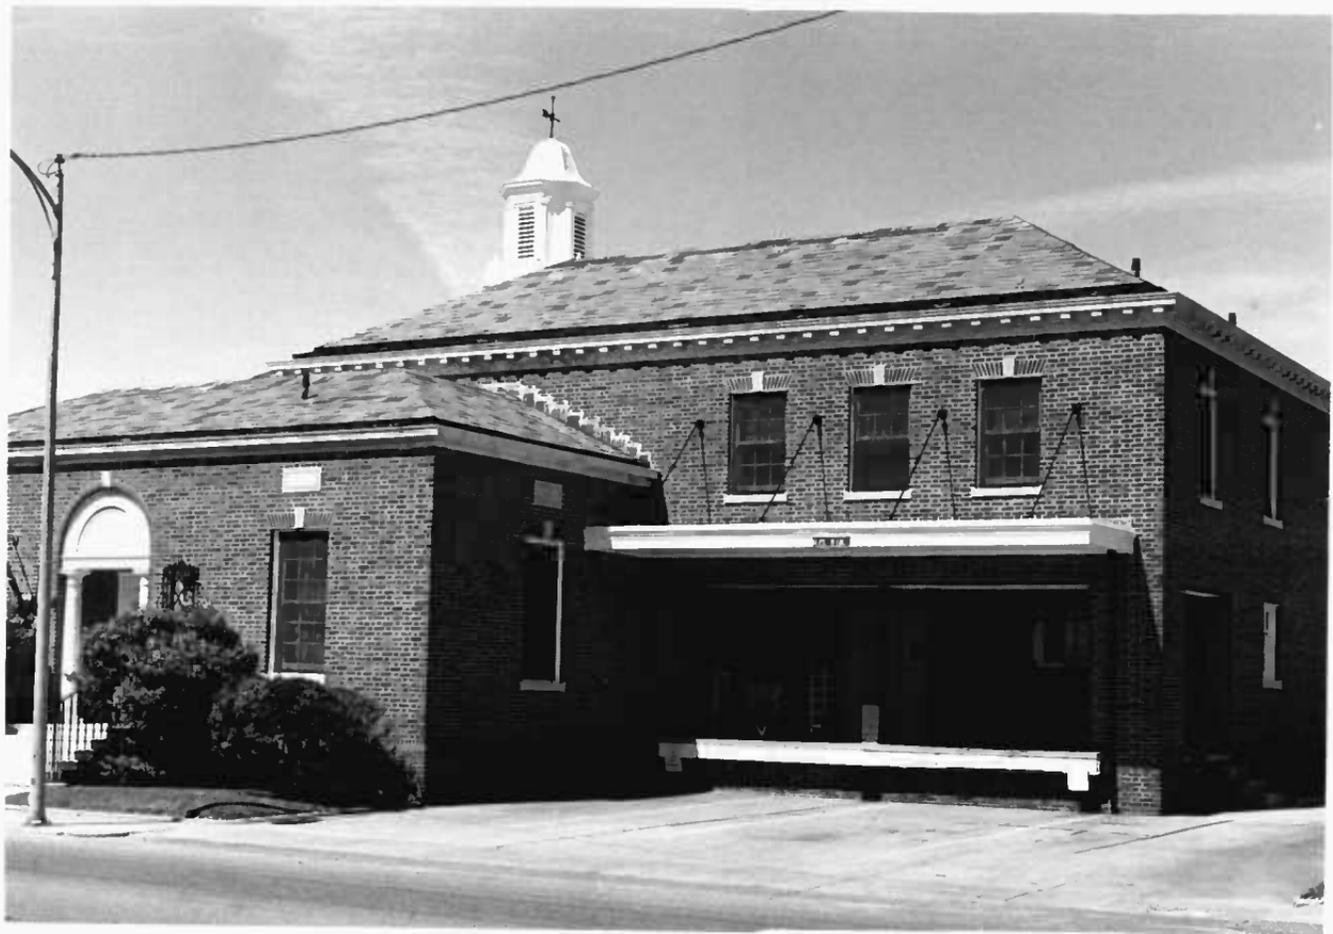
S-307

The east side elevation of the wing is a basically symmetrical facade with a center entrance and flanking nine over nine sash windows finished in the same manner as the south windows. The center side entrance is entered at the top of a flight of six marble steps and within a slightly recessed alcove. Tuscan columns flank the six-panel door and support a solid arched fan-shaped panel. The round arch is interrupted by a small keystone. Positioned directly to the north (right) of the door is a small grilled window opening. The molded cornice stretches across at the base of the roof, and it is finished with an intricate Greek key bed molding. Directly behind the east wing is the post office loading platform which fills the first floor space. The second floor is pierced by three 9/9 sash windows.

Crisfield Post Office
Crisfield, Somerset County
East Elevation
7/85 Photographer - Paul Touart
Neg/Maryland Historical Trust

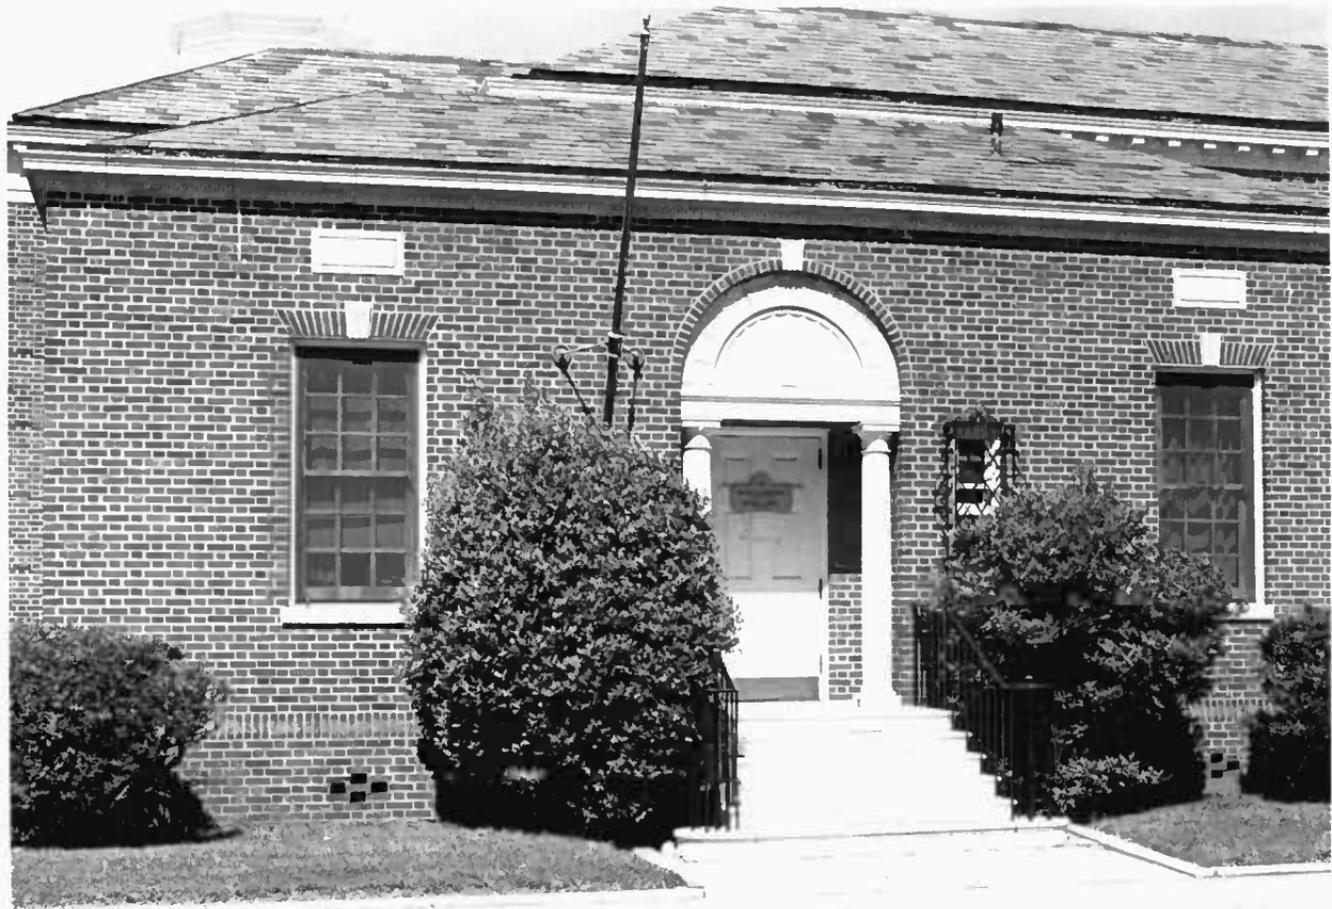
S-307

Crisfield Post Office
Crisfield, Somerset County
East Door
7/85 Photographer - Paul Touart
Neg/Maryland Historical Trust

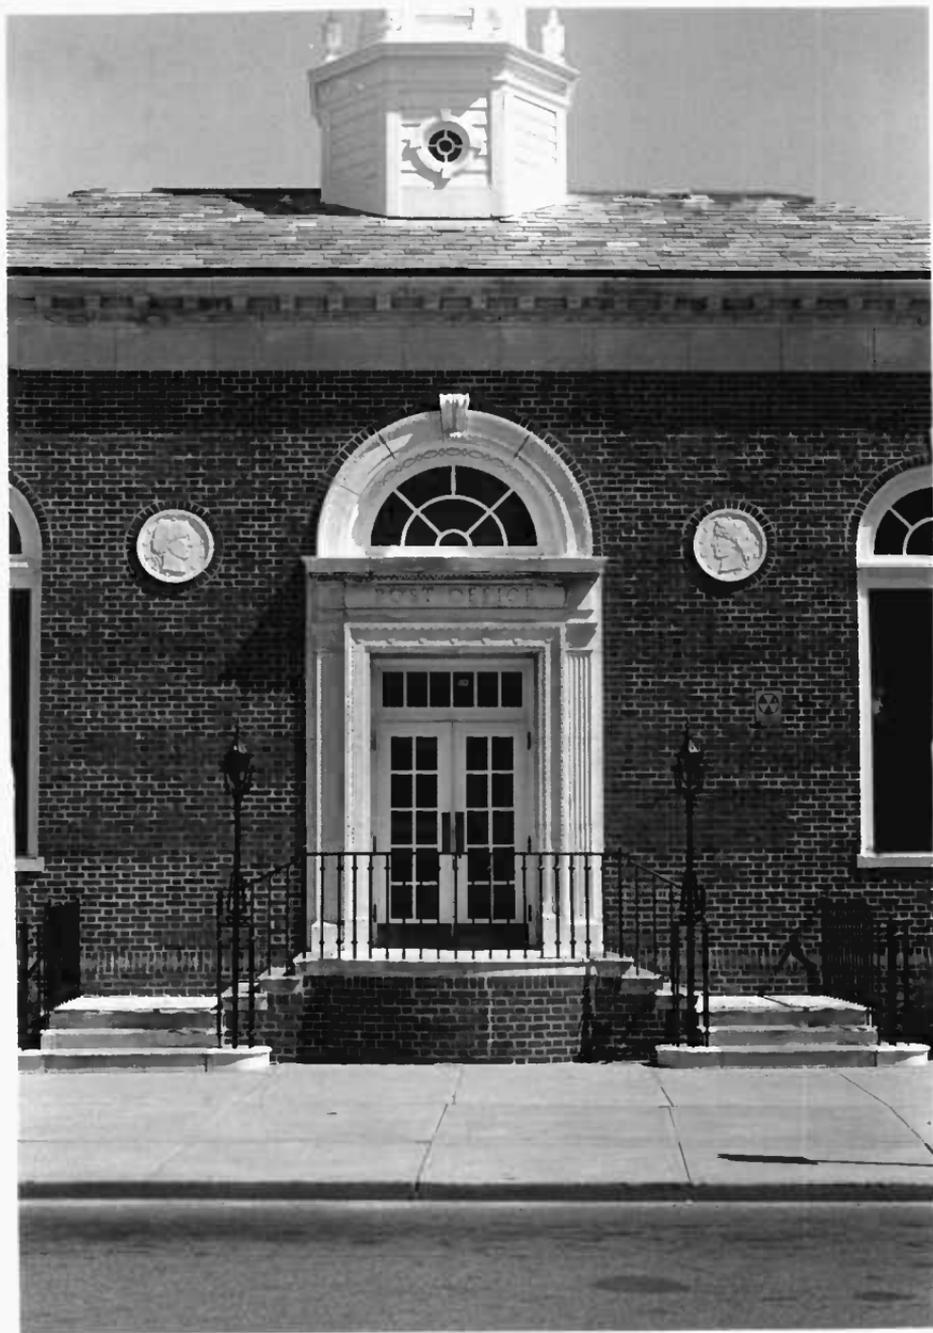
S-307

The south (main) facade of the center block is a symmetrical elevation with a classically inspired entrance and flanking nine over nine sash windows. The front door is situated on a raised platform with access provided by a twin stair of marble steps surrounded by iron railings. The double-door entrance is topped by a six-light transom and framed by a classical entablature with an arched fanlight. The decorated ovolo molded door surround is flanked by fluted pilasters which support a cushion frieze and broken cornice. The cushion frieze is inscribed, "Post Office". Above the cornice is an arched fanlight with a molded surround interrupted by a scrolled keystone. The wall space to each side of the entrance is marked by a round medallion with a relief sculpture of a classical profile. The flanking nine over nine sash windows are topped by arched fanlights. A limestone keystone is centered within the round brick arch.

Crisfield Post Office
Crisfield, Somerset County
Front Door
7/85 Photographer - Paul Touart
Neg/Maryland Historical Trust
