S-325
McCready House
Crisfield
private

Maryland Historical Trust State Historic Sites Inventory Form

Survey No. S-325

historic McCready House

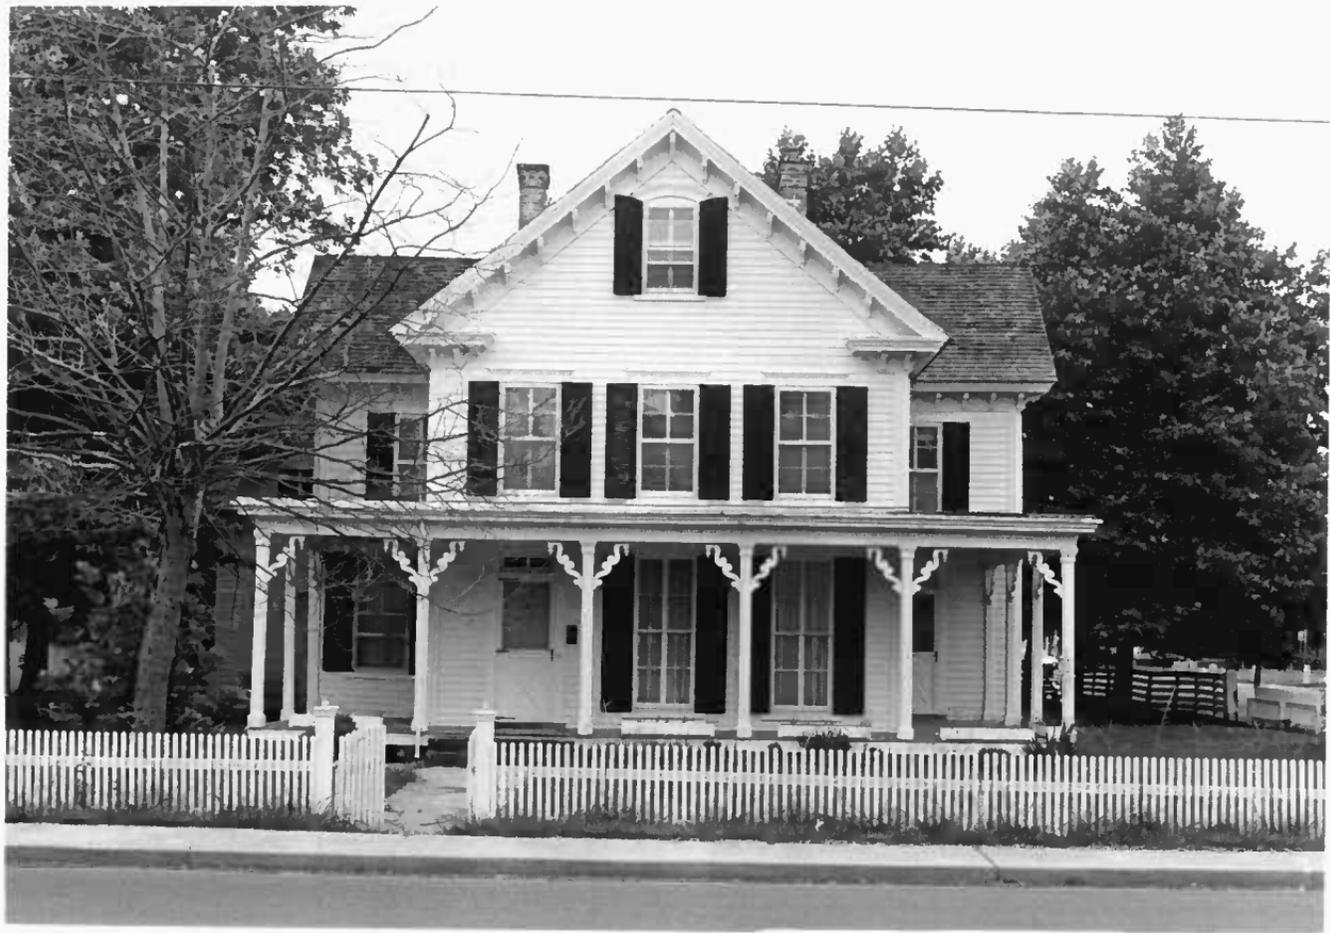
South Elevation

The south (main) facade of the tee-plan is a gable-front elevation of three bays. The entrance is located in the left (west) bay with a heavily molded four-panel door. The adjacent window openings have four over four sash that stretch from the floor to the ceiling and are flanked by louvered shutters. The first floor is covered by a wraparound porch of chamfered posts and snake-curved corner brackets. A side porch entrance opens into the rear section from the east end. The second floor of the main elevation is marked by three evenly spaced four over four sash windows with louvered shutters, while the upper gable is pierced by a single four over two sash with an arched header and corresponding arched shutters.

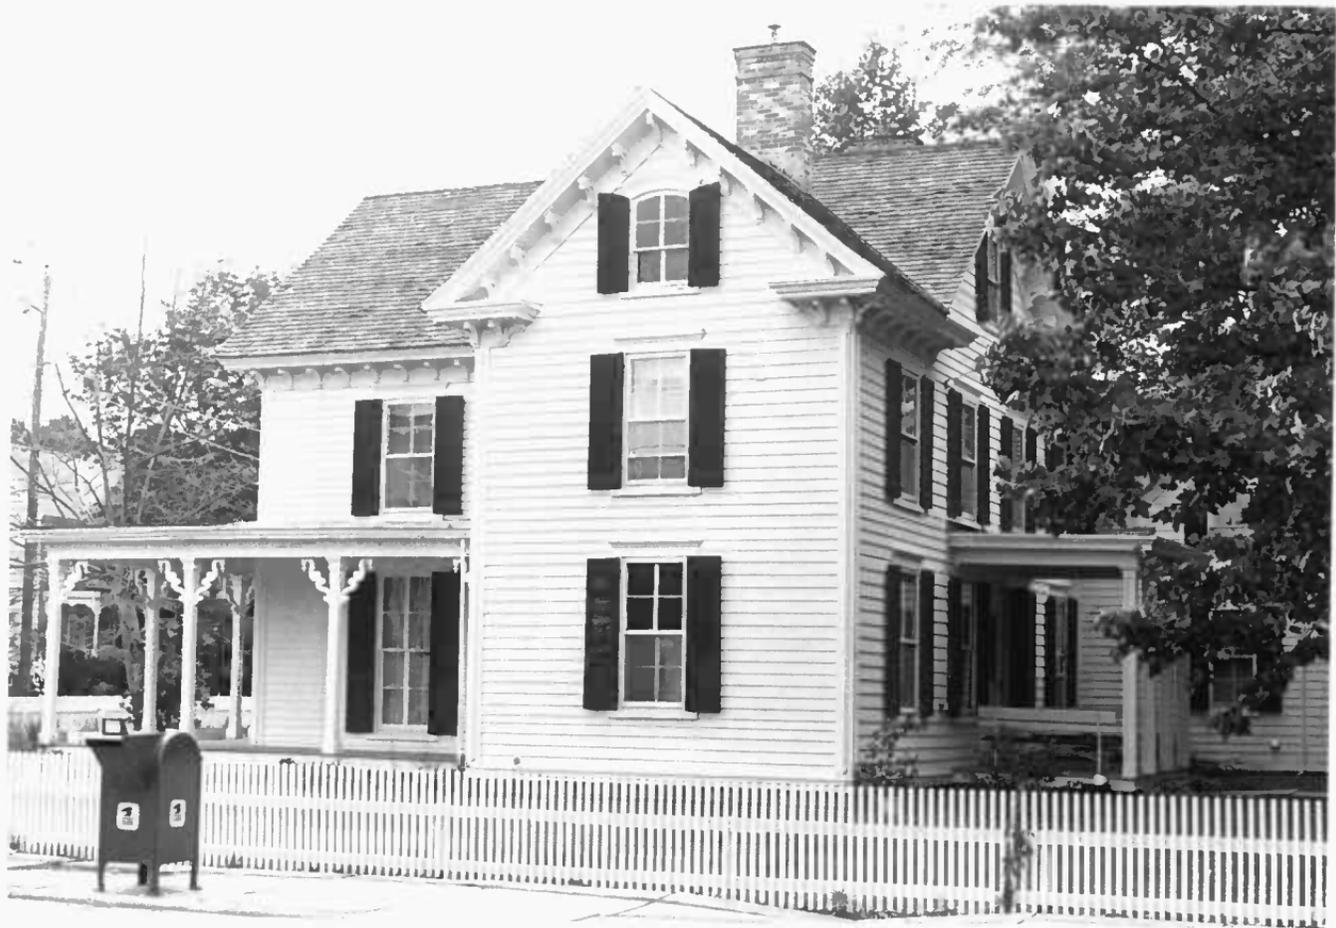
East Elevation

The east and west side elevations are essentially the same. The uneven facade of the tee-plan is pierced by a combination of four over four or two over two sash windows. The east gable end of the rear section has a single four over four sash on the first and second floors and a single four over two sash that lights the attic.
