S-338
 Adams Farm
 Princess Anne vicinity
 private

c. 1825-1860, c. 1900

National Register of Historic Places Registration Form

historic name Adams Farm
other names/site number Old Adams Farm S-338

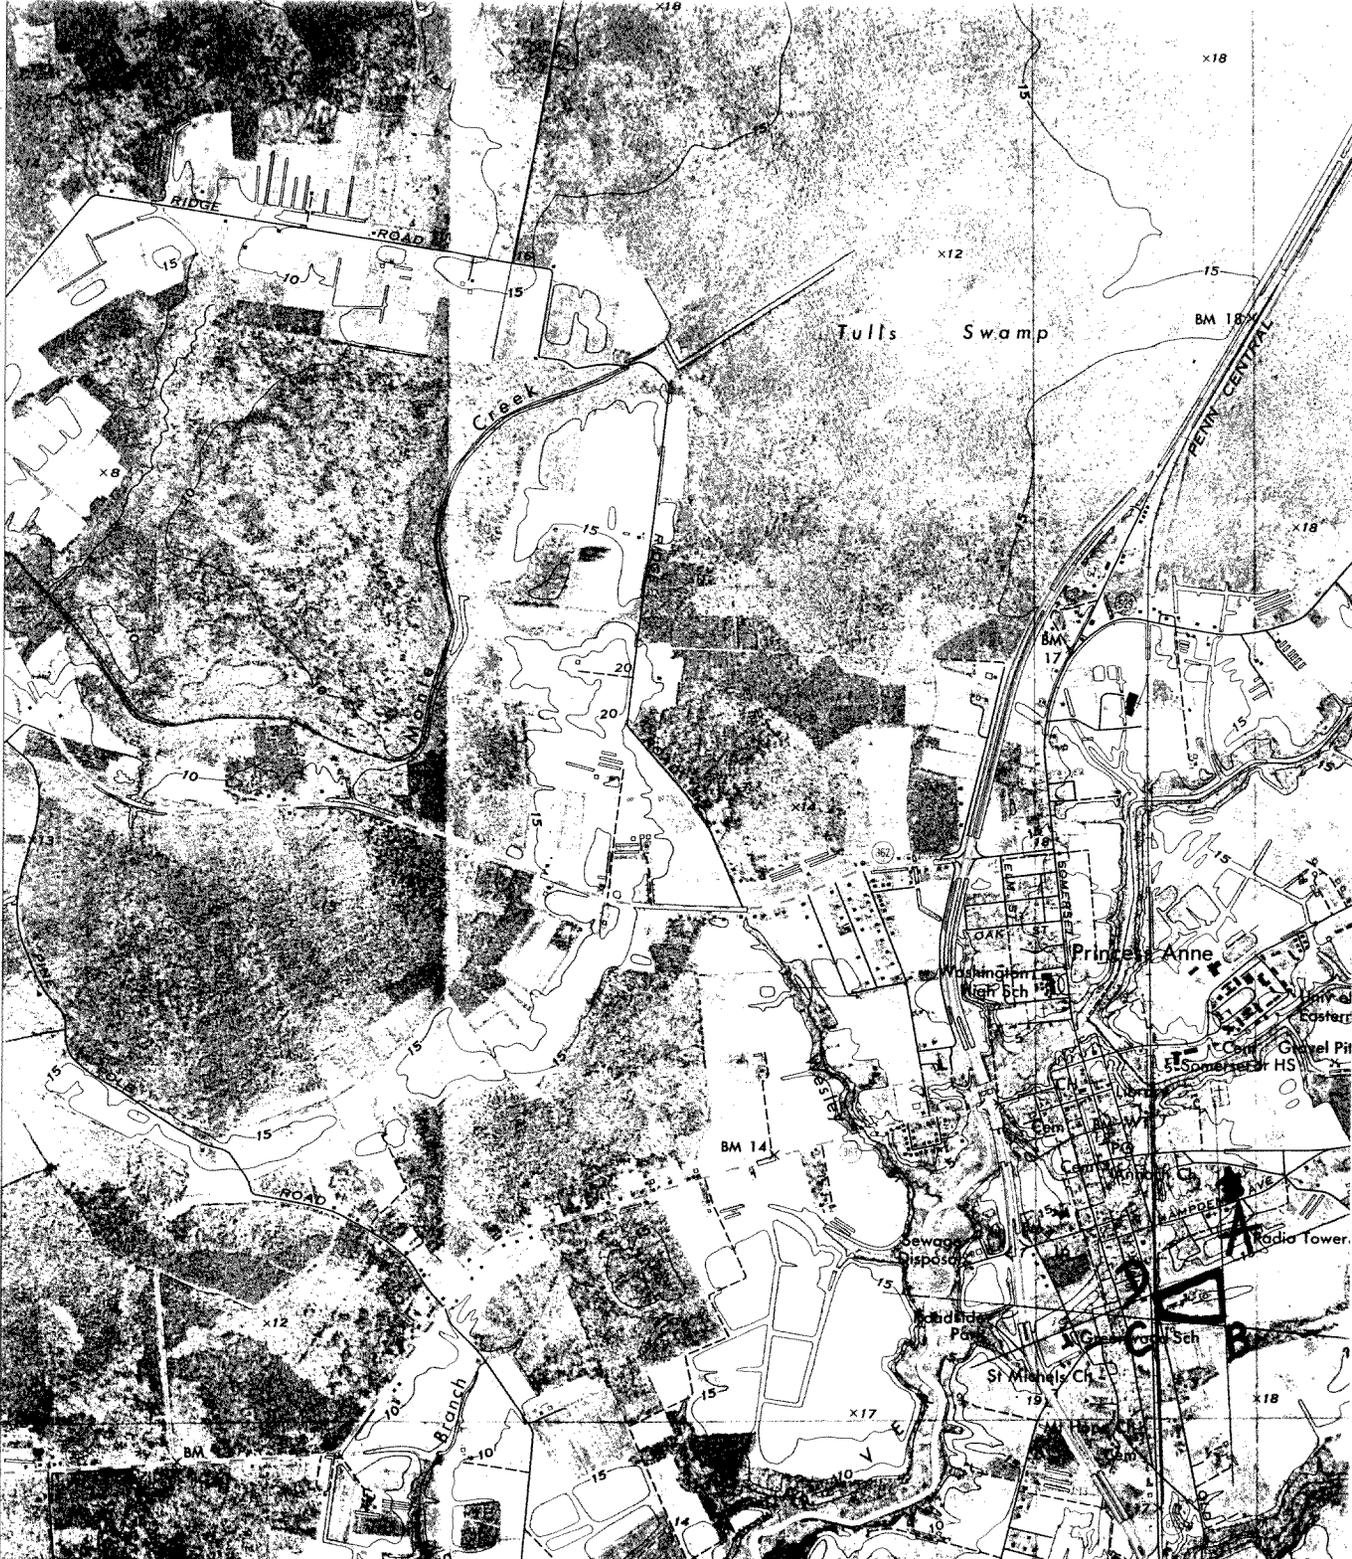
RESOURCE SKETCH MAP
1988

ADAMS FARM S-338
PRINCESS ANNE VICINITY
SOMERSET COUNTY, MD.
NO SCALE

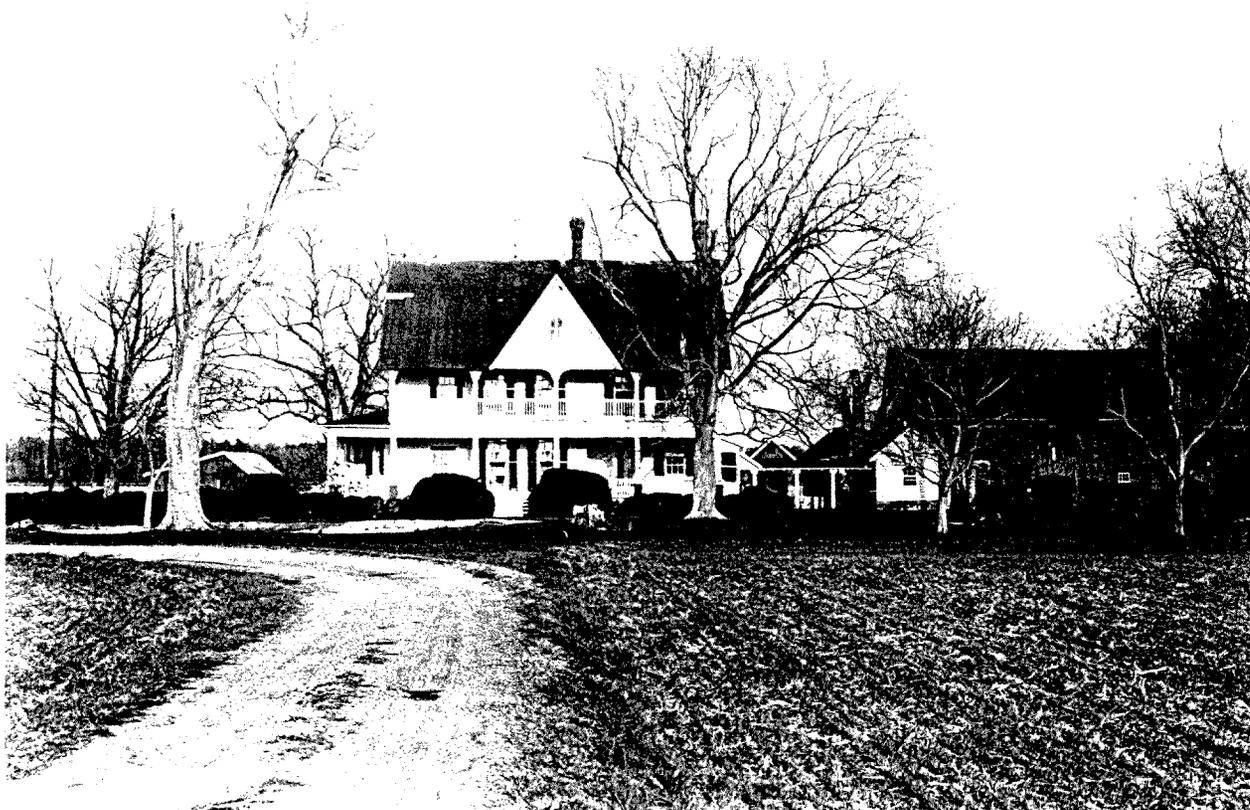
1/13

ADAMS FARM
5-338
PRINCESS ANNE VICINITY, SEWERGEE C., MD.
WEST ELEVATION
3186 PINE TERRACE, PHOTODUPLICATION
1450 / MD. HIST. TRUST

The facade or west elevation is asymmetrical and covered by a two-story engaged porch. The first floor of the porch is supported by Tuscan columns, probably dating circa 1900, on brick plinths. The second floor has chamfered posts trimmed with decorative corner brackets. These posts and brackets probably date from the 1880's. Stretching between the posts on both floors are turned baluster railings. The facade has a large cross-gable roof with fishscale shingles, a round arched two-over-two sash window, and pierced barge boards.

The first floor wall is an uneven surface marking the shift between the antebellum house and the turn of the century addition. The northern three bays, circa 1900, are filled with a side entrance (north bay and principal door) and two adjacent nine-over-two sash windows flanked by louvered shutters. The entrance has a partially paneled door with glazing above the lock rail. The southern two bays of the facade are set back from the main wall surface with a pair of French doors topped by a three-light transom and a six-over-six sash window flanked with louvered shutters. The surface of the second floor is even and lit by four large scale nine-over-two sash windows framed by louvered shutters and a small six-over-one sash window located in the northernmost bay.

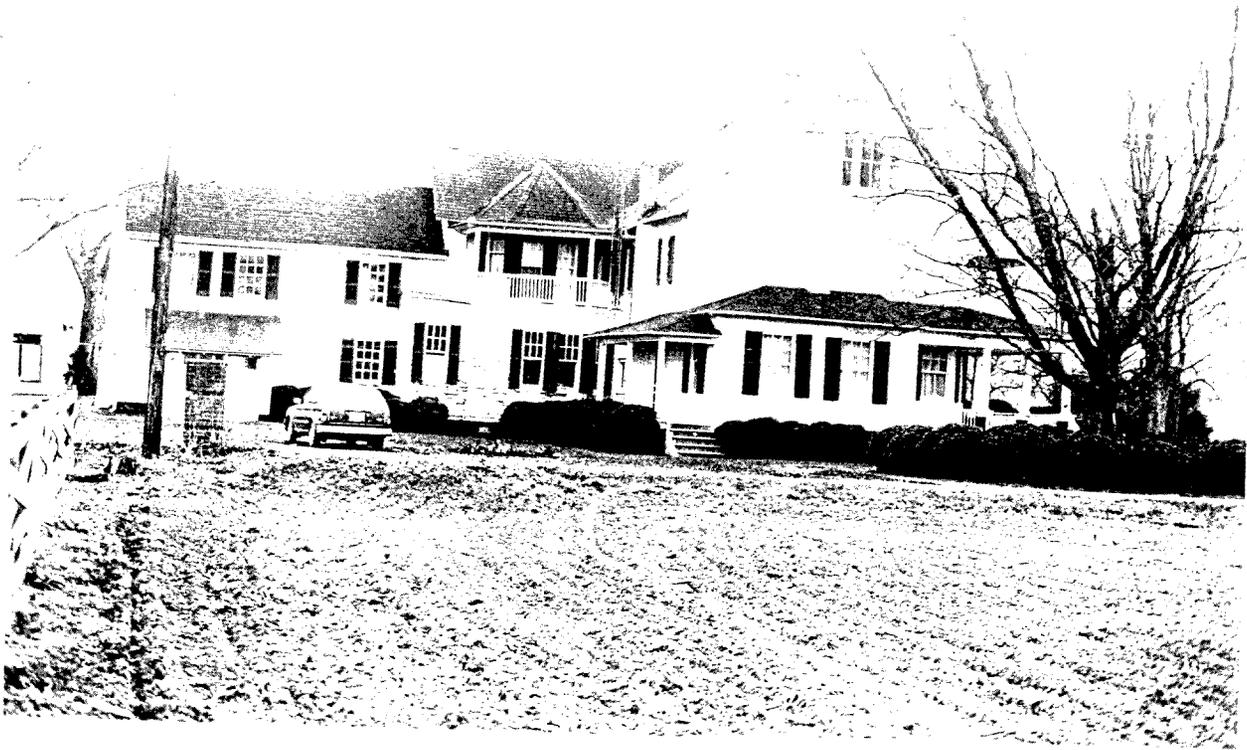
Adams Farm S-338
Princess Anne vicinity, Somerset County
North Elevation
2/86, Paul Touart, Photographer
Neg./Md. Historical Trust

The north gable end has a bay window on the first floor and a Tuscan columned porch which ties into the facade porch. The east portion of the first floor is enclosed under a shed roof with exposed and decorated rafter feet. The second floor is a blind wall. The gable has a three-part window. The point of the gable has decorative sawnwork. A narrow brick chimney finished with a corbelled cap rises on the exterior.

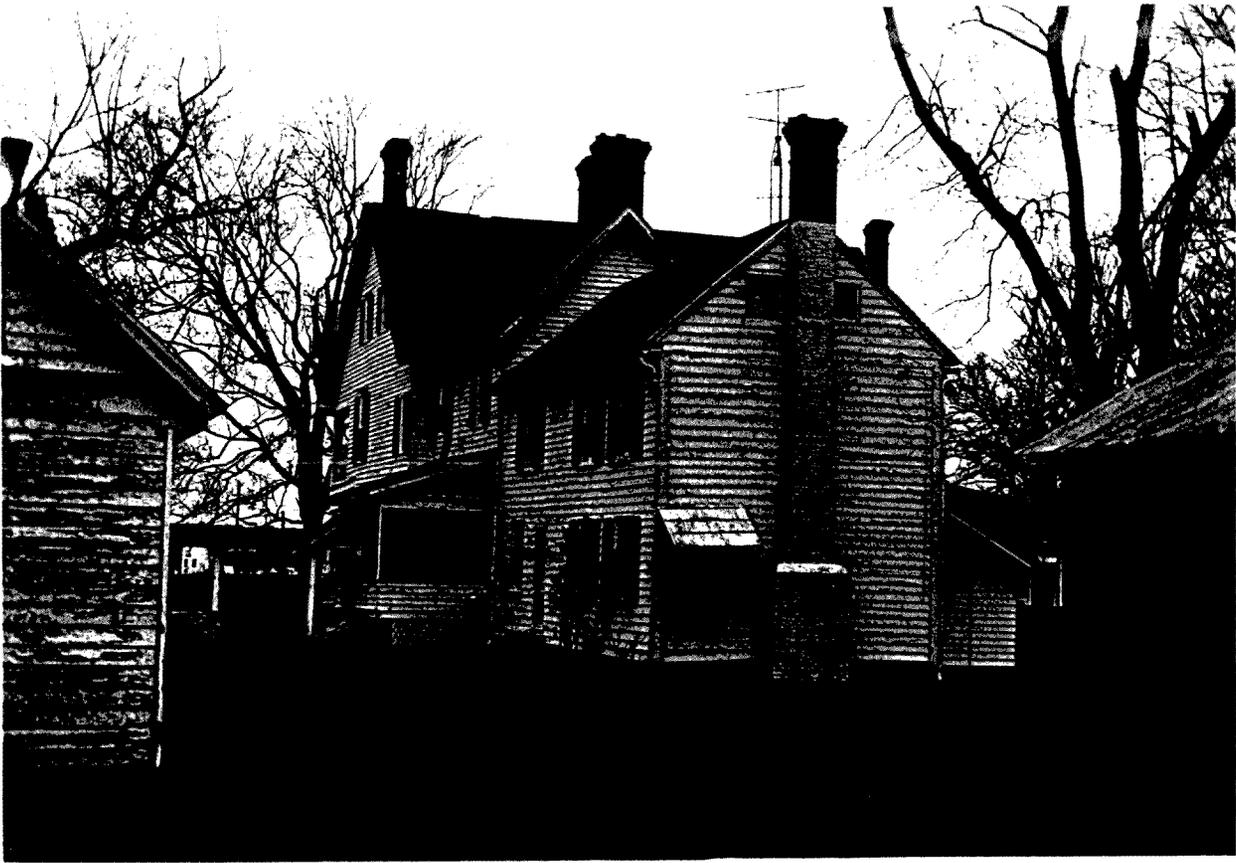
5/13

Adams Farm S-338
Princess Anne vicinity, Somerset County
East Elevation
2/86, Paul Touart, Photographer
Neg./Md. Historical Trust

The east wall of the main house is partially covered by the two-story service wing which was built in several stages. From construction evidence it appears a single-story hyphen connected the main house with the rear two-story service wing. A seam in the weatherboards and a shift in window construction between the upper and lower windows suggests such an arrangement. The second floor to the current kitchen was apparently raised at the same time the main house was enlarged upward. The northern section of the east wall has a single-story Tuscan columned rear porch that provides access to a back door.

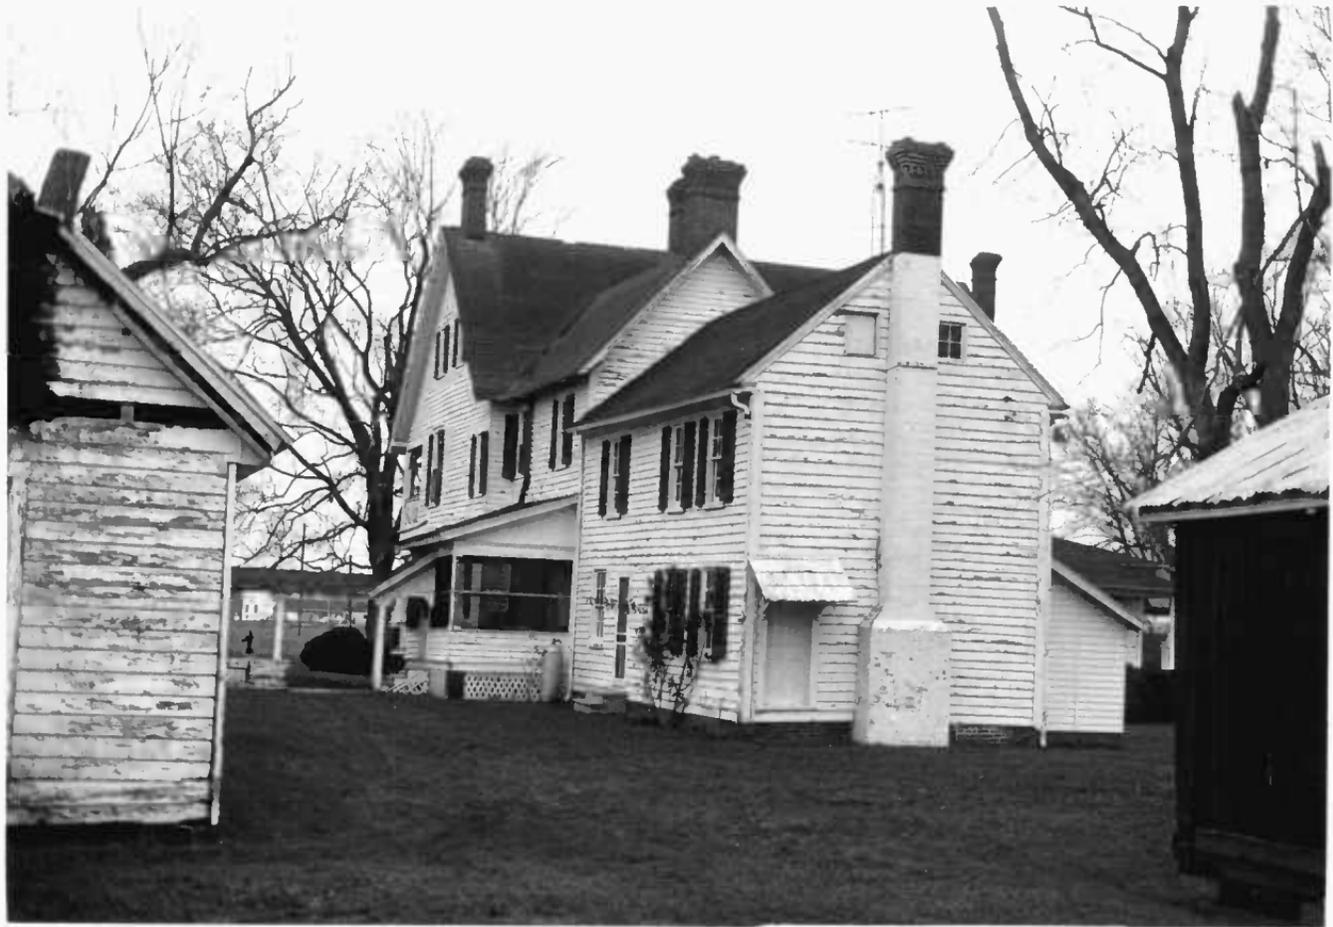
Adams Farm S-338
Princess Anne vicinity, Somerset County
East Elevation
2/86, Paul Touart, Photographer
Neg./Md. Historical Trust

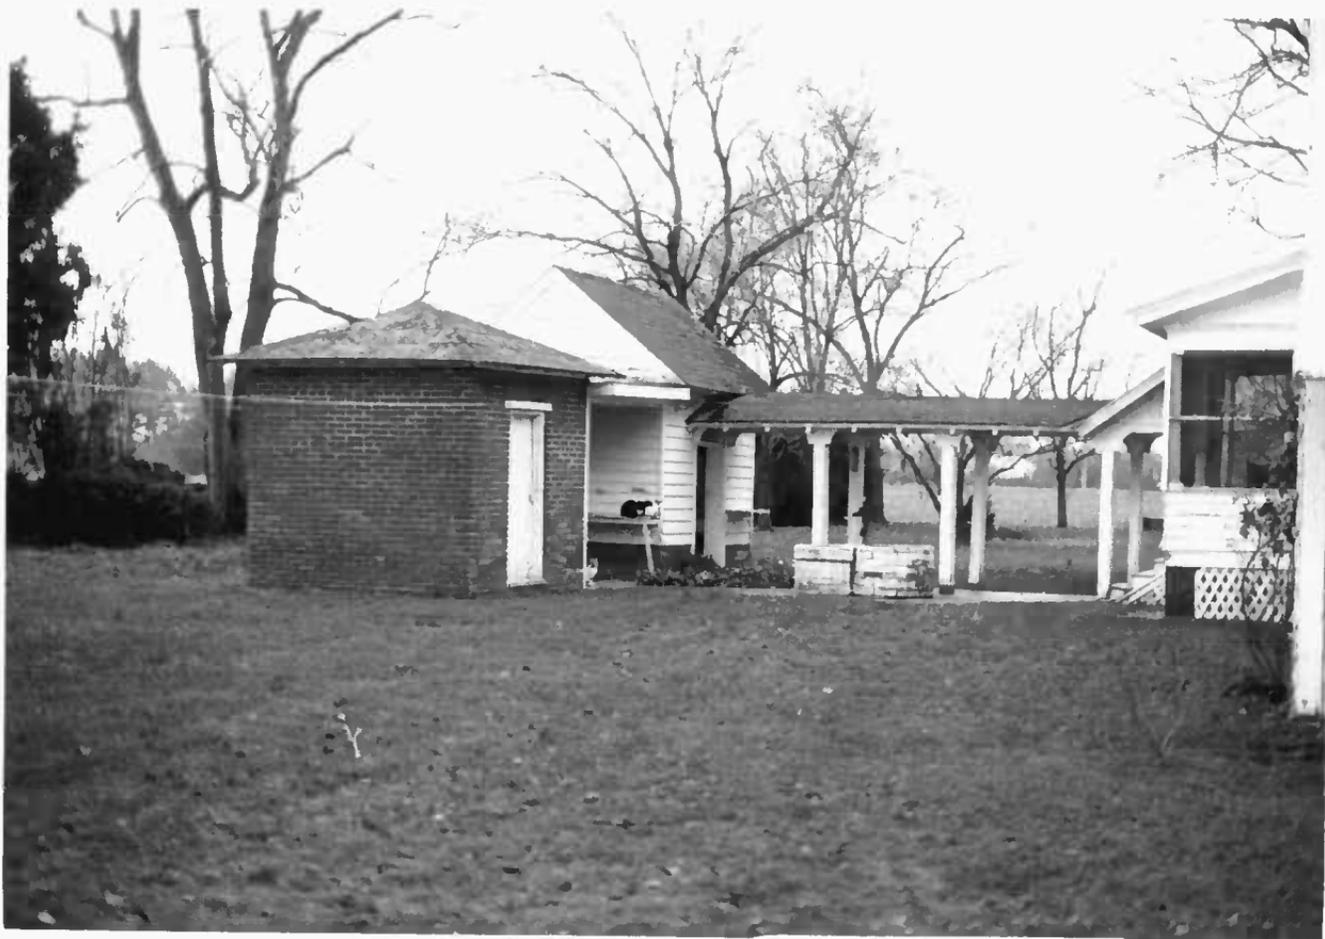
Adams Farm S-338
Princess Anne vicinity, Somerset County
Wash House and Dairy
2/86, Paul Touart, Photographer
Neg./Md. Historical Trust

Surrounding the farmhouse are over a dozen outbuildings, a boxwood garden and a lawn containing mature shade trees. Connected to the house by an open colonnade is a frame nineteenth century wash house supported by a brick foundation and covered with a wood shingle gable roof. Piercing the front wall is a board-and-batten door topped by a louvered vent. Six-over-six sash windows light the east and west walls, and a shed addition is attached to the south side. The interior has been reworked and is now covered with wall board.

A brick dairy with a pyramidal roof stands directly east of the wash house. Four seven-course common bond brick walls are covered by a pyramidal tin roof with exposed rafter feet. The interior has a sunken floor, and the walls are whitewashed. This building also dates from the nineteenth century.

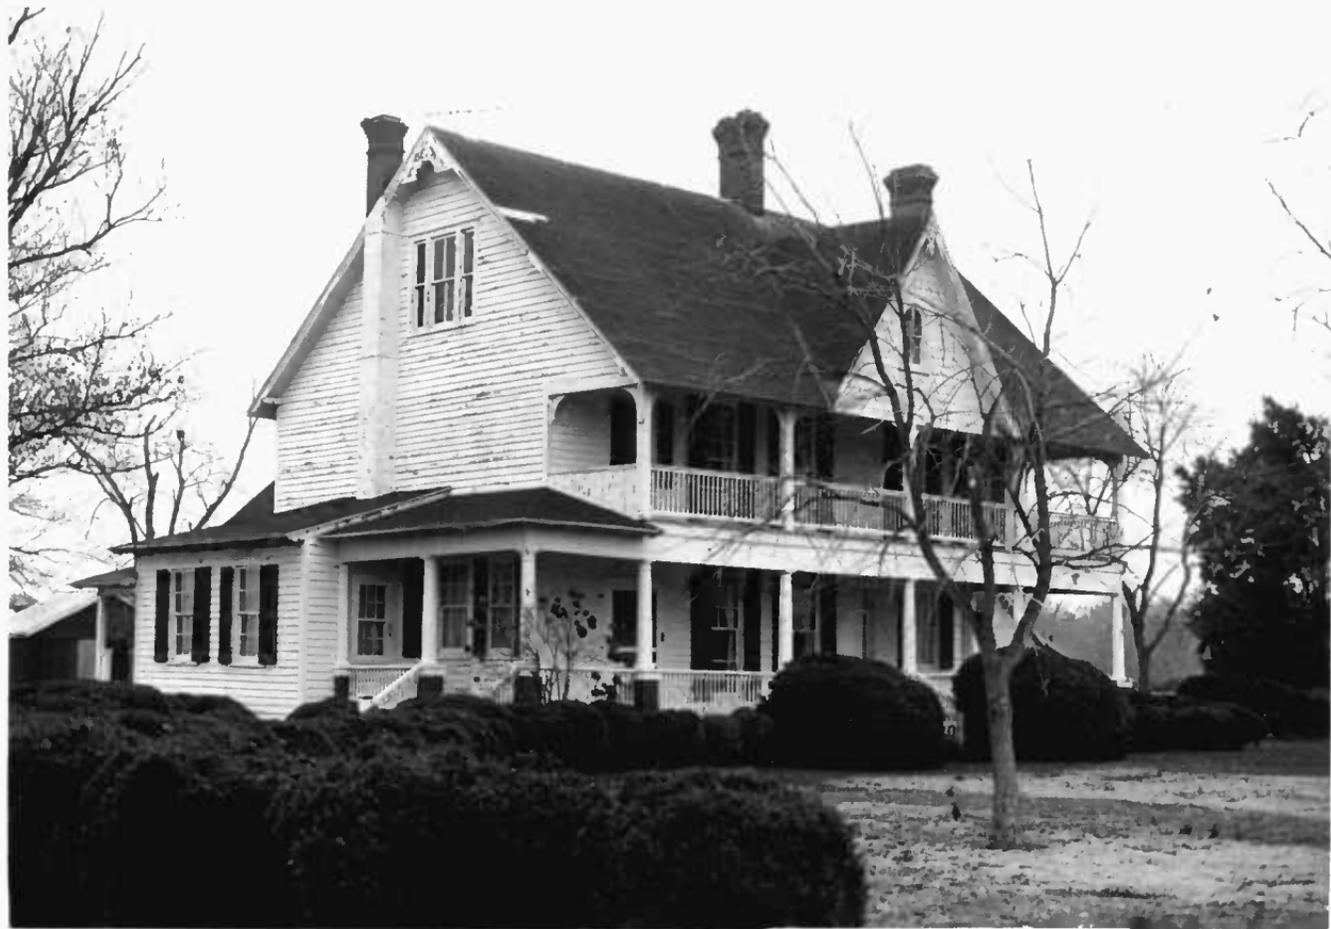
Adams Farm S-338
Princess Anne vicinity, Somerset County
Northwest Elevation
2/86, Paul Touart, Photographer
Neg./Md. Historical Trust

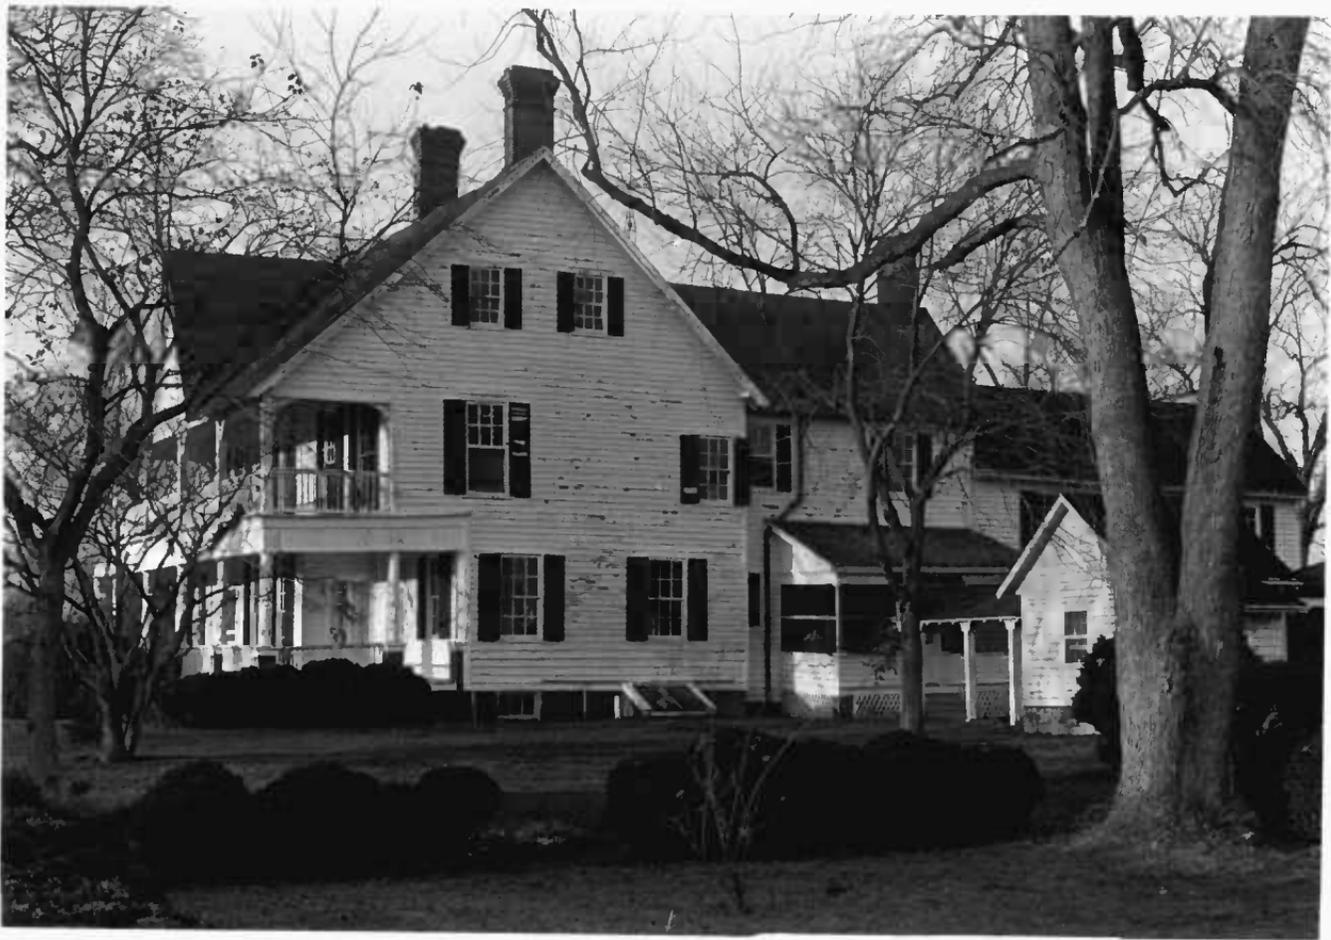
Adams Farm S-338
Princess Anne vicinity, Somerset County
South Elevation
2/86, Paul Touart, Photographer
Neg./Md. Historical Trust

The south wall of the house is an asymmetrical arrangement of six-over-six sash windows. A bulkhead cellar entrance and a small cellar window pierce the foundation wall. Two six-over-six windows light the attic and flank the interior end brick chimney. The chimney has a corbelled top.

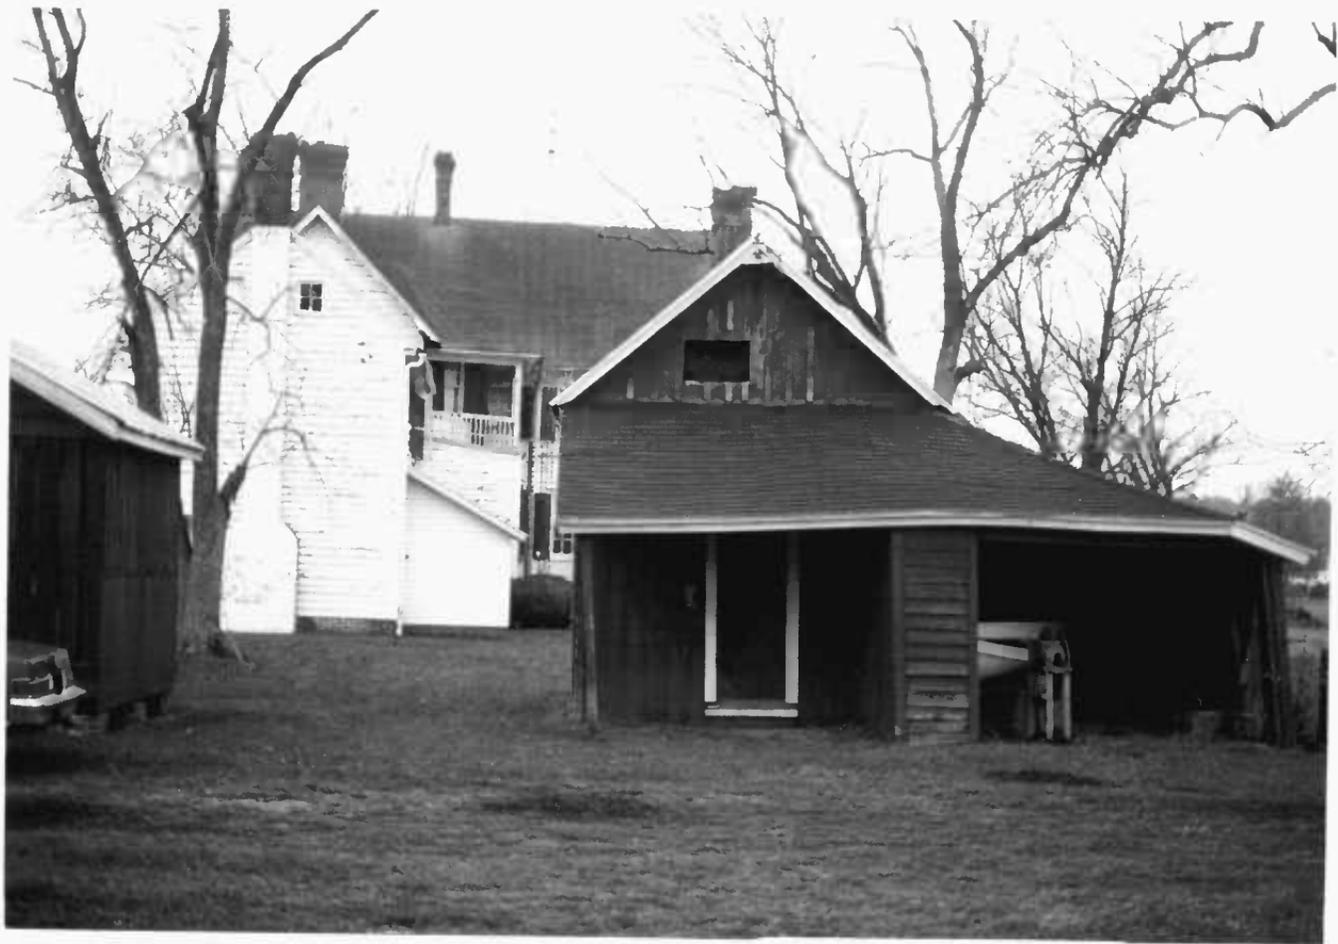
Adams Farm S-338
Princess Anne vicinity, Somerset County
Potato House and Dwelling
2/86, Paul Touart, Photographer
Neg./Md. Historical Trust

A converted nineteenth century potato house stands immediately north of the paired corn crib. Now used as a pigeon house, the single-story frame structure has a minimal brick foundation and an asphalt shingle roof. Shed roofed extensions are attached to the north and east sides, and a narrow brick stove stack rises on the west gable end. The interior has been fitted with board sheathing.

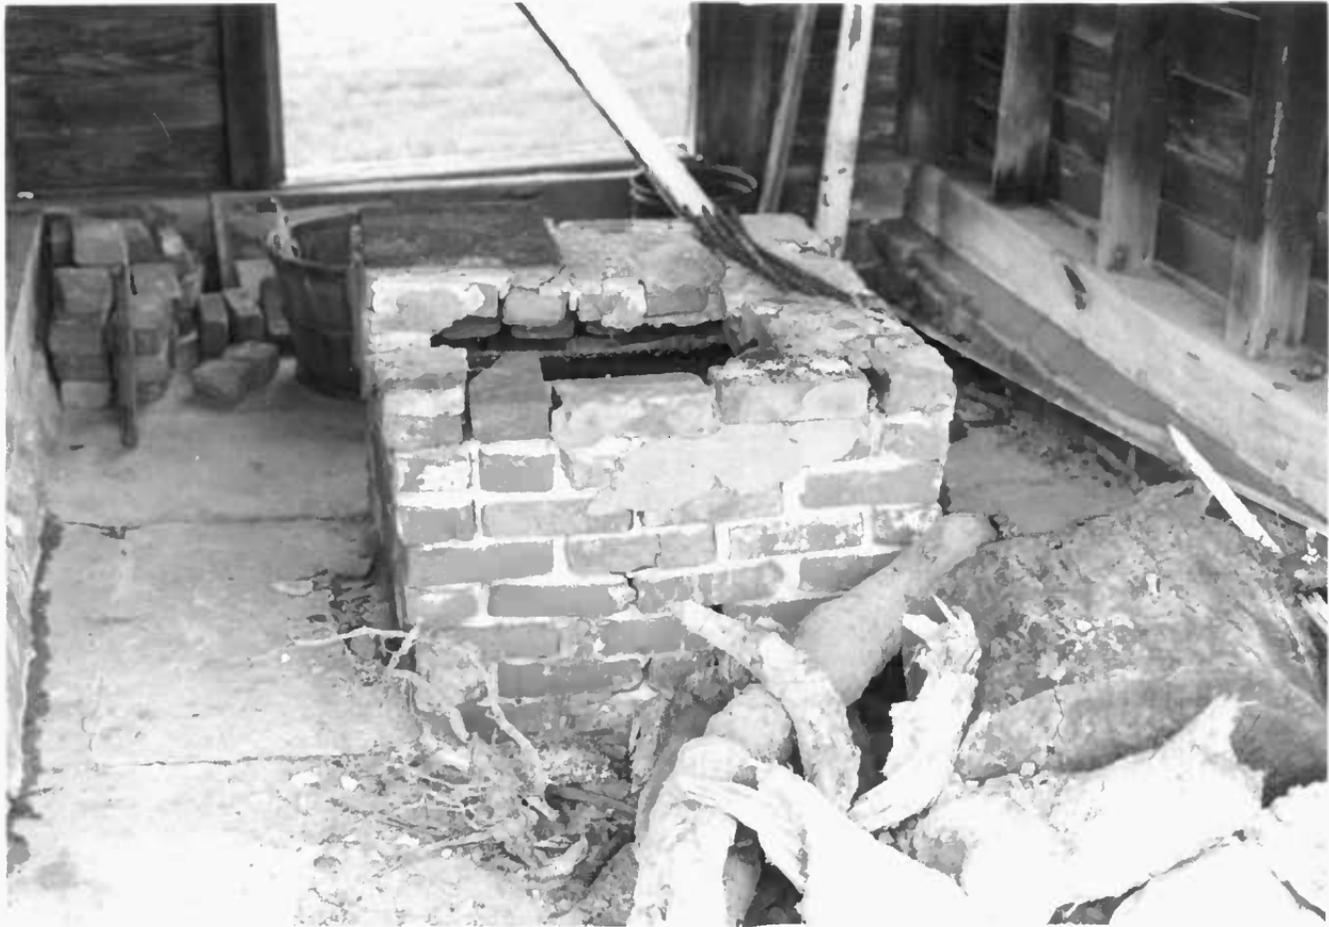
Adams Farm S-338
Princess Anne vicinity, Somerset County
Smoke House Hearth
2/86, Paul Touart, Photographer
Neg./Md. Historical Trust

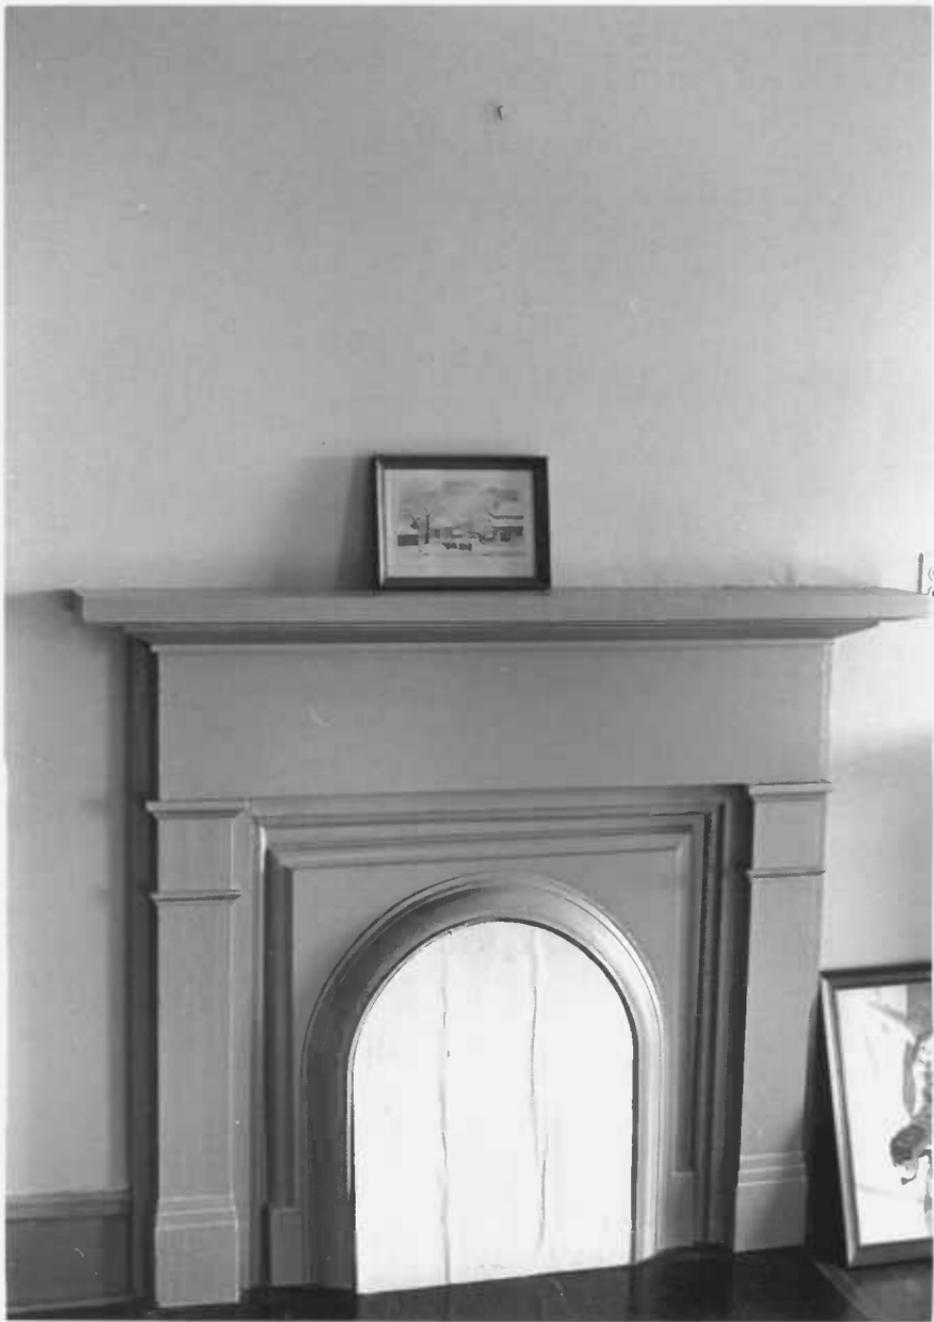
Adams Farm S-338
Princess Anne vicinity, Somerset County
Bedroom Mantel
2/86, Paul Touart, Photographer
Neg./Md. Historical Trust

The front bedrooms are largely fitted with Victorian style woodwork, however, a mid-nineteenth century Greek Revival mantel is located in the middle bedroom. The Greek Revival mantel has simplified pilasters, a plain frieze and a thick mantel shelf. The pilaster bases are stepped in the same manner as the door surround in the dining room. The southwest bedroom has a turn of the century mirrored mantel piece with slender colonettes flanking a

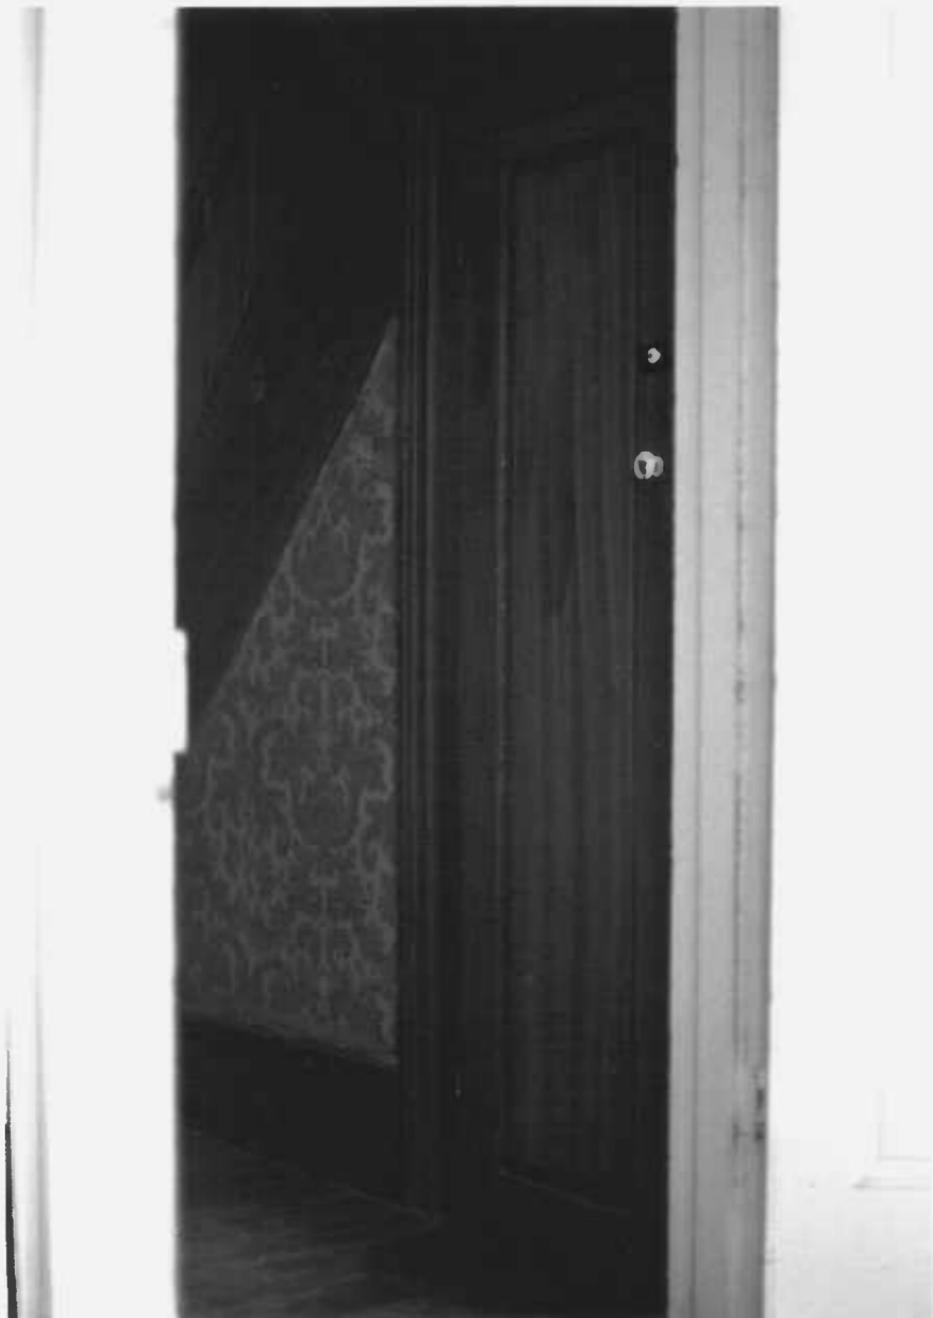
Adams Farm S-338
Princess Anne vicinity, Somerset County
Attic Stair Closet
2/86, Paul Touart, Photographer
Neg./Md. Historical Trust

The second floor of the main block is divided into three bedrooms with a rear hall. A four-panel door opening from the back hall provides access to a narrow passage and closed stringer attic stair. The staircase retains its Victorian layer of oak graining. A one-panel door opens into the closet space beneath the stair. Chamfered newel posts are topped by ball finials. A circular profile handrail and rectangular balusters are reused elements from an early to mid-nineteenth century stair.
